5.0 Falls City, Texas, Disposal Site

The Falls City, Texas, Uranium Mill Tailings Radiation Control Act (UMTRCA) Title I Disposal Site (site) was inspected on March 6, 2019. No changes were observed in the disposal cell or associated drainage features, and inspectors found no cause for a follow-up inspection.

Figure 5-1. 2019 Annual Inspection Drawing for the Falls City, Texas, Disposal Site

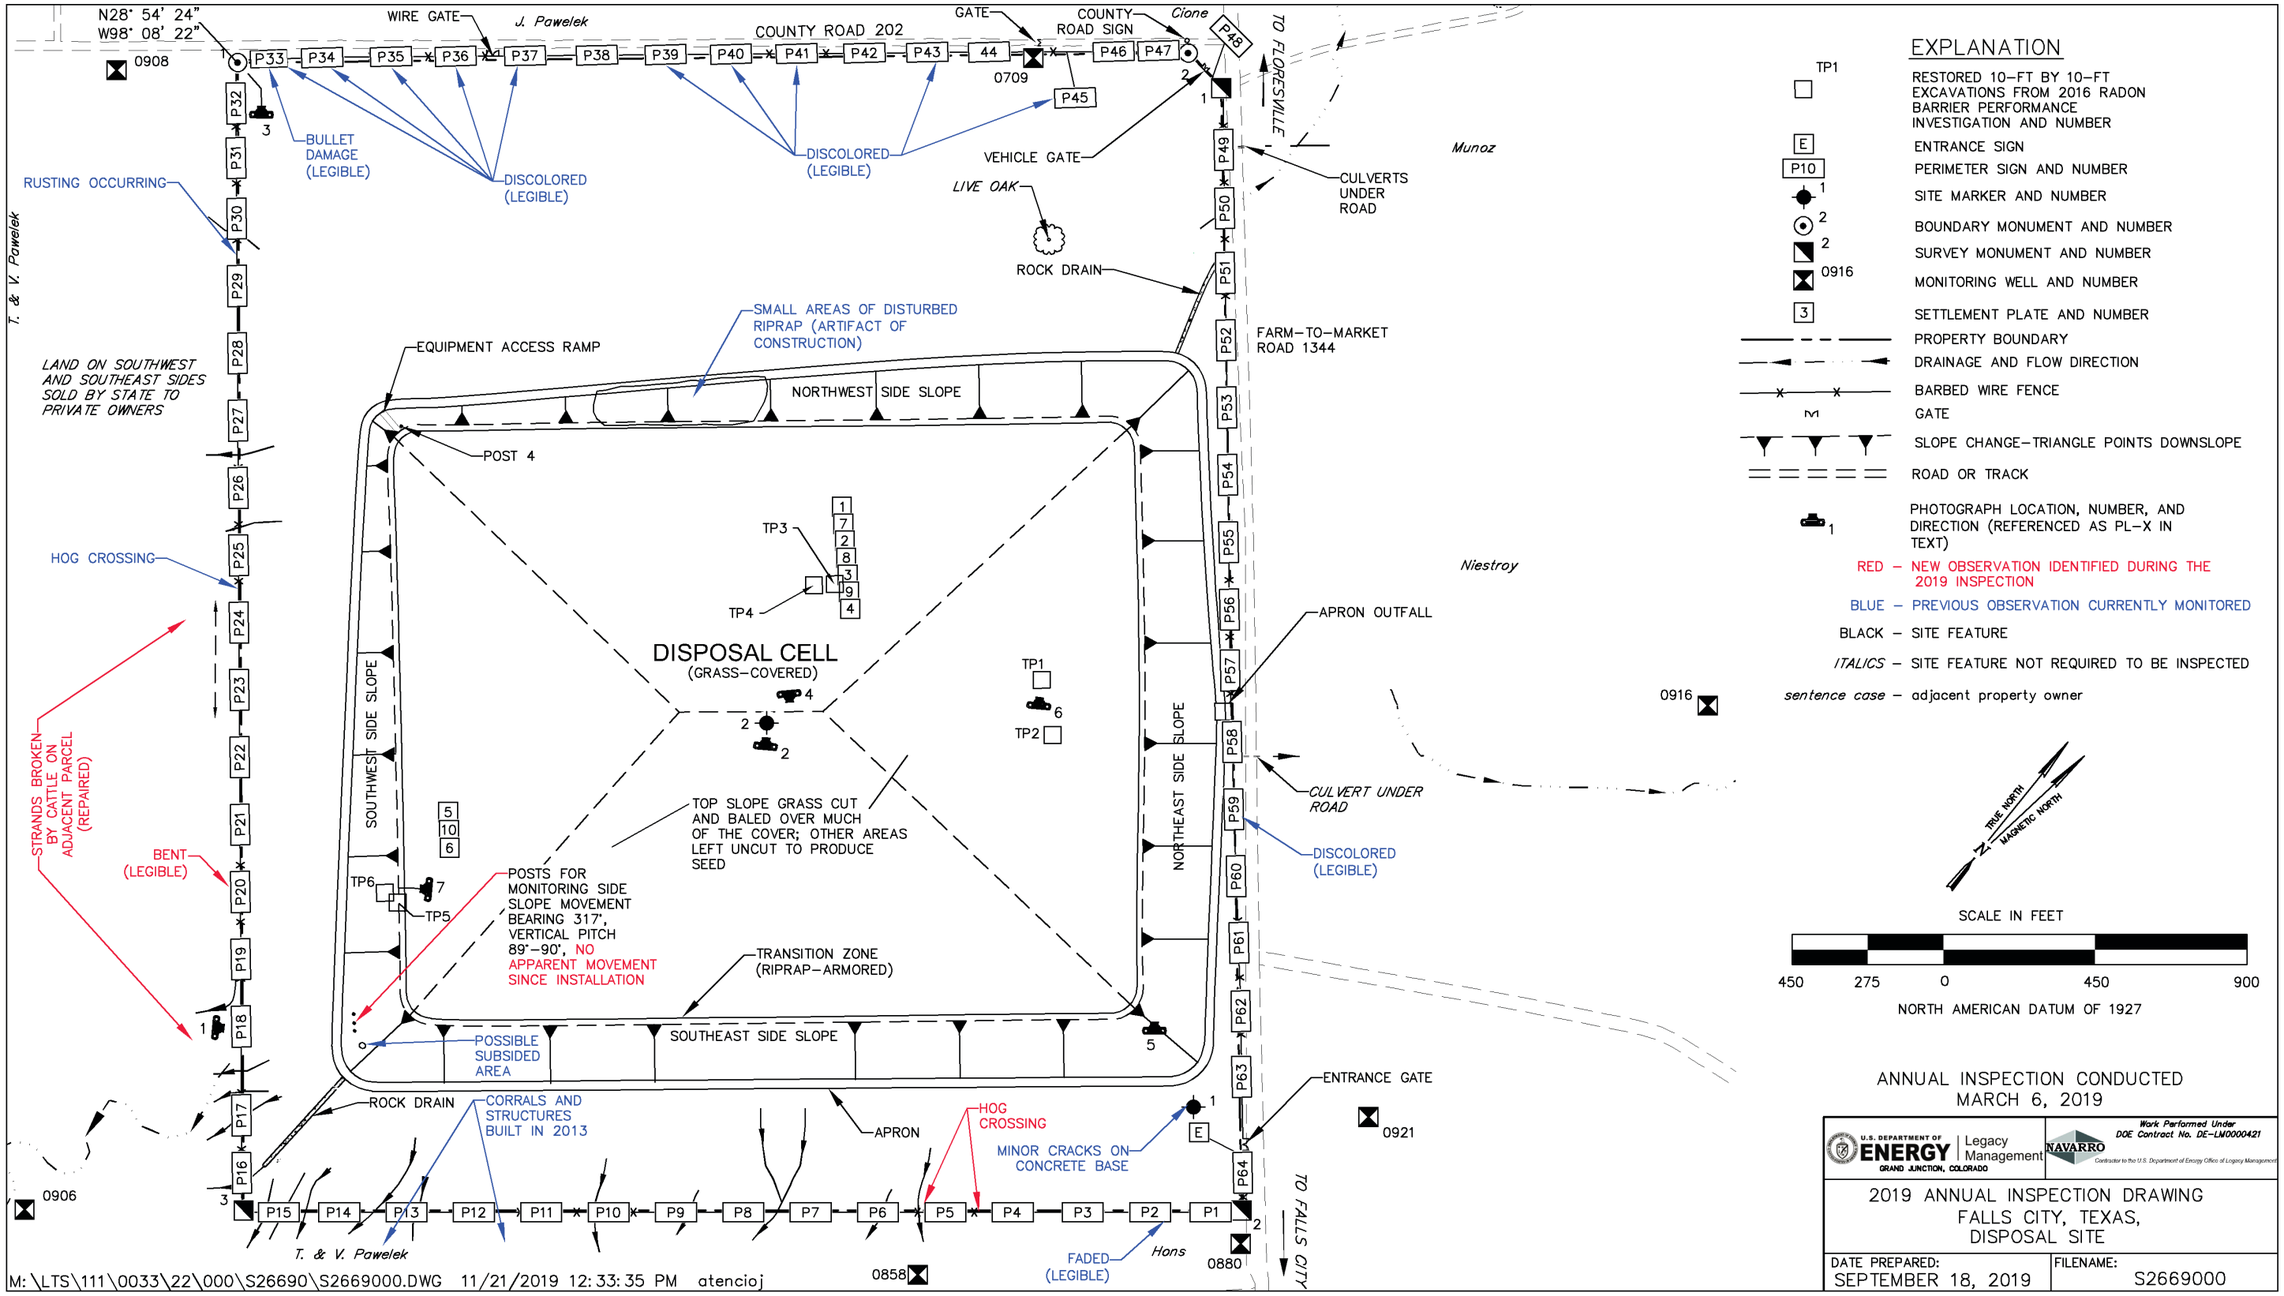
Figure 5-1 shows the locations of site features in black, including site surveillance features and inspection areas. Site features that are present but not required to be inspected are shown in italic font. Observations from previous inspections that are currently monitored are shown in blue text, and new observations identified during the 2019 annual inspection are shown in red. Inspection results and recommended maintenance activities associated with site surveillance features are described in the following subsections. Photographs to support specific observations are noted in the text and in Figure 5-1 by photograph location (PL) numbers. The photographs and photograph log are presented in Section 5.10.

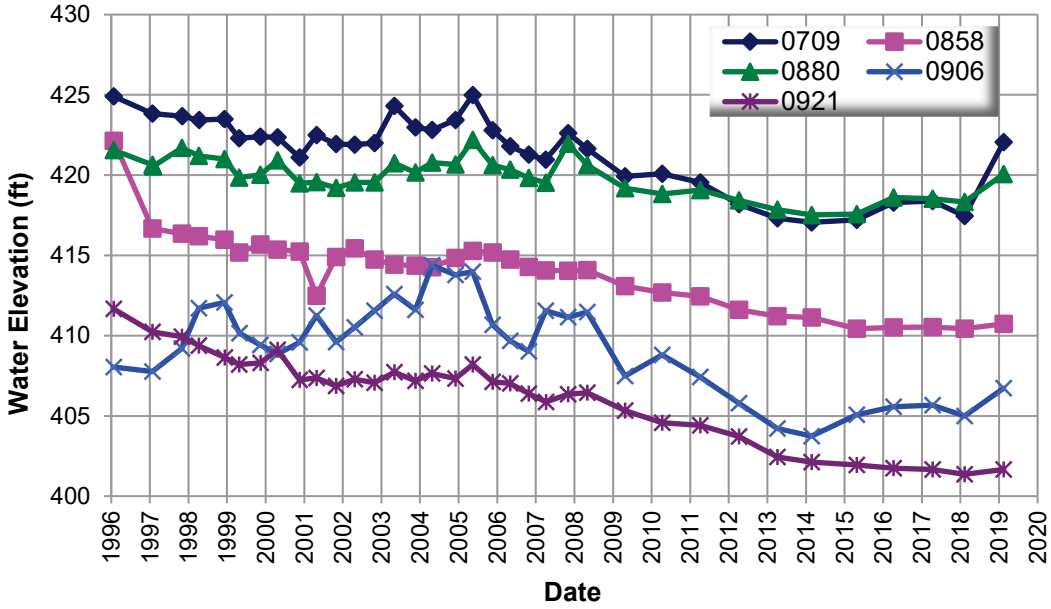
Figure 5-3. Water-Level Measurements at Disposal Cell Performance Monitoring Wells at the Falls City, Texas, Disposal Site

Since 1996, groundwater levels in the disposal cell performance monitoring wells have decreased overall, with decreases ranging from approximately 3 to 12 ft (Figure 5-3). In 2019, water levels in monitoring wells 0709, 0880, and 0906 increased at a steeper rate of change than has occurred in recent years (Figure 5-3), while water levels in monitoring wells 0858 and 0921 increased less abruptly. The water level in monitoring well 0906 has fluctuated more than water levels in the other monitoring wells, showing other short-term increases while decreasing over the longer period. The reason why 0906 fluctuates more than other wells is unknown. The general decrease in water levels across the entire disposal cell performance monitoring network might reflect (1) the dissipation of the processing site–related groundwater mound beneath the disposal cell or (2) the reduction of transient drainage from the disposal cell. Monitoring wells 0908 and 0916 are not shown in Figure 5-3 nor subsequent time concentration plots

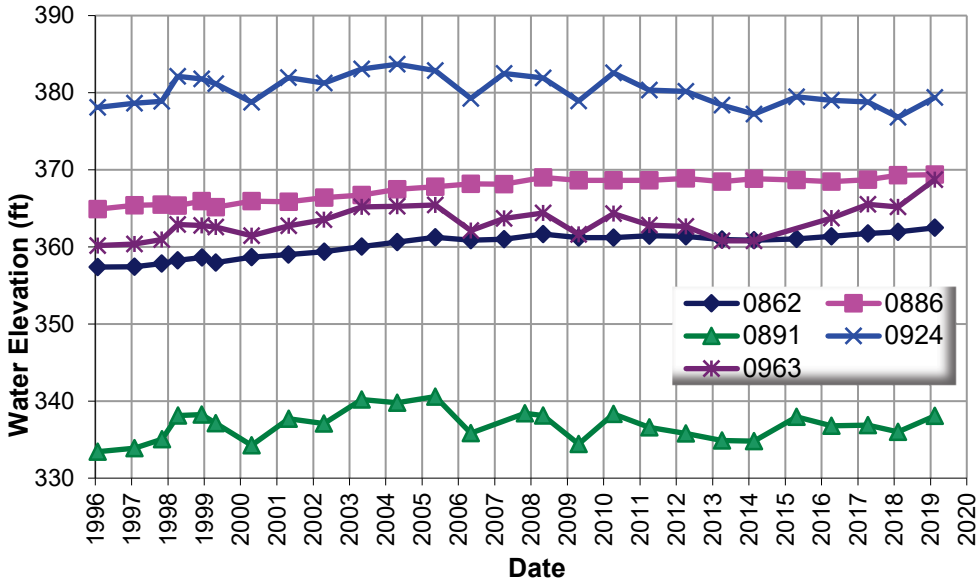
Figure 5-4. Water-Level Measurements at Groundwater Compliance Monitoring Wells at the Falls City, Texas, Disposal Site

Mann-Kendall testing indicates water level trends are generally increasing in the groundwater compliance monitoring wells 0862, 0886, 0891, and 0963 (Figure 5-4). Overall, these water levels have increased about 4 ft since 1996. Mann-Kendall testing indicates no trend in water levels at monitoring well 0924.

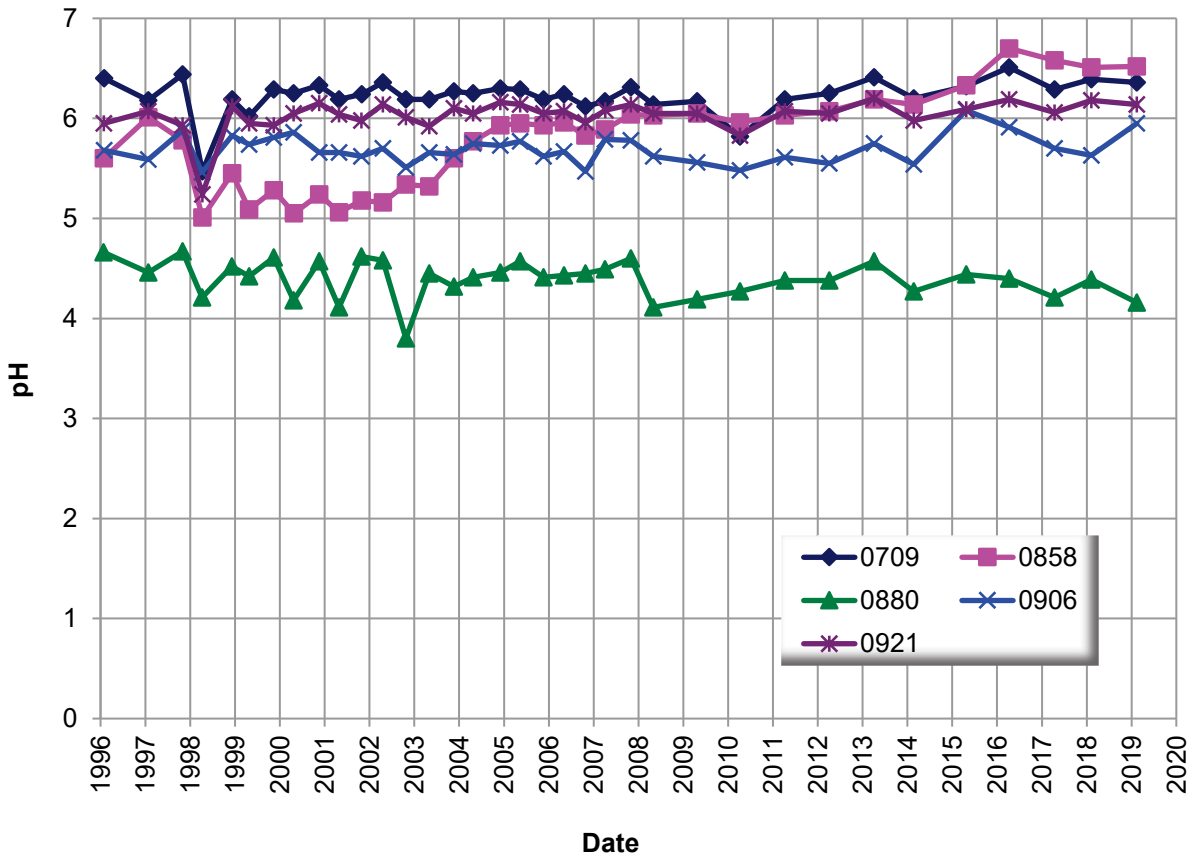
Figure 5-5. pH at Disposal Cell Performance Monitoring Wells at the Falls City, Texas, Disposal Site

pH: At the disposal cell performance monitoring wells, pH levels have historically been greater than the pH in tailings pore fluids (pH level of 2.93), with no significant upward or downward trends. Mann-Kendall testing indicates no trend in pH values at monitoring wells 0709 and 0906, an increasing trend at monitoring wells 0858 and 0921, and a decreasing trend at monitoring well 0880. In 2019, the pH levels in monitoring wells 0709, 0880, and 0921 decreased slightly, while the pH levels for monitoring well 0858 and 0906 increased slightly. The 2019 pH levels were within the range of historical values for all disposal cell performance monitoring wells (Figure 5-5).

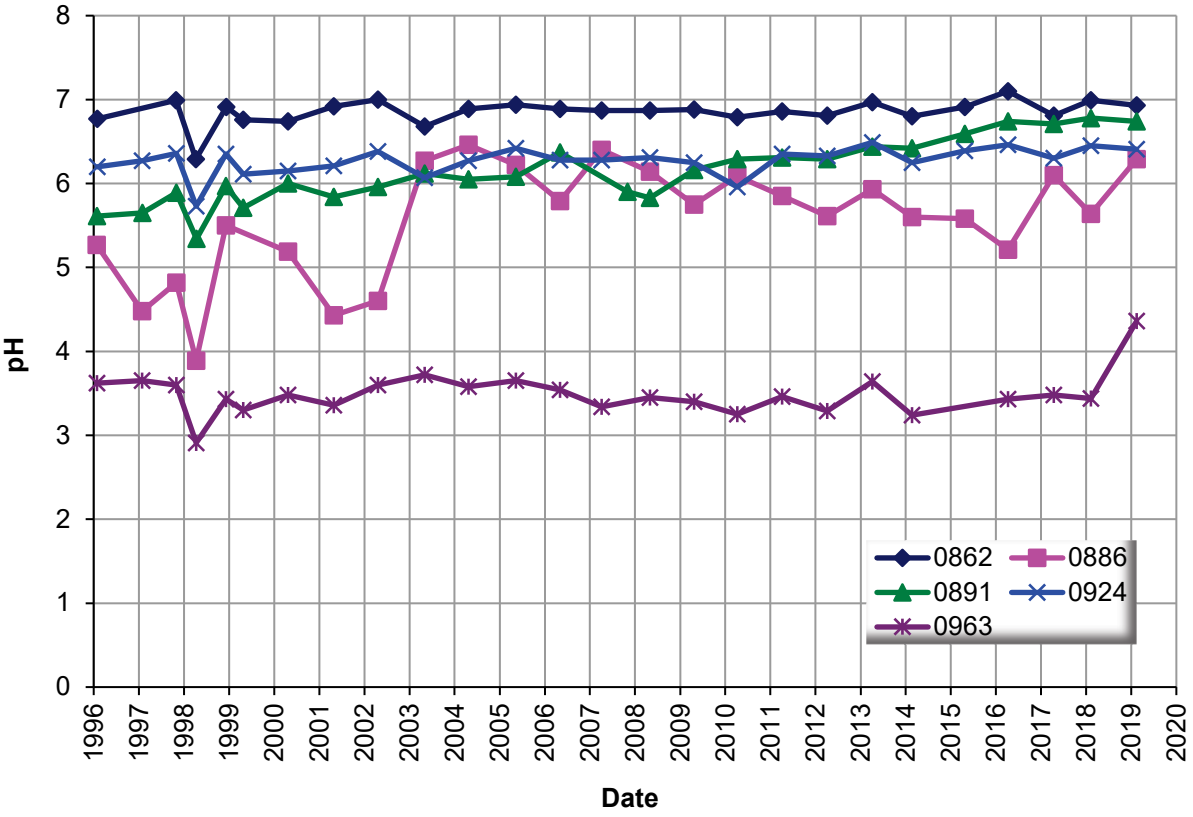
Figure 5-6. pH at Groundwater Compliance Monitoring Wells at the Falls City, Texas, Disposal Site

At the groundwater compliance monitoring wells, pH levels have historically been greater than the pH in groundwater contaminated by processing activities, with no significant upward or downward trends. Mann-Kendall testing indicates no trend in pH values at monitoring wells 0862, 0886, and 0963 and an increasing trend at monitoring wells 0891 and 0924. In 2019, the pH levels for monitoring wells 0886 and 0963 increased, while the pH levels for monitoring wells 0862, 0891, and 0924 slightly decreased (Figure 5-6). The 2019 pH levels were within the range of historical values for all groundwater compliance monitoring wells except monitoring well 0963, where the pH has increased above the historical maximum. The pH in monitoring

well 0963 historically has been lower than at the other locations, and in 2019 it remains similar to the pH in the tailings pore fluids.

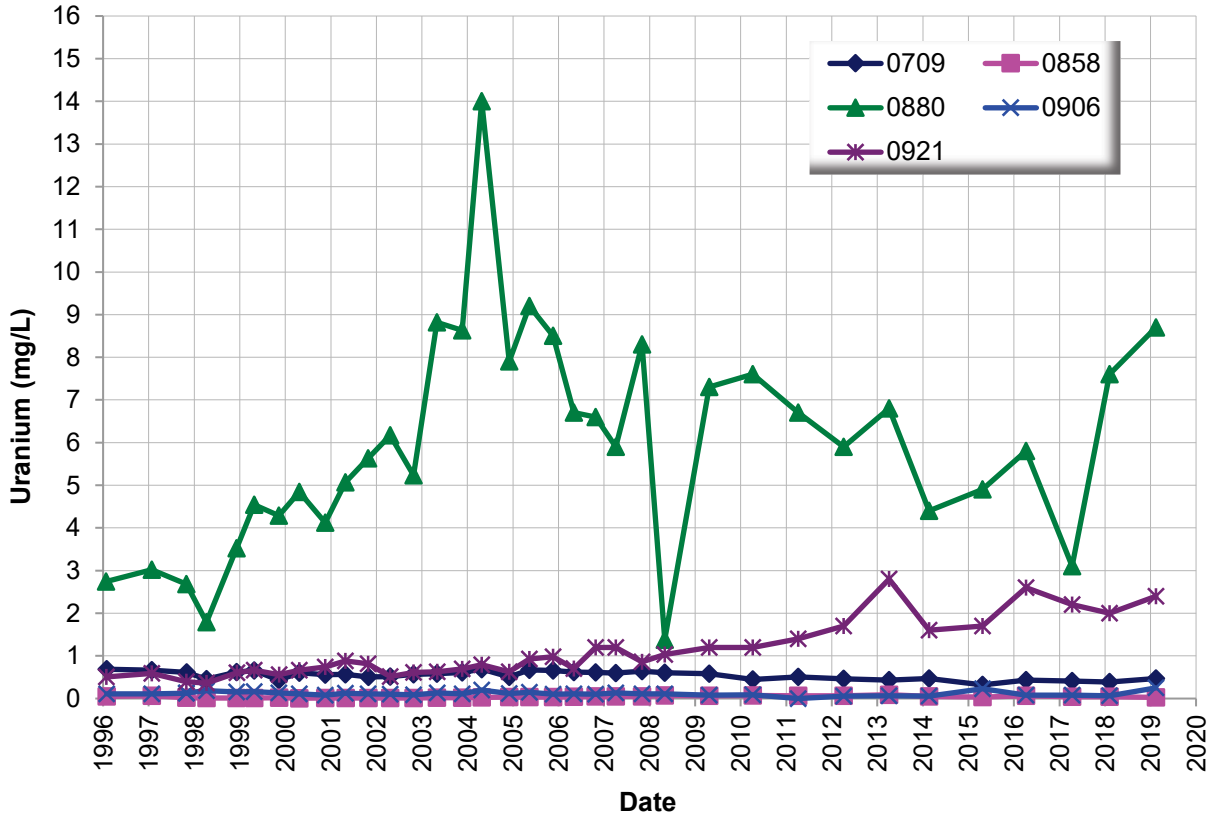
Figure 5-7. Uranium Concentrations at Disposal Cell Performance Monitoring Wells at the Falls City, Texas, Disposal Site

Uranium: The 2019 uranium concentrations for disposal cell performance monitoring wells were within the range of historical values for all groundwater compliance monitoring wells (Figure 5-7). In 2019, the uranium concentrations for monitoring wells 0709, 0906, and 0858 remained generally constant when compared with previous results. The uranium concentration in monitoring well 0921 increased slightly, maintaining a generally increasing trend. The concentration in monitoring well 0880 increased from 7.6 milligrams per liter (mg/L) to 8.7 mg/L. Uranium concentrations in monitoring well 0880 show considerable variation, ranging from a low of 1.38 mg/L in 2008 to a high of 14 mg/L in 2004, and the 2019 uranium concentration is within the range of historical concentrations.

Uranium concentrations in disposal cell performance monitoring well 0880 have varied considerably since 1996, ranging from 1.38 mg/L in 2008 to 14 mg/L in 2004 (Figure 5-7). The uranium concentration was 8.7 mg/L in 2019. The pH at this location is less than at other disposal cell performance monitoring wells. Water levels at all the cell performance monitoring wells trended lower from 2007 until 2016, then increased in recent years (Figure 5-3). Because the uranium concentrations at some of the cell performance monitoring wells have been steady and concentrations vary at other locations, local conditions are likely influencing uranium concentrations. This is reasonable because (1) the disposal cell is located on tailings that were placed in existing open pit mines, (2) subeconomic ore remains in unmined areas, (3) the uppermost aquifer beneath the cell is oxidized and near the aquifer recharge area, and (4) uranium mineralization processes, which involve redistributing and concentrating uranium in the formation materials, are ongoing. Given the local conditions listed above, it is difficult to assess whether elevated uranium concentrations in the uppermost aquifer are a result of disposal cell performance or existing background conditions.

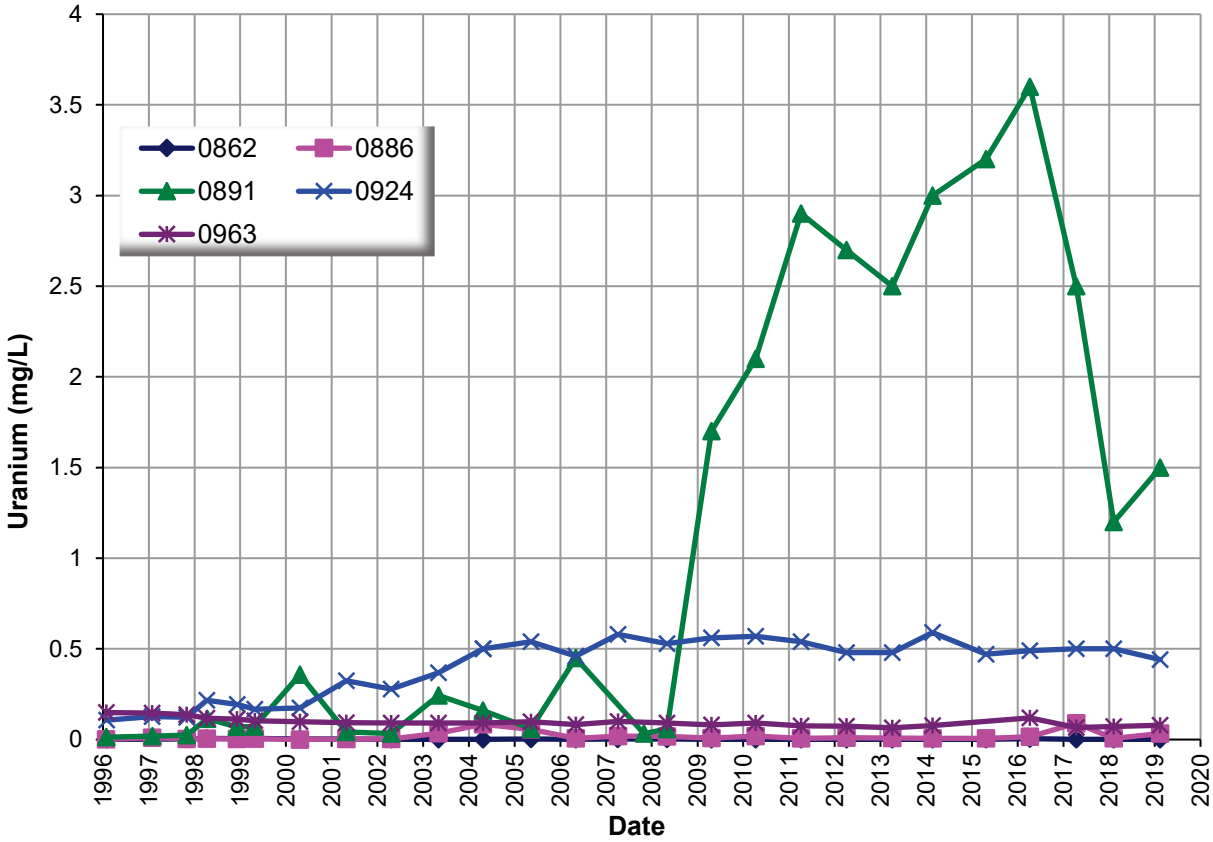
Figure 5-8. Uranium Concentrations in Groundwater Compliance Monitoring Wells at the Falls City, Texas, Disposal Site

The 2019 uranium concentrations for groundwater compliance monitoring wells were within the range of historical values for all groundwater compliance monitoring wells (Figure 5-8). The uranium concentration at monitoring wells 0862, 0886, and 0963 remains less than 0.2 mg/L. The uranium concentration at monitoring well 0924 has been relatively stable since 2004, fluctuating between 0.4 mg/L and 0.6 mg/L. Since 2008, the uranium concentrations measured at monitoring well 0891 have been greater than at other monitoring wells and are currently elevated when compared to the historical range for the well but not for the historical range of the aquifer (DOE 2010). The 2019 uranium result (1.5 mg/L) at monitoring well 0891 is slightly greater than the 2018 result at this location (1.2 mg/L) but remains significantly less than the 2016 uranium result of 3.7 mg/L and less than the uranium concentration value used for groundwater in the Dilworth aquifer in the *Baseline Risk Assessment of Ground Water*

Contamination at the Uranium Mill Tailings Site Near Falls City, Texas (3.04 mg/L) (DOE 1995). This suggests that a slug of groundwater with elevated uranium has flowed past this location.

The high uranium concentrations in groundwater compliance well 0891 since 2008, have been trending downward since 2015, likely reflects the passage of a slug of groundwater with elevated uranium flowing from the direction of the former processing site. Historical data from upgradient monitoring wells that were abandoned in 2001 show a uranium anomaly moved past them (Figure 5-9) (DOE forthcoming). LM defined the groundwater flow directions in the Deweesville and the Dilworth aquifers and identified areas of low pH where tailings-derived fluids have consumed all of the natural buffering capacity (DOE 2008, Figures 2-7 and 2-8). Monitoring well 0891 is completed in the Dilworth aquifer. Monitoring well 0963 (completed in the Deweesville Sandstone) is in a zone of low pH where groundwater in the Deweesville aquifer flows into the underlying Dilworth aquifer. Monitoring well 0966 is the next downgradient Dilworth aquifer well.

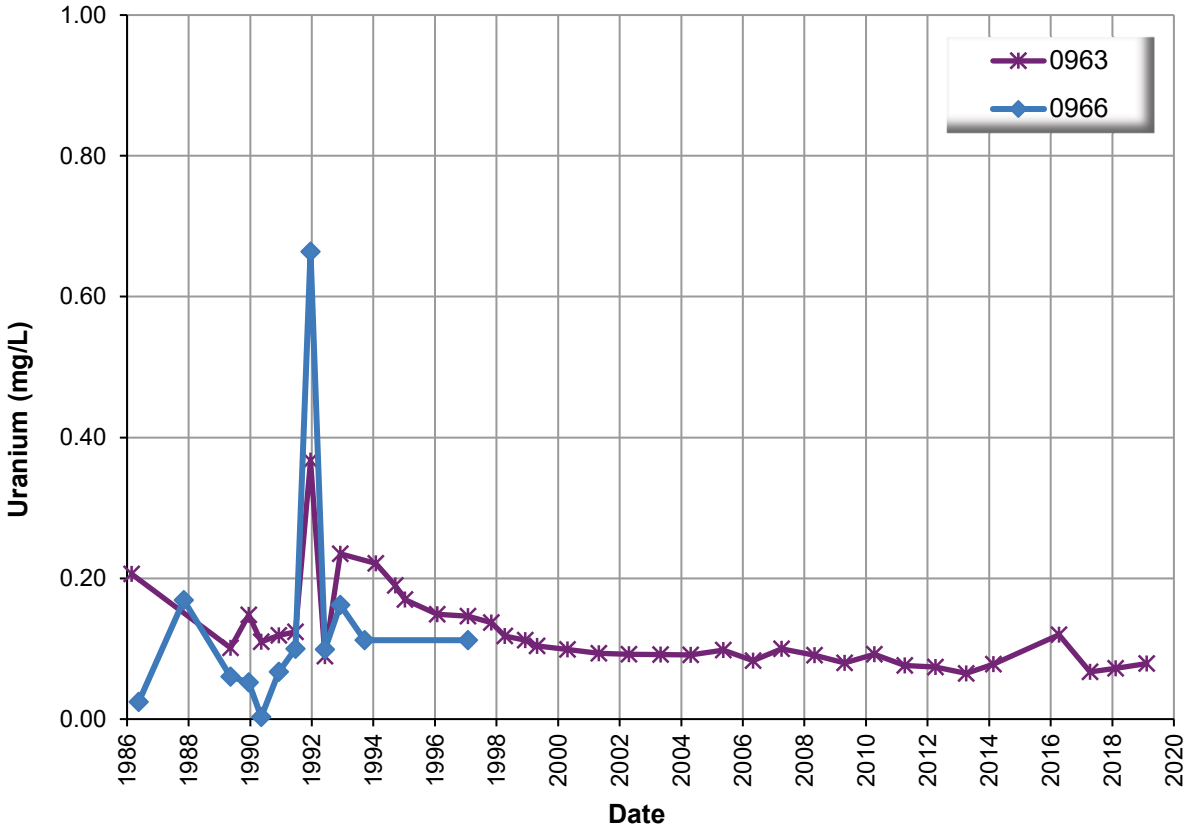
Figure 5-9. Uranium Concentrations in Monitoring Wells 0963 (in the Deweesville Aquifer) and 0966 (in the Dilworth Aquifer)

Figure 5-9 shows uranium concentration spikes in both wells (0963 and 0966) in 1992, with slowly declining uranium concentrations in 0963 over time (data for monitoring well 0966 are limited). This is likely due to an initial release of uranium and low pH tailings fluids during tailings deposition and subsequent acid leaching, with tailings removal by 1994 (DOE forthcoming). Monitoring well 0891 is the next Dilworth well directly downgradient of the low pH zone. Additionally, the elevated uranium at monitoring well 0891 is accompanied by elevated alkalinity and chloride, which also supports the conclusion that the elevated uranium is the result of passage of a slug of groundwater containing processing-related constituents.
