SUBJECT: Transmittal of the December 2014 Fernald Site Inspection Forms and the December 2014 OSDF Inspection Report

Fernald Preserve Field Walkdown Inspection Report

Fernald Preserve OSDF Walkdown Inspection Report

On-Site Disposal Facility Inspection Report

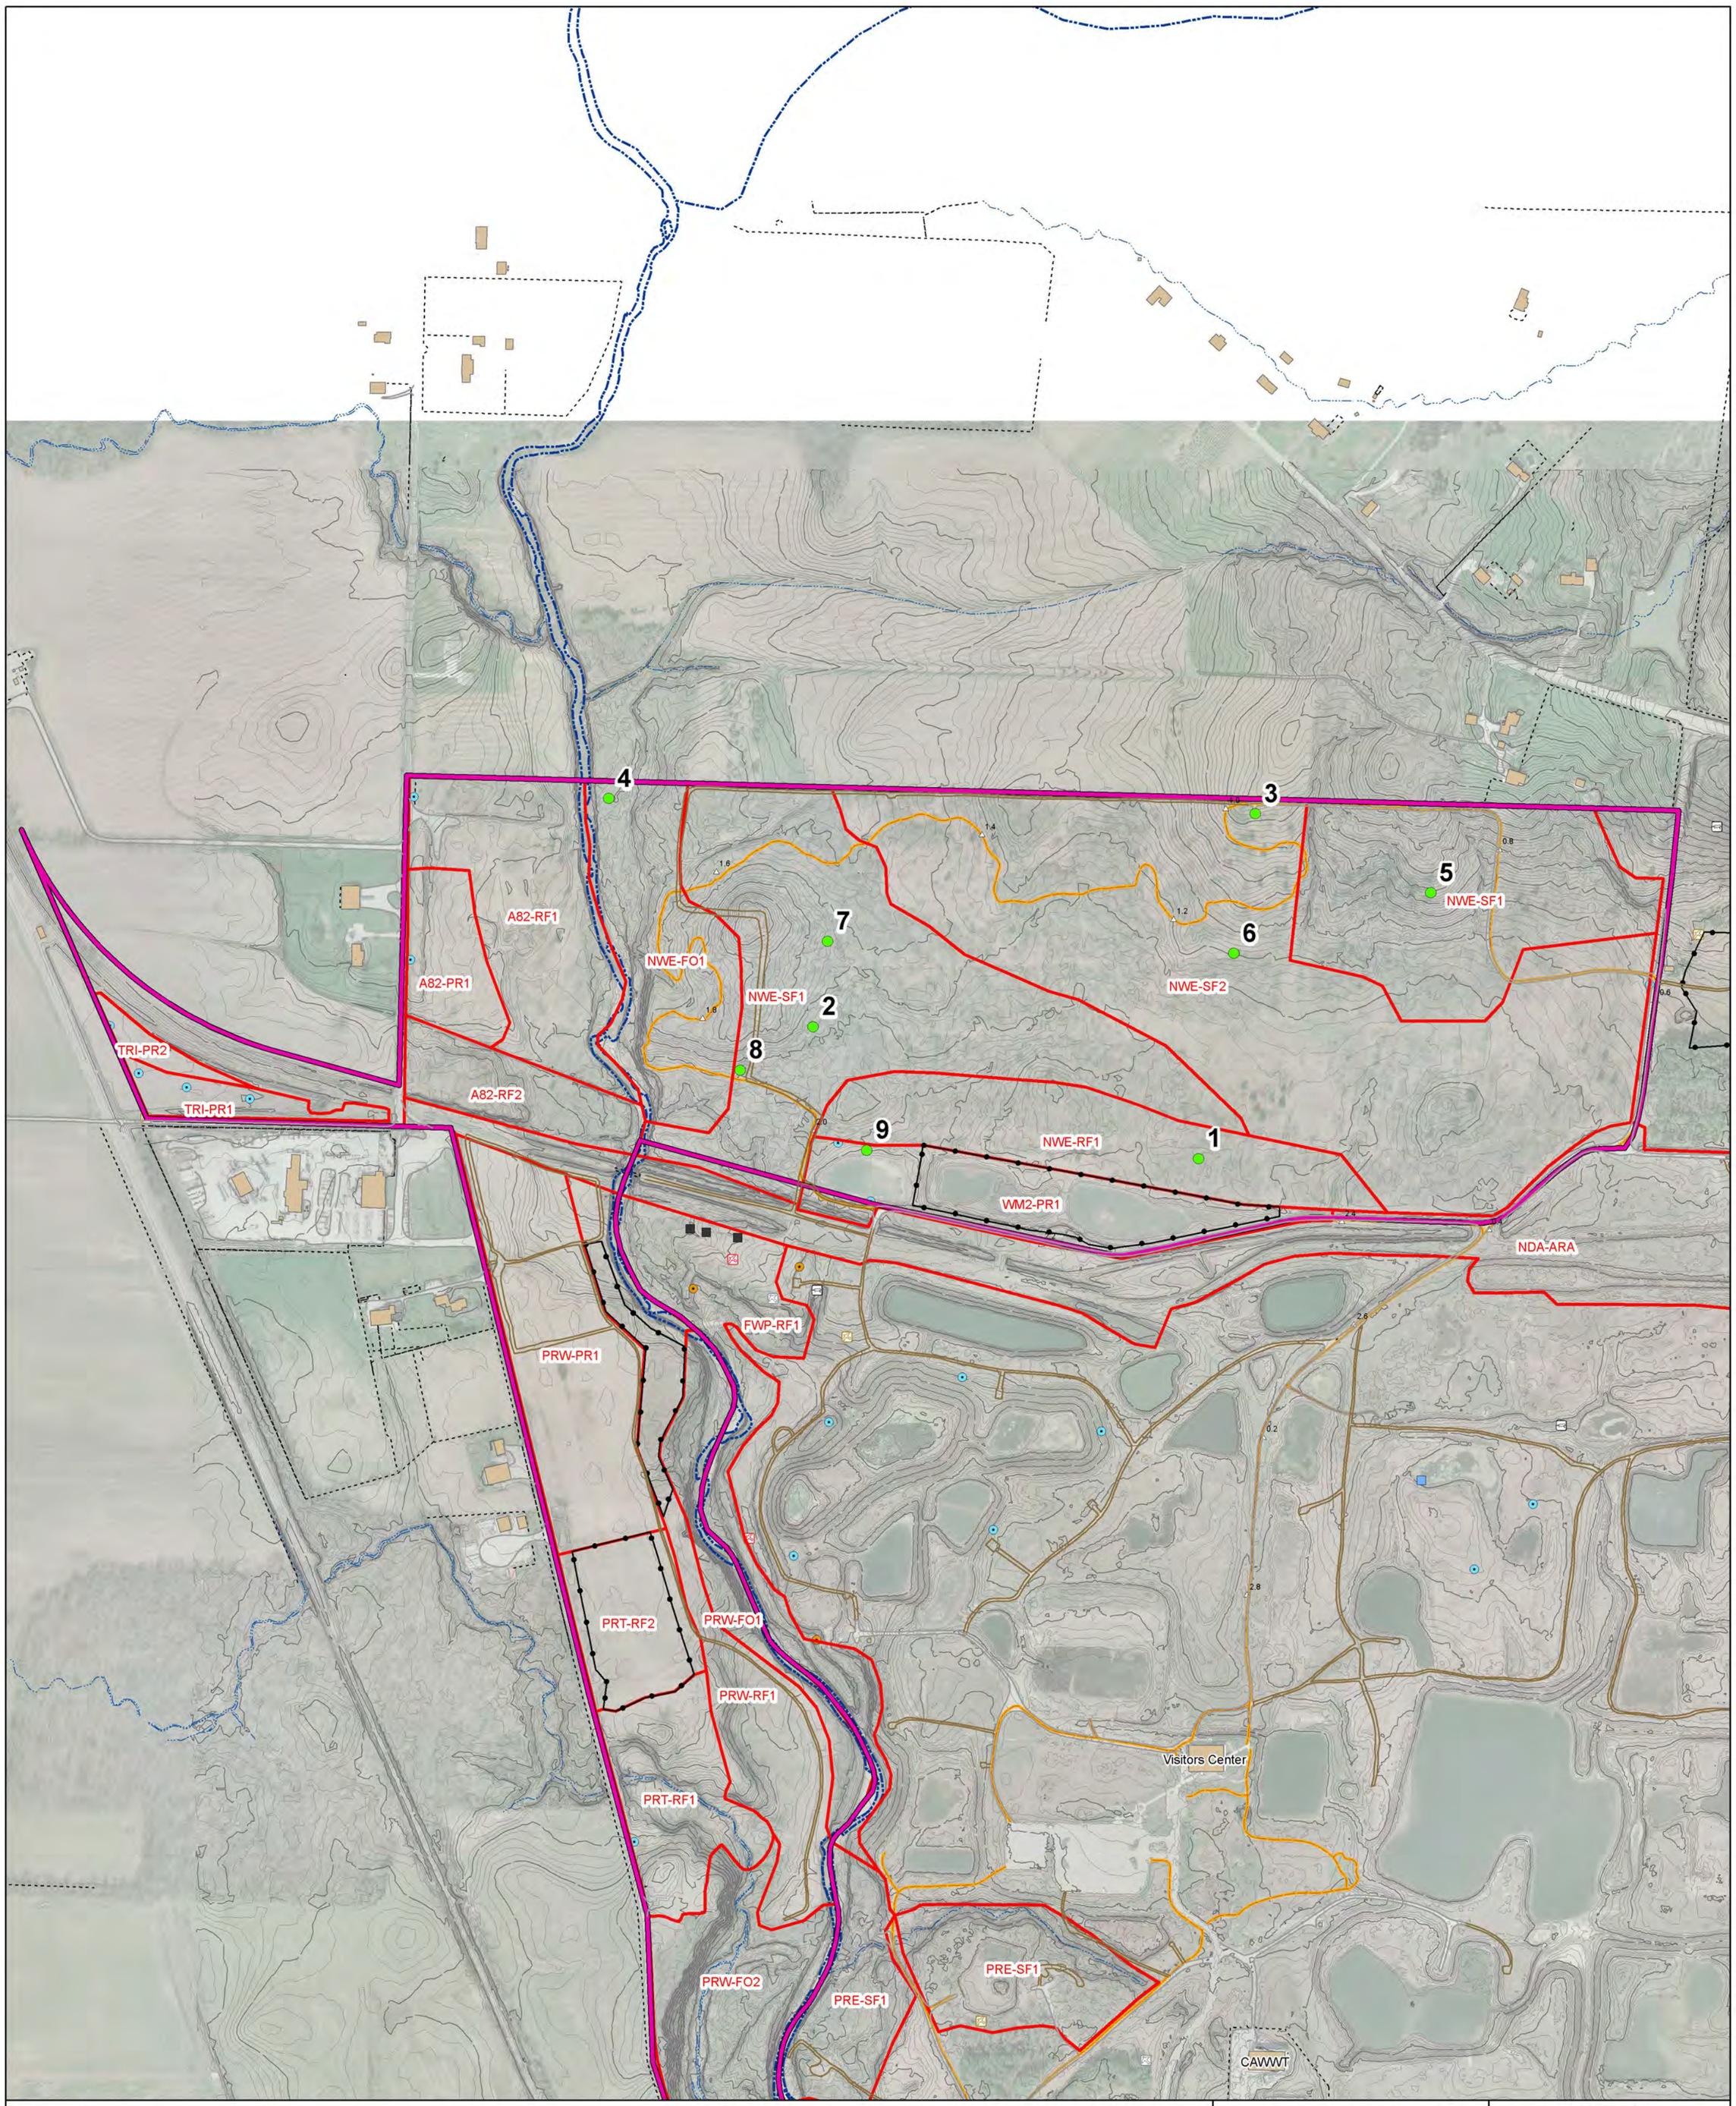
Fernald Preserve
West Quadrant - North Half
December 2014

Map No.	Location	GPS?	Type of Finding	Description	Photo? (File No.)
1	North of east end of WM2	No	Vegetation	Stand of teasel	
2	East and north of service road, northwest of WM2	No	Vegetation	Pear tree	
3	Edge of Hickory trail at property line	No	Debris	old t-post	
4	Deer trail	No	Debris	Wire	
5	West of n/s section of Hickory trail	No	Vegetation	Autumn olive	
6	South of trail…just south of snag	No	Other	knife and pop can	
7	along second access cut	No	Other	Dead deer, 12 pt. buck. No obvious injury.	
8	Where (north) access road meets Hickory Trail	No	Signage	Authorized Access sign is down	
9	WM2 wetlands	No	Other	Deer cages still present

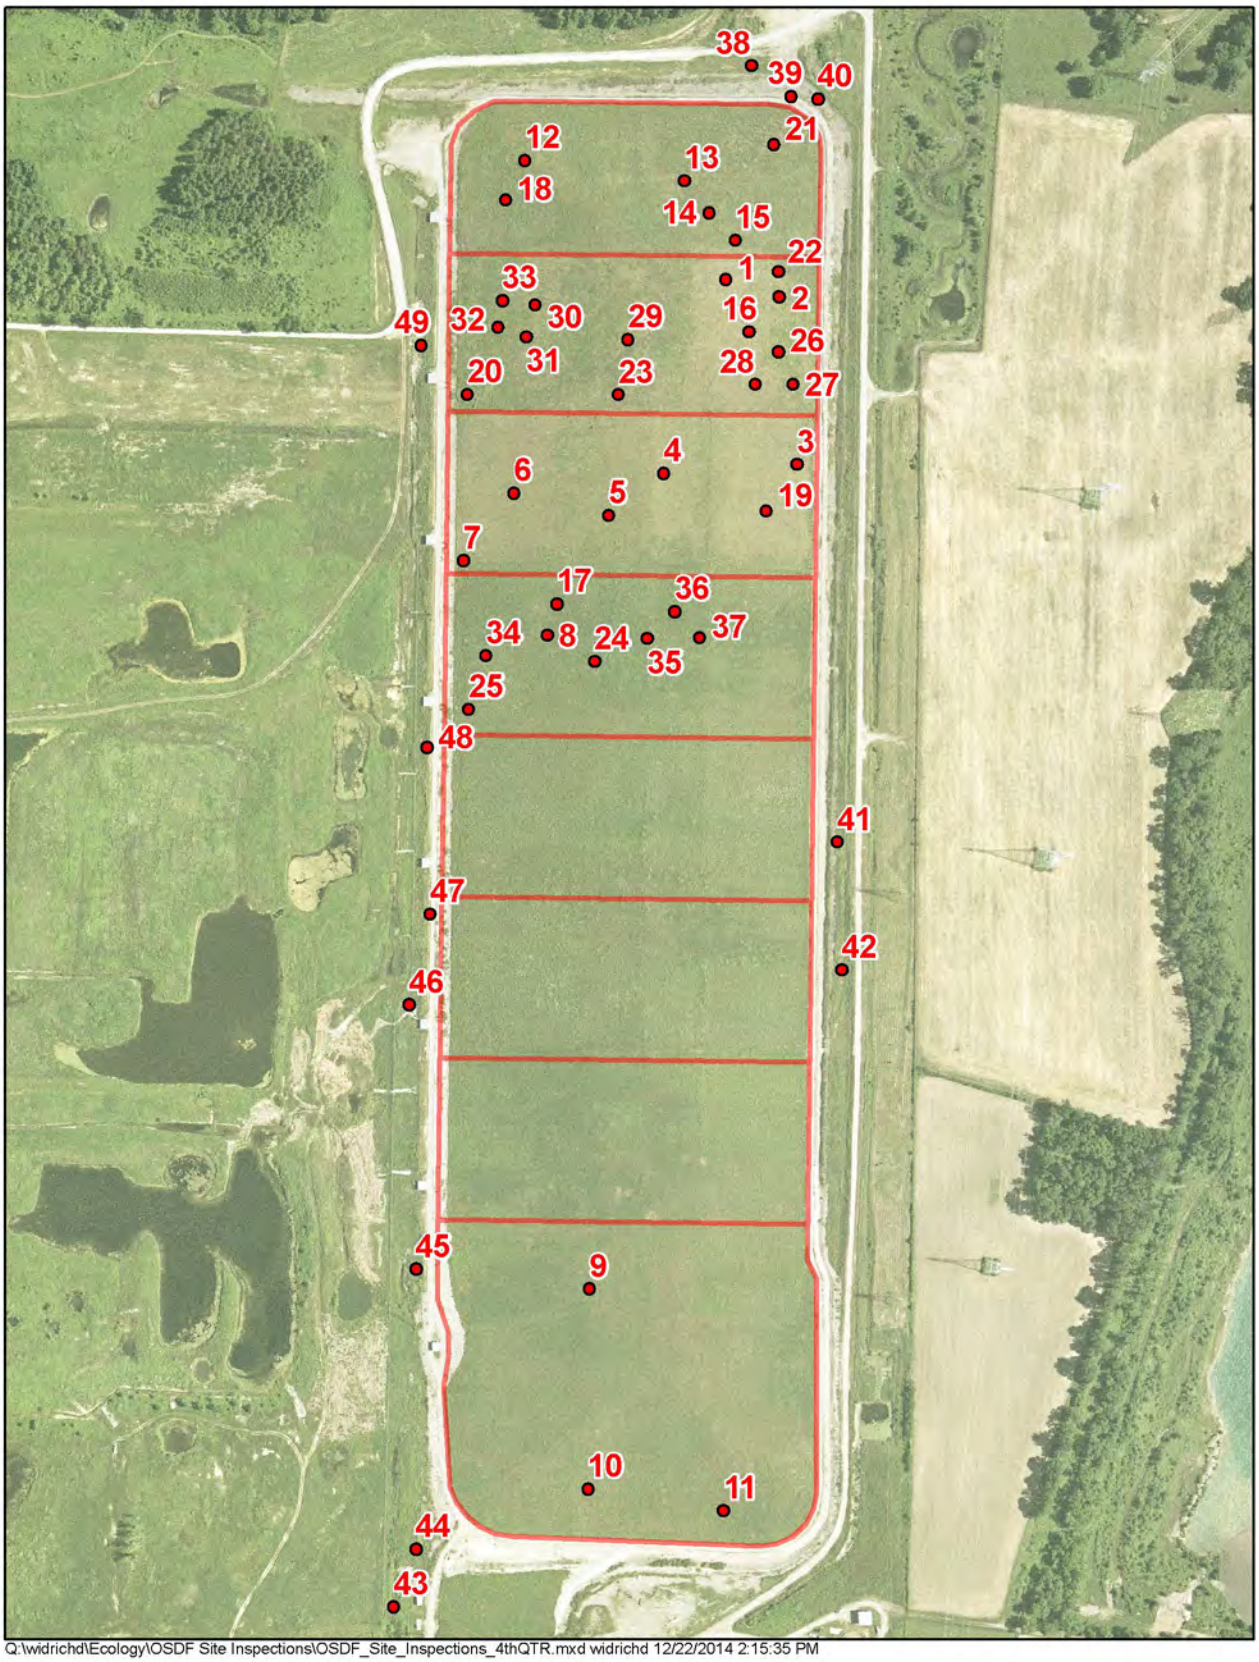
OSDF Inspection Findings December 2014

Map No.	Location	GPS?	Type of Finding	Description	Photo? (File No.)
1	Cell 2, east 6:1, mid-way up slope	No	Vegetation	Pear tree	
2	Cell 2, east 6:1, bottom of slope	No	Vegetation	Pear trees	
3	Cell 3, east 6:1, bottom of slope	No	Vegetation	Woody vegetation	
4	Cell 3, east 6:1, midway up slope	No	Vegetation	Pear tree	
5	Cell 3 top	No	Vegetation	Honeysuckle and numerous pear	
6	Cell 3, west 6:1 slope	No	Vegetation	Many pear trees on slope	
7	Cell 3, west 6:1, bottom of slope, south end	No	Biointrusion	animal burrow	
8	Cell 4, west 6:1 slope	No	Vegetation	Pear trees	
9	Cell 8, west top	No	Rock	Stone	
10	Cell 8, south face, bottom of slope	No	Rock	Stone	
11	Cell 8, south slope, bottom east	No	Rock	stone	
12	Cell 1, northwest face near top	No	Vegetation	woody vegetation x 2	
13	Cell 1, northeast face	No	Vegetation	Pear tree x 3+	
14	Cell 1, northeast face	No	Vegetation	Pear trees x 3

Map No.	Location	GPS?	Type of Finding	Description	Photo? (File No.)
15	Cell 1, east face on south end,	No	Vegetation	Pear tree	
16	Cell 2, all of cell cap	No	Vegetation	Pear trees all over cell cap	
17	Cell 4, west slope	No	Vegetation	Bare ground	
18	Cell 1, west face above VH1	No	Vegetation	bush	
19	cell 3, east side	No	Vegetation	Pear tree	
20	Cell 2, west toe, edge of rip rap	No	Biointrusion	animal burrow	
21	Cell 1, east toe	No	Vegetation	Callery pear x 2	
22	Cell 2, east face, north end, about 20 yards up from toe	No	Vegetation	Callery pear x 2	
23	Cell 2, top, near 2/3 boundary	No	Biointrusion	rodent hole	
24	Cell 4, west 10:1, south end	No	Vegetation	Cedar tree	
25	Cell 4, west toe, south end	No	Vegetation	Cedar	
26	Cell 2, east side	No	Vegetation	Pear tree	
27	Cell 2, east side	No	Vegetation	Pear tree	
28	Cell 2, east side	No	Vegetation	Pear tree	
29	Cell 2, top	No	Vegetation	Pear tree	
30	Cell 2, west 6:1	No	Vegetation	Pear tree

31	Cell 2, west 6:1	No	Vegetation	Group of 5 pears	
32	Cell 2, west face	No	Vegetation	Group of 4 pear trees

Map No.	Location	GPS?	Type of Finding	Description	Photo? (File No.)
33	Cell 2, west face	No	Vegetation	Group of 3 pear trees	
34	Cell 4, west face	No	Vegetation	Pear tree	
35	Cell 4 top	No	Vegetation	Pear tree	
36	Cell 4, top	No	Vegetation	Pear	
37	Cell 4, top	No	Vegetation	Pear tree	
38	Northeast corner at fence	No	Vegetation	Small cedar tree	
39	Northeast corner road toe	No	Vegetation	Pear sapling and cedar	
40	Northeast corner on fence	No	Signage	Sign hanging by one wire	
41	East side fence at Cell 5	No	Fencing	Top barb arm and barb wire out	
42	east edge of rock channel at Cell 6	No	Vegetation	Pear seedling	
43	Southwest corner drainage	No	Vegetation	Woody vegetation	
44	Southwest corner mowed flat at drainage	No	Vegetation	teasel and thistle rosettes	
46	At fence behind Valve House 6	No	Fencing	cross brace on chainlink fence bent up	
47	At west fence between VH 5 and VH 6	No	Fencing	Post in fence line bent

48	West fence line at cell 4/5 boundary	No	Vegetation	Cedar tree seedling	
49	Drainage behind Valve House 2 and extending to the north	No	Vegetation	pear saplings
