SUBJECT: **Transmittal of the June 2012 Fernald Preserve Site Inspection Forms**

Fernald Preserve Field Walkdown Inspection

Fernald Preserve
Consolidated Finding Locations
for June 2012 Site Inspection

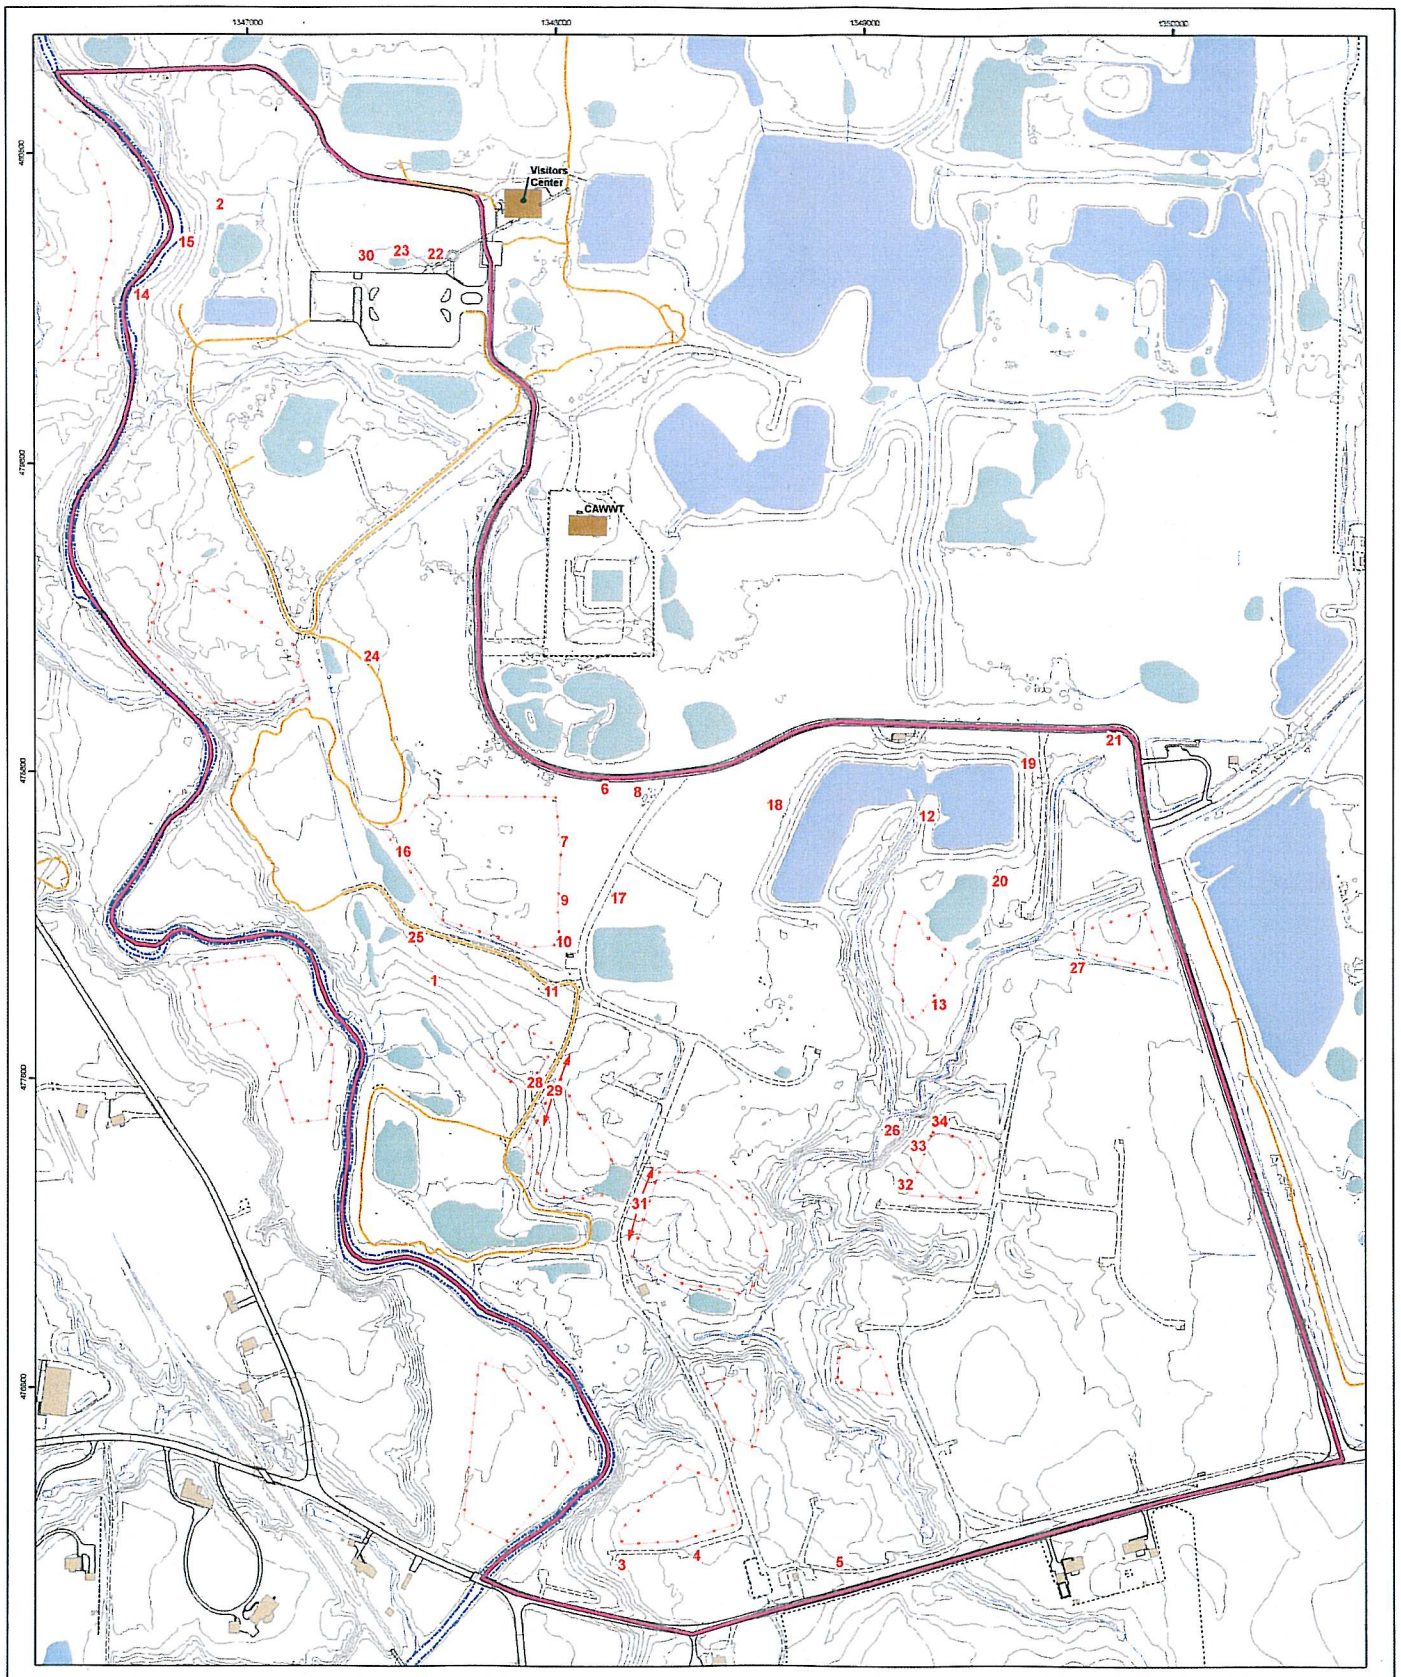
Type of Finding						Follow Up		
No.	Location (Use Map Whenever Possible)	GPS?	Unauthorized Use	Disturbance	Vegetation	Other	Description	Photo? (File No.)	Corrected	Maintenance Req'd	Cont. Observation
1	Top of SWU	NO			X		Thistle	NA	X		
2	North of silos ponds	NO			X		Spotty bare/gravel	NA		X	
3	At well house	NO				X	Debris and rusted parts	NA	X		
4	At well house	NO				X	Exposed wires (from removal?)	NA		X	
5	Near gravel road	NO				X	Metal	NA	X		
6	South edge of road	NO			X		Canada thistle	NA		X	
7	East side of south pines deer fence	NO				X	Deer fence off posts	NA		X	
8	Ditch line on edge of road	NO				X	Sink holes	NA		X	
9	East side of south pines deer fence	NO				X	Holes in gate	NA		X	
10	SE corner of south pines deer fence	NO				X	Fence sagging off poles	NA	X		
11	Next to wells at top of SWU	NO			X		Thistle patch	NA	X		
12	Land between SWRB	NO				X	Piece of pipe	NA	X		
13	Radiation hotspot deer fence – east side	NO				X	Zip ties broken, fence hanging	NA		X

14	Paddys Run – east bank west of silos ponds	NO				X	10' x 20' exposed fabric, rocks gone	NA		X	
15	Paddys Run – east bank west of silos ponds	NO				X	Fallen tree cages	NA		X	
16	Former wheel wash	NO			X		Thistle and teasel	NA	X		
17	Gravel road to SWU	NO			X		Thistle	NA	X		
18	West side SWRB	NO			X		Teasel	NA		X	
19	NE corner SWRB	NO			X		Thistle	NA	X		
20	East of radium hot spot	NO			X		Thistle	NA	X		
21	South side of access road	NO			X		Teasel (patchy)	NA	X		
22	North of rain garden	NO				X	Asphalt	NA	X		
23	North of rain garden	NO				X	Asphalt	NA	X		
24	Shingle Oak trail	NO			X		Teasel	NA		X	
25	Sycamore trail	NO			X		Teasel	NA		X	
26	Drainage area	NO			X		Garlic mustard	NA		X	
27	Well access	NO			X		Teasel	NA		X	
28	SE corner of deer fence	NO			X		Thistle patch	NA		X

Type of Finding						Follow Up		
No.	Location (Use Map Whenever Possible)	GPS?	Unauthorized Use	Disturbance	Vegetation	Other	Description	Photo? (File No.)	Corrected	Maintenance Req'd	Cont. Observation
29	Drainage E of Sycamore trail	NO				X	Concrete (chunks)	NA		X	
30	N of Visitors Center parking lot	NO				X	Debris – asphalt	NA	X		
31	Dance hall road	NO		X			Erosion rill	NA		X	
32	Deer fence	NO				X	Limbs on deer fence*	NA		X	
33	Deer fence	NO			X	X	Grapes pulling down fence	NA		X	
34	Deer fence	NO				X	Top of fence unattached	NA		X

NOTE: Findings are numbered and provided on the June 2012 Field Walkdown Form.
