LMS/HAT/S14765

Mexican Hat UMTRCA Disposal Cell Side Slope Cover Depressions Evaluation Report Mexican Hat, Utah

January 2019

U.S. DEPARTMENT OF ENERGY | Legacy Management

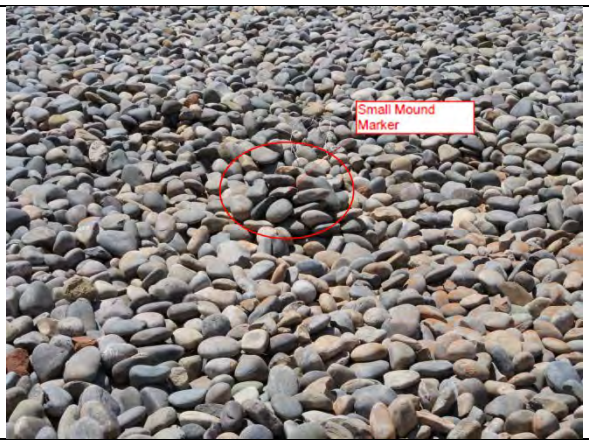
Photo 12 – Rock Mon @ TP1

- Investigated areas were backfilled by hand and left in a slightly depressed condition relative to the adjacent surfaces. Stone mounds which last longer than flagging were made near the center of each location for future location of the areas that were investigated. Measurements were made between the perimeter marked with rebar and the investigated areas so that the investigated areas could be plotted on the map upon return to the office. However, it is recommended that a topographical survey be performed to locate the investigation areas.

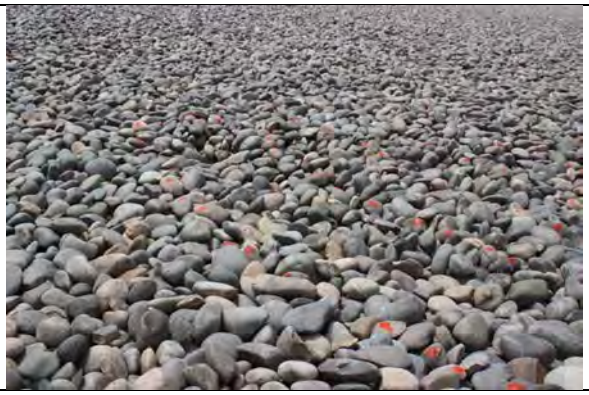
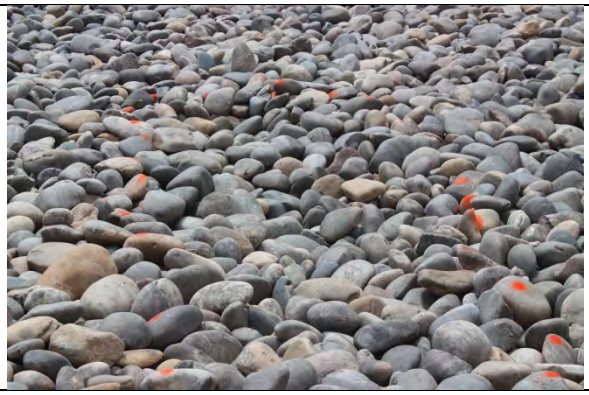
Photo 21 Red outlines of depressions near the toe of northeast slope and Gully #2	Photo 22 Red outlines of depressions near the toe of northeast slope and Gully #2

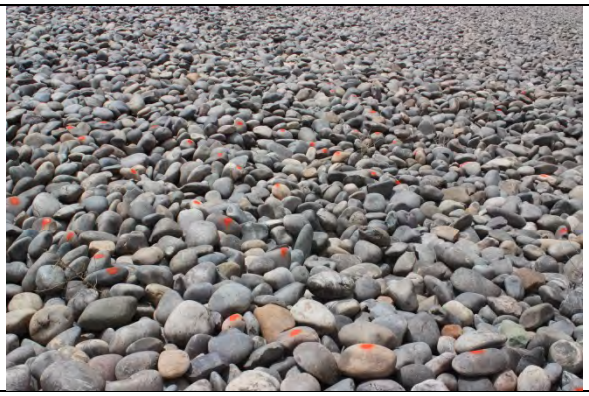
Photo 23 Red outlines of depressions near the toe of northeast slope and Gully #2	Photo 24 Red outlines of depressions near the toe of northeast slope and Gully #2

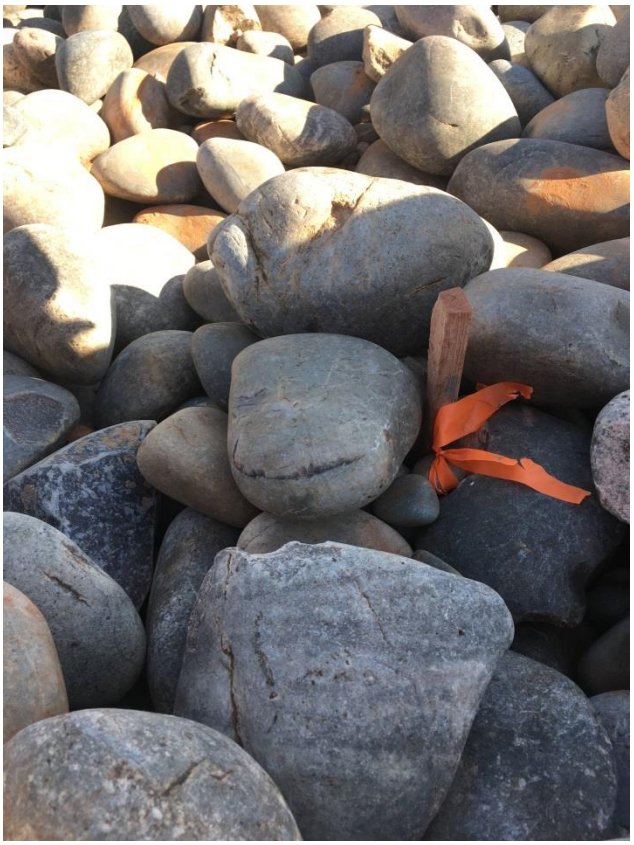
Void near toe of northeast side slope

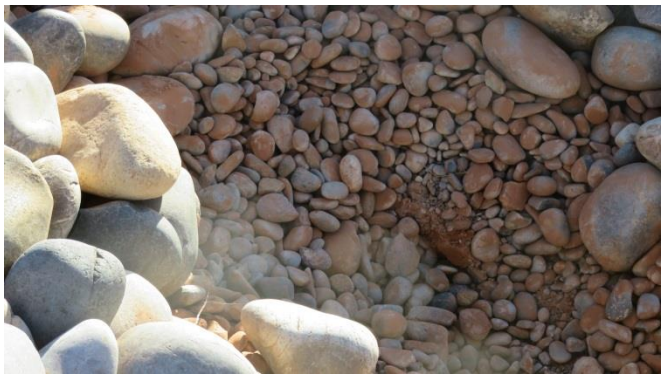
TP6 - Bedding Layer/Depression
