Volume 11
ENVIRONMENTAL APPRAISAL REPORT OF THE MOUND PLANT

MLM-ML-96-43-0001

ENVIRONMENTAL APPRAISAL REPORT OF THE MOUND PLANT

Prepared March 29, 1996 by:
EG&G Mound Applied Technologies
P.O. Box 3000
1 Mound Road
Miamisburg, OH 45343

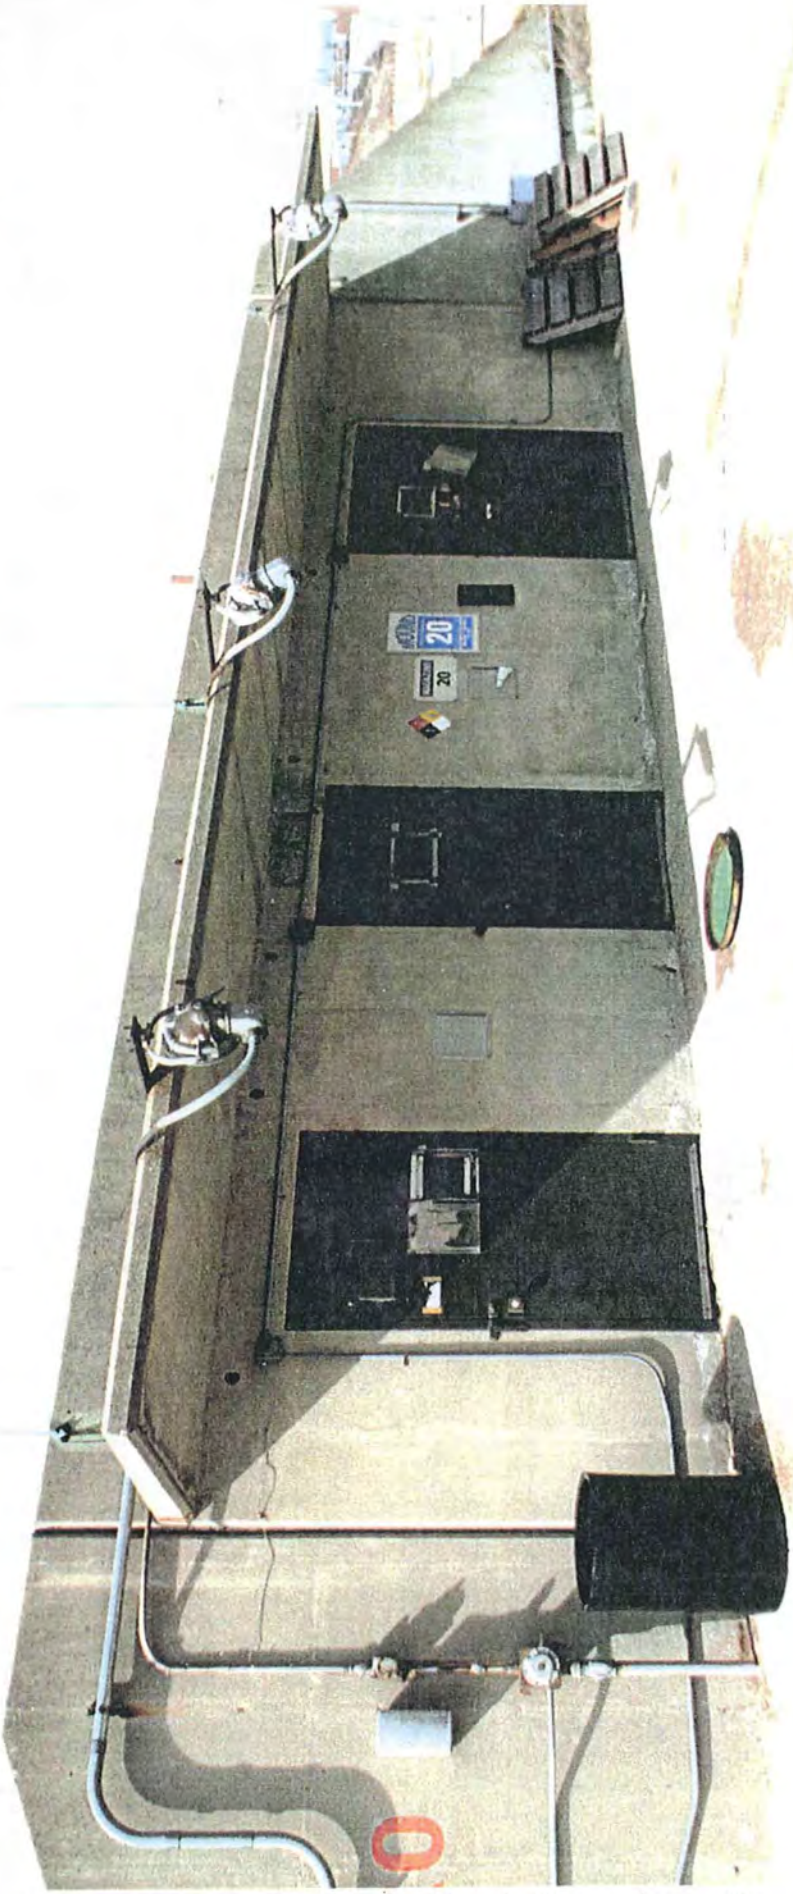
9.123.6.6 Photographs

Mound Plant Magazine 20

Magazine 20 has been emptied. There is no apparent energetic materials residue.

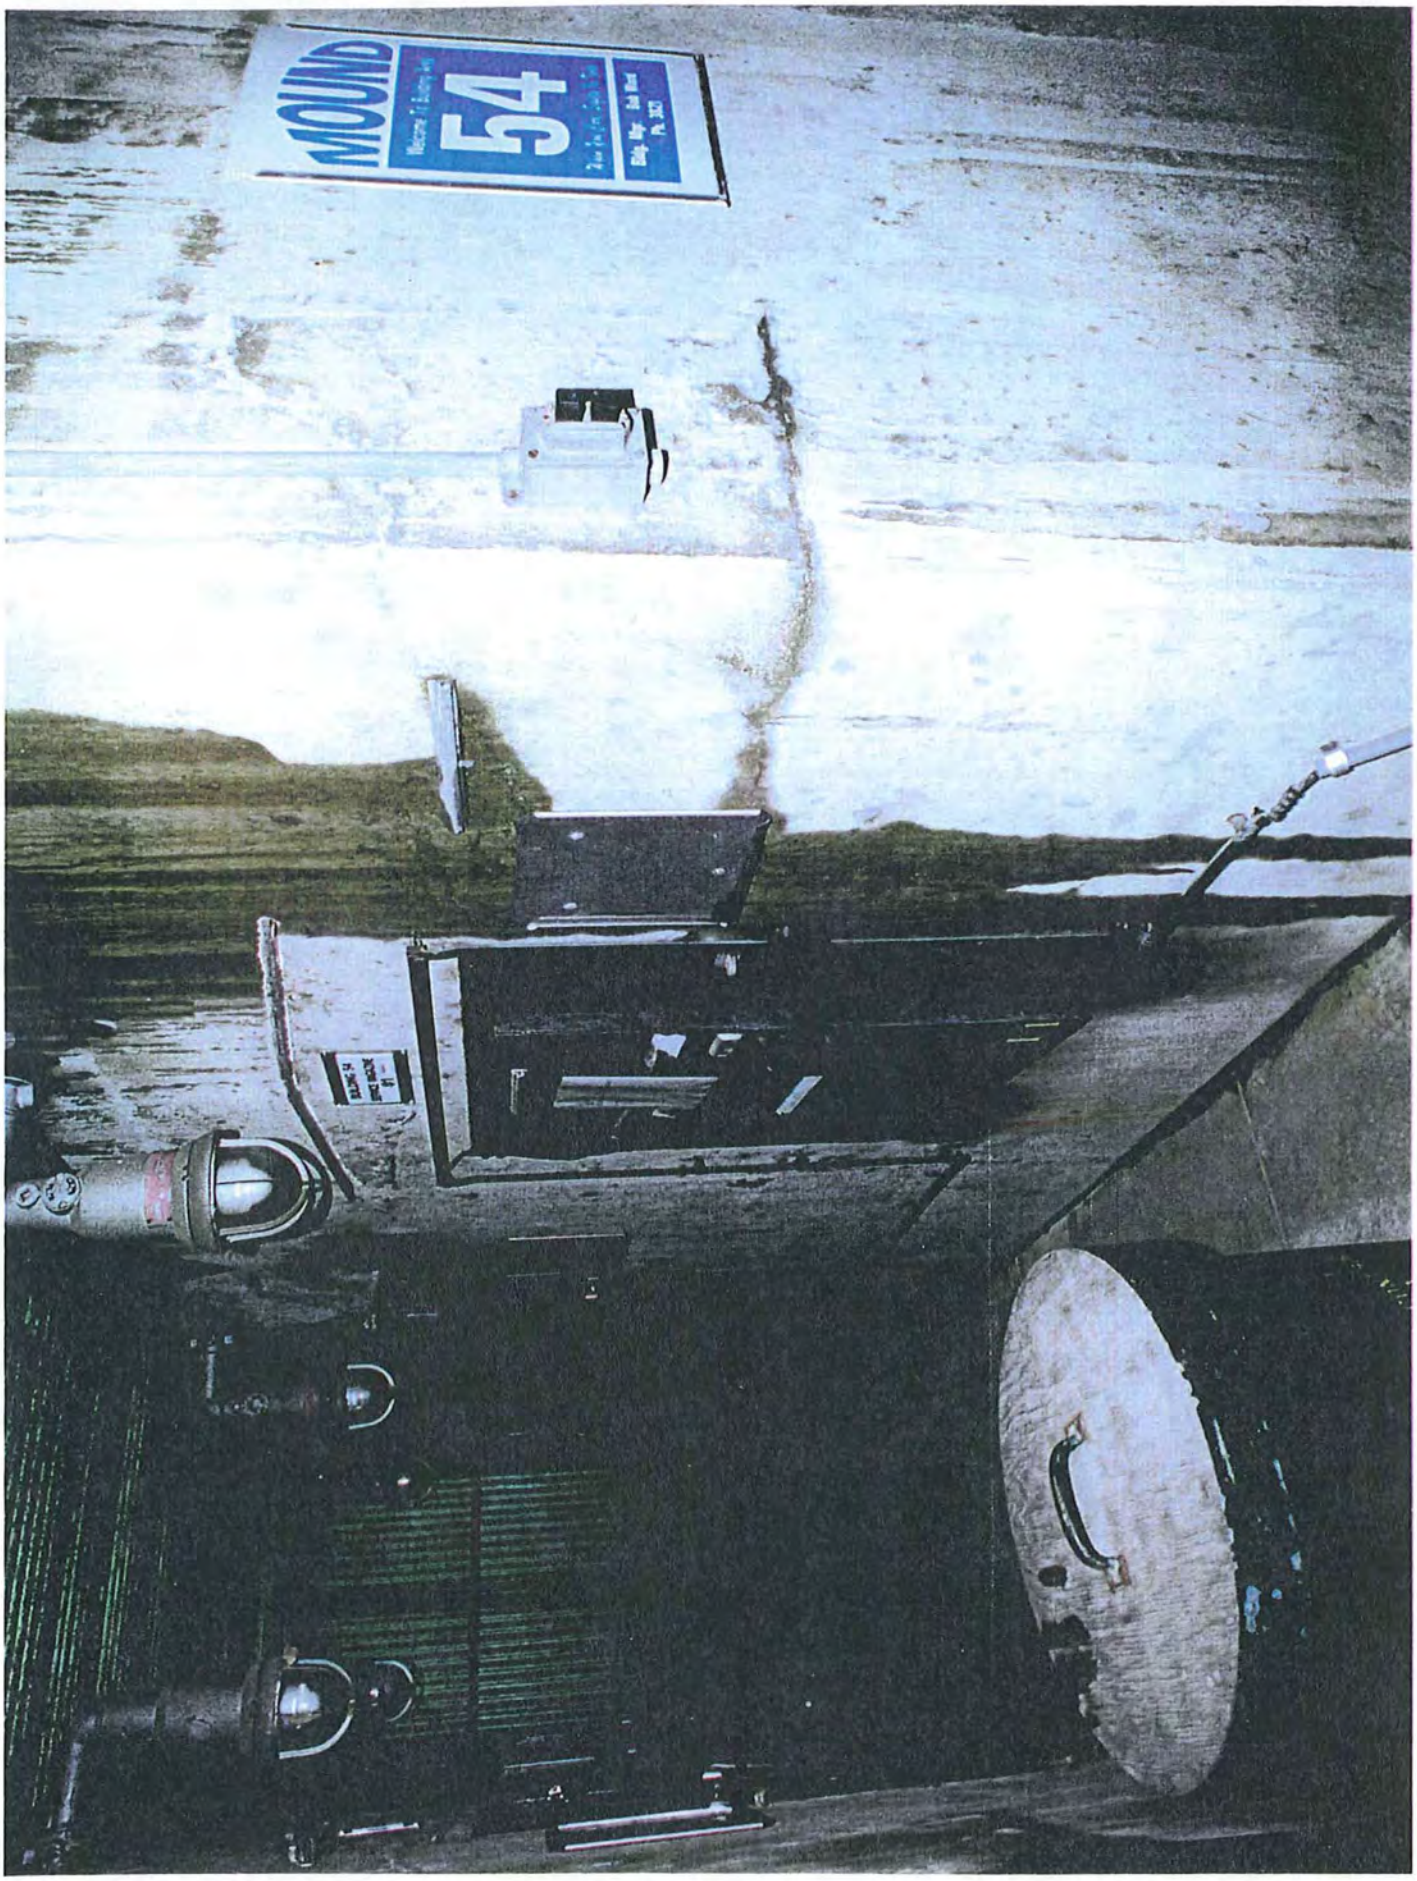
9.126.6.6 Photographs

Mound Plant Magazine 54
