MOUND PLANT
Potential Release Site Package
PRS # 86

PRS 86

MOUND PLANT
PRS 86
ACTINIUM CONTAMINATION
NEAR UNDERGROUND SEPTIC TANK

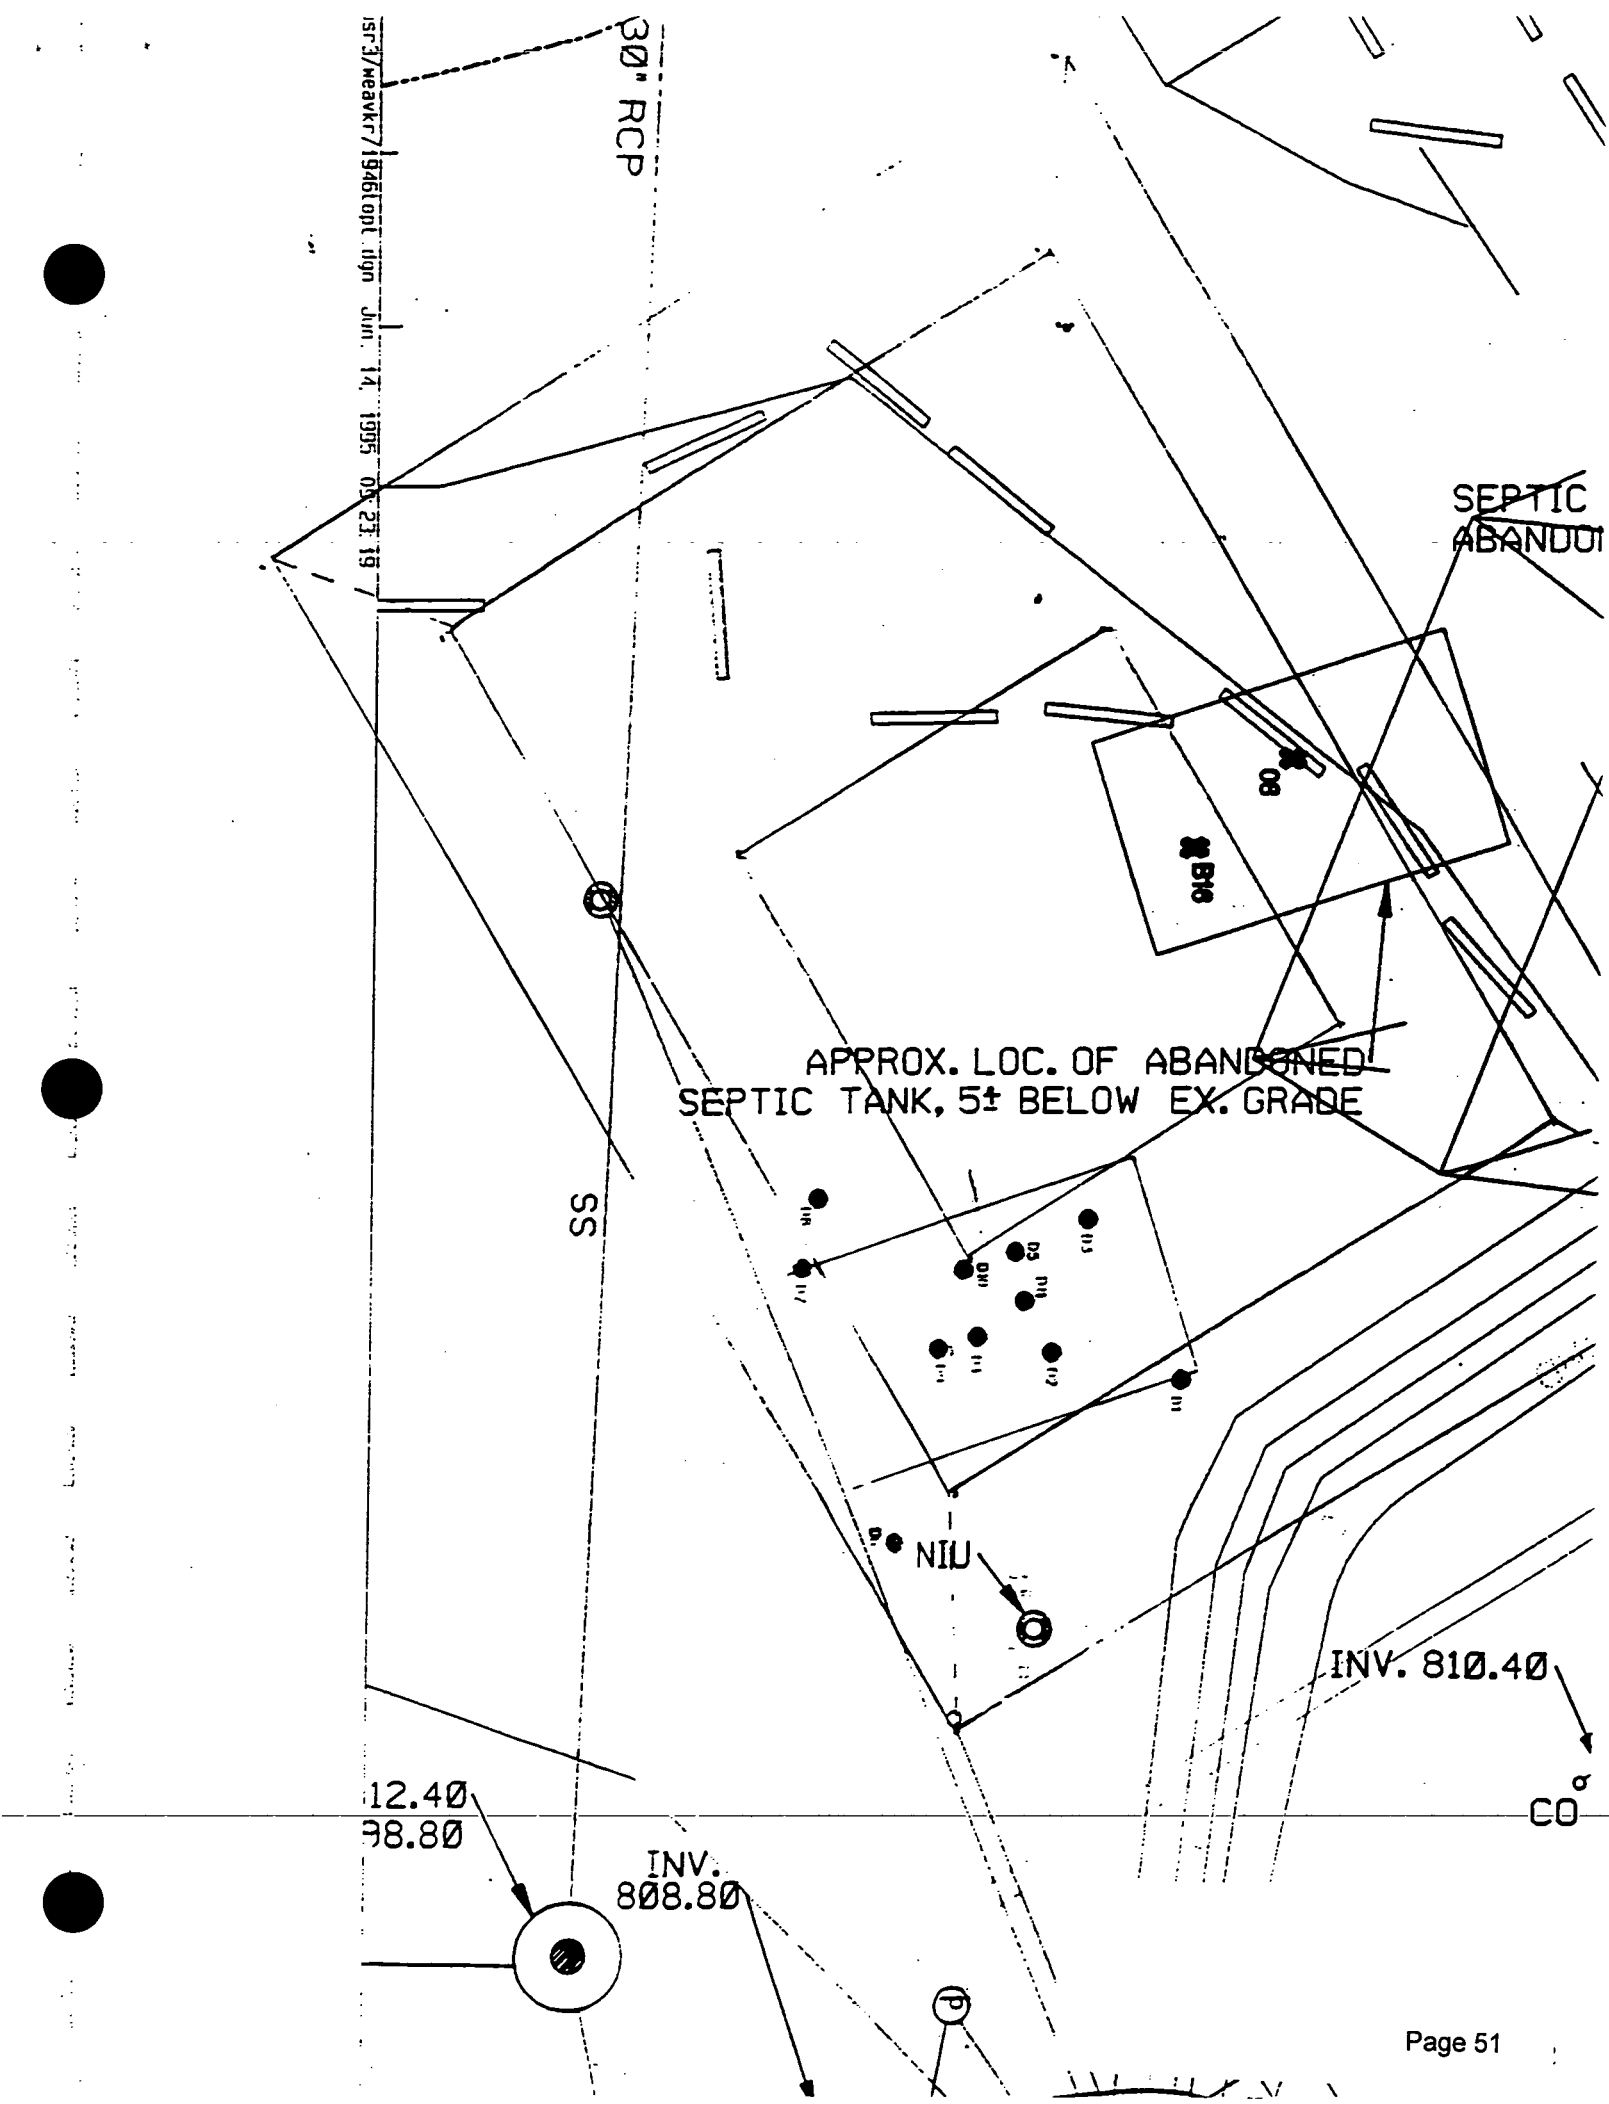
30" RCP
SEPTIC
APPROX. LOC. OF ABANDONED
SEPTIC TANK, 5± BELOW EX. GRADE
SS
NIU
INV. 810.40
INV.
808.80

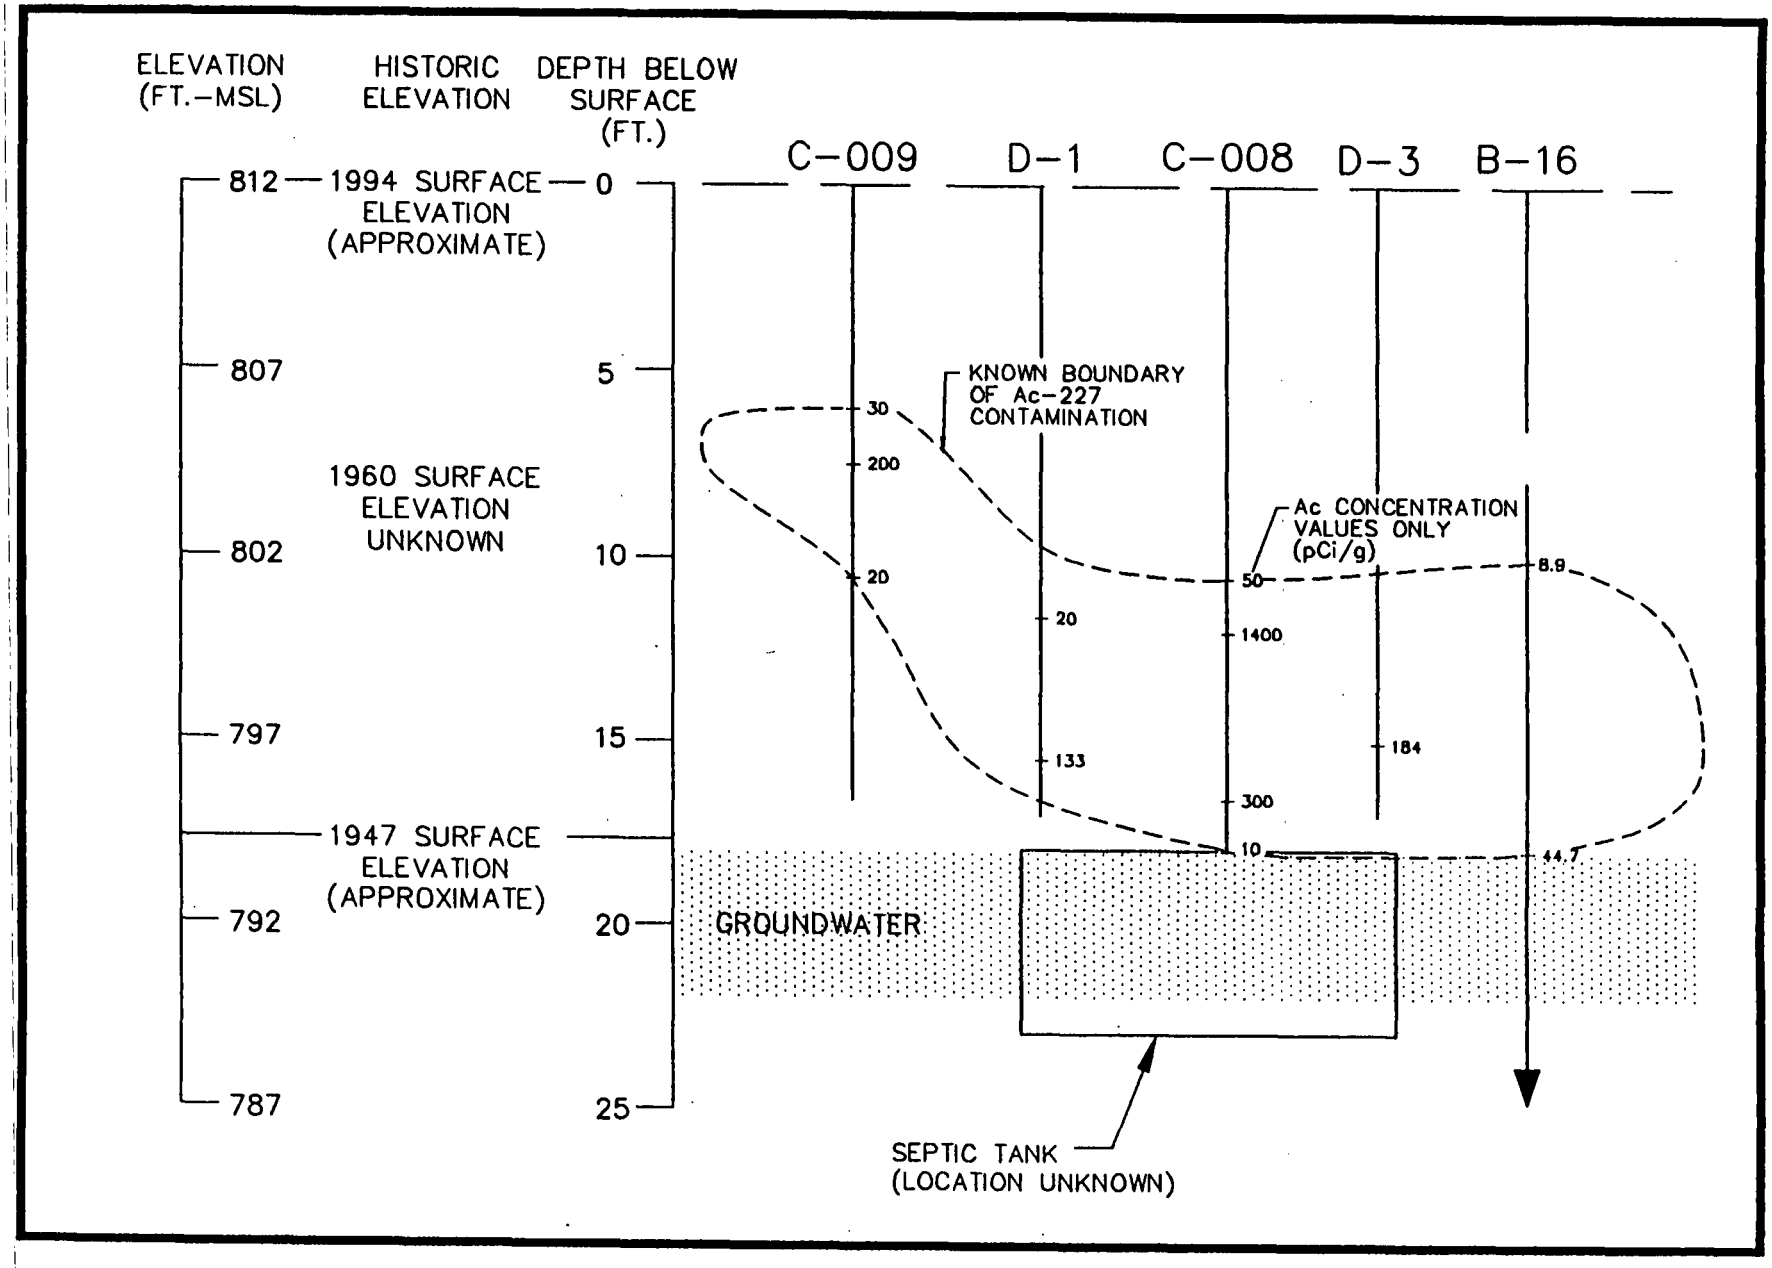
Figure 2.4. Conceptual Model

Using the sampling information from the three soil borings and the Geoprobe a conceptual model presented in Figure 2.4 was developed to show the zone of contamination detected in the subsurface.
