SUBJECT: Contract No. DE-AC24-97OH20044
BUILDINGS 35/59: RELEASE OF FINAL ON-SCENE COORDINATOR REPORT

ON SCENE COORDINATOR (OSC) REPORT

BUILDINGS 35 & 59

REMOVAL ACTION

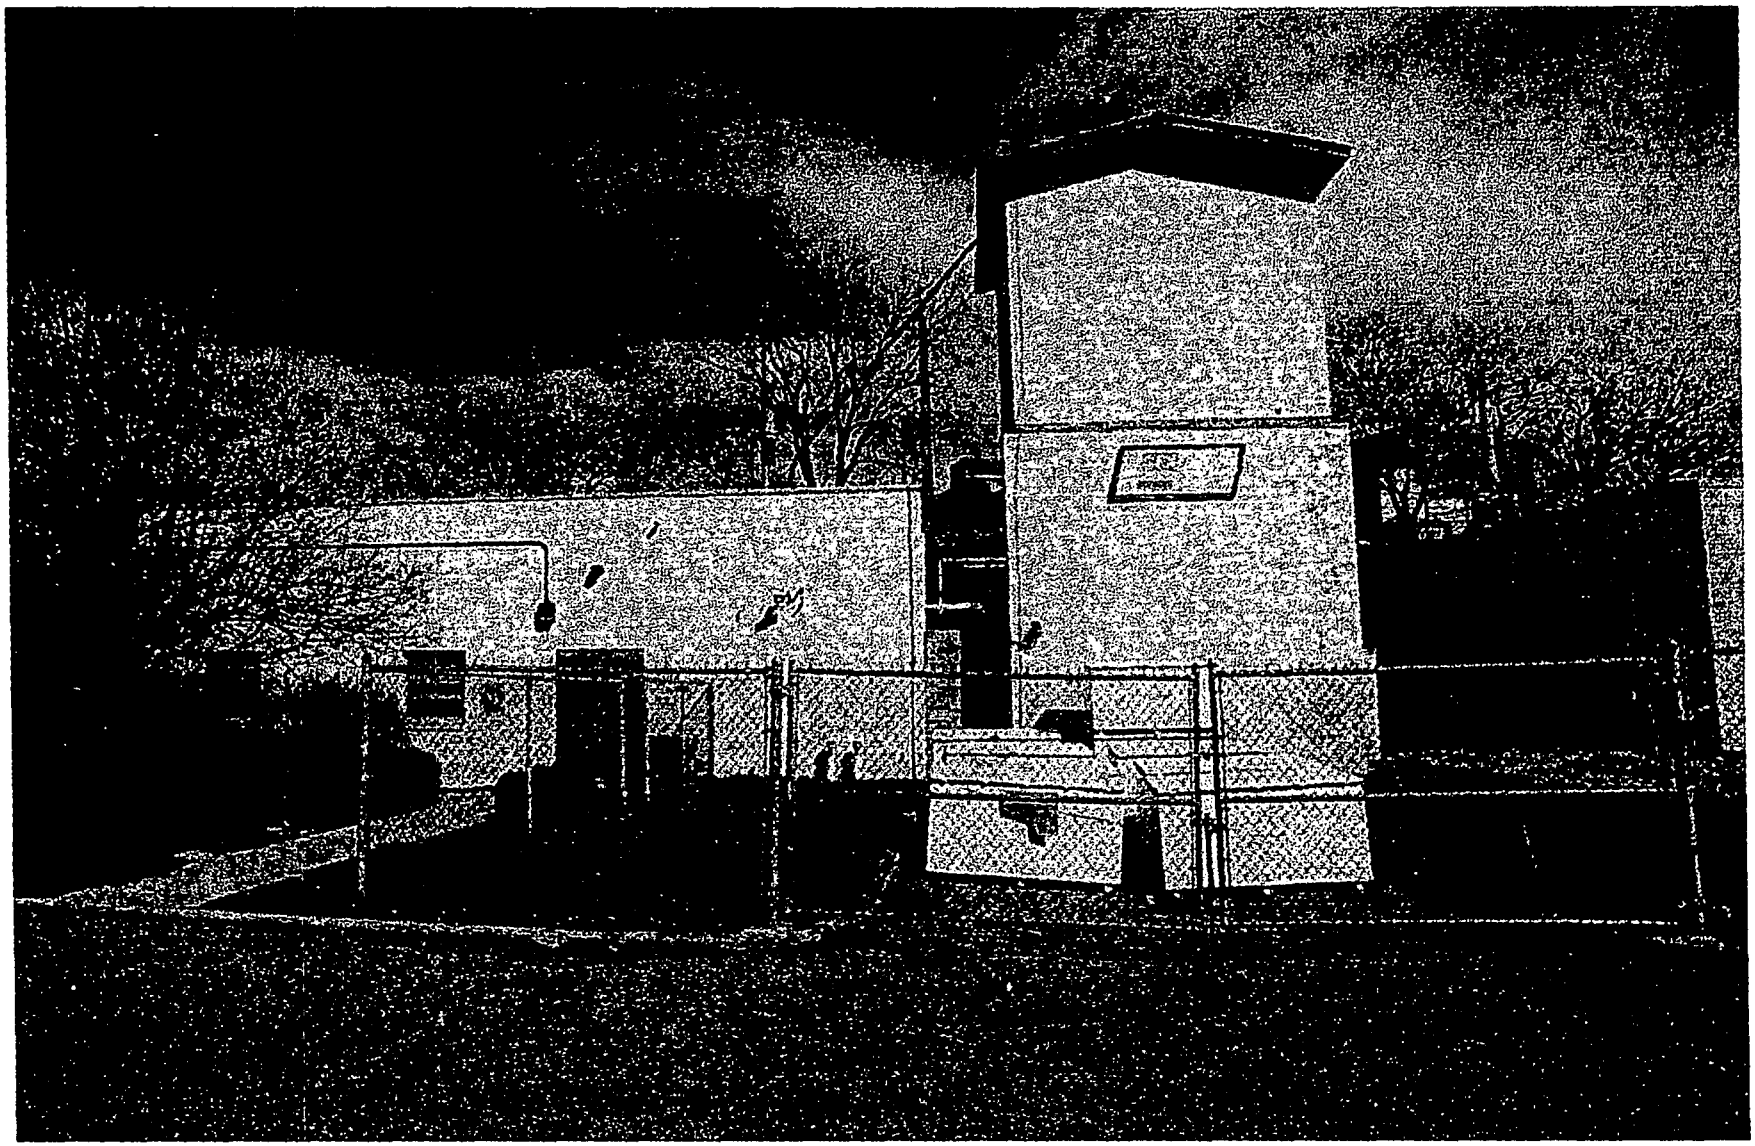
Buildings 35 (on the left) and 59.
Photographer is south of the buildings. (March 6, 1996)

Demolition of Building 35 in progress.
(April 13, 1998)

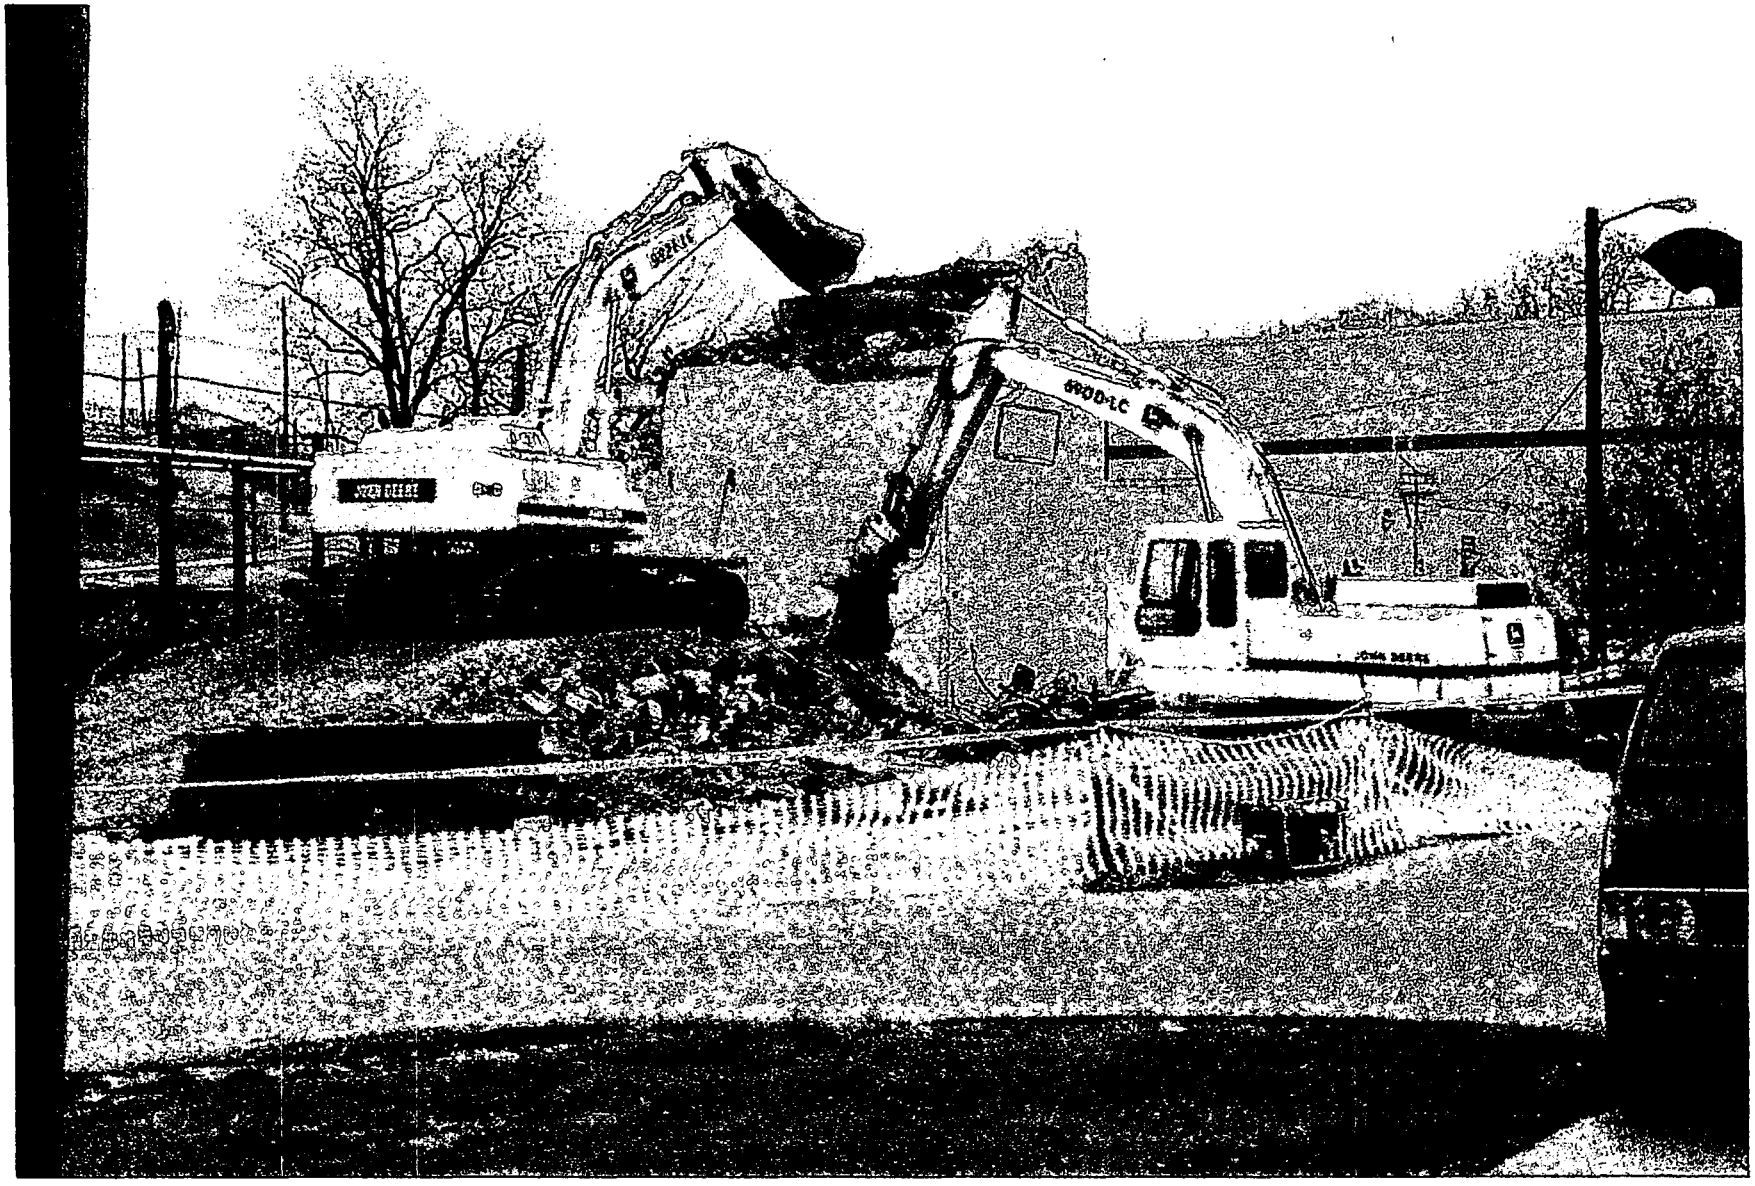
Demolition of Building 59.
The heavy duty equipment is removing the structure surrounding the "donut." (April 15, 1998)

Further progress in demolition of Building 59.
The "donut" is clearly visible at the top of the structure. (April 15, 1998)

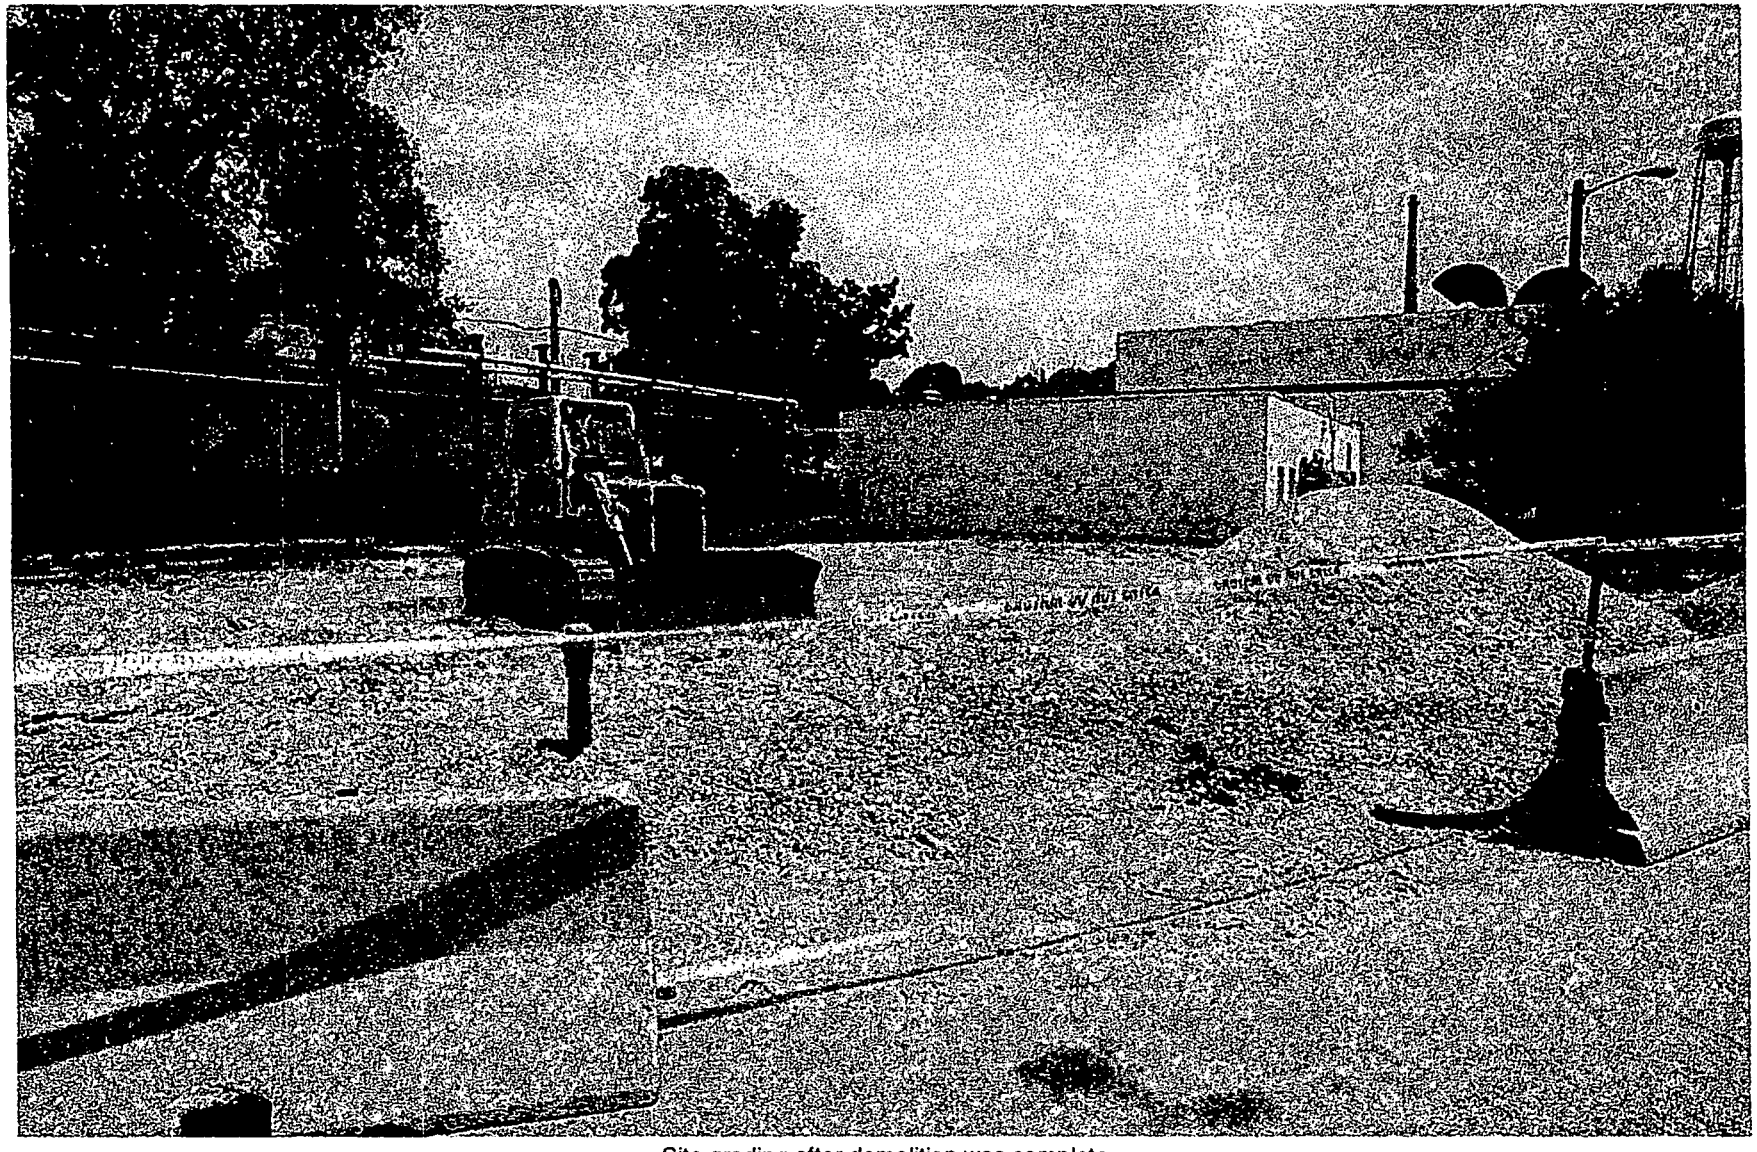
Site grading after demolition was complete.
(May 26, 1998)

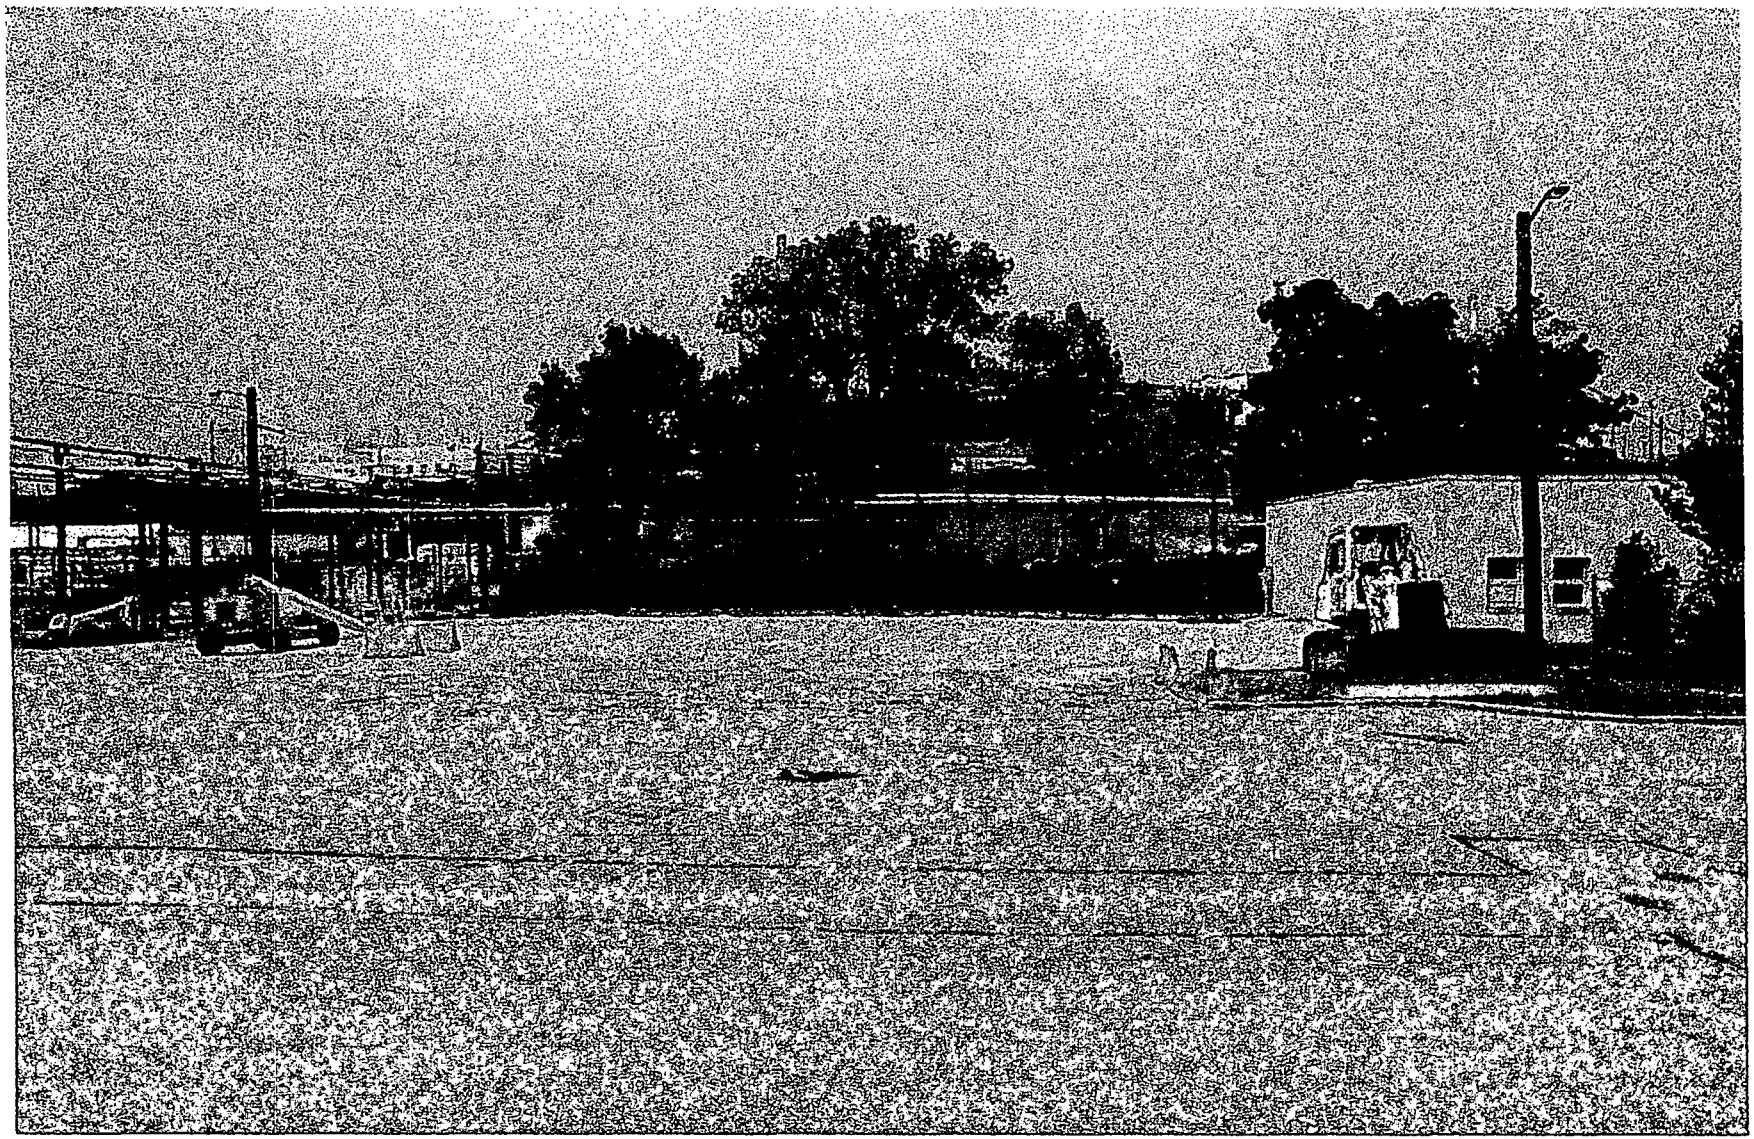
Site grading complete.
(July 16, 1998)

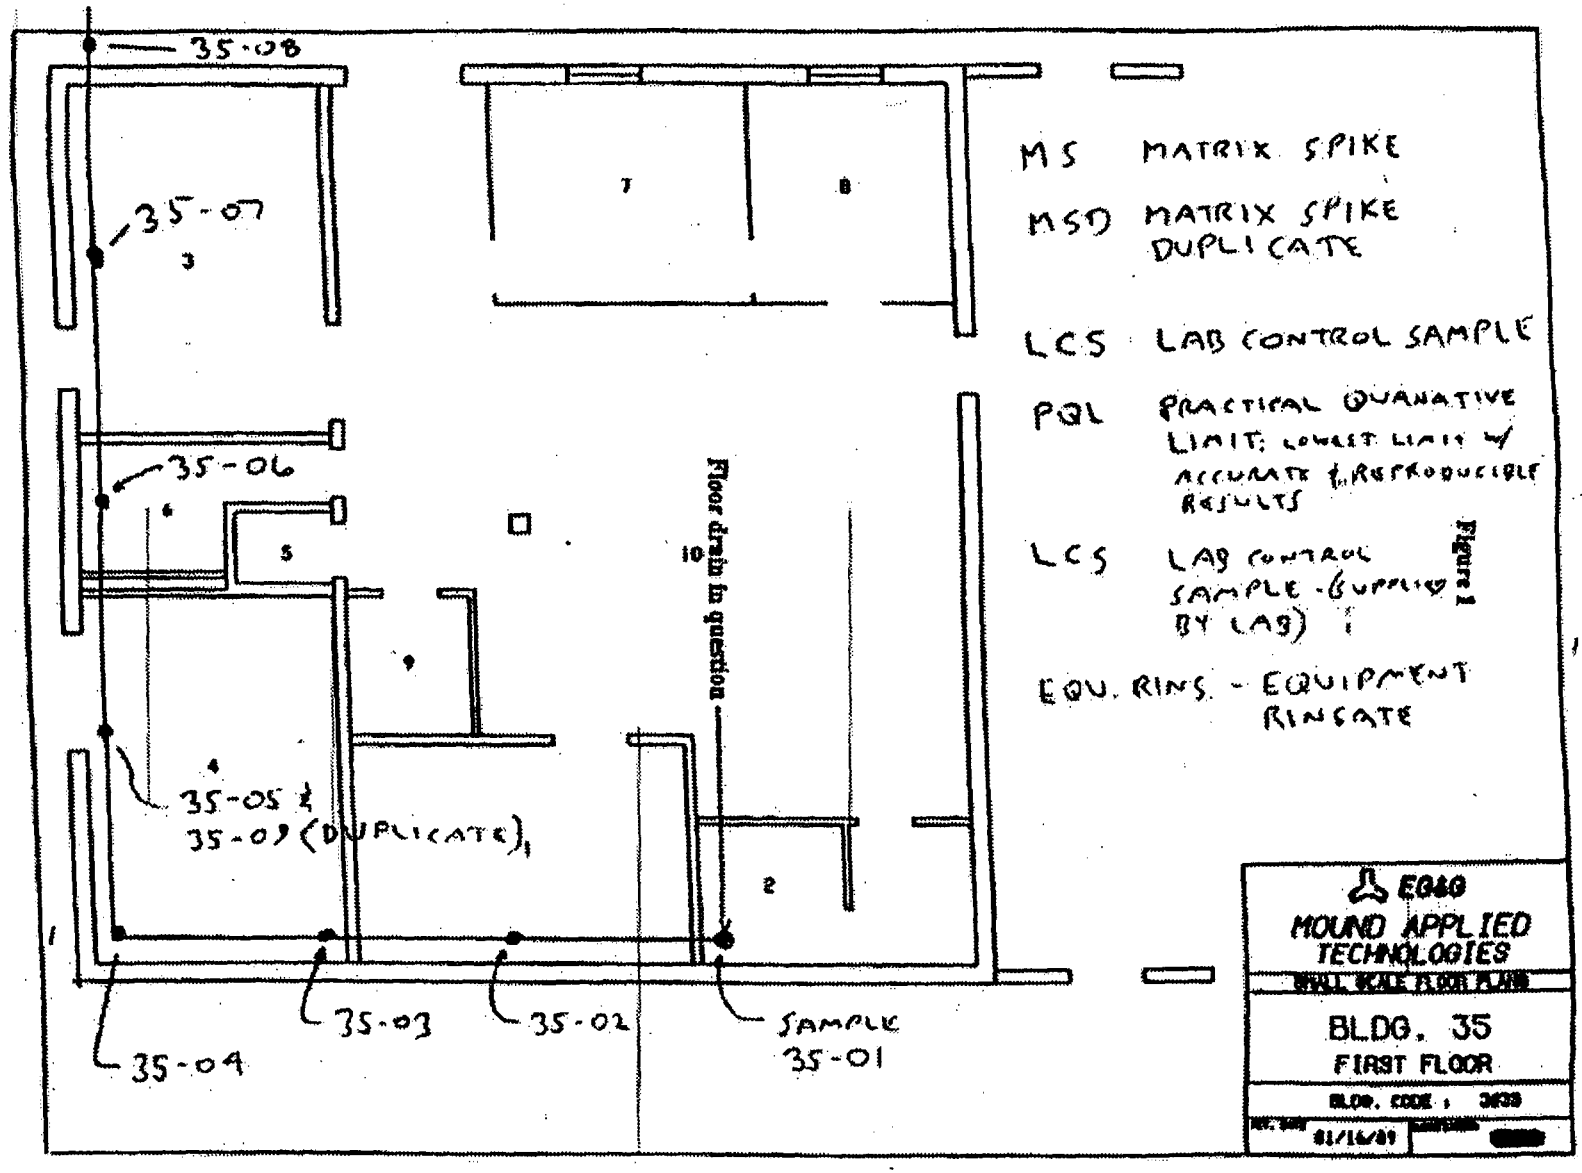
Figure 1

Composite samples were taken on May 13, 1998 from 8 equal segments of a pipe trench formed by the removal of a floor drain in Building 35. These samples were taken as part of the Building 35 Floor Drain Sample and Analysis Plan written by Dave Adkins and received May 6, 1998. The samples were sent to Quanterra Environmental Services, St. Louis, on May 14, 1998 for RCRA Metals, Percent Moisture and Reactive Sulfide analysis using SW-846 compliant methods.

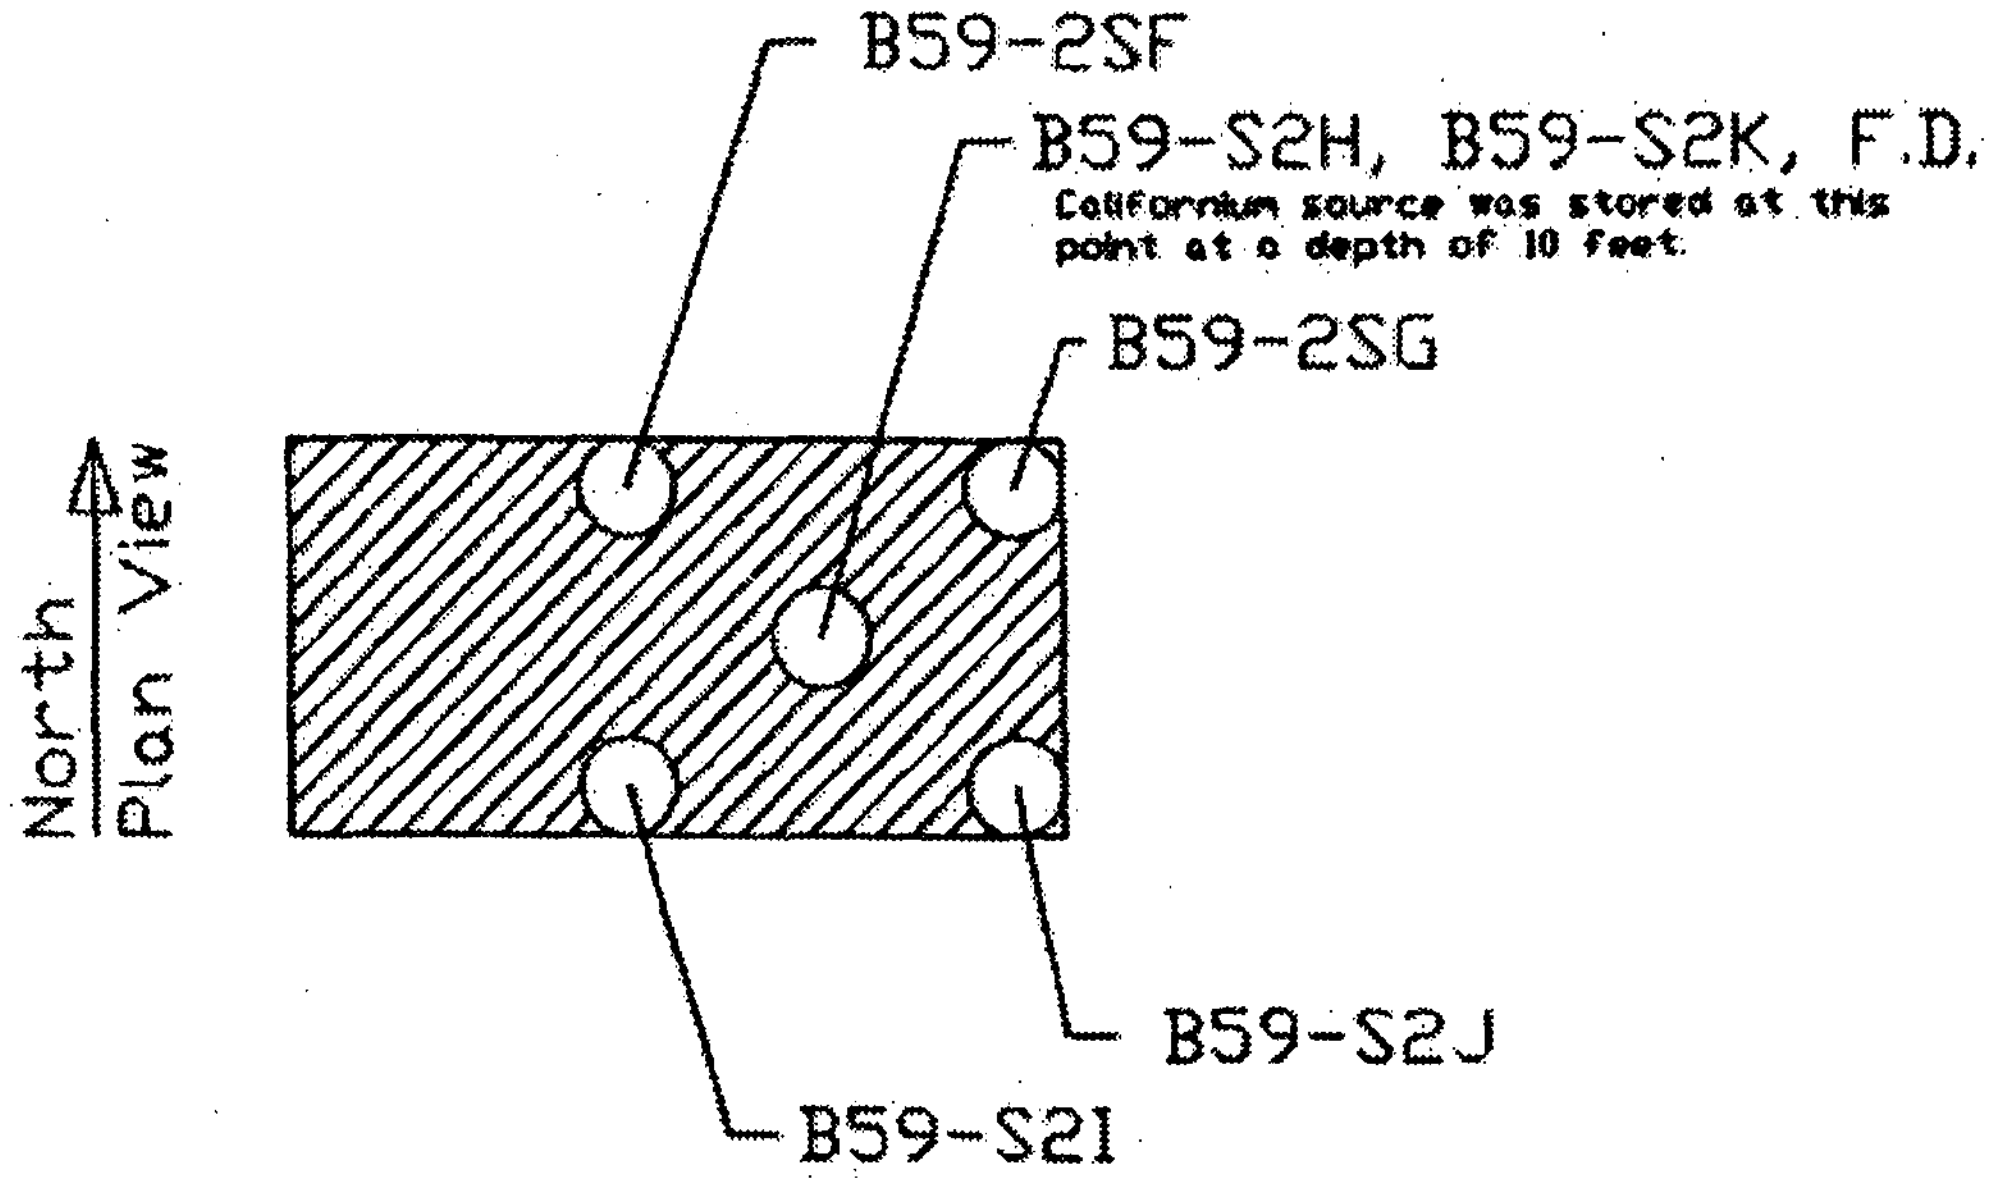
Building 59 Resample, 07/28/98

During the initial sampling (May 13, 1998), gamma-ray spectrometry measurements of one soil sample (B59-S2A, see Figure C-2) indicated the presence of ^{210}Pb at 20 pCi/g. Before this location was further excavated in July, another sample was taken from this location (B59-S2L). This sample was analyzed by low energy photon spectral analysis and indicated the presence of ^{210}Pb at 28 pCi/g. After the additional excavation was complete, another sample was obtained and analyzed for ^{210}Pb by the same method. The measurement results indicate 0.8 pCi/g ^{210}Pb and the background concentration of ^{210}Pb is ~1 pCi/g. These results are summarized in Table 6.

*Refer to Figure C-2 for sample location.

B59-S2L - Taken at old S2A position and depth (12 ft) for Pb-210 only.

B59-S2M - Taken at old S2A position, bottom of remediation (16 ft depth) for Pb-210 only.
