SUBJECT: Contract No. DE-AC24-97OH20044
BUILDING DS: DELIVERY OF FINAL BUILDING DATA PACKAGE

Building Data Package

DS Bldg.

Located within Release Block Q

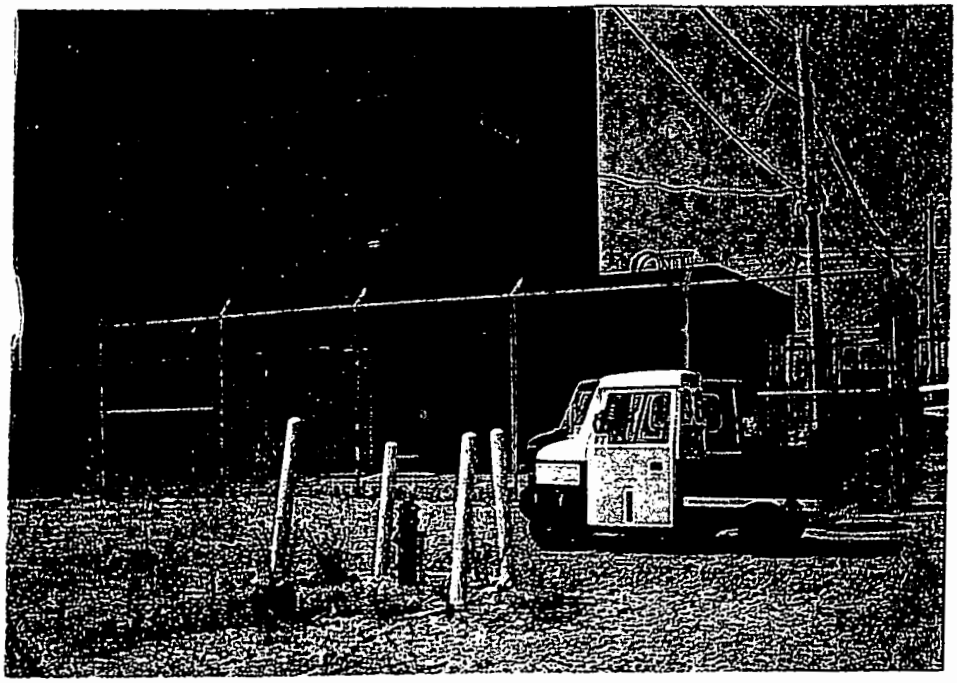
PHOTO 2:

T-BUILDING SHAFT AT
NORTHWEST CORNER OF BUILDING DS
VIEW SOUTHWEST

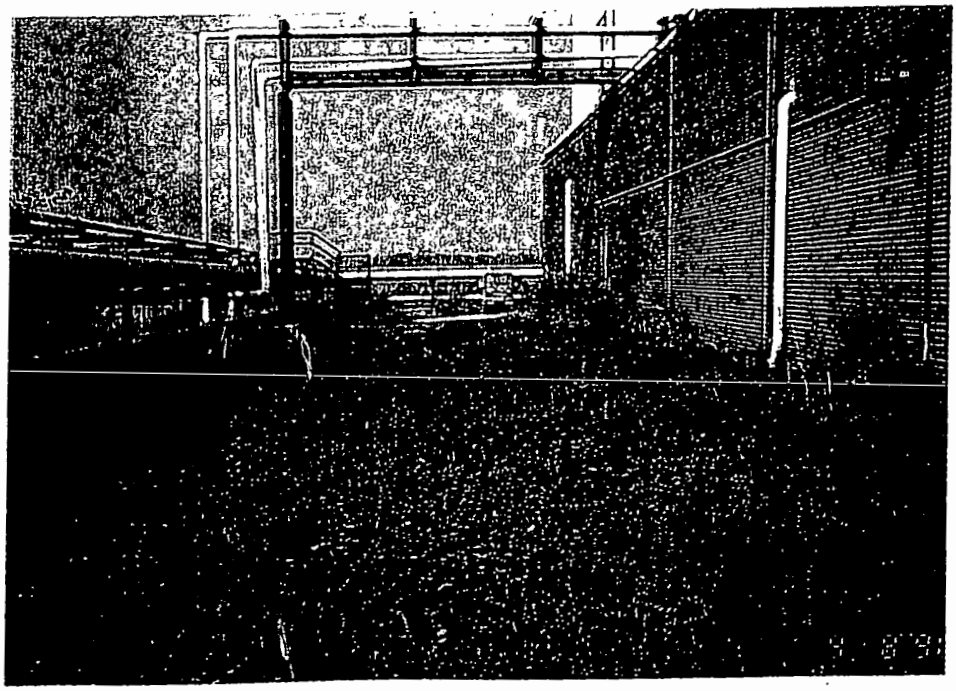
PHOTO 4:

The southern edge of the Mound Main Hill slopes steeply down from the narrow grass lawn behind Building DS (Photograph 4 and 5). Steam and chiller brine supply pipes are routed along the edge of the hill (Photograph 6). The hillside is covered with brush vegetation.

SOUTH SIDE OF BUILDING DS AT RIGHT
COS BUILDING AT LEFT
VIEW EAST

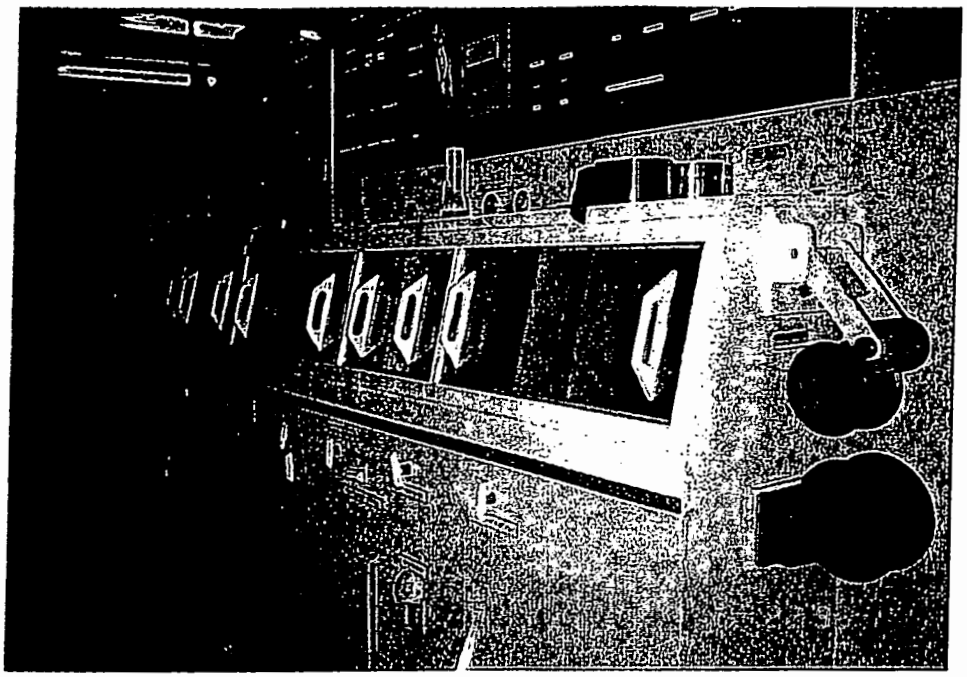
PHOTO 25:

UV PHOTO RESIST EXPOSING
UNIT - STAR CITY
ROOM 126

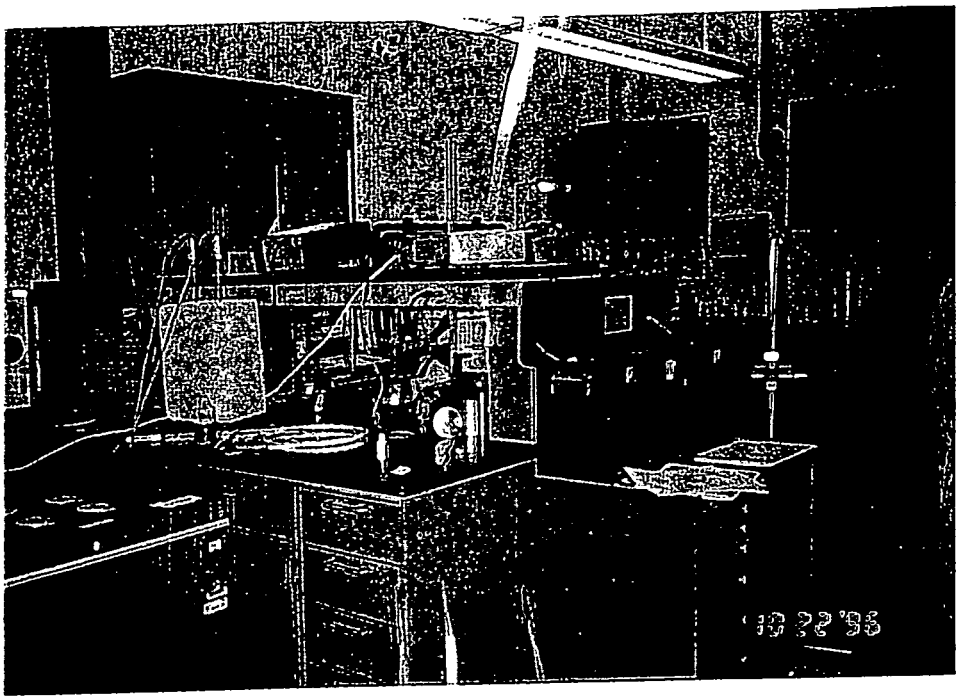
PHOTO 27:

FUME HOODS AND FLAMMABLE
CABINET
ROOM 118

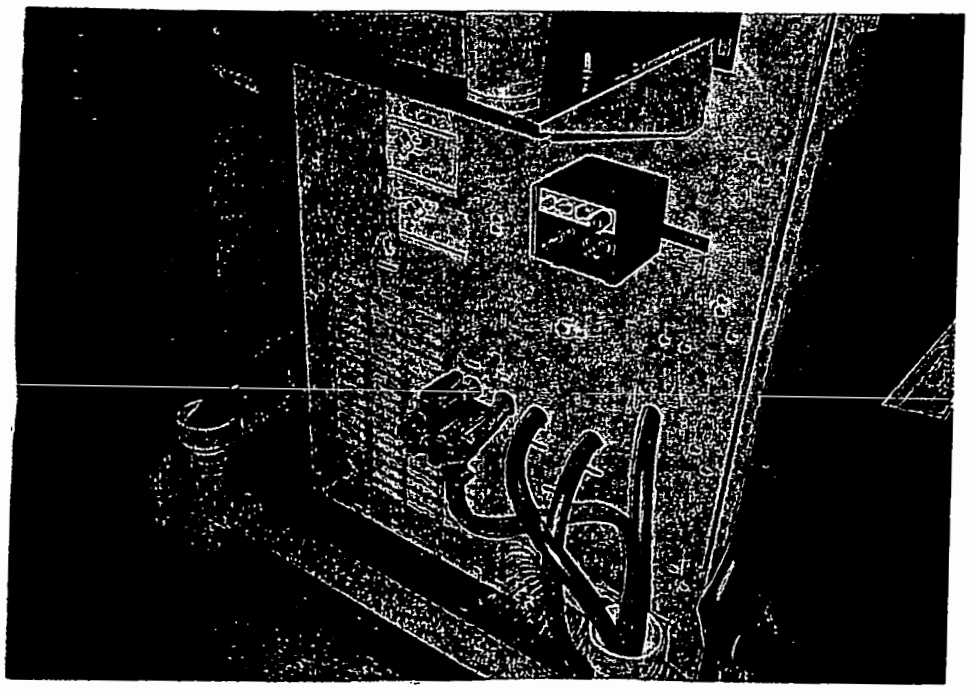
PHOTO 34:

X-RAY UNIT IN
ROOM 213

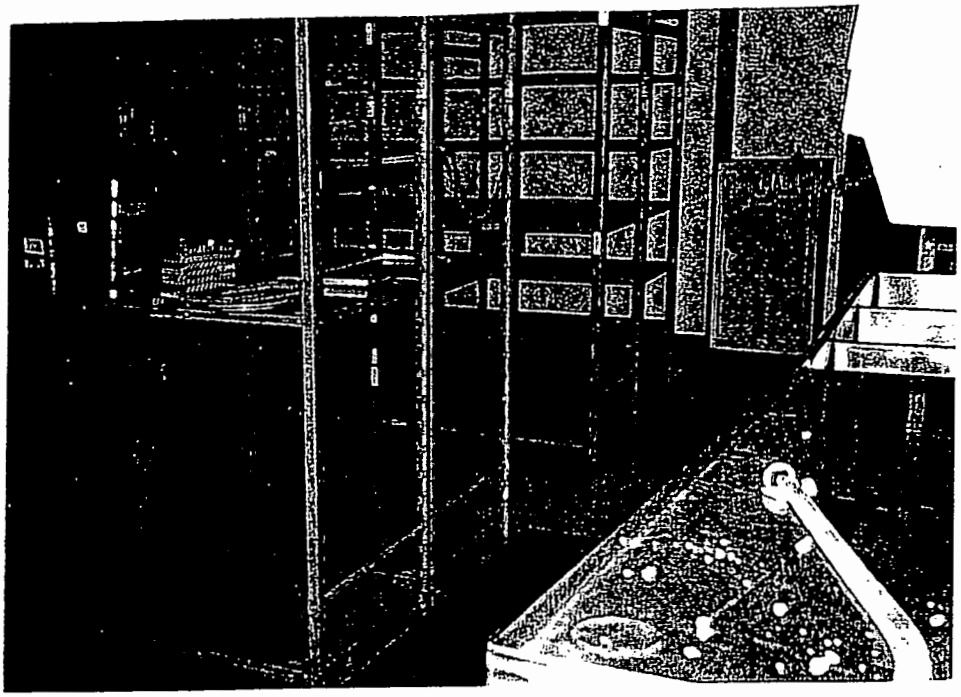
PHOTO 35:

X-RAY PHOTO DEVELOPER
IN ROOM 208B

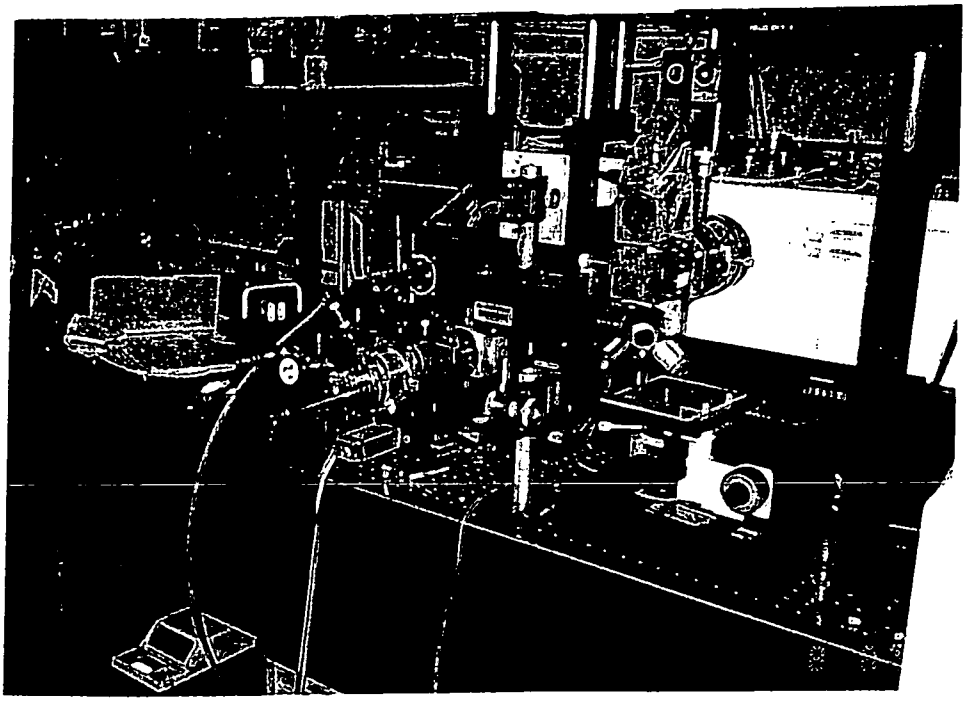
PHOTO 53:

LASER WELDER IN
ROOM 206

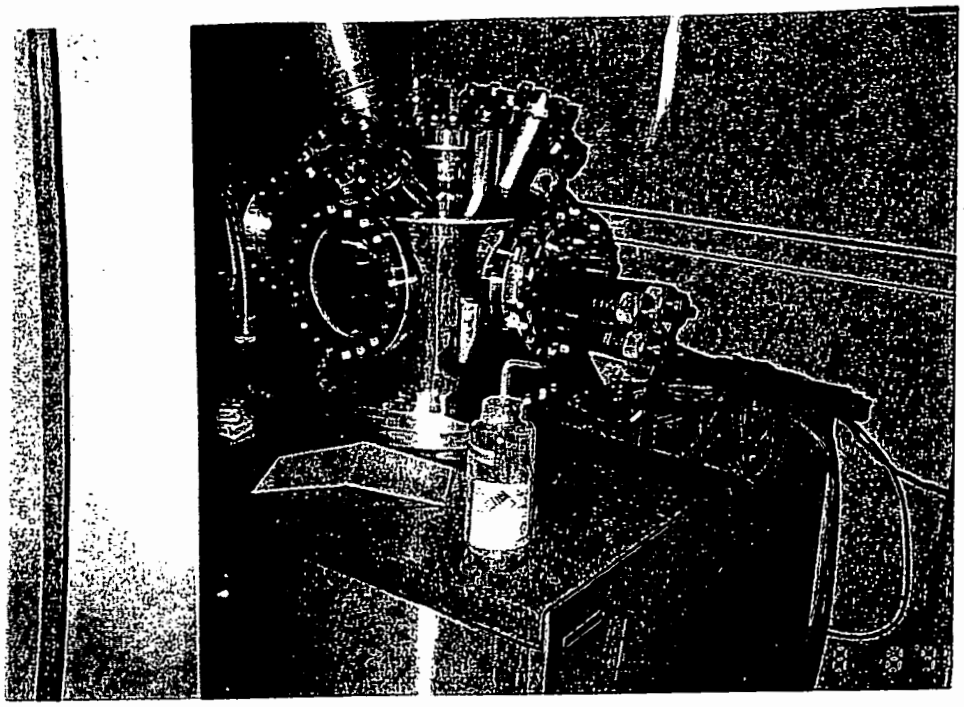
PHOTO 54:

Room 231 is a laser welding development lab used for finding laser ignited detonators (Photograph 54). Bulk explosives are used in this area. The room contains spectroscopy type equipment including the laser welders (Photograph 55).

LASER WELDER DEV. LAB
ROOM 231

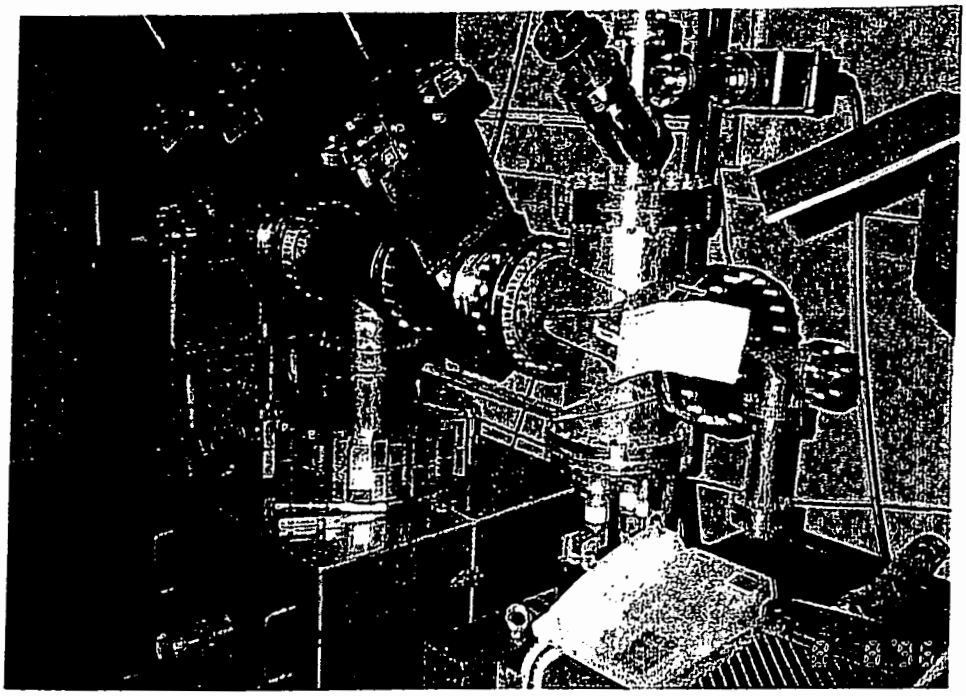
PHOTO 56:

Room 245 is the ion separator laboratory, containing a 30-foot long Varian ion separator (Photograph 56), three robotic units, and a smaller ion separator (Photograph 57).

30-FOOT ION SEPARATOR
ROOM 245

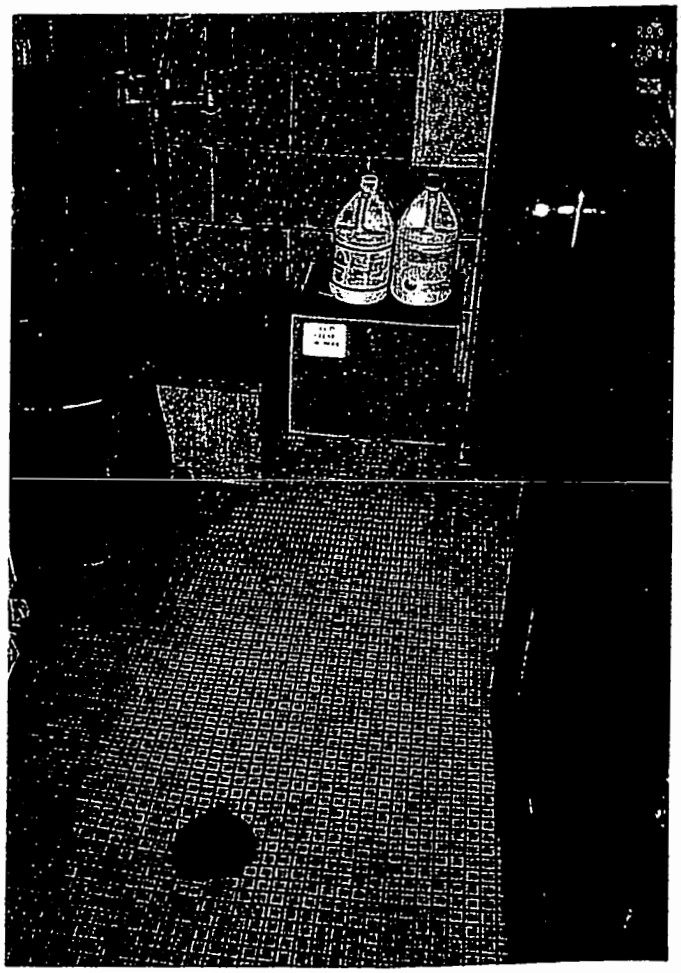
PHOTO 57:

SMALLER ION SEPARATOR
ROOM 245

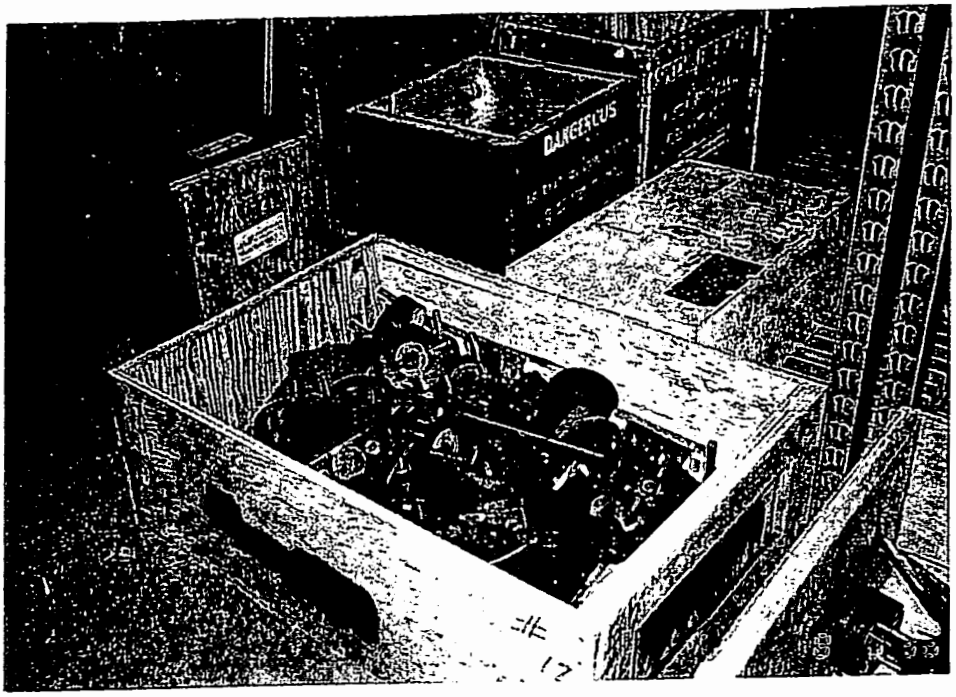
PHOTO 58:

Room 254 is a janitors closet. This room contains a floor sink with a floor drain (Photograph 58).

JANITOR'S CLOSET
ROOM 254

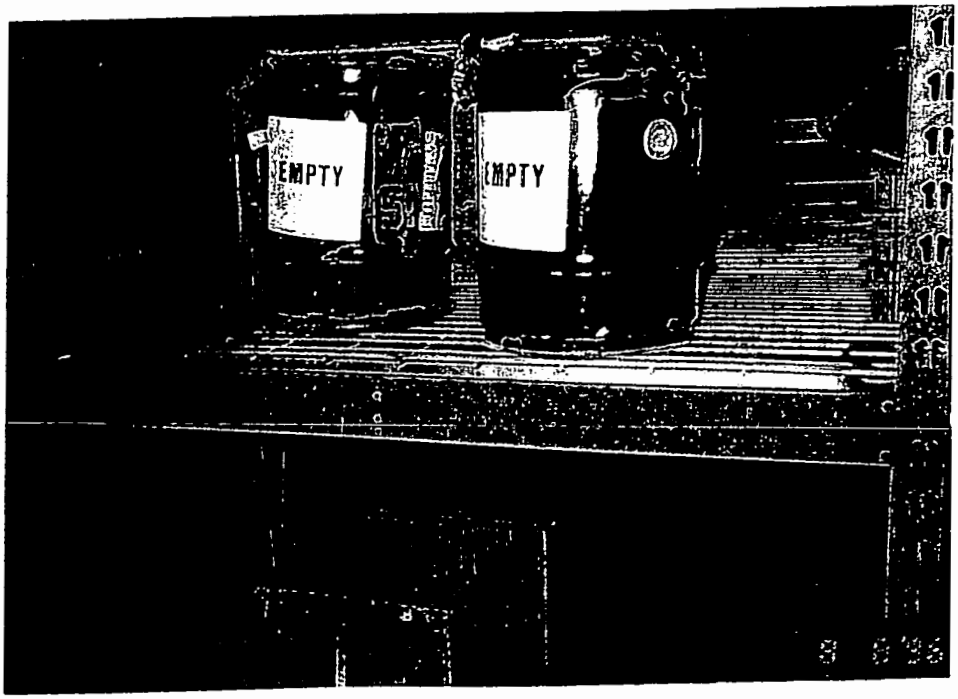
PHOTO 59:

METAL PARTS IN WAREHOUSE
WEST DOCK
BUILDING DS

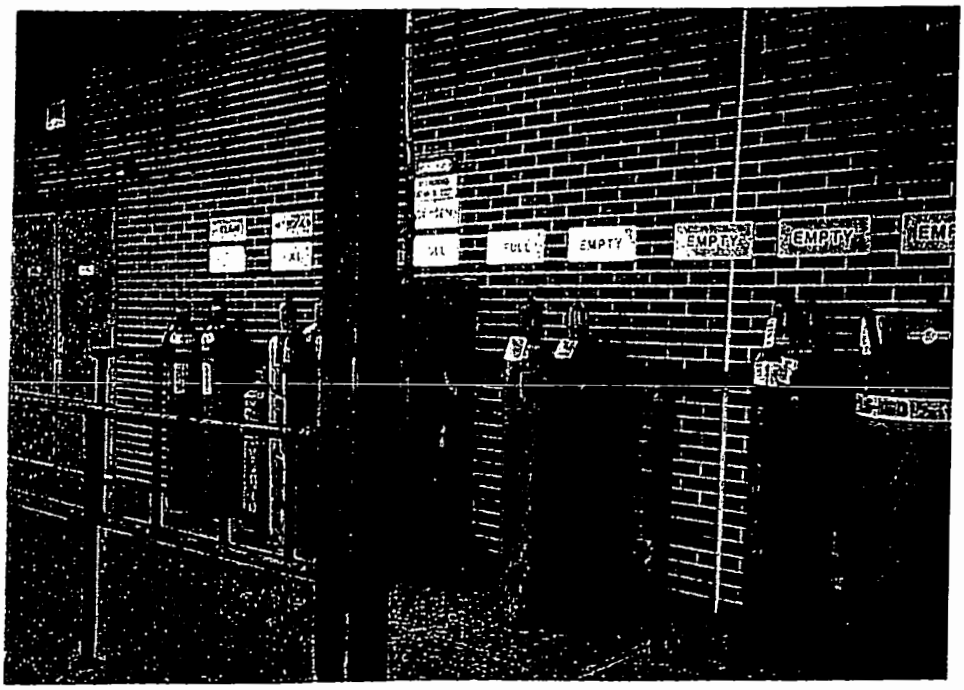
PHOTO 61:

NITROGEN DEWARS, WEST DOCK
BUILDING DS

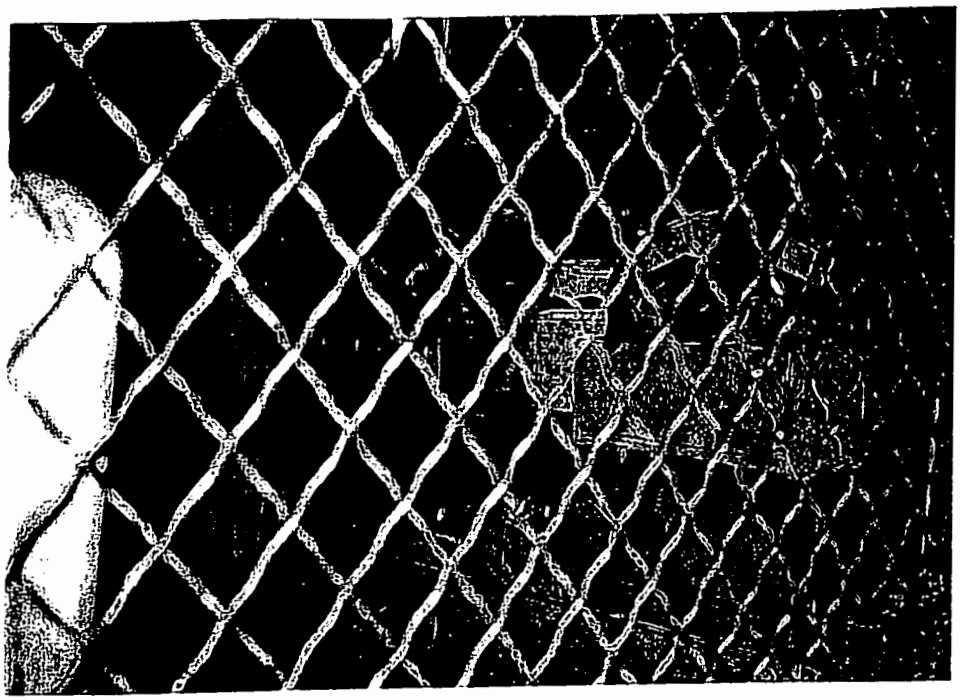
PHOTO 62:

CYLINDER STORAGE
WEST DOCK, BUILDING DS

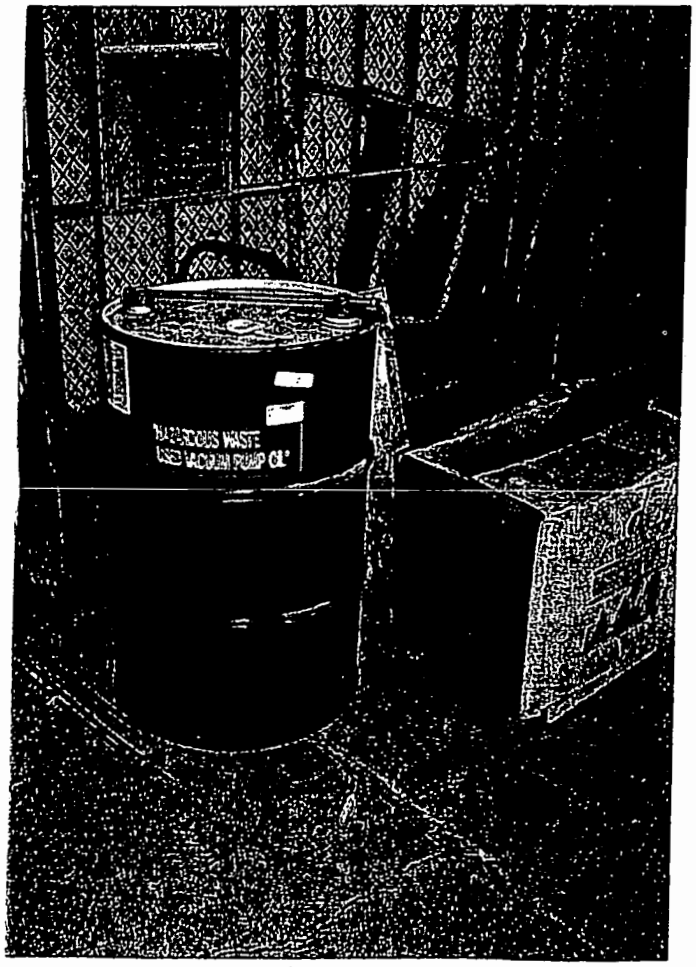
PHOTO 63:

VACUUM PUMP OIL IN TOOL CRIB
WEST DOCK, BUILDING DS

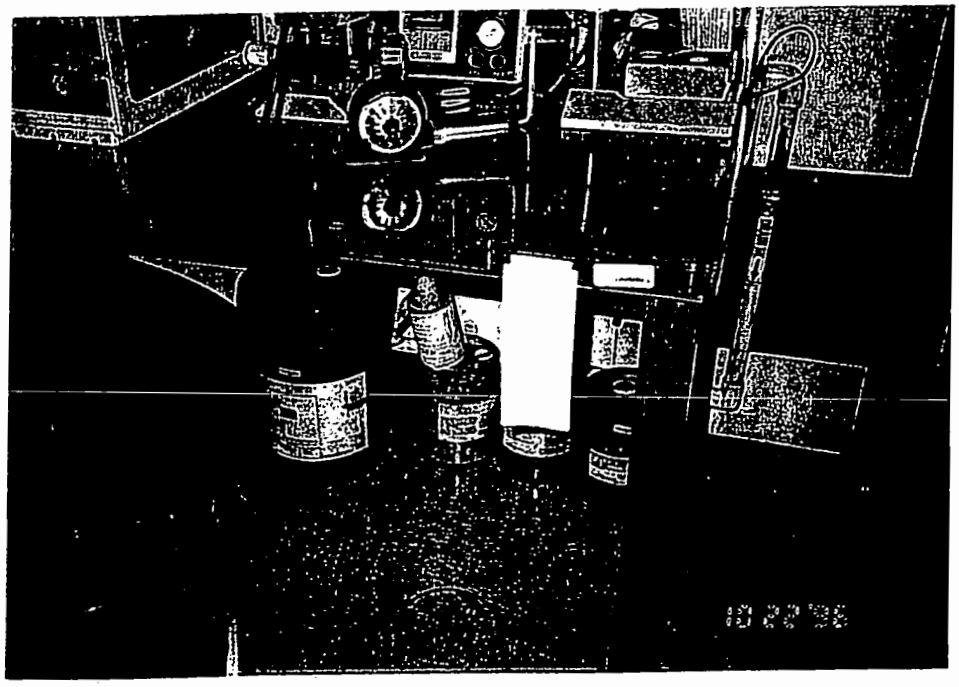
PHOTO 67:

In the rear of Room 125A is a cleaning hood with solvent dispensers and a sump for previous cleaning operations. Under the cleaning hood are stains that appear to be from past chemical storage practices. These stains have been cleaned as far as practical. The building manager confirms that these stains were most probably rust from corrosion of spacers under a catch container.

STAINING UNDER SOLVENT
HOOD
ROOM 125

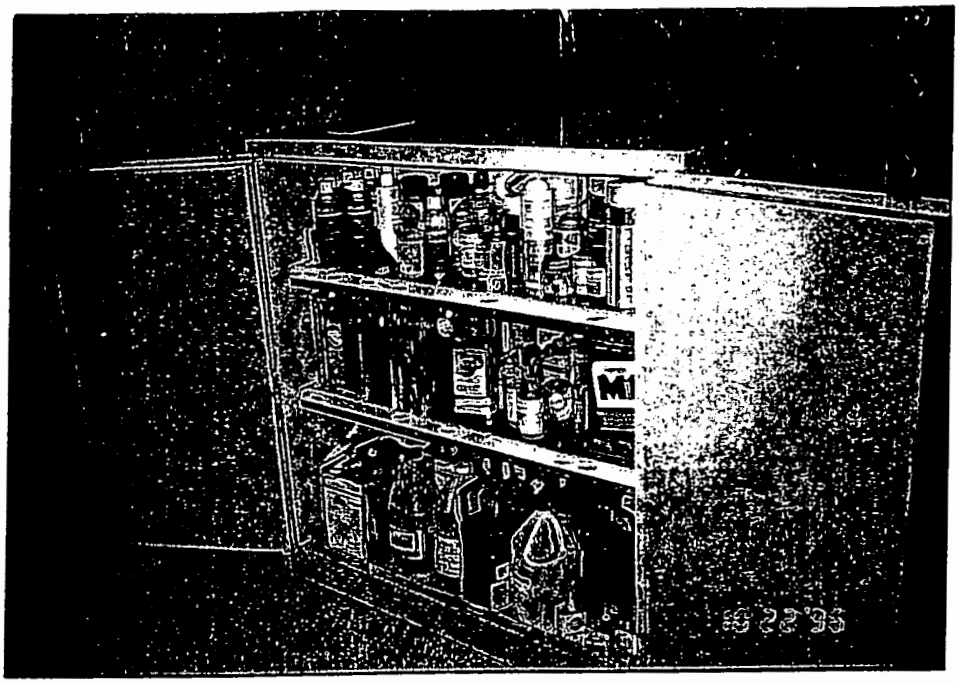
PHOTO 72:

maintenance of the machines and cleaning of the machines, standards and samples. As a matter of routine operation, the solvents and alcohols are placed on a rag, used for cleaning purposes, then disposed via the sanitary waste. The small quantities of wastes generated by the Metrology laboratories is staged in a flammable storage cabinet in Room 118 (Photograph 72), where the EG&G Waste Management group will coordinate the proper disposal of these chemicals.

FLAMMABLE CABINET
IN ROOM 118

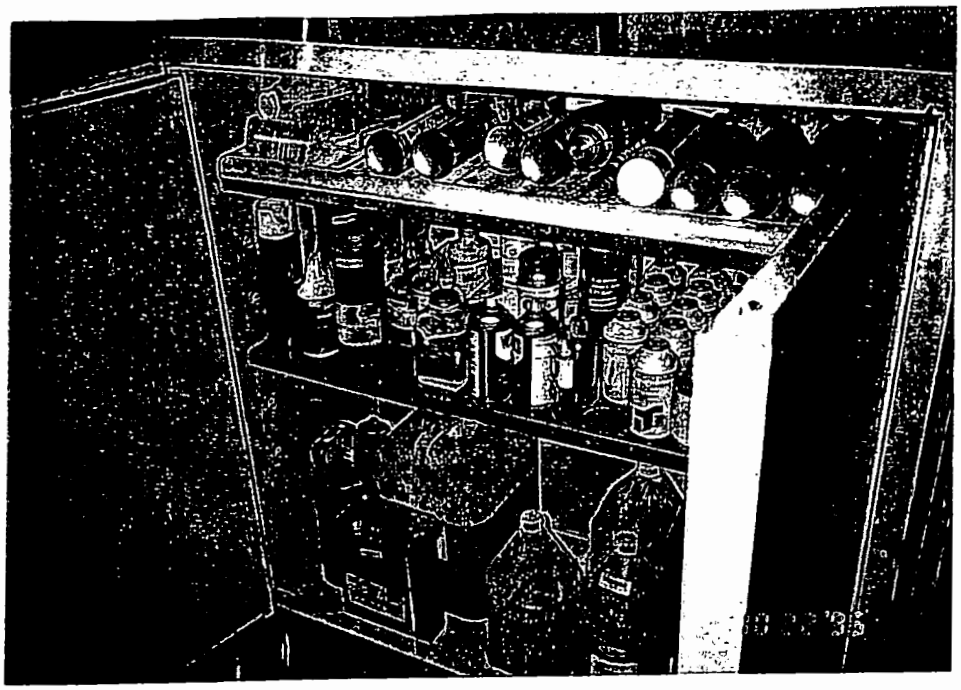
PHOTO 74:

CHEMICAL STORAGE
ROOM 135B
