SUBJECT: Contract No. DE-AC24-03OH20152
Statement of Work Requirement 055 - Regulator Reports
BUILDING 72 CLOSEOUT REPORT, FINAL

Miamisburg Closure Project
CLOSEOUT REPORT

Building 72
(Demolition)

Final
February 2005

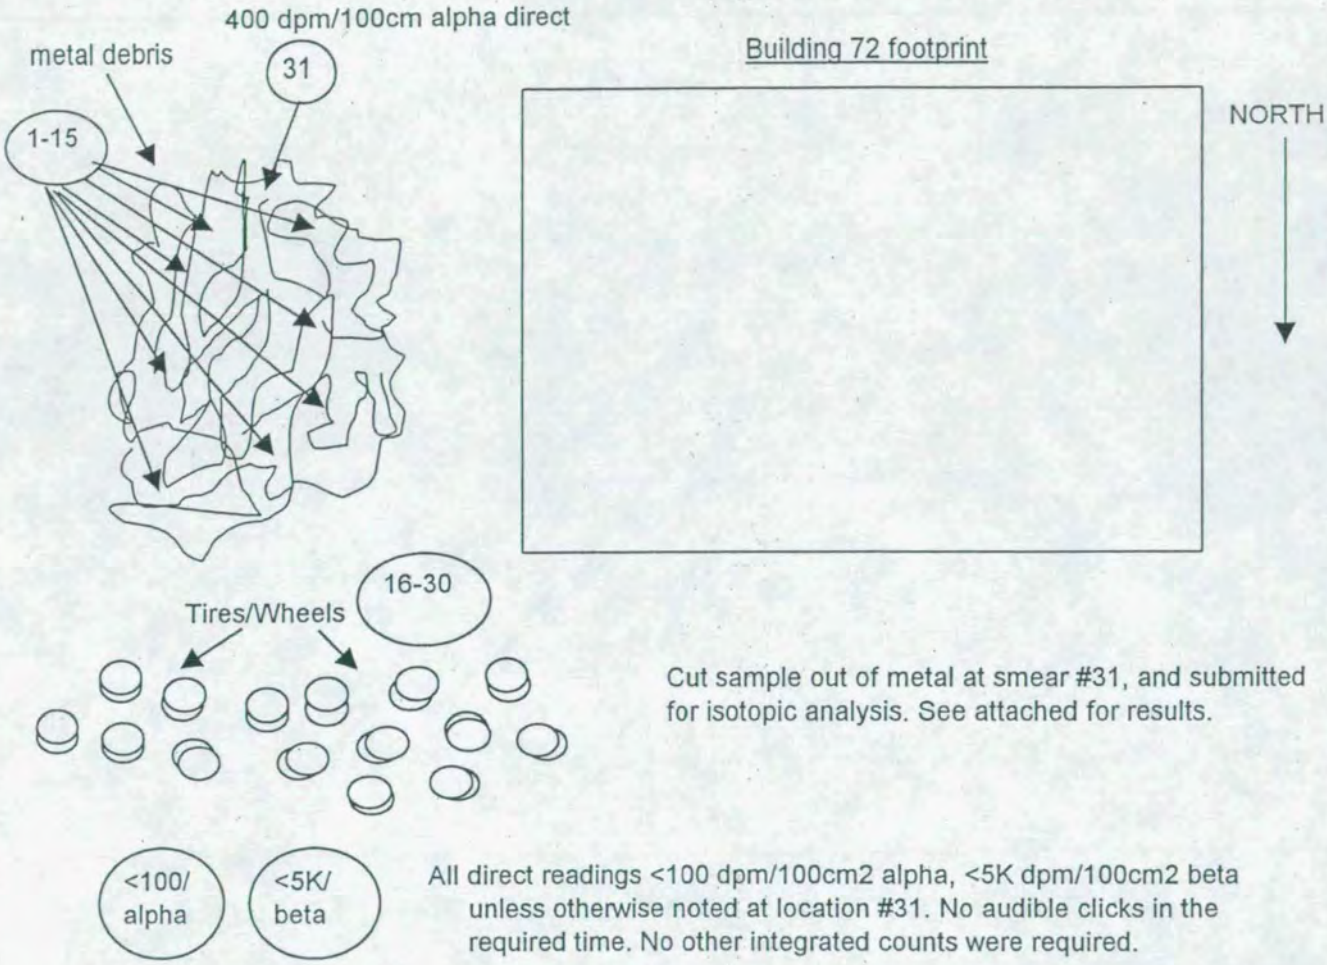
Cut sample out of metal at smear #31, and submitted for isotopic analysis. See attached for results.

All direct readings <100 dpm/100cm2 alpha, <5K dpm/100cm2 beta unless otherwise noted at location #31. No audible clicks in the required time. No other integrated counts were required.

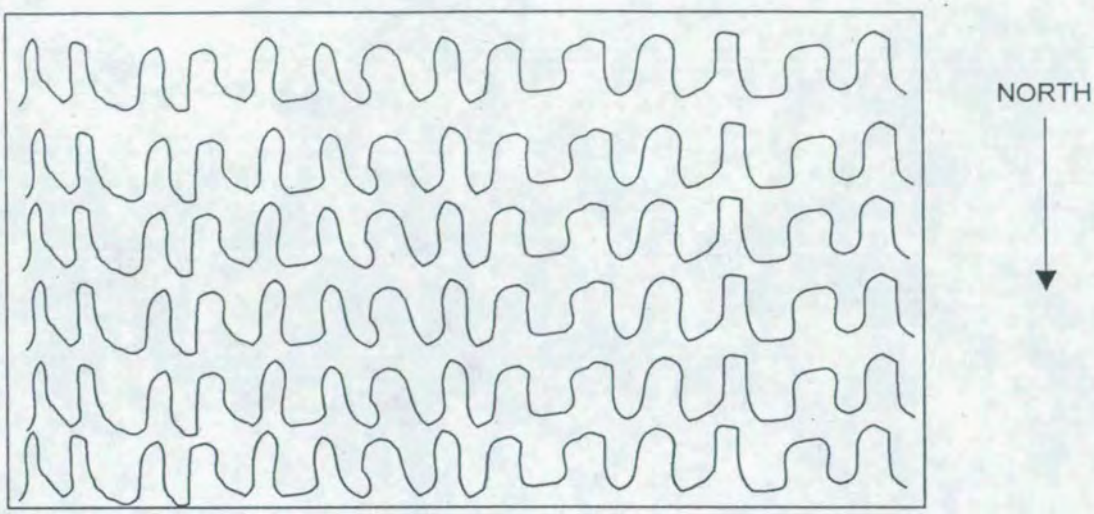
Building 72 Footprint

FIDLER results for indication purposes only.
Background - 120 cpm
All results were less than or equal to background
