In accordance with the Rocky Flats Cleanup Agreement, please find the page changes to the Pre-Demolition Survey Report for Building 447, for your review and approval. These changes were a result of staff review of the initial data.

B444-A-000088

PRE-DEMOLITION SURVEY MAP

BUILDING 447 LOW-LEVEL WASTE AREA MAP

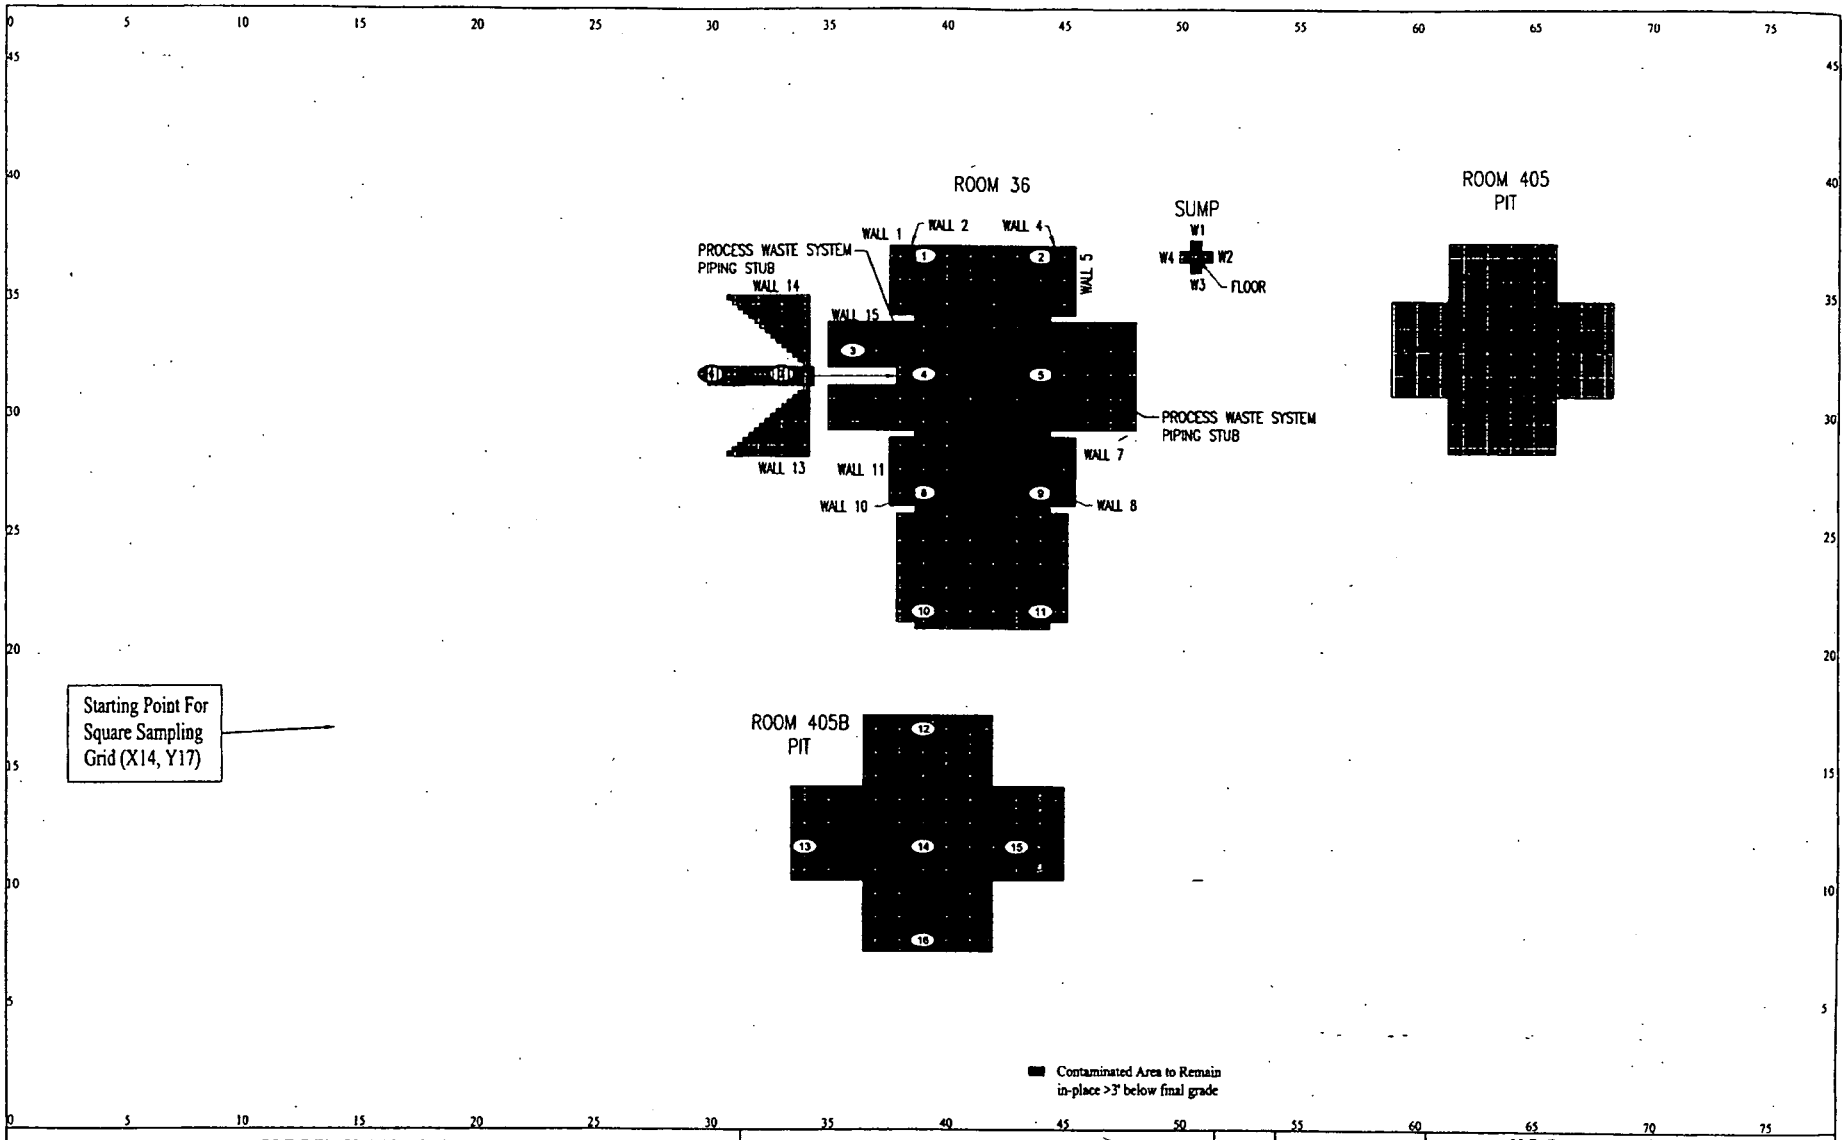
Survey Area/Unit Description: Rooms 36 405 Pit & 405B Pit, All Surfaces

- filled-in concrete trenches (filled with concrete) in Rooms 405B and 406B,
- the floor and lower walls of Pit 405A (<5,000-30,000 dpm/100cm^2 fixed, <1,000 dpm/100cm^2 loose),
- two contaminated Process Waste System piping stubs in the Room 36 Pit

Based on in-process core samples of the filled in concrete trenches in Rooms 405B & 406B, it was calculated that the worst case scenario of average contamination inside the inaccessible areas of the trenches is 1.222 pCi/gram of depleted uranium holdup. Based on in-process surveys of Pit 405A, it was calculated that the worst case scenario of average contamination on the inaccessible areas of the pit would be 38.737 pCi/gram of depleted uranium holdup.
