The U.S. Department of Energy/Rocky Flats Field Office is pleased to provide copies of the Polychlorinated Biphenyls Closeout Report. The Polychlorinated Biphenyls Closeout Report was prepared using the language in the Draft Implementation Guidance Document. The Polychlorinated Biphenyls Closeout Report will also be used as a final closure document for the addressed sites under the Industrial Area Operable Unit Record of Decision.

COMPLETION REPORT

SOURCE REMOVAL

July 29, 1997

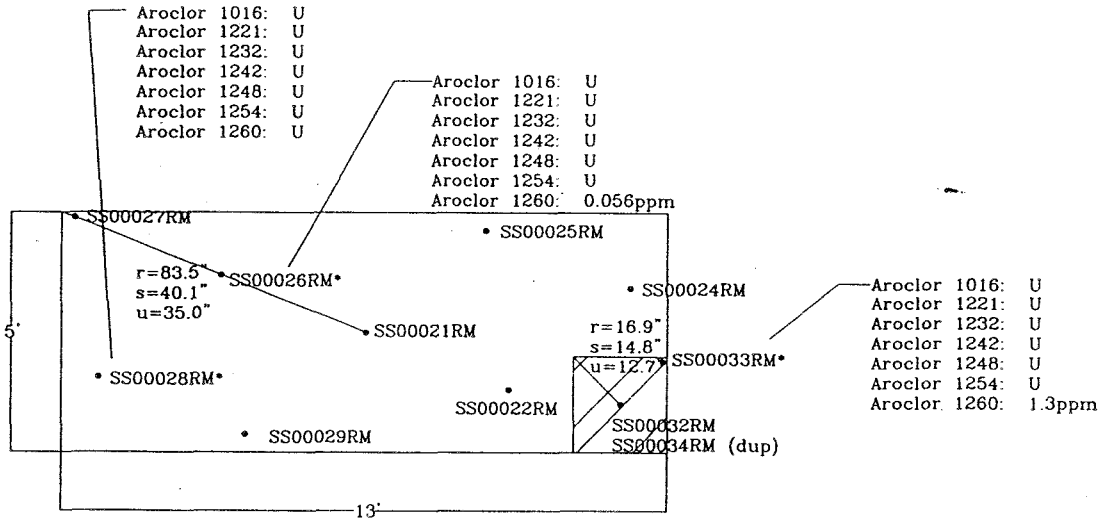
DETAILED MAP OF PCB SITE #10

Note:
All samples are <10ppm PCBs by immunoassay analysis.

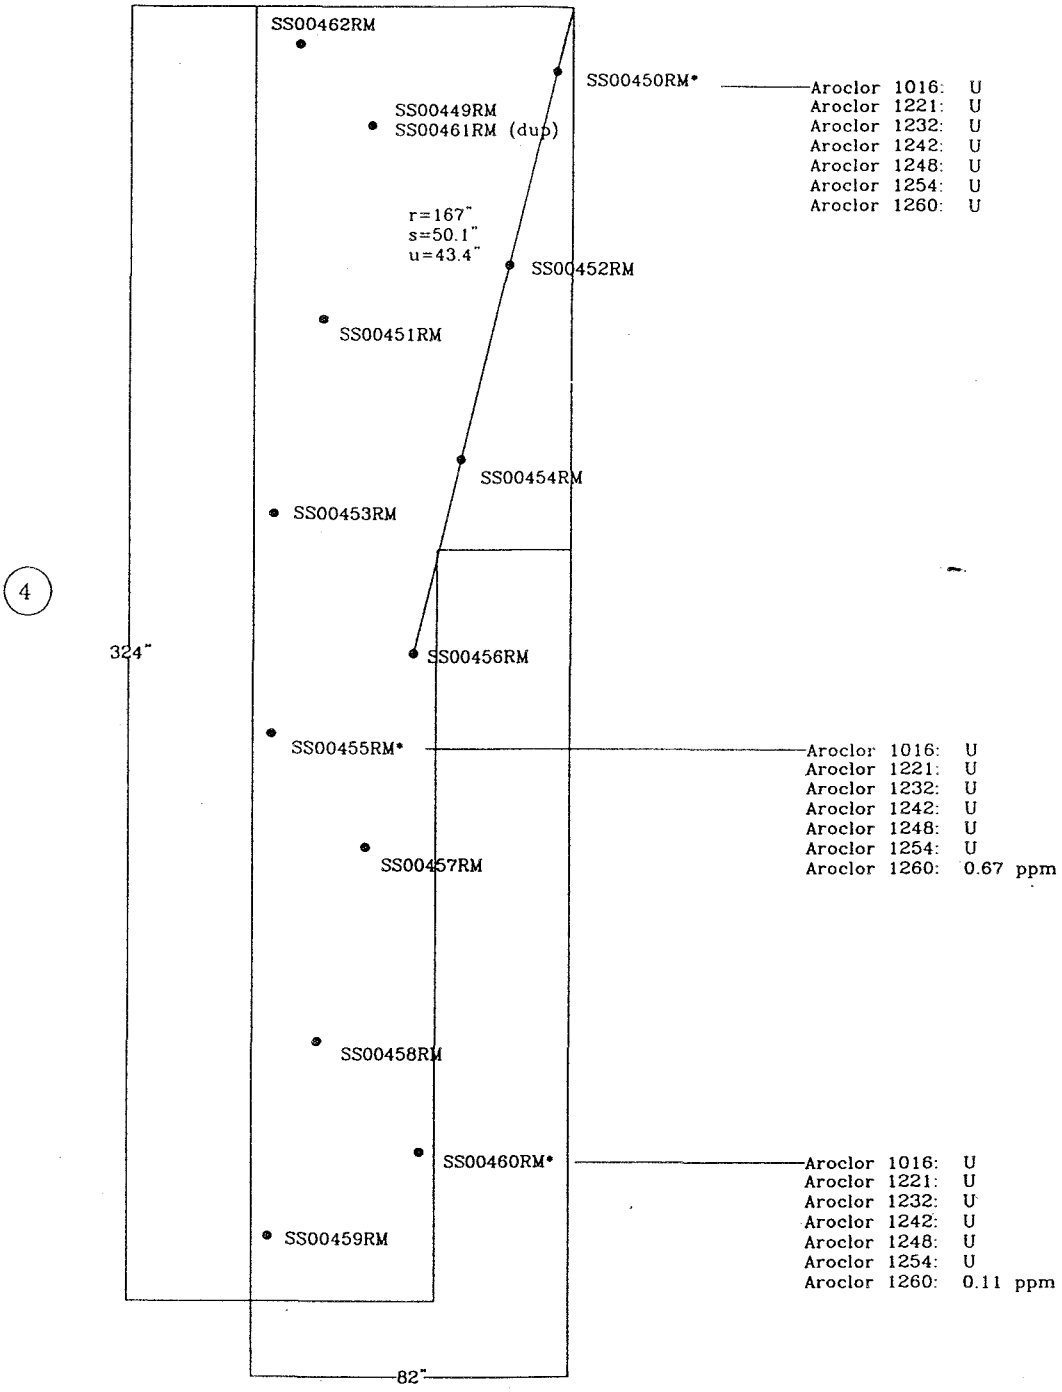
MRI GRID LAYOUT
PCB-12/13 (Substation 661/675)

Note:
All samples are <10ppm PCBs by immunoassay analysis.

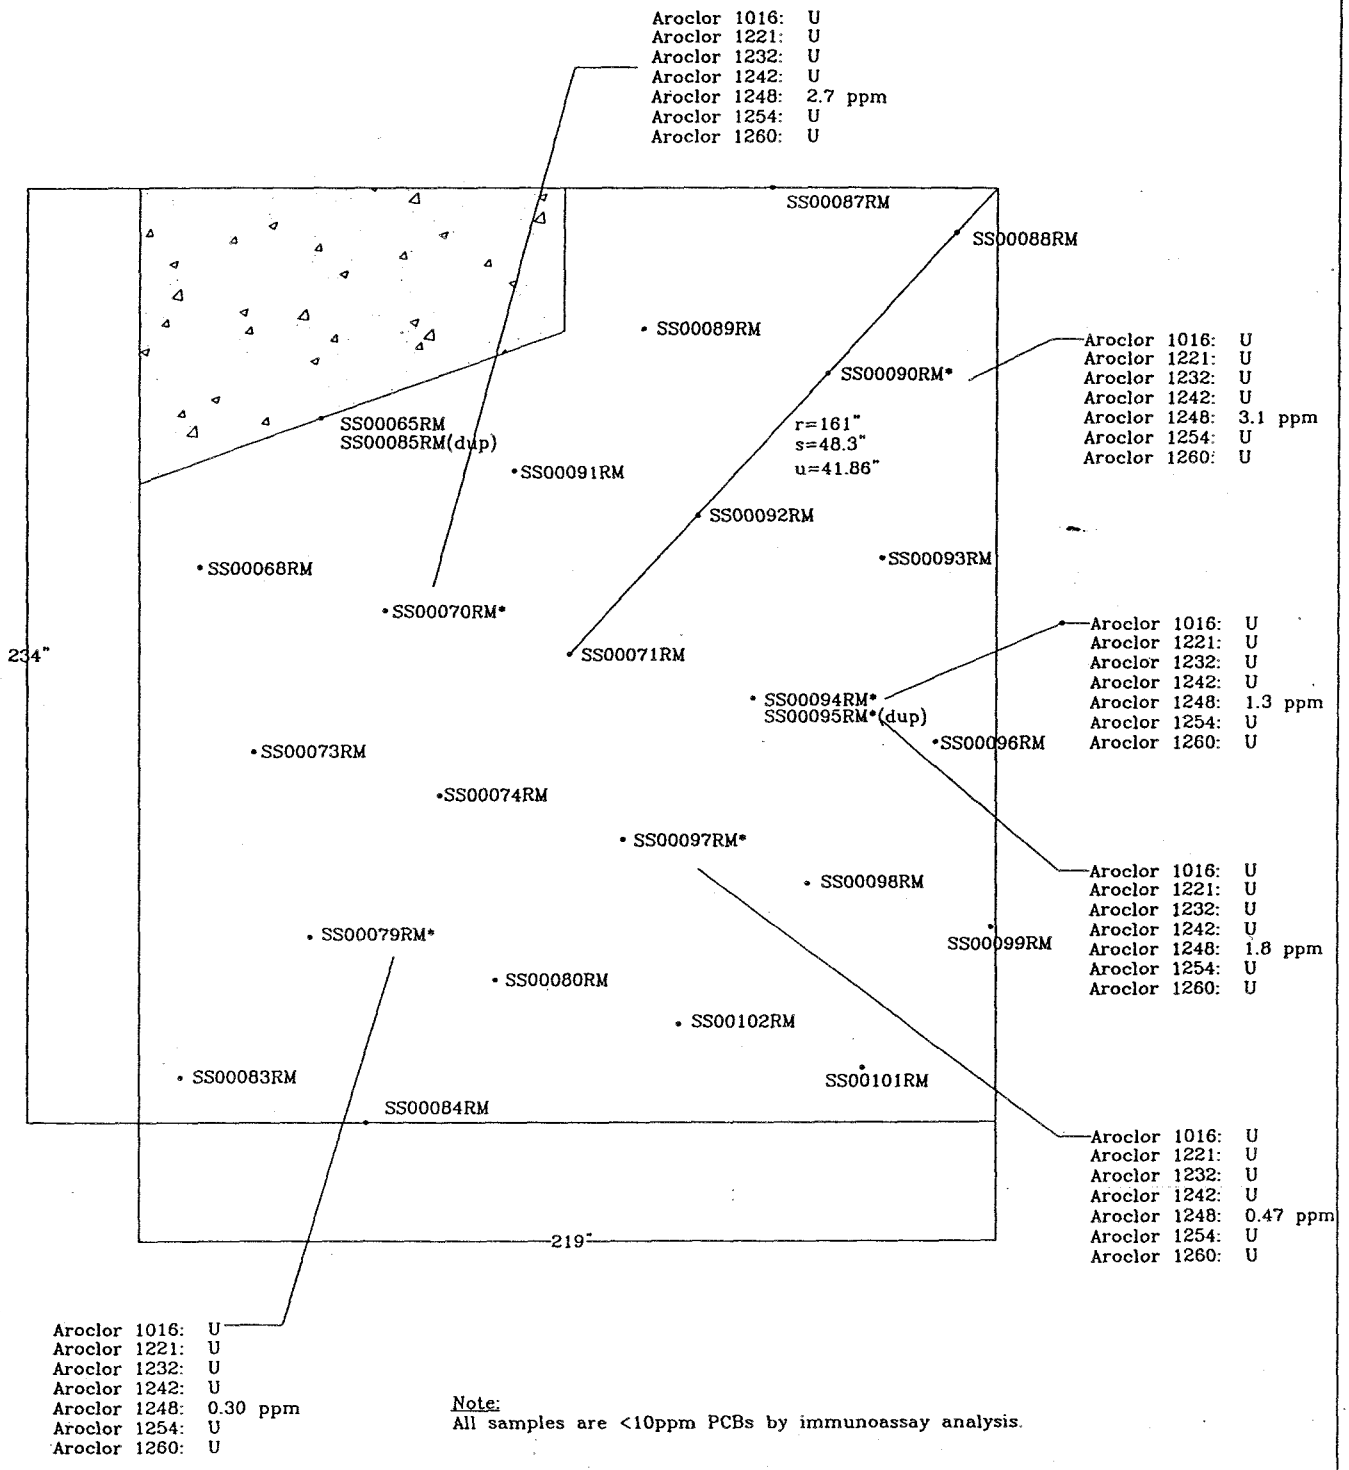
SITE SURVEY FOR REMEDIATION OF PCBs PCB SITE #17

Note:
All samples are <10ppm PCBs by immunoassay analysis.

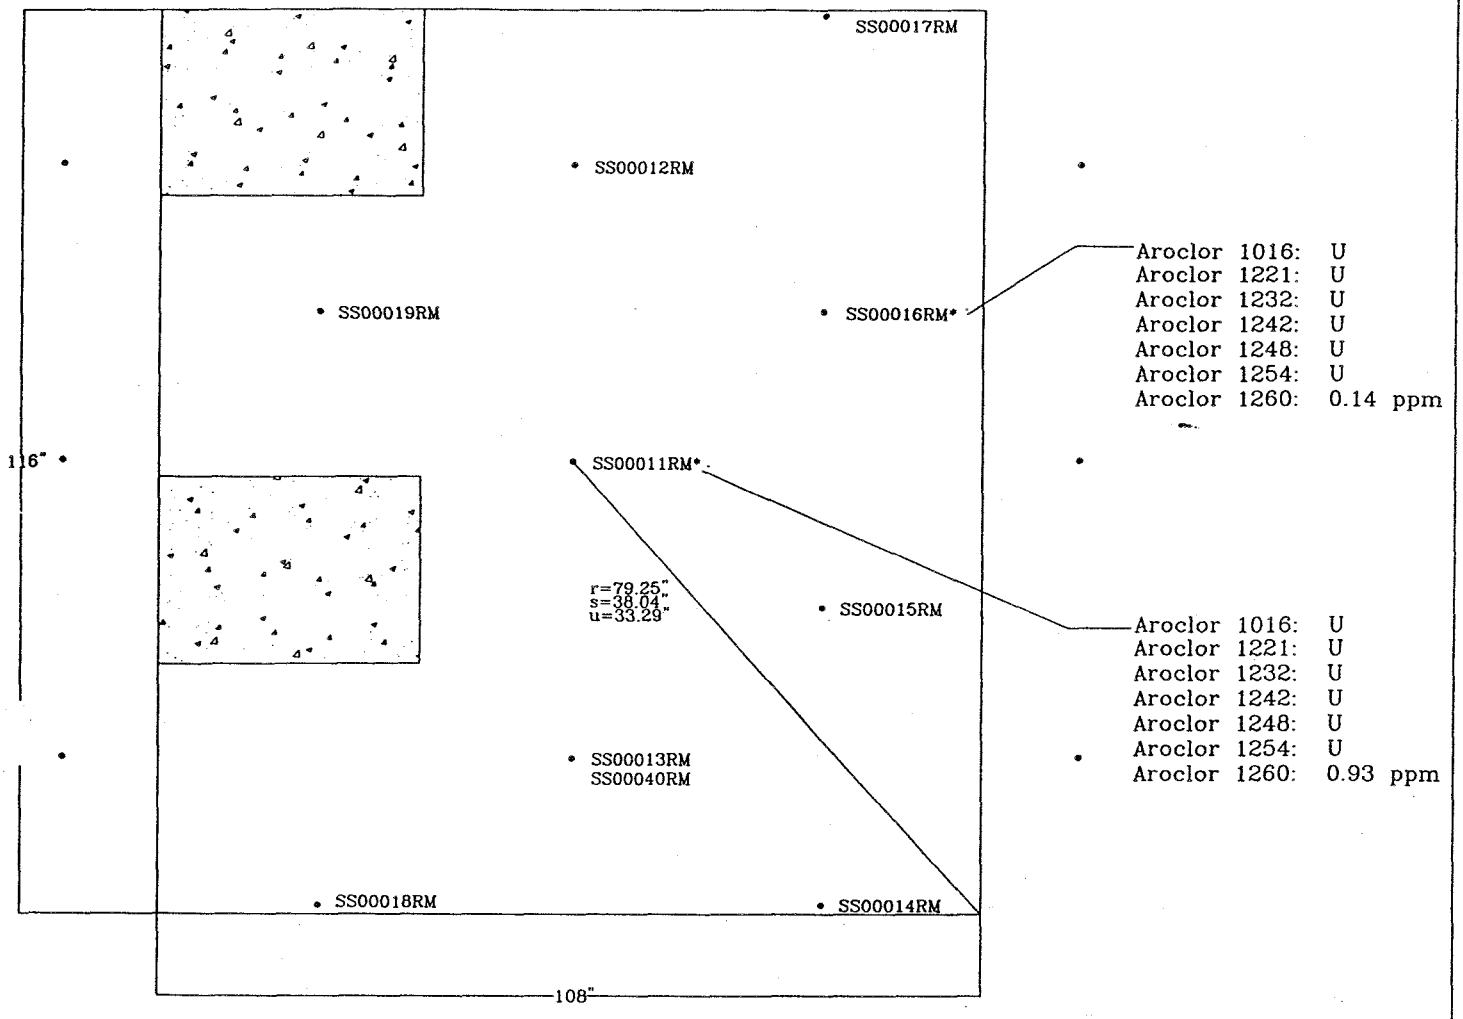
SOIL REMOVED FROM PCB SITE #20

Note:
All samples are <10ppm PCBs by immunoassay analysis.

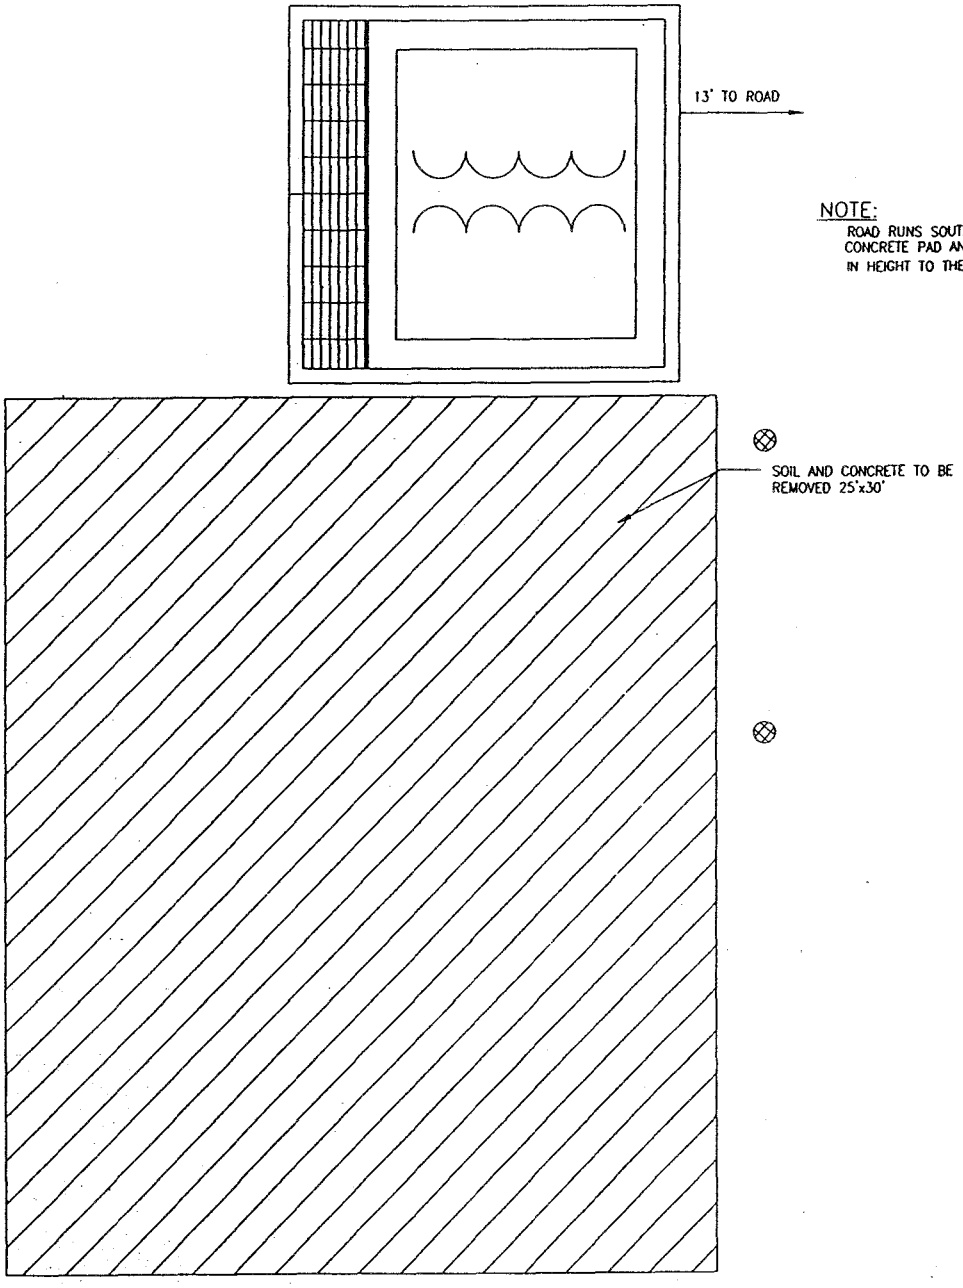
Soil to Be Removed
PCB SITE #21
(NW of Bldg 776)

NOTE:
ROAD RUNS SOUTH AND EAST OF CONCRETE PAD AND SLOPES 4'-6' IN HEIGHT TO THE ROADS.

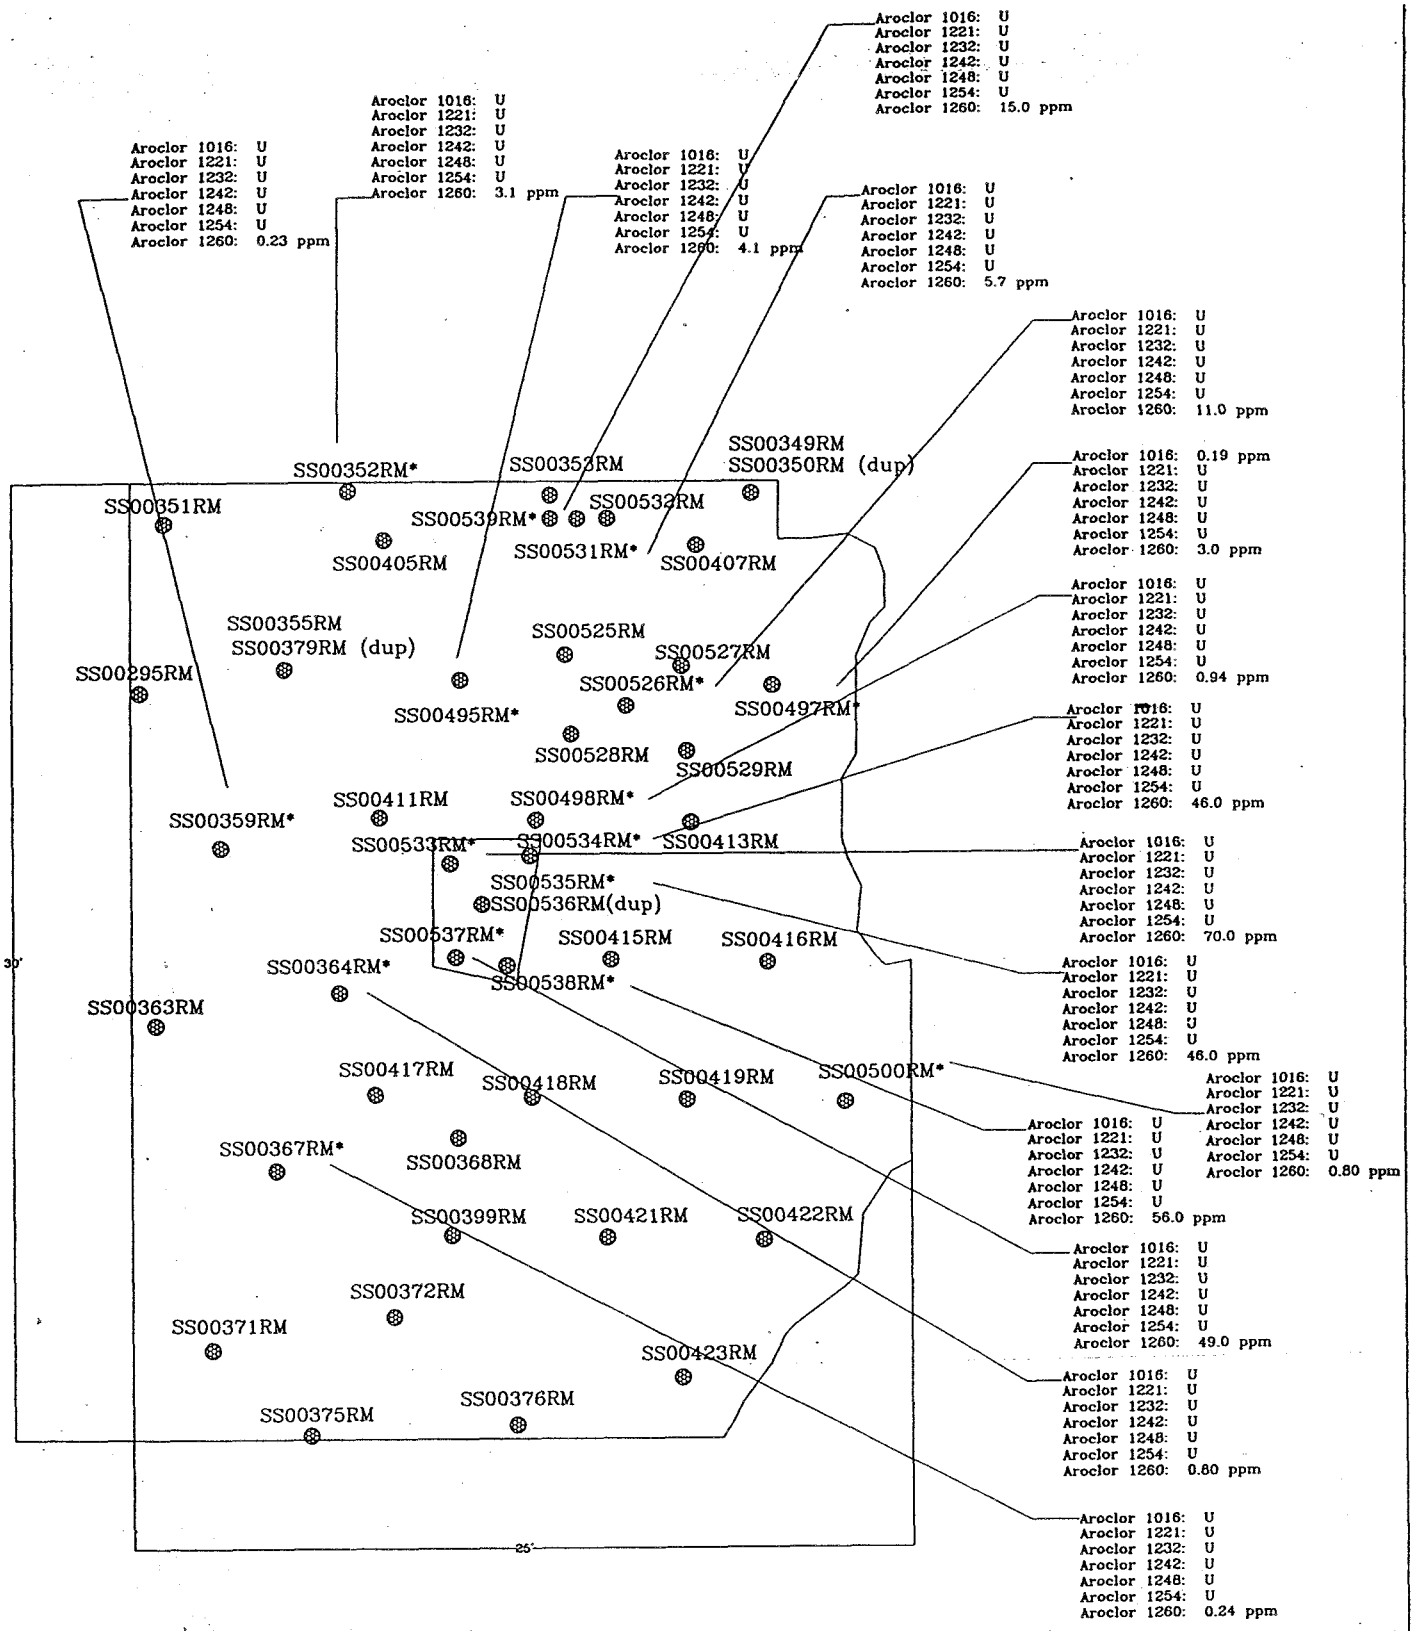
Note:
All samples are <25ppm PCBs by immunoassay analysis unless otherwise noted.

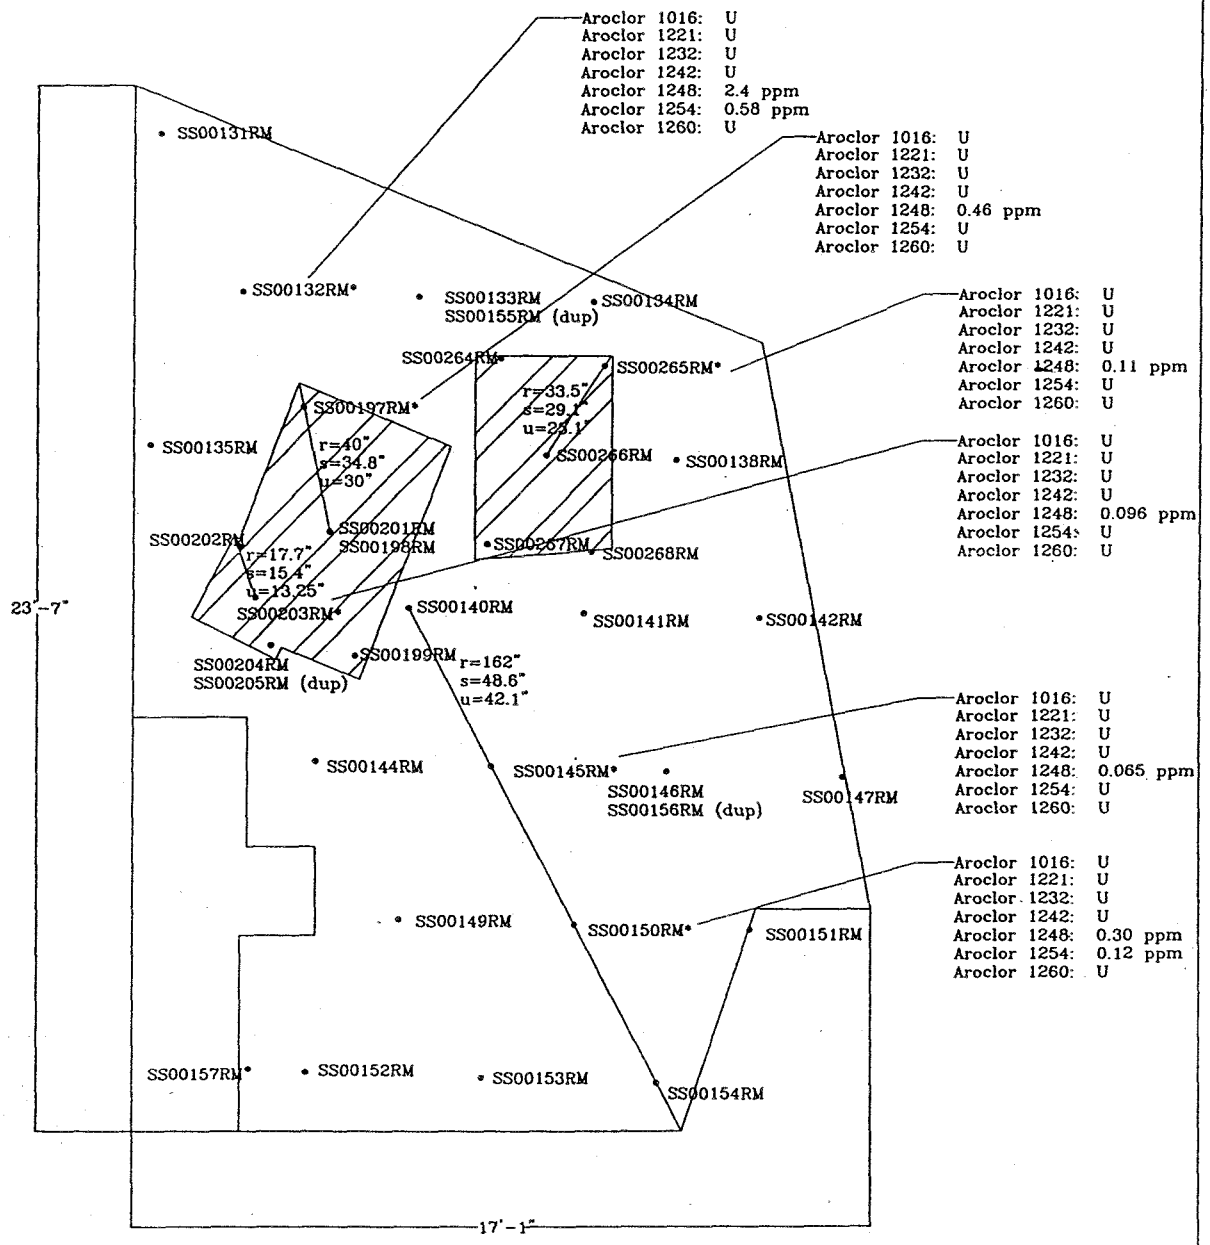
SITE SURVEY FOR REMEDIATION OF PCBs PCB SITE #23

All Samlpes are <10 ppm PCB's by Immunoassay analysis

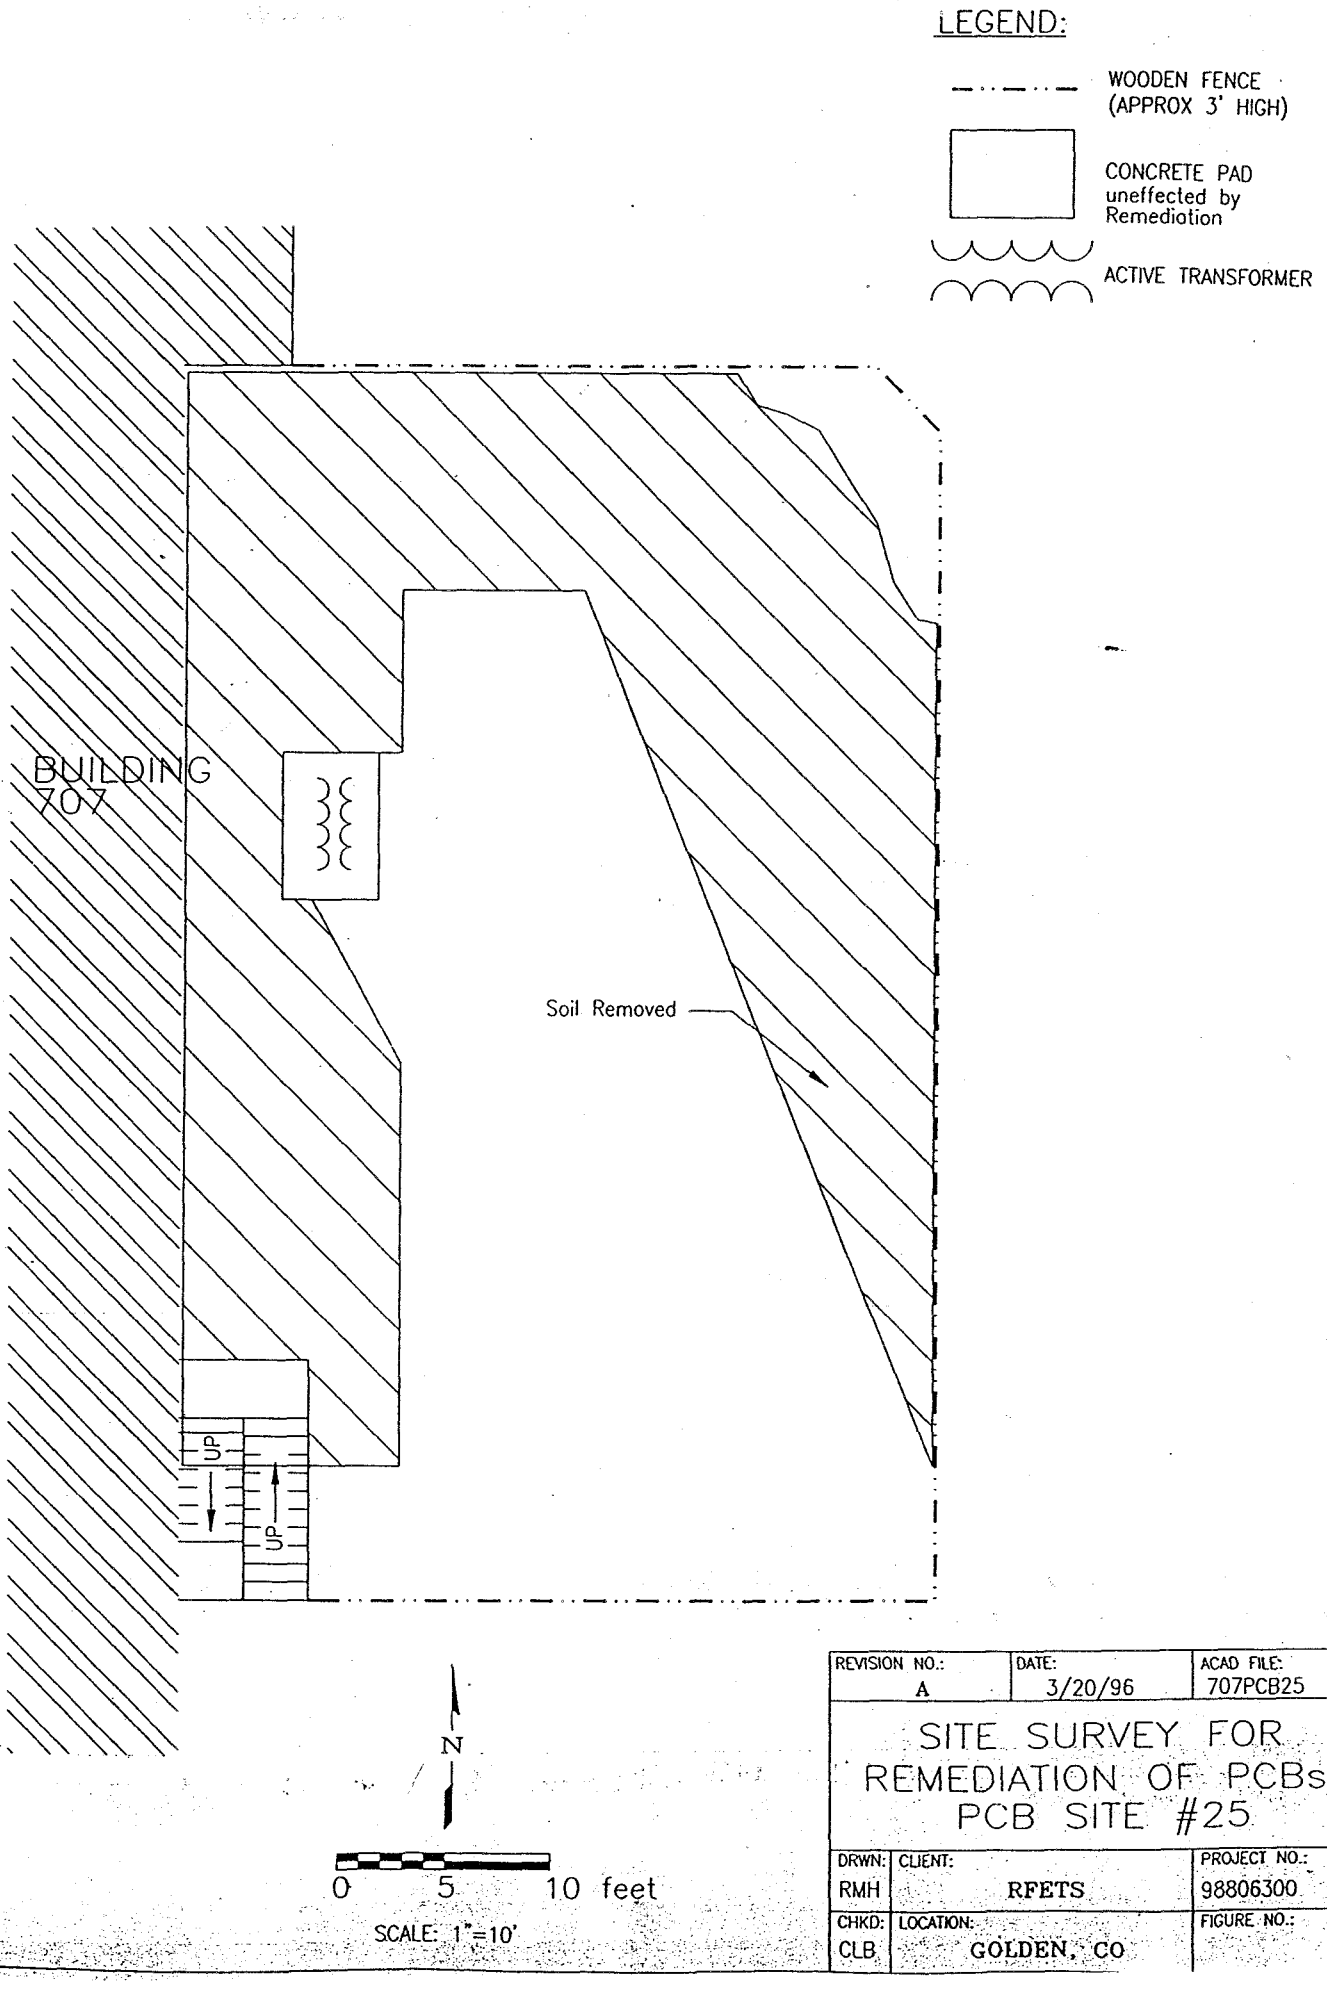
SITE SURVEY FOR REMEDIATION OF PCBs PCB SITE #25

In 1991, one of the six transformers located on the rooftop of Building 707 was identified as leaking PCB dielectric oil. Further investigation revealed that rain water had carried PCBs, via a downspout, from the contaminated rooftop to the soil below. An extensive PCB cleanup was initiated in 1991 and 1992 under TSCA regulations and the roof was declared clean. The contaminated soil area below was cordoned off and marked "PCB Contaminated Area" until appropriate actions could be taken under CERCLA. Approximately 64.8 yd^3 of soil were removed from an area immediately south of the main entrance doorway of Building 707 (east side) using backhoes, front-end loaders, excavators, bobcats and hand shovels during the second half of September 1995. The PCB-25 site was confirmed at <10 ppm PCBs by weight using EPA Method 8080. The confirmation of remediation of soils at this site provide the basis for NFA status.

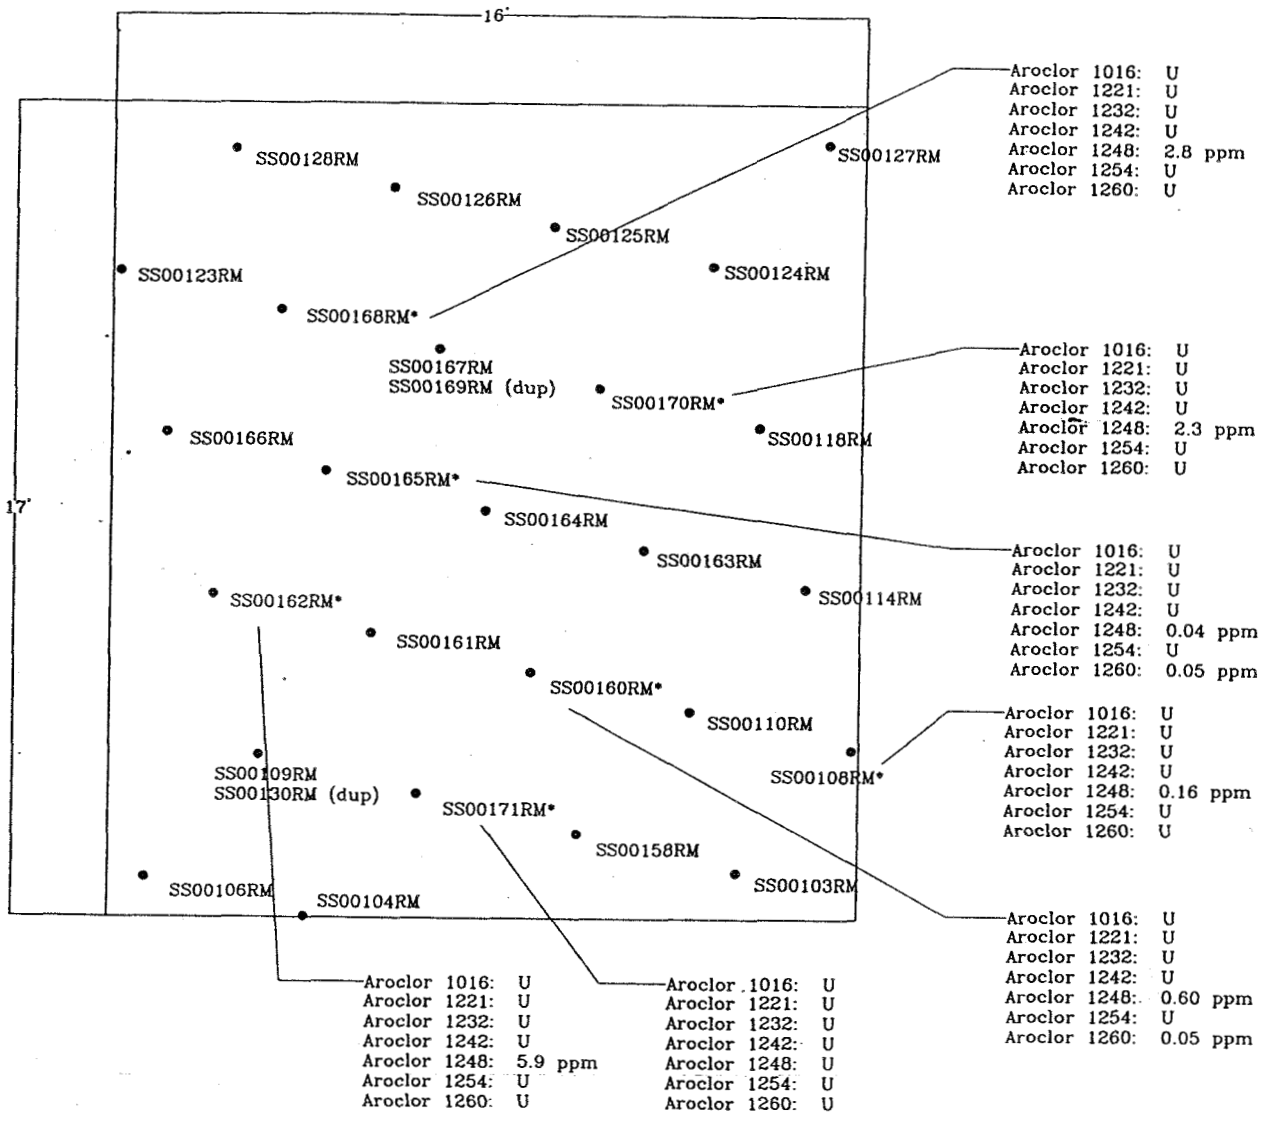
SITE SURVEY FOR REMEDIATION OF PCBs PCB SITE #26

Note:
All samples are <10ppm PCBs by immunoassay analysis.

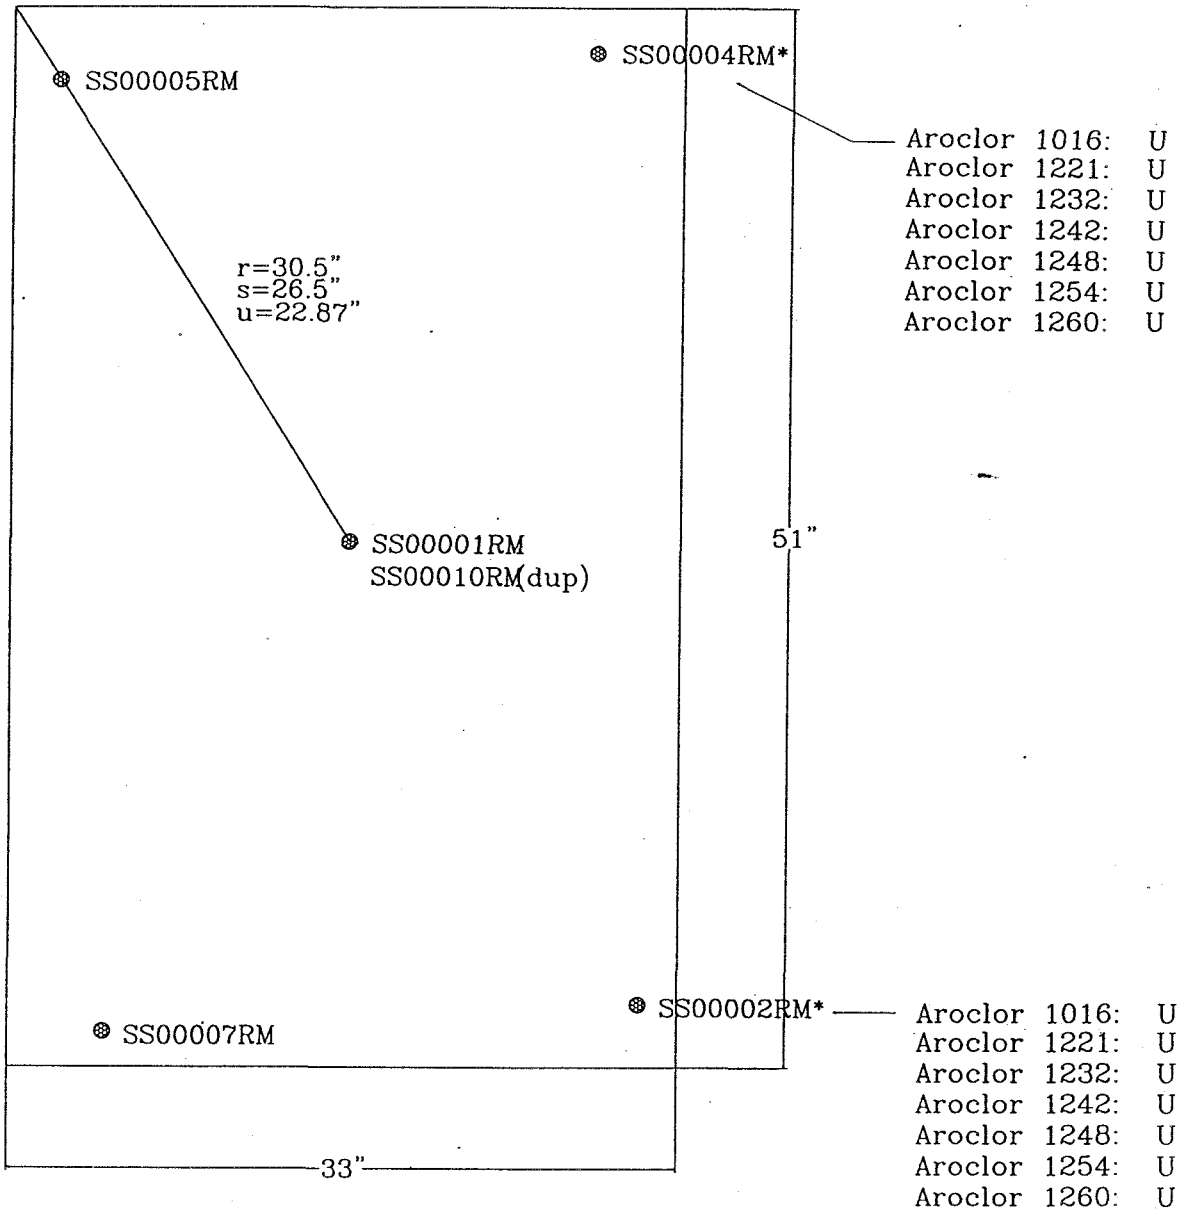
SITE SURVEY FOR REMEDIATION OF PCBs PCB SITE #33

Note:
All samples are <10ppm PCBs by immunoassay analysis.

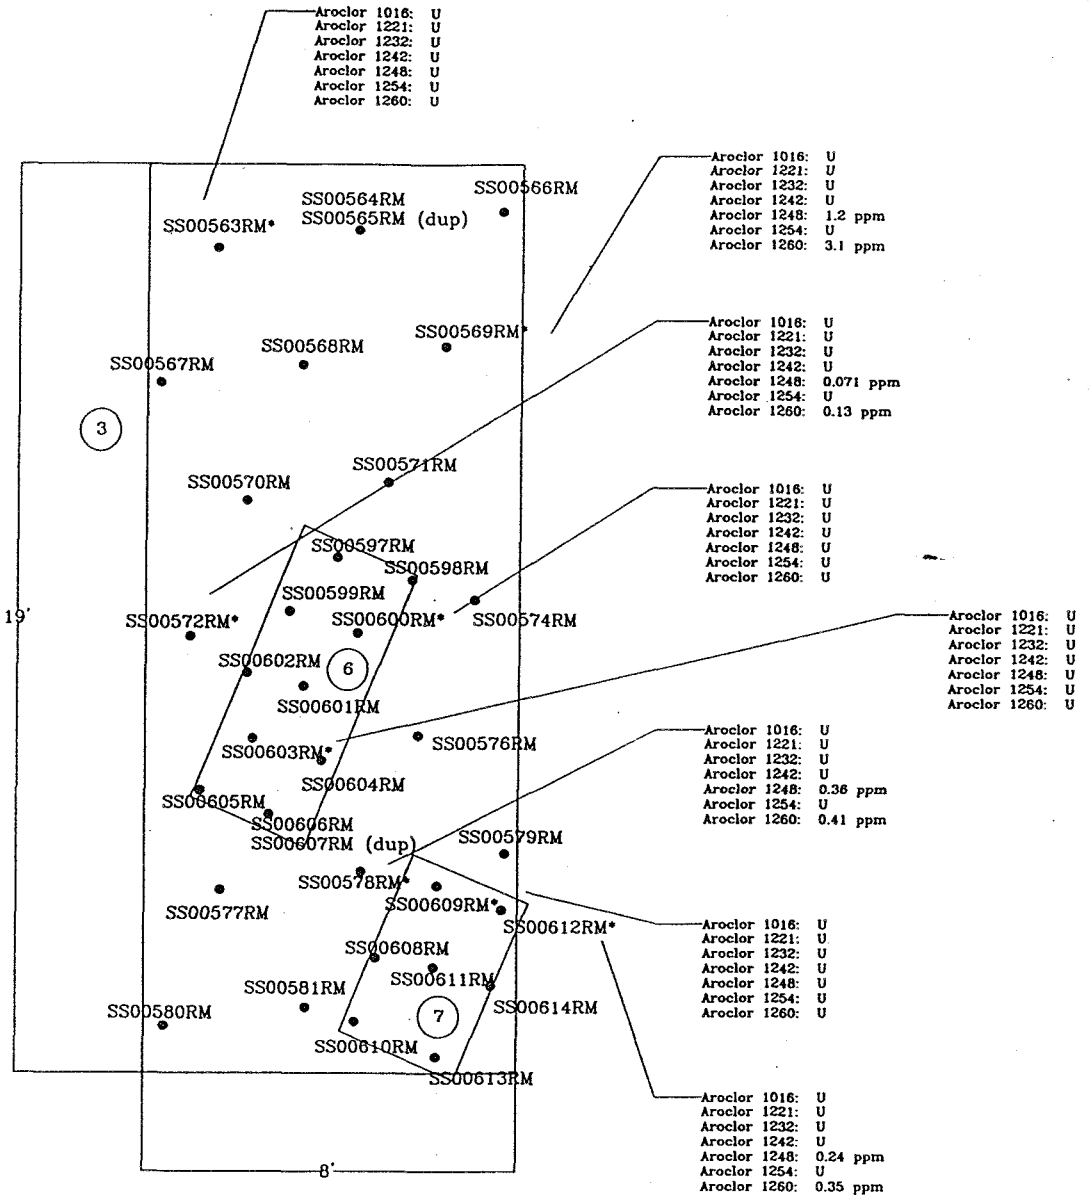
MRI GRID LAYOUT
PCB-37 (Bldg. 662)

Note:
All samples are <25 ppm PCBs by immunoassay analysis.
