1.0 Ambrosia Lake, New Mexico, Disposal Site

1.1 Compliance Summary

The Ambrosia Lake, New Mexico, Uranium Mill Tailings Radiation Control Act (UMTRCA) Title I Disposal Site was inspected on August 19, 2015. The disposal cell was in excellent condition. Inspectors identified no maintenance needs or cause for a follow-up or contingency inspection.

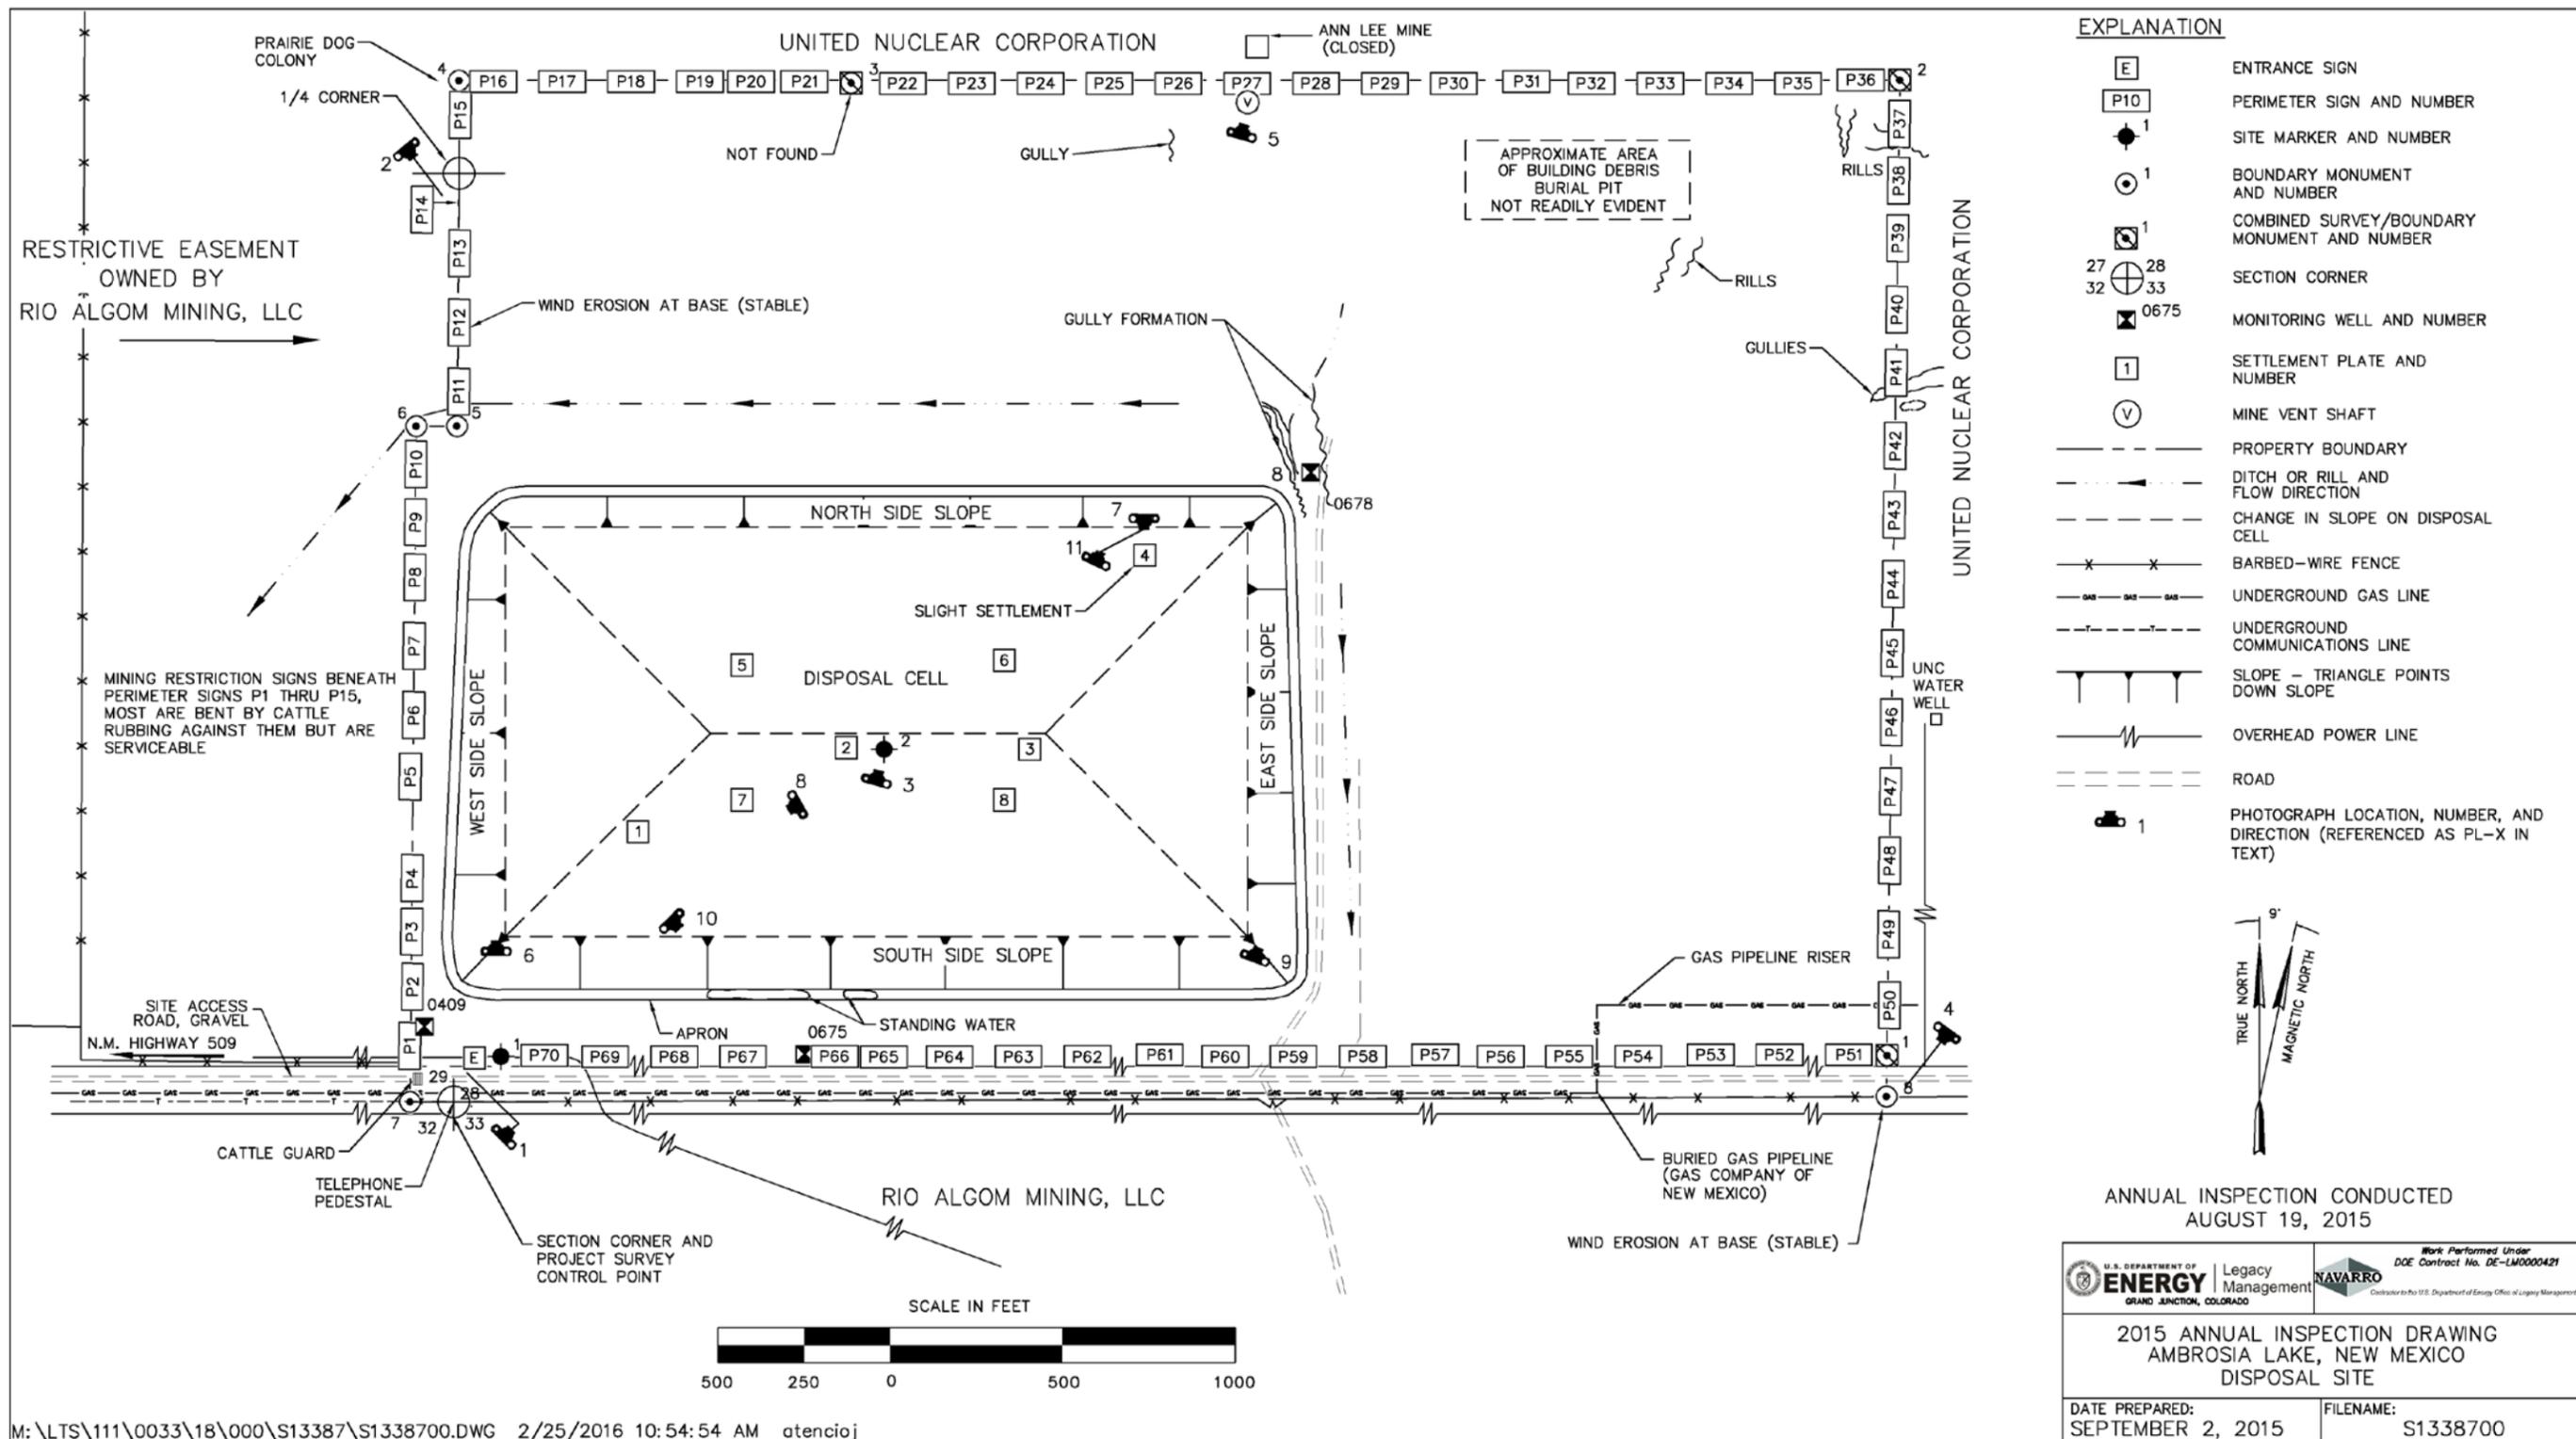
Figure 1-1. 2015 Annual Inspection Drawing for the Ambrosia Lake Disposal Site

Figure 1-1 shows the locations of site surveillance features. Inspection results and recommended maintenance activities associated with site surveillance features are included in the following

subsections. Photographs to support specific observations are identified in the text and on Figure 1-1 by photograph location (PL) numbers.
