**Post-Closure Inspection and  
Monitoring Report  
for Corrective Action Unit 417:  
Central Nevada Test Area Surface,  
Hot Creek Valley, Nevada**

**January 2009**

Office of  
Legacy Management

LMS/CNT/S04704

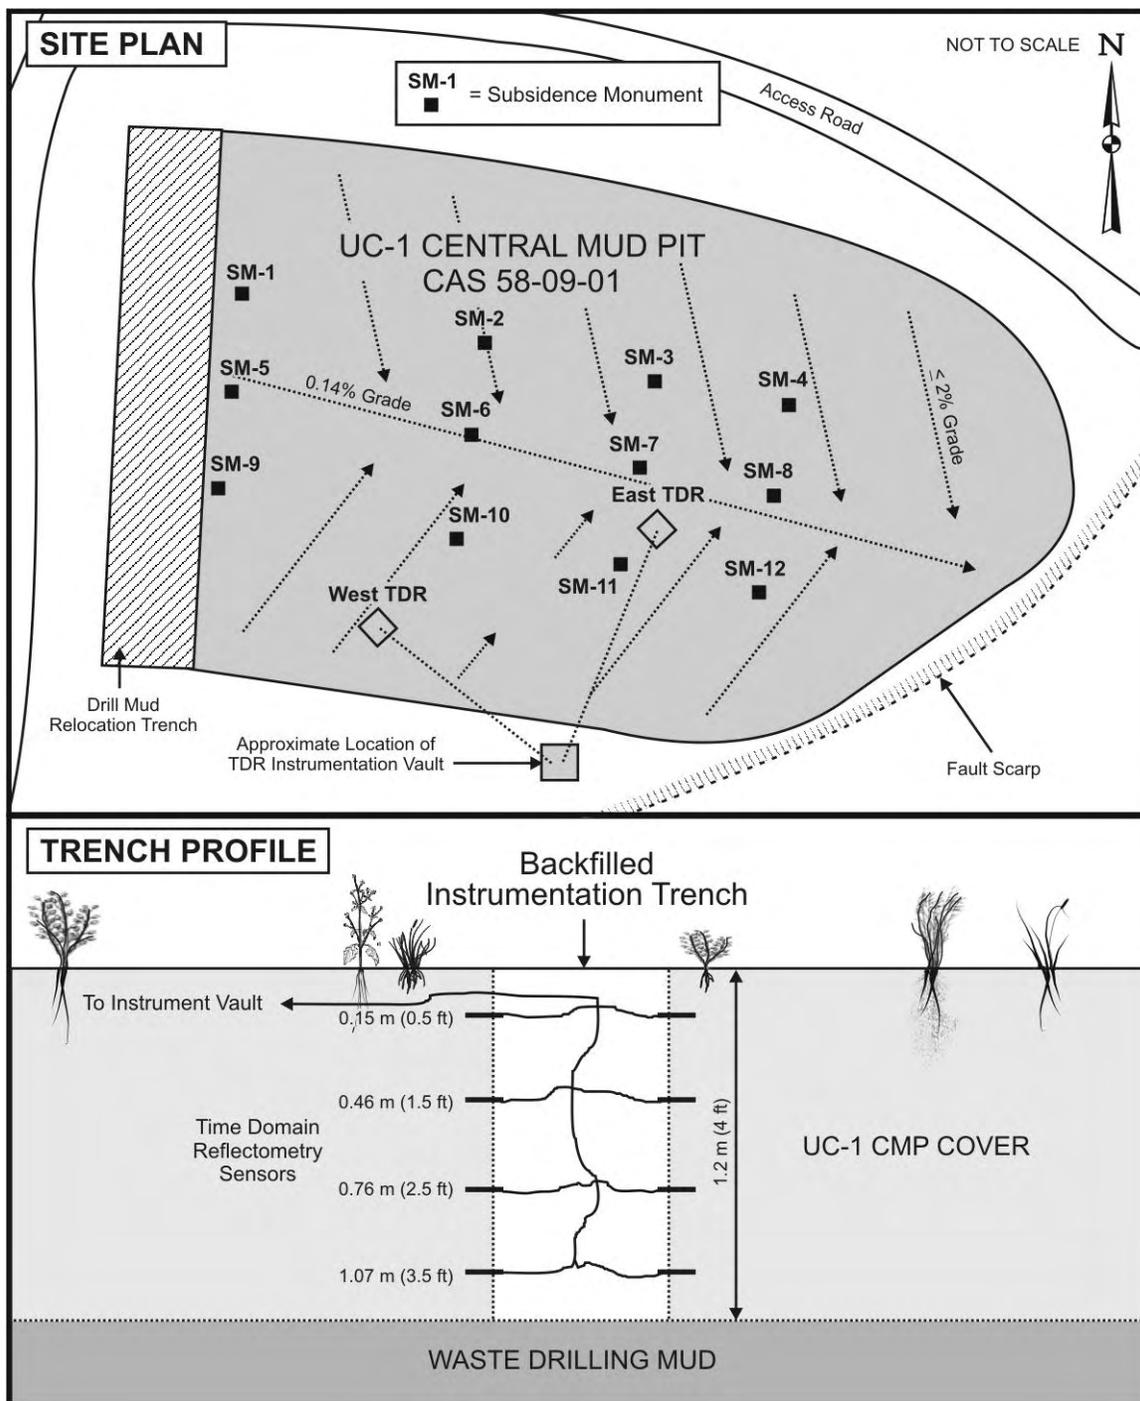
Figure 2-1. UC-1 CMP Cover Monitoring Instrumentation

Twelve SMs were installed on the UC-1 CMP cover to provide elevation control and measure subsidence of the cover located above the CMP and relocation trench (NNSA/NV 2001). These SMs are shown in Figure 2–1. The baseline subsidence survey was completed on December 4, 2000, and is used as the reference to calculate subsidence for each subsequent survey. Beginning in 2007, annual subsidence monitoring replaced the biannual subsidence monitorings that had taken place since 2002. The UC-1 baseline survey locations and elevations are provided in Table 3–1 and presented in graphical form in Figure 3–3.

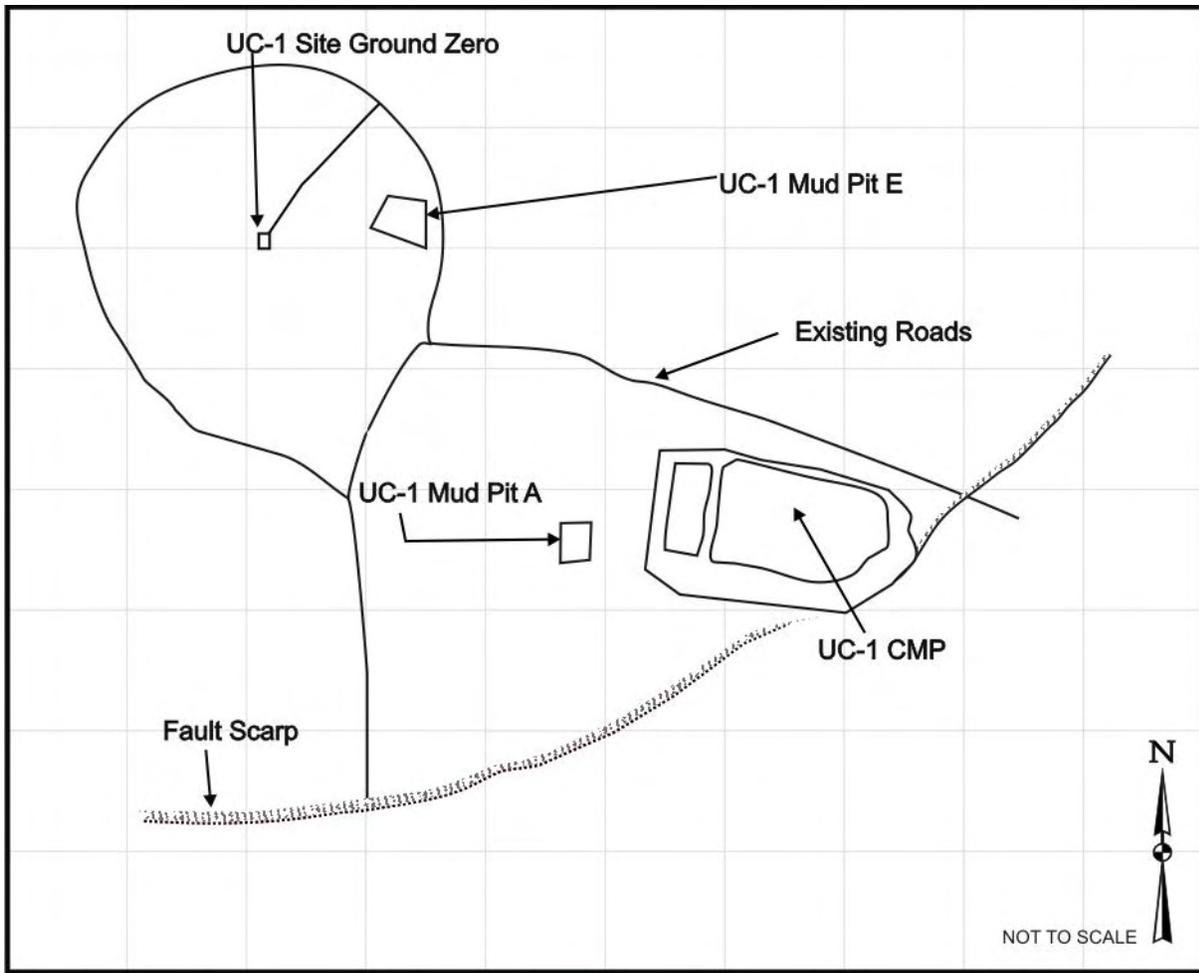
Figure 3-1. Location of UC-1 Mud Pits A and E

The CMP site was in good condition. All locks, fencing, and signs were in good order. The vegetation on the cover continues to look drought-stressed. No issues were identified with the monuments, and no maintenance or repairs were recommended. All other signs and monuments at Mud Pits A and E (Figure 3–1) were in excellent condition.

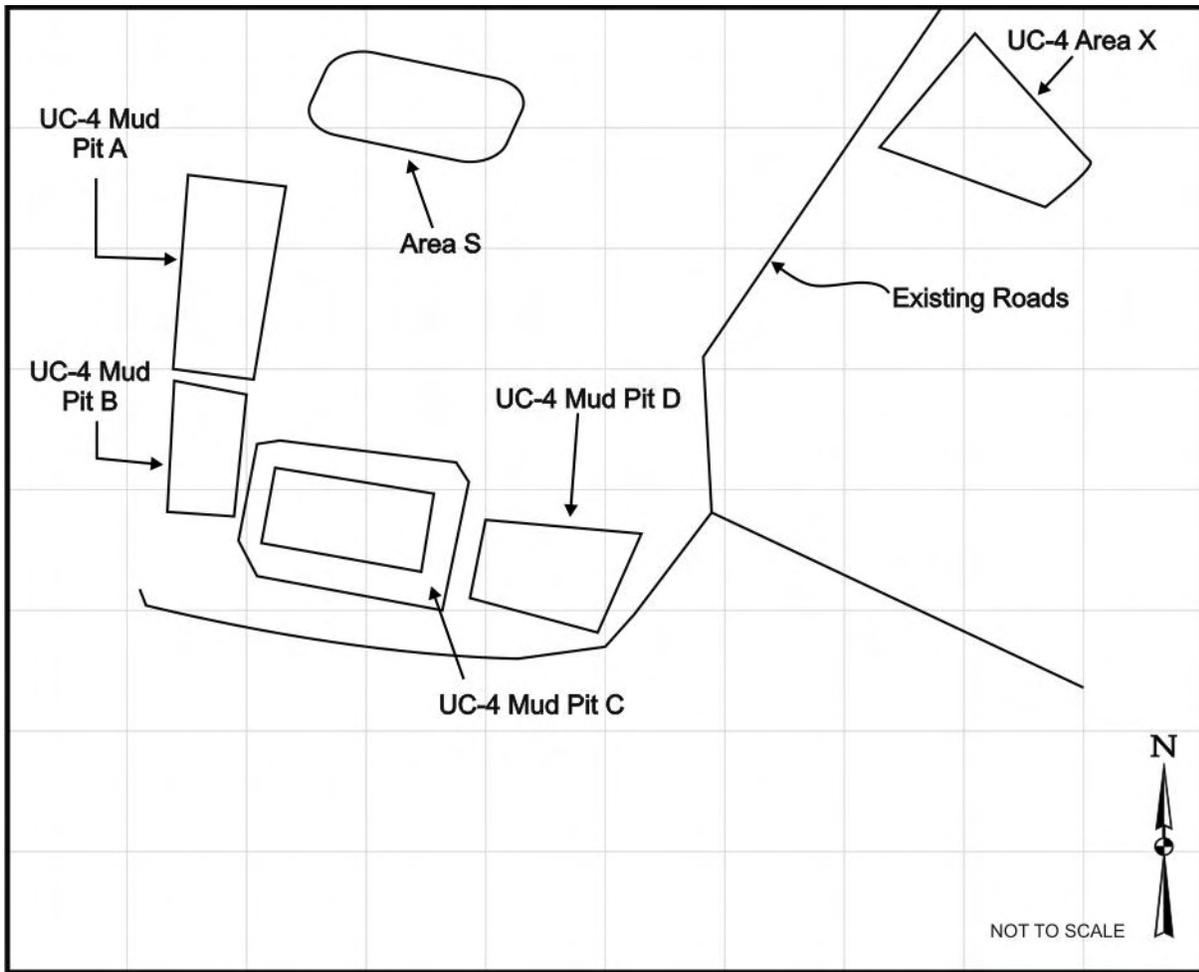
Figure 3–2. Location of UC-4 Mud Pits A, B, D, S, and X

The Mud Pit C fence and SMs were in good condition. A pin on the gate lock hasp was missing, but it does not affect the integrity of the locking mechanism. No erosion or subsidence was observed on the cover. Mud Pits A, B, and D were in excellent condition, and no issues were identified with Area S or Area X (Figure 3–2). The overall condition of the site was good, and no issues were noted that affected the integrity of the cover and appurtenances.

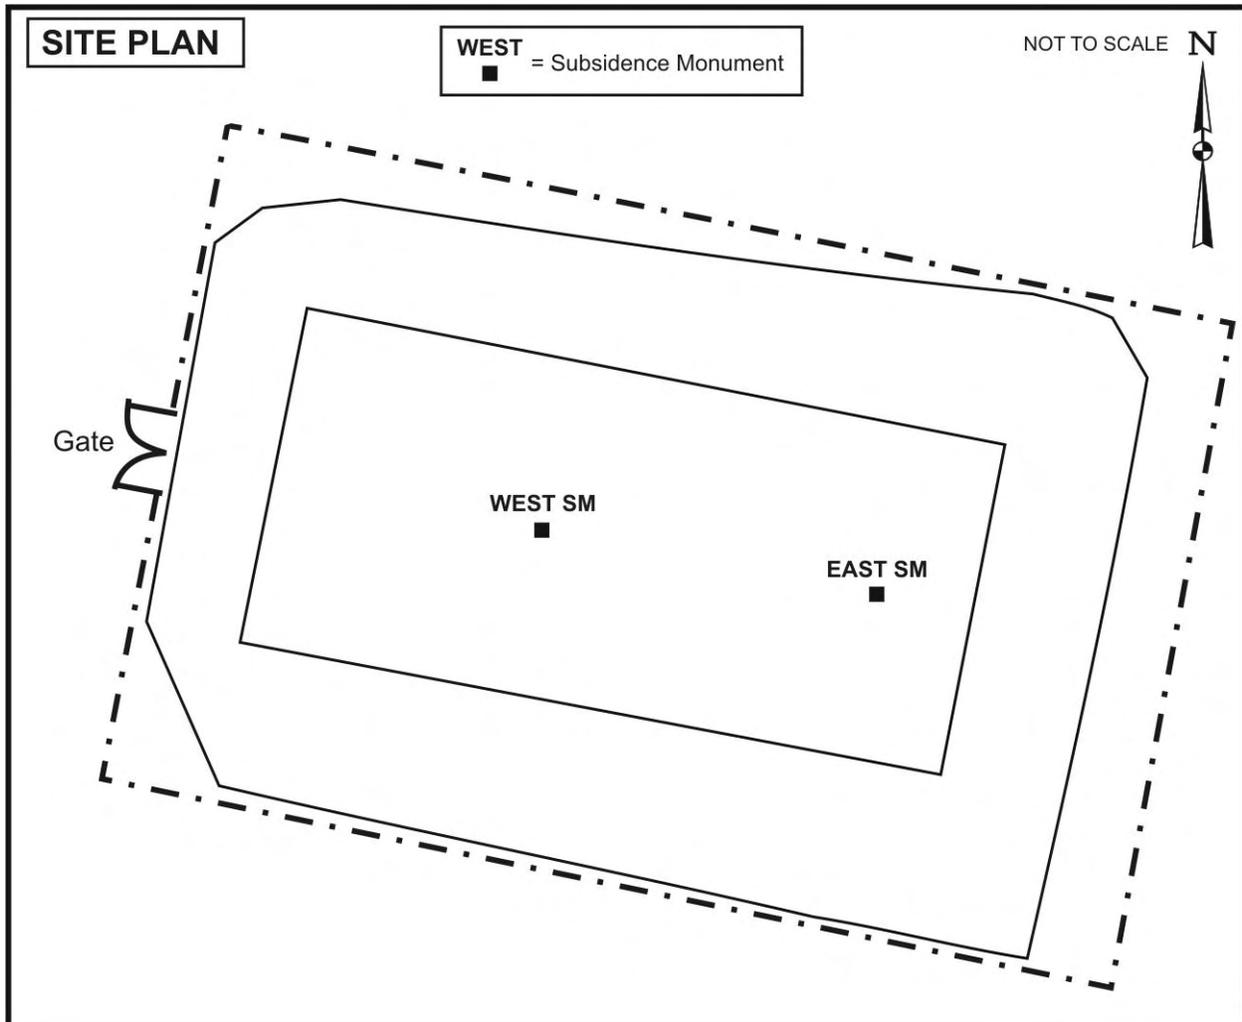
Figure 3–4. UC-4 West and East Monuments

Two permanent SMs (west and east monuments) were installed in the cover to provide elevation control for measuring the subsidence of the cover. These SMs are shown in Figure 3–4. The baseline subsidence survey was completed on October 12, 1999, and is used as the reference survey to calculate subsidence. The UC-4 baseline survey locations and elevations are provided in Table 3–2 and are presented in graphical form in Figure 3–5. Settling of the west monument is still slightly greater than the predicted settling of 5 cm (2 in.); the total subsidence is 6.4 cm (2.5 in.) since the baseline survey in October 1999. The east monument has subsided a total of 2.7 cm (1.1 in.) since the baseline survey. The largest changes occurred within the first year.
