# Post-Closure Inspection and Monitoring Report for Corrective Action Unit 417: Central Nevada Test Area Surface, Hot Creek Valley, Nevada

March 2013

LMS/CNT/S09307

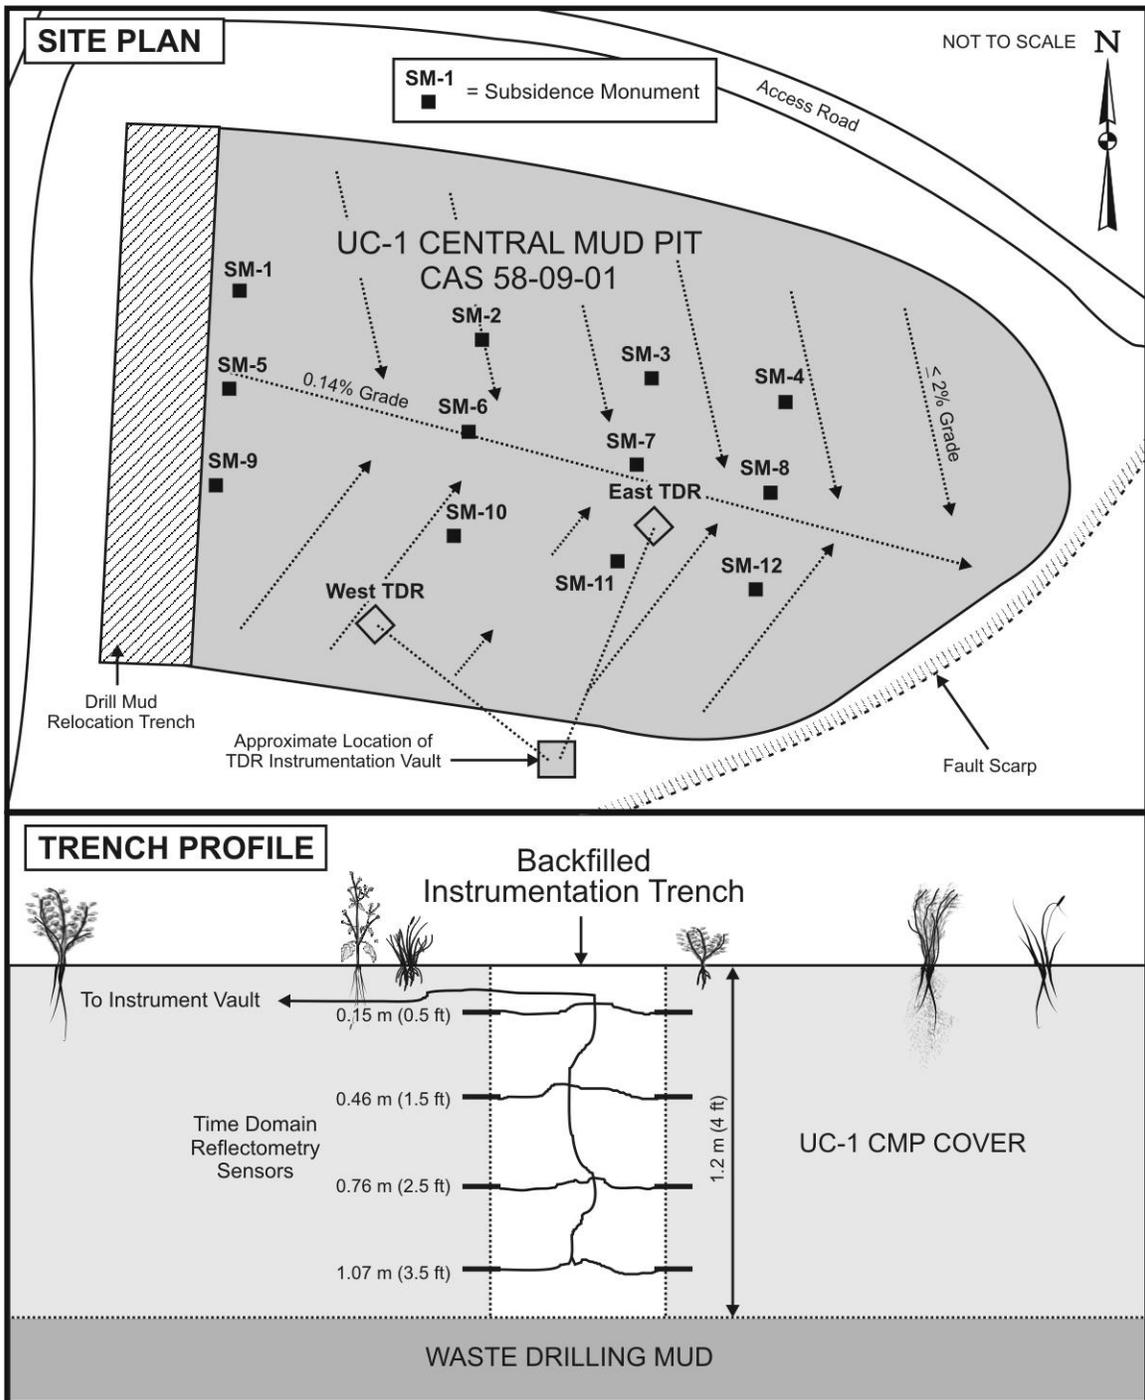
Figure 3. UC-1 CMP Cover Monitoring Instrumentation

Twelve SMs were installed on the UC-1 CMP cover to provide elevation control and measure subsidence of the cover and relocation trench (NNSA/NV 2001). Figure 3 shows these SMs. The baseline subsidence survey was completed on December 4, 2000, and is used as the reference to calculate subsidence for each subsequent survey. Beginning in 2007, annual subsidence monitoring replaced the semiannual subsidence monitoring that had taken place since 2002. In 2011, the annual subsidence monitoring was replaced by biennial subsidence monitoring that was conducted for the first time in 2012. The UC-1 baseline survey locations and elevations are provided in Table B-1 in Appendix B, and are presented in graphical form in Figure 7.

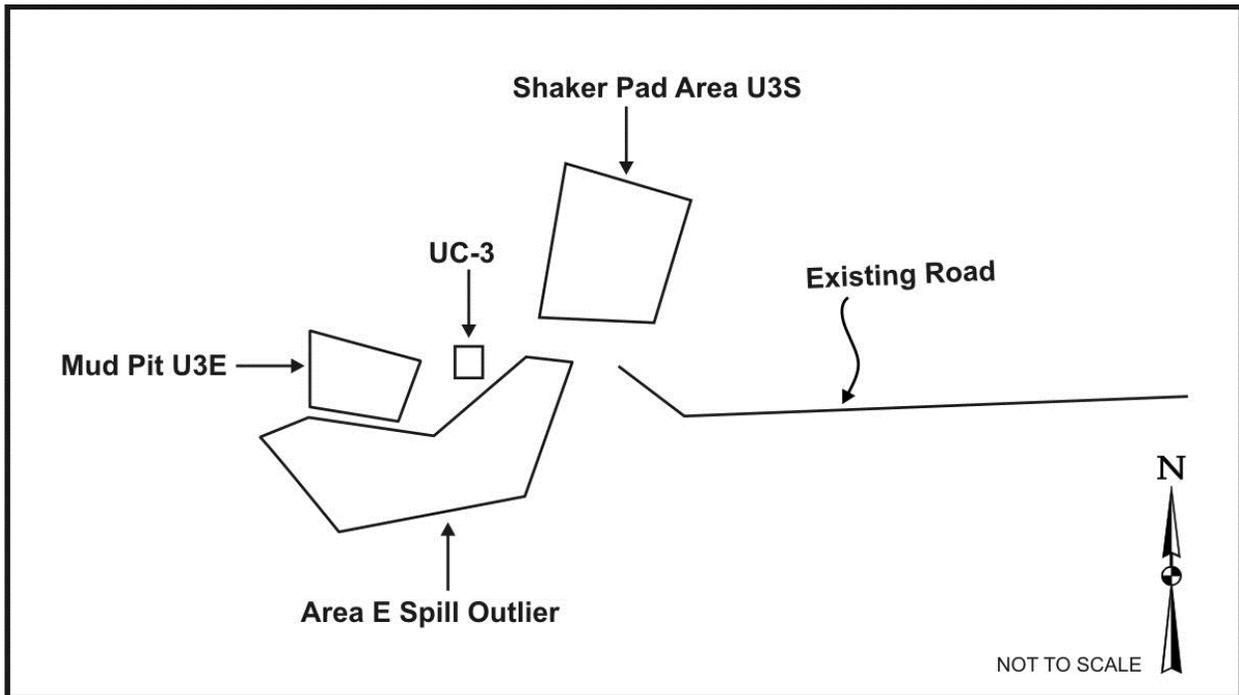
Figure 5. Location of UC-3 Significant Features

The site was in excellent condition (Figure 5). No issues with the monuments or signs were identified at the time of the inspections, and no maintenance or repairs were recommended.

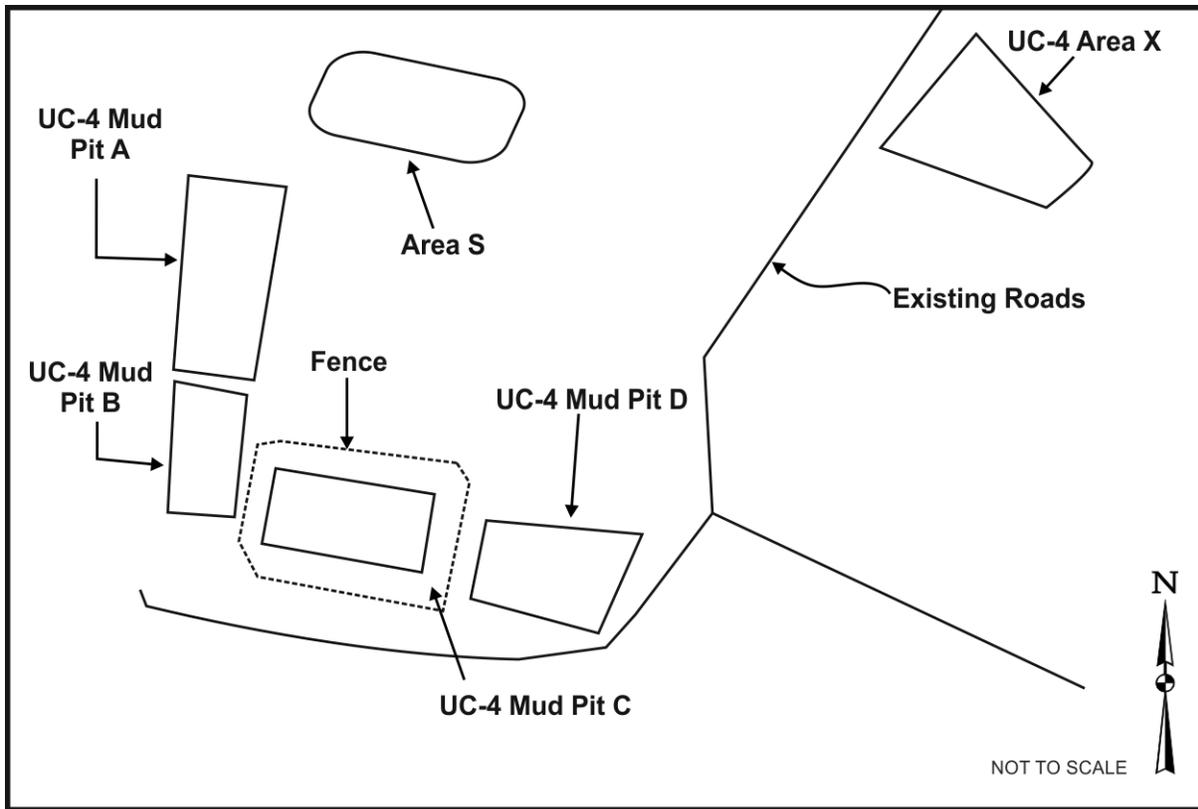
Figure 6. Location of UC-4 Significant Features

The Mud Pit C fence and SMs were in good condition at the time of the inspections. No erosion rills were identified, and previously identified rills showed no further signs of activity. No new erosion concerns were apparent at the time of the inspections. Some sagebrush was growing on the surface of the cap, but the inspection team used mechanical methods to remove a large amount of the vegetation during the 2012 inspection. No issues that affected the integrity of the cover and appurtenances were noted. Mud Pits A, B, and D were in excellent condition, and no issues were identified with Area S or Area X (Figure 6).

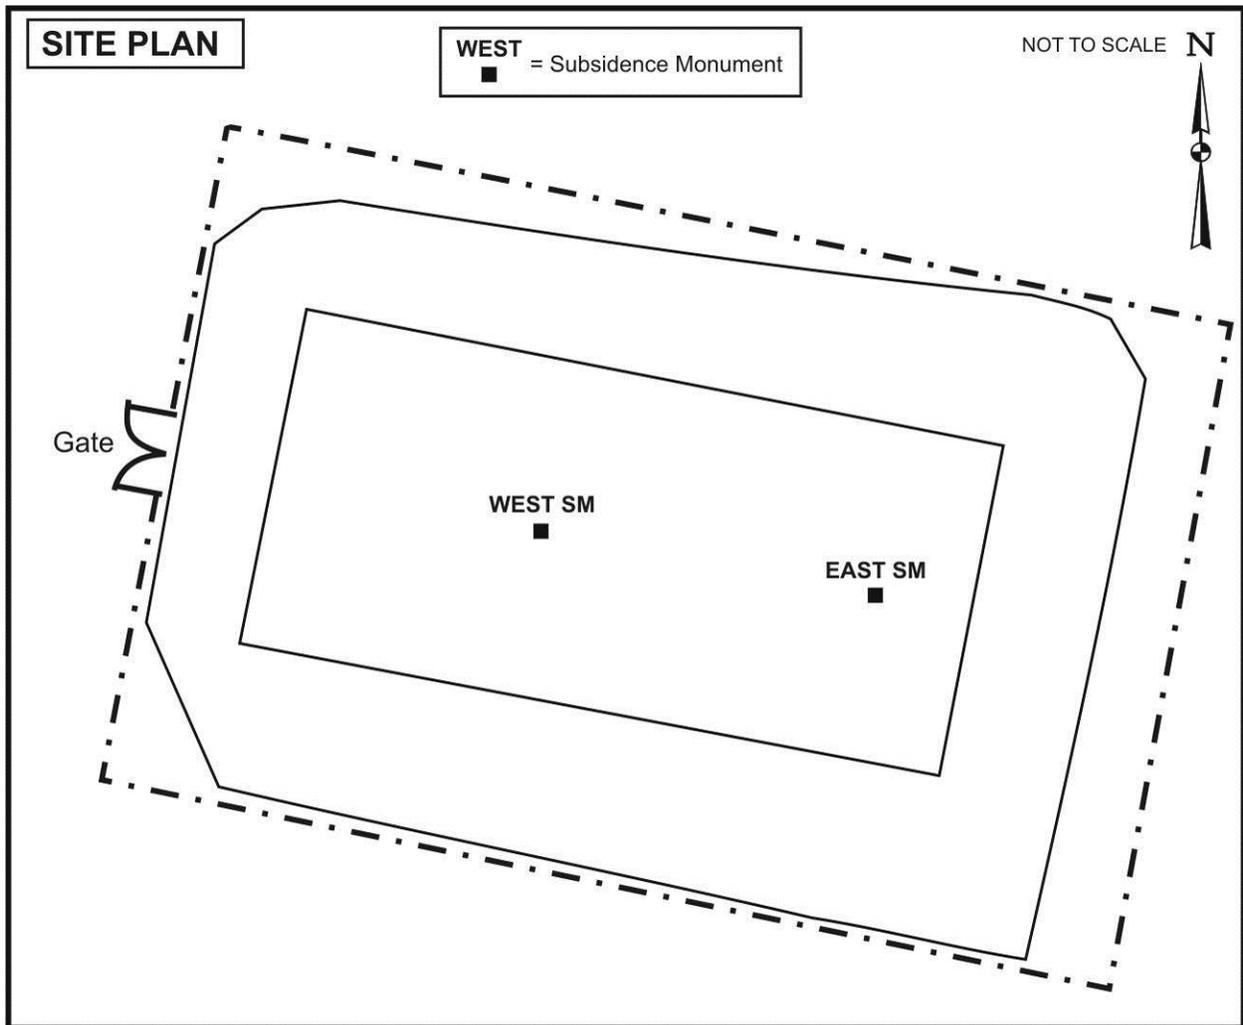
Figure 8. UC-4 West and East Monuments

Two SMs (west and east monuments) were installed in the UC-4 cover to provide elevation control for measuring the subsidence of the cover. Figure 8 shows these SMs. An initial subsidence survey was completed on October 12, 1999, and is used as a baseline to calculate subsidence. The UC-4 baseline survey locations and elevations are provided in Table B-2 in Appendix B, and are presented in graphical form in Figure 9. Since the last subsidence survey in 2010, both SMs show a decrease in elevation. The elevation of the east SM decreased 0.01 m (0.394 in), and the elevation of the west SM decreased 0.013 m (0.512 in) since the last subsidence survey.

Historically, settling of the west SM is still slightly greater than the predicted settling of 0.05 m (2 in); the total subsidence is 0.057 m (2.24 in) since the baseline survey in October 1999. The east SM has subsided a total of 0.024 m (0.94 in) since the baseline survey. The largest changes occurred during the first 3 years.

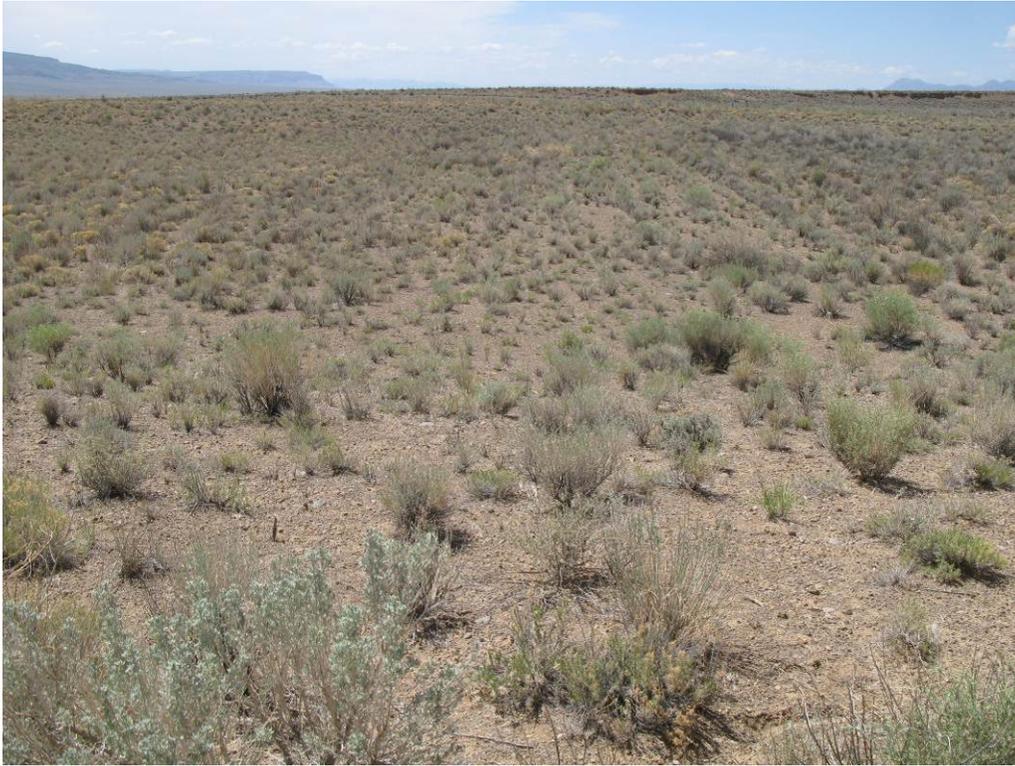
During the 2012 vegetation survey, total live foliar cover on the CMP cover was estimated at 20 to 30 percent<sup>1</sup>. Rubber rabbitbrush and thread snakeweed were the dominant species, and secondary species were big sagebrush, fourwing saltbush, and Indian ricegrass. In the CMP perimeter area, total live foliar cover was estimated at 13 to 20 percent. Rubber rabbitbrush and big sagebrush were dominant, and thread snakeweed was secondary. Foliar cover was slightly higher in the native area, at 29 to 35 percent. Big sagebrush was the dominant species; thread snakeweed and bottlebrush squirreltail were secondary. Drought stress was evident across the UC-1 site, and many small shrubs on the CMP cover were dead. Tables C-2, C-3, and C-4 show results from the quadrat data collected in 2012 on the CMP cover, in the CMP perimeter area, and in an undisturbed, native area, respectively. Photographs 1, 2, and 3 (Section C6, below)

*Photograph 1. View south of CMP cover vegetation*

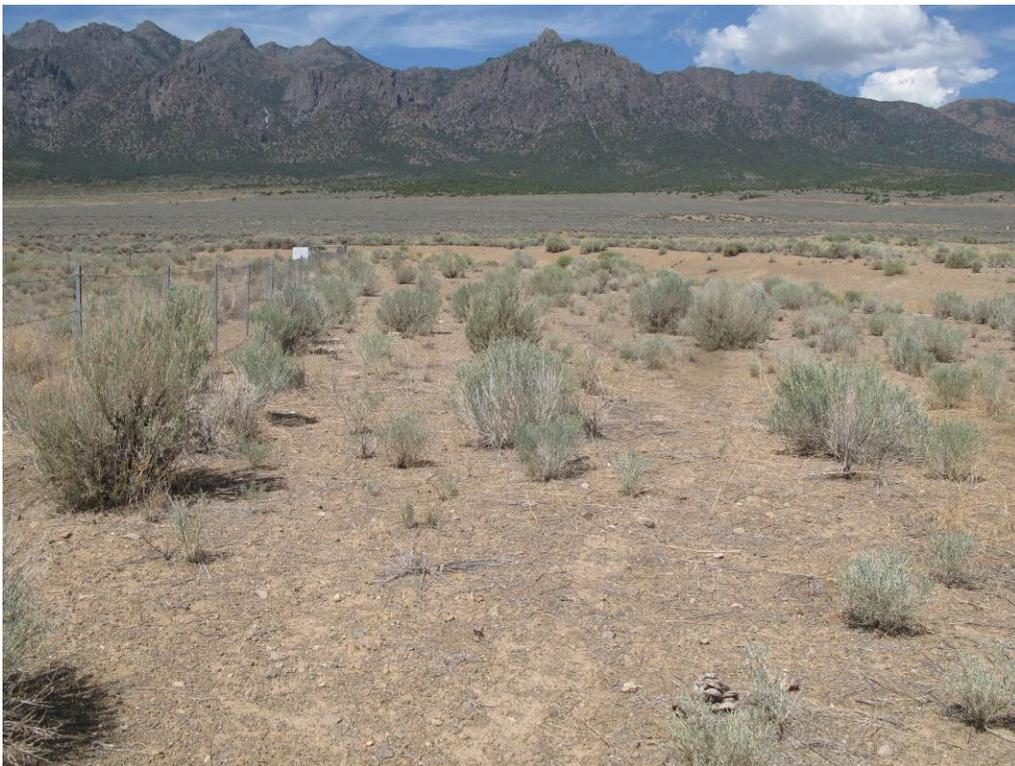
*Photograph 2. View west of vegetation in the CMP perimeter area*

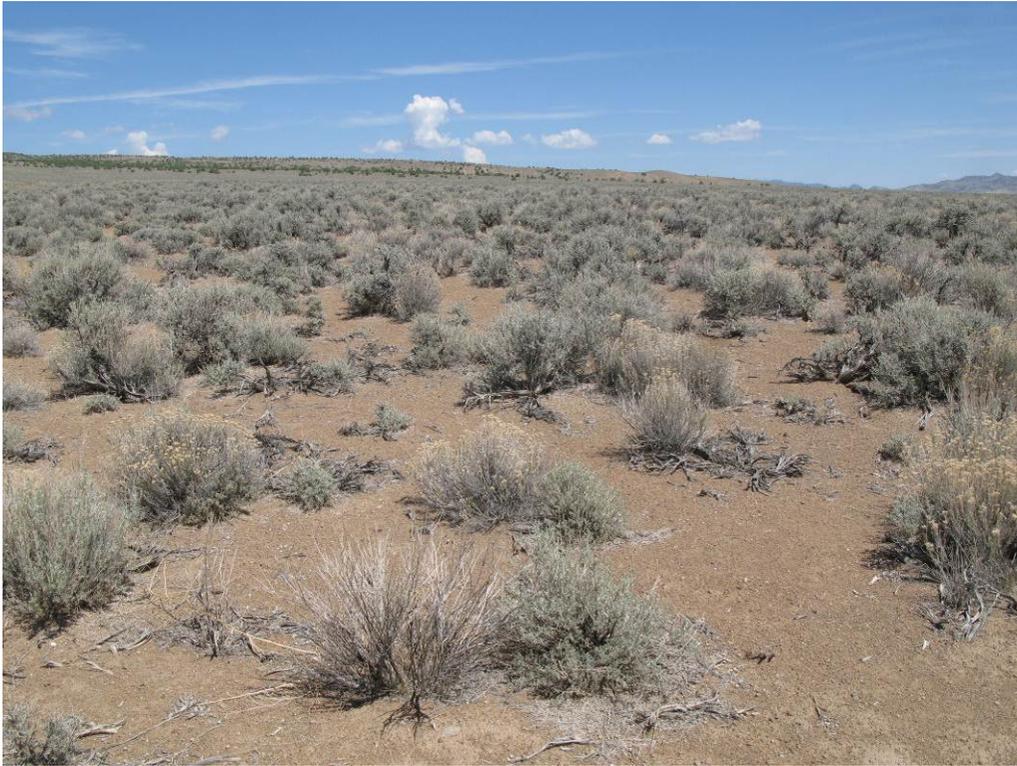
*Photograph 3. View north of undisturbed, native area*
