Post-Closure Inspection and Monitoring Report for Surface Corrective Action Unit 417 at the Central Nevada Test Area, Nevada, Site

January 2015

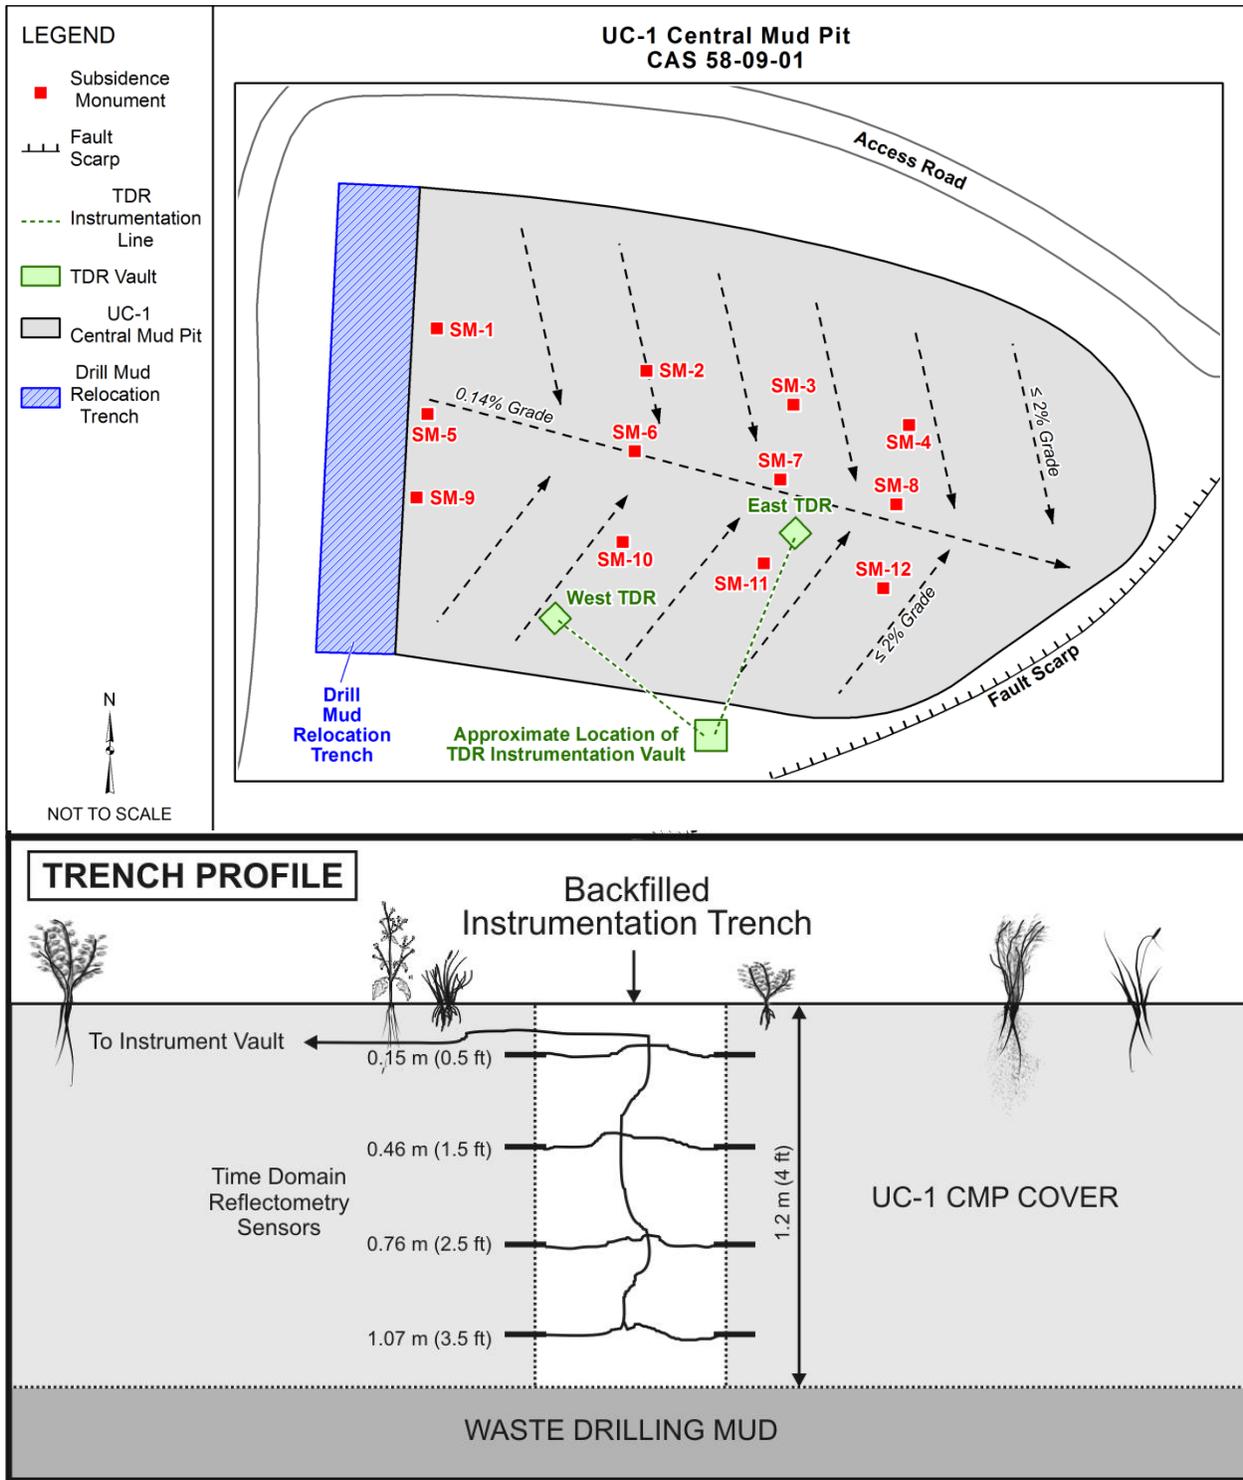
TDR sensors were buried in the cover at two locations (West TDR and East TDR) during cover construction. At both locations, two TDR sensors were placed below the surface of the cover at the following depths: 0.15, 0.46, 0.76, and 1.07 m (0.5, 1.5, 2.5, and 3.5 ft) (Figure 3). The TDR nests are located approximately 48 m (157 ft) northwest and 48 m (157 ft) northeast of the instrument vault.

Figure 3. UC-1 CMP Cover Monitoring Instrumentation

Twelve SMs were installed on the UC-1 CMP cover to provide elevation control and to measure subsidence of the cover and relocation trench (NNSA/NV 2001). Figure 3 shows these SMs. The baseline subsidence survey was completed on December 4, 2000, and is used as the reference to calculate subsidence for each subsequent survey. Beginning in 2007, annual subsidence monitoring replaced the semiannual subsidence monitoring that had taken place since 2002. In 2011, the annual subsidence monitoring was replaced by biennial subsidence monitoring that was conducted for the first time in 2012. The UC-1 baseline survey locations and elevations are provided in Table B-1 in Appendix B, and are presented in graphical form in Figure 7.

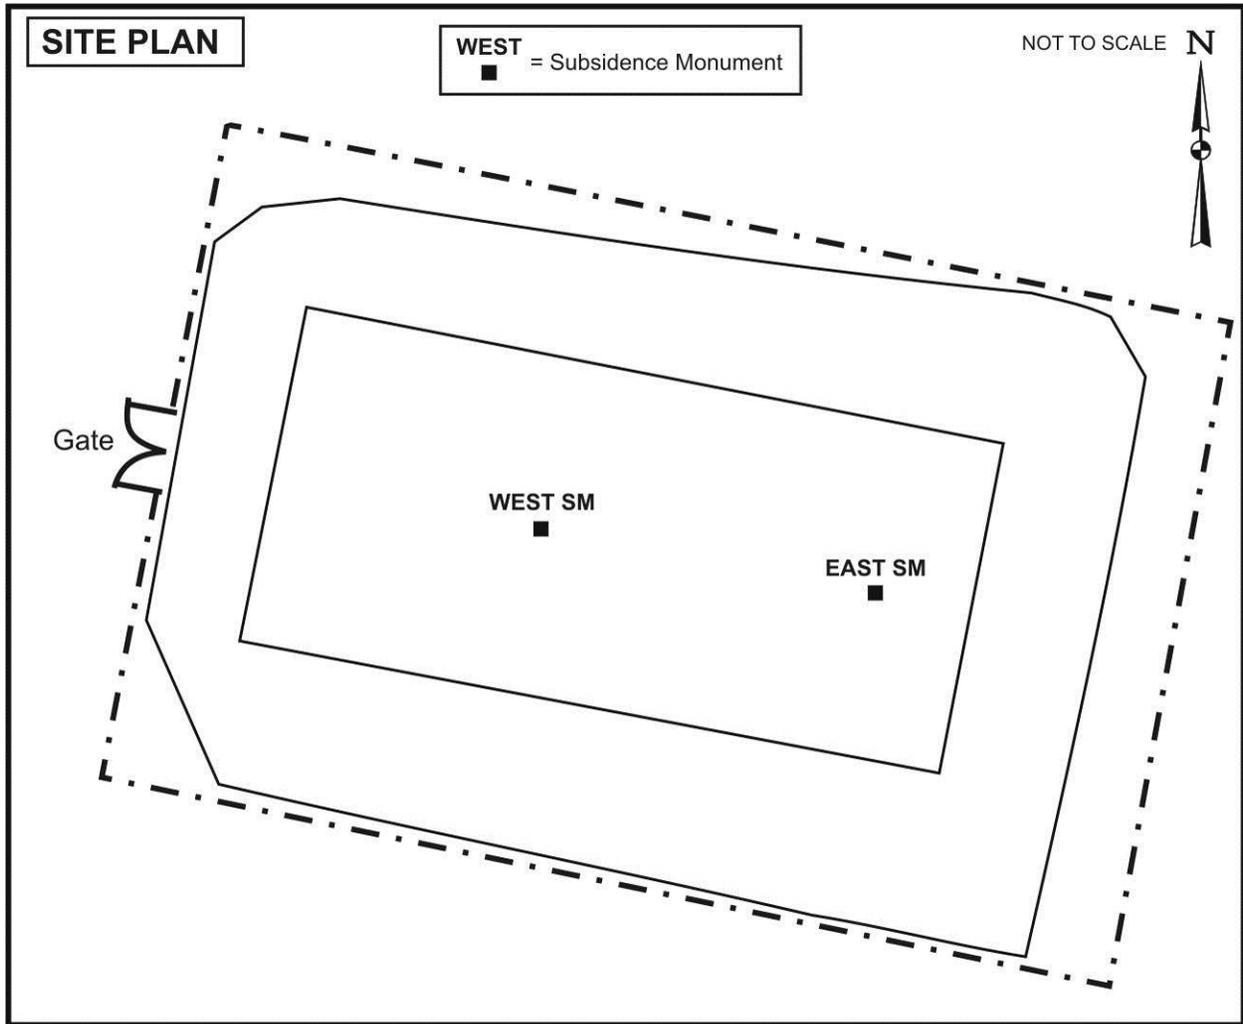
Figure 8. UC-4 West and East Monuments

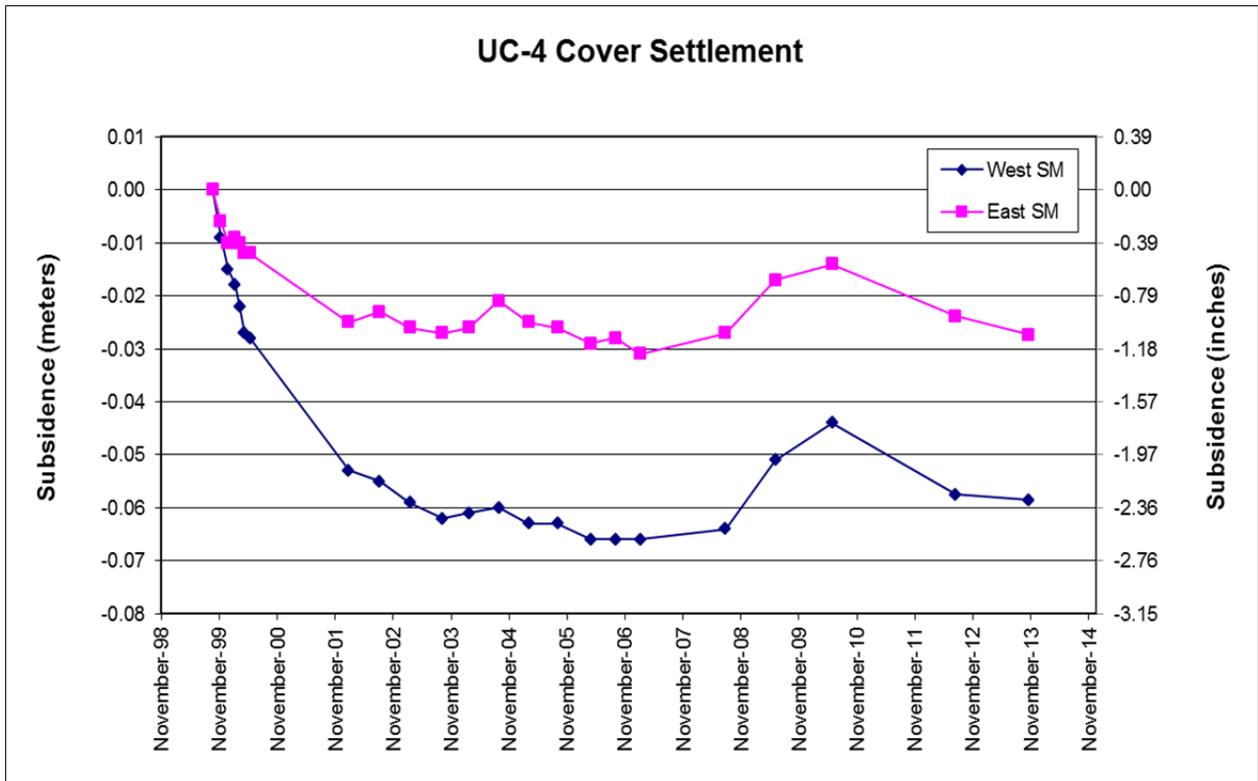
Figure 9. UC-4 Cover Settlement

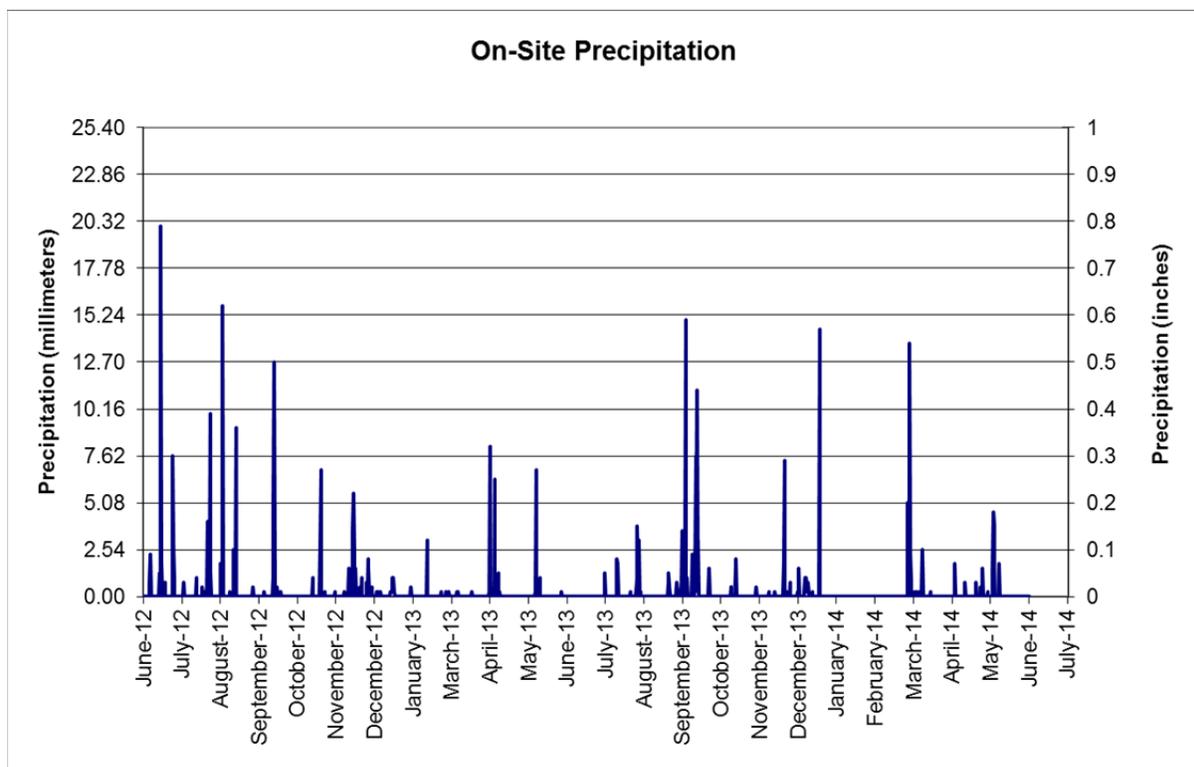
Figure 12. July 1, 2012, through June 3, 2014, Site Precipitation Data

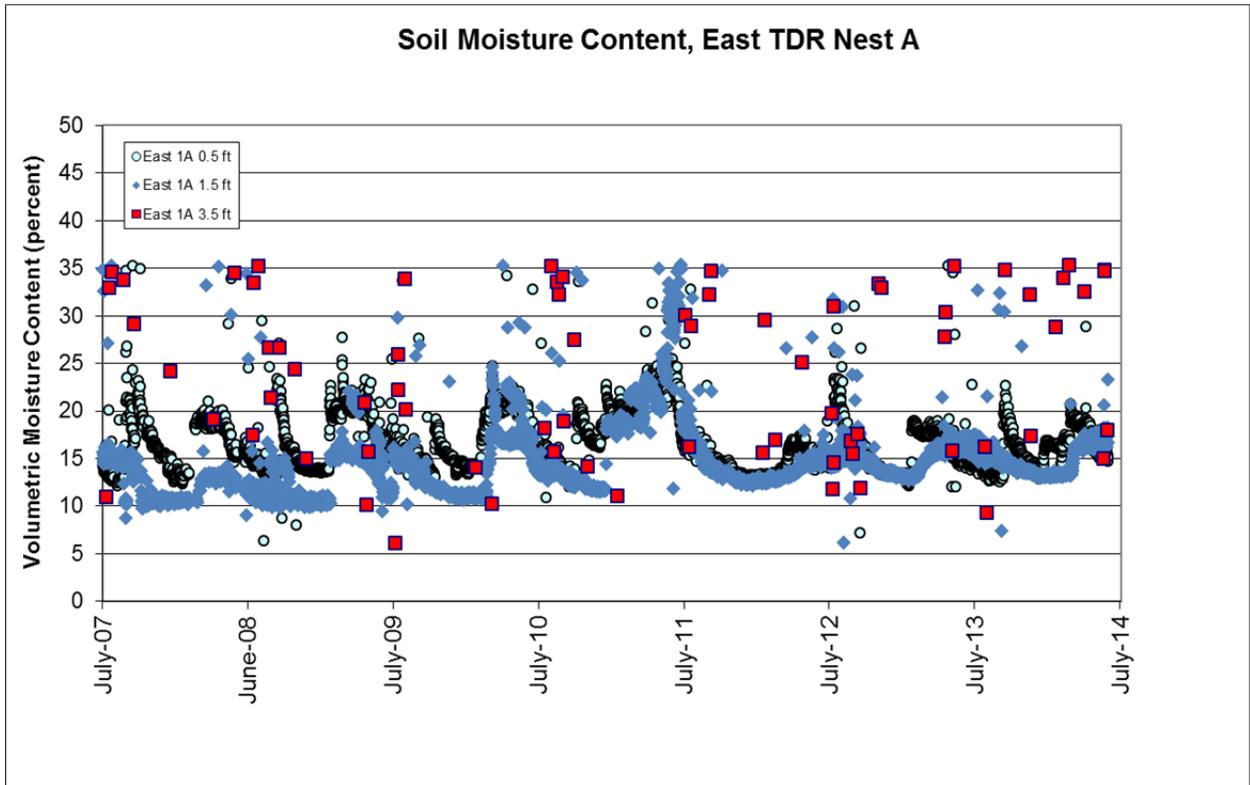
Soil moisture data obtained for the 0.76 and 1.07 m (2.5 and 3.5 ft) depths of the east TDR nests (Figure 13 and Figure 14) continue to be discontinuous and appear to be corrupted. Previously, the lengthy cable created a problem in measuring the reflected signal from the TDR probes (NNSA/NV 2007). It was also thought that the erratic data may be an indication of saturated conditions at these depths. Soil samples were collected near the deepest TDR sensors on August 23, 2013, to evaluate this theory. Soil moisture results indicated the soil was not saturated and that the moisture content at these depths was approximately 8 percent. Data from the two deepest sensors are required to establish soil-moisture-monitoring compliance criteria. A Path-Forward plan is being developed to address the requirement for establishing soil-moisture-monitoring compliance criteria and for future monitoring at the site.

Figure B-2. July 2007 through July 2014 UC-1 Soil Moisture Content, East TDR Nest A

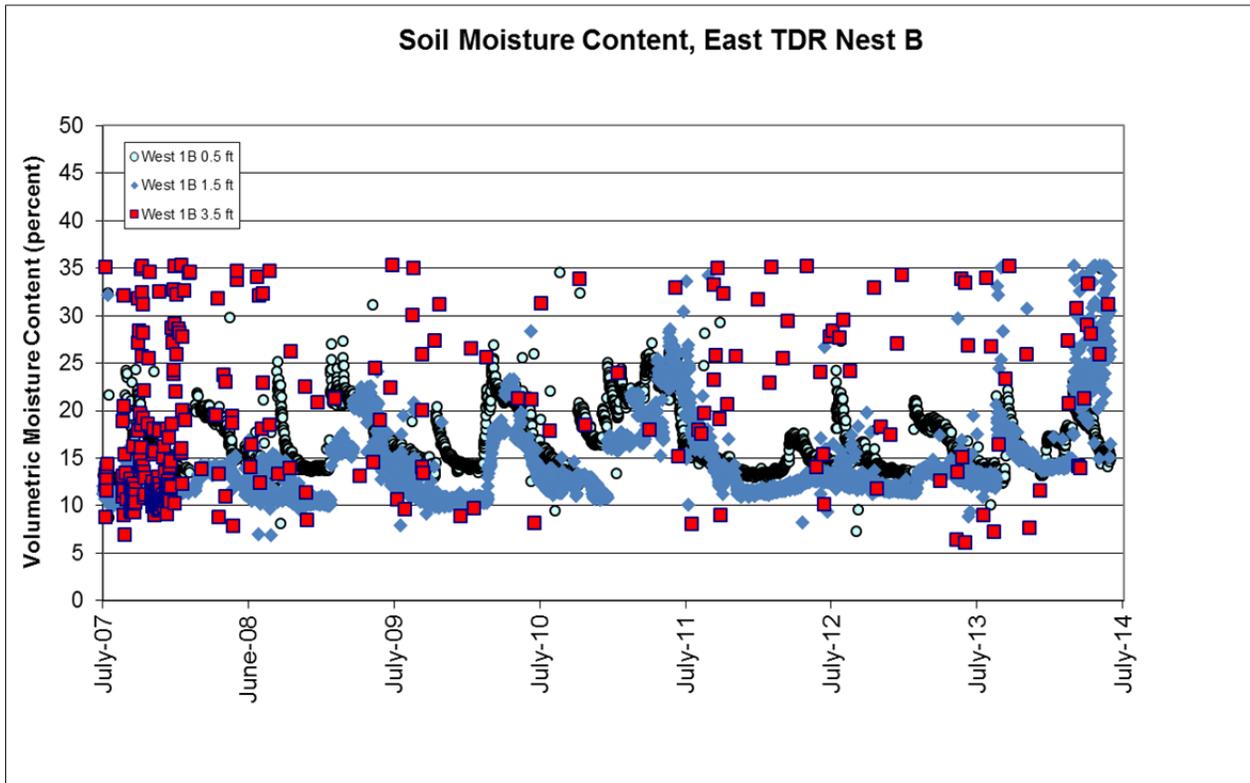
Figure B-3. July 2007 through July 2012 UC-1 Soil Moisture Content, East TDR Nest B

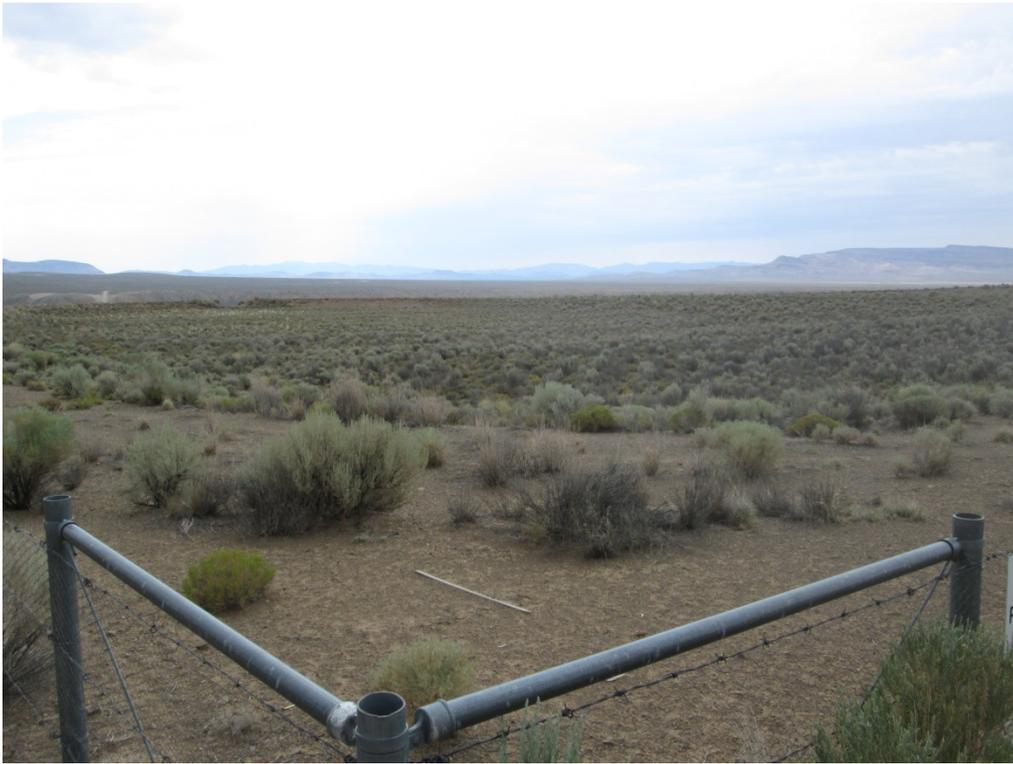
Vegetation on the fenced CMP cover continues to be healthy and sustainable (Photograph 1). Total foliar cover averaged 25 percent and was dominated by rubber rabbitbrush, sagebrush, and threadleaf snakeweed. Secondary species included fourwing saltbush, galleta grass, Indian ricegrass, and bottlebrush squirreltail, all desirable species. The percentage of total foliar cover in the CMP cover area increased from the previous years. In comparison, values for total foliar

Photograph 1. View southeast of CMP cover vegetation from northwest fence corner

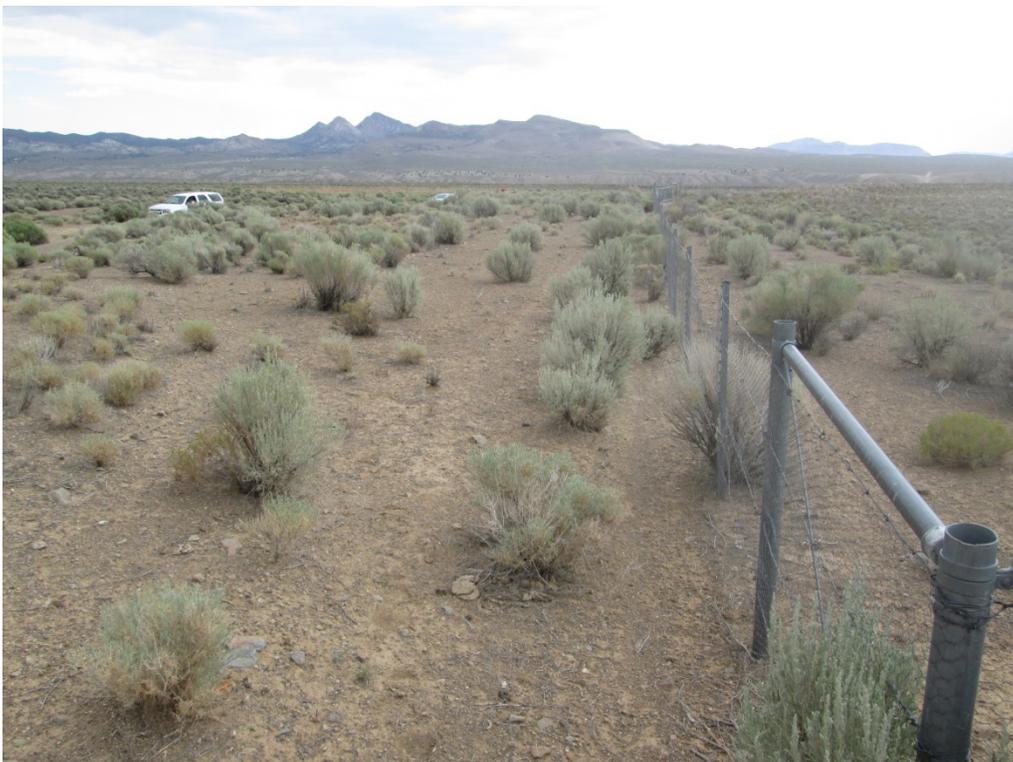
Total foliar cover in the CMP perimeter area (Photograph 2), typically not as high as that inside the fenced area, was estimated at 20 percent. The same plants dominated the CMP perimeter area as dominated the CMP cover. As in previous years, the plants in the perimeter area showed signs of being grazed.

Photograph 2. View east of CMP perimeter area along the north fence line

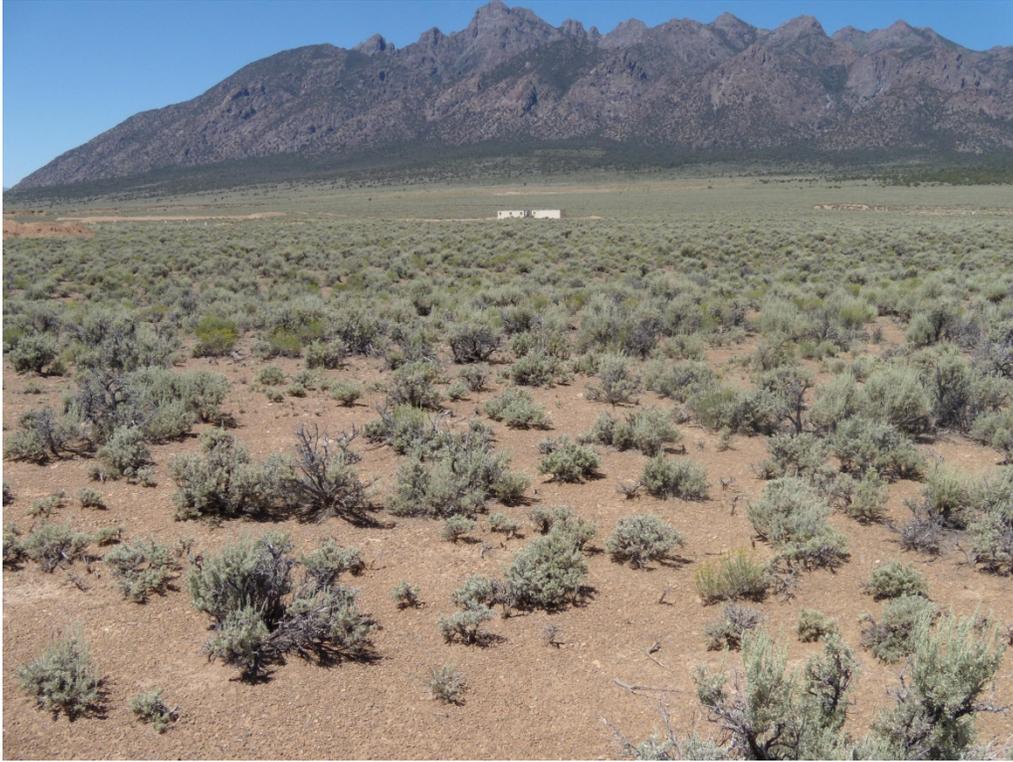
Total foliar cover in the native area⁵ (Photograph 3), estimated at 23 percent, was similar to that on the CMP cover and perimeter. However, the species richness value (6) was less than the values observed on the CMP cover (11) and perimeter areas (10) (Table C-2). Vegetation was dominated by sagebrush and galleta grass.

Photograph 3. View southwest of native area immediately north of the CMP cover (taken in 2009)
