**RADIOLOGICAL SURVEY REPORT
FOR THE DUPONT
CHAMBER WORKS PLANT
Deepwater, New Jersey**

Bechtel National, Inc.
Advanced Technology Division

June 1984

RADIOLOGICAL SURVEY
OF THE
E. I. DUPONT DE NEMOURS AND COMPANY
CHAMBERS WORKS PLANT
DEEPWATER, NEW JERSEY

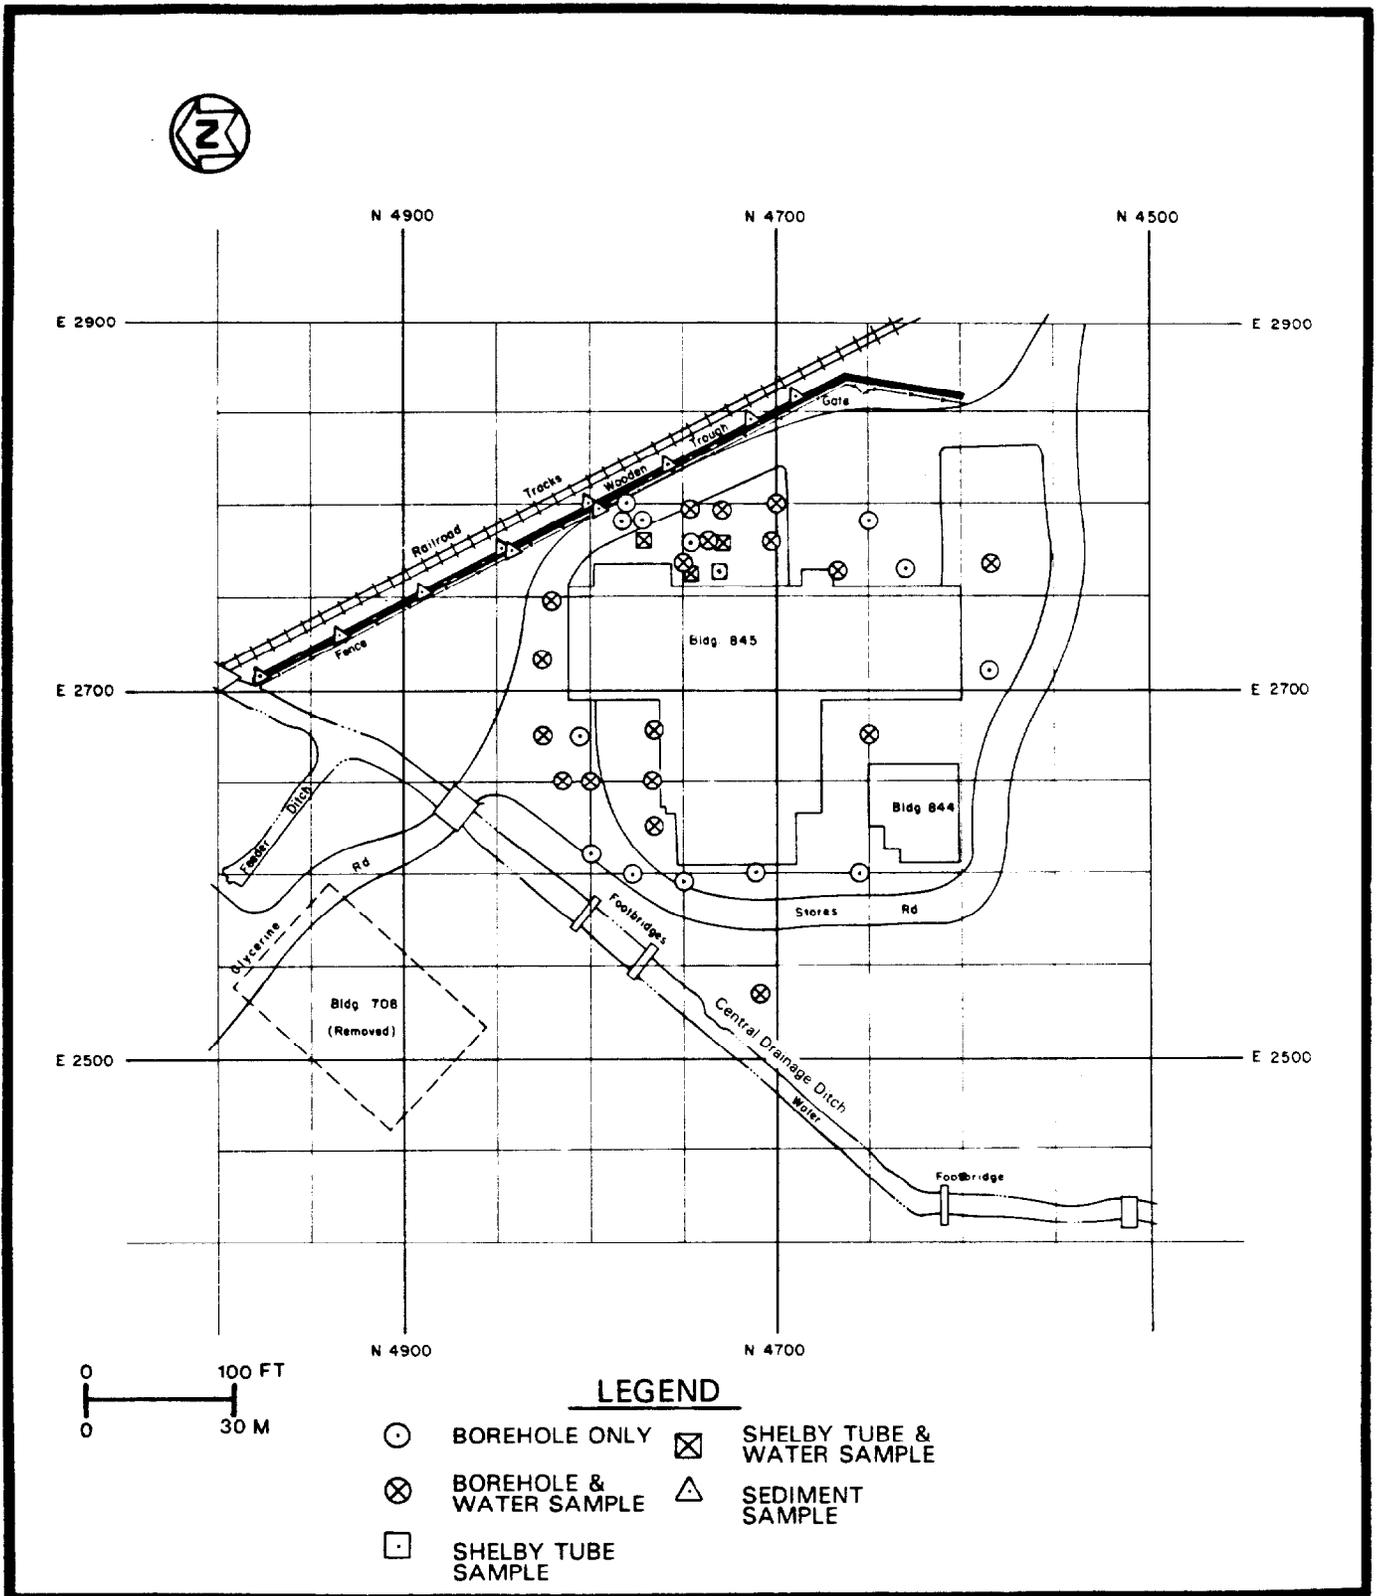
FIGURE 4-1 BOREHOLES AND SAMPLING LOCATIONS IN THE VICINITY OF BUILDING 845

Due to the high water table encountered under the DuPont site, in many instances soil samples could not be collected. However, four Shelby tube soil samples were taken in the area east of Building 845 (refer to Figure 4-1). Specific analysis results are presented in Table 5-5, which lists the samples by coordinates and depth. The results indicate uranium is the major contaminant, with levels ranging from 0.63 to 7,398.0 pCi/g. The DOE remedial action guideline for uranium is 150 pCi/g.

Ten sediment samples were collected from the drainage trough located east of Building 845. Sampling locations are shown in Figure 4-1. All samples were analyzed for uranium-238, and concentrations ranged from 10.9 to 255.6 pCi/g. Selected samples also were analyzed for uranium-234, uranium-235, thorium-232 and radium-226. Results are given in Table 5-6. All results were below the DOE guidelines for these radionuclides (Ref. 4).

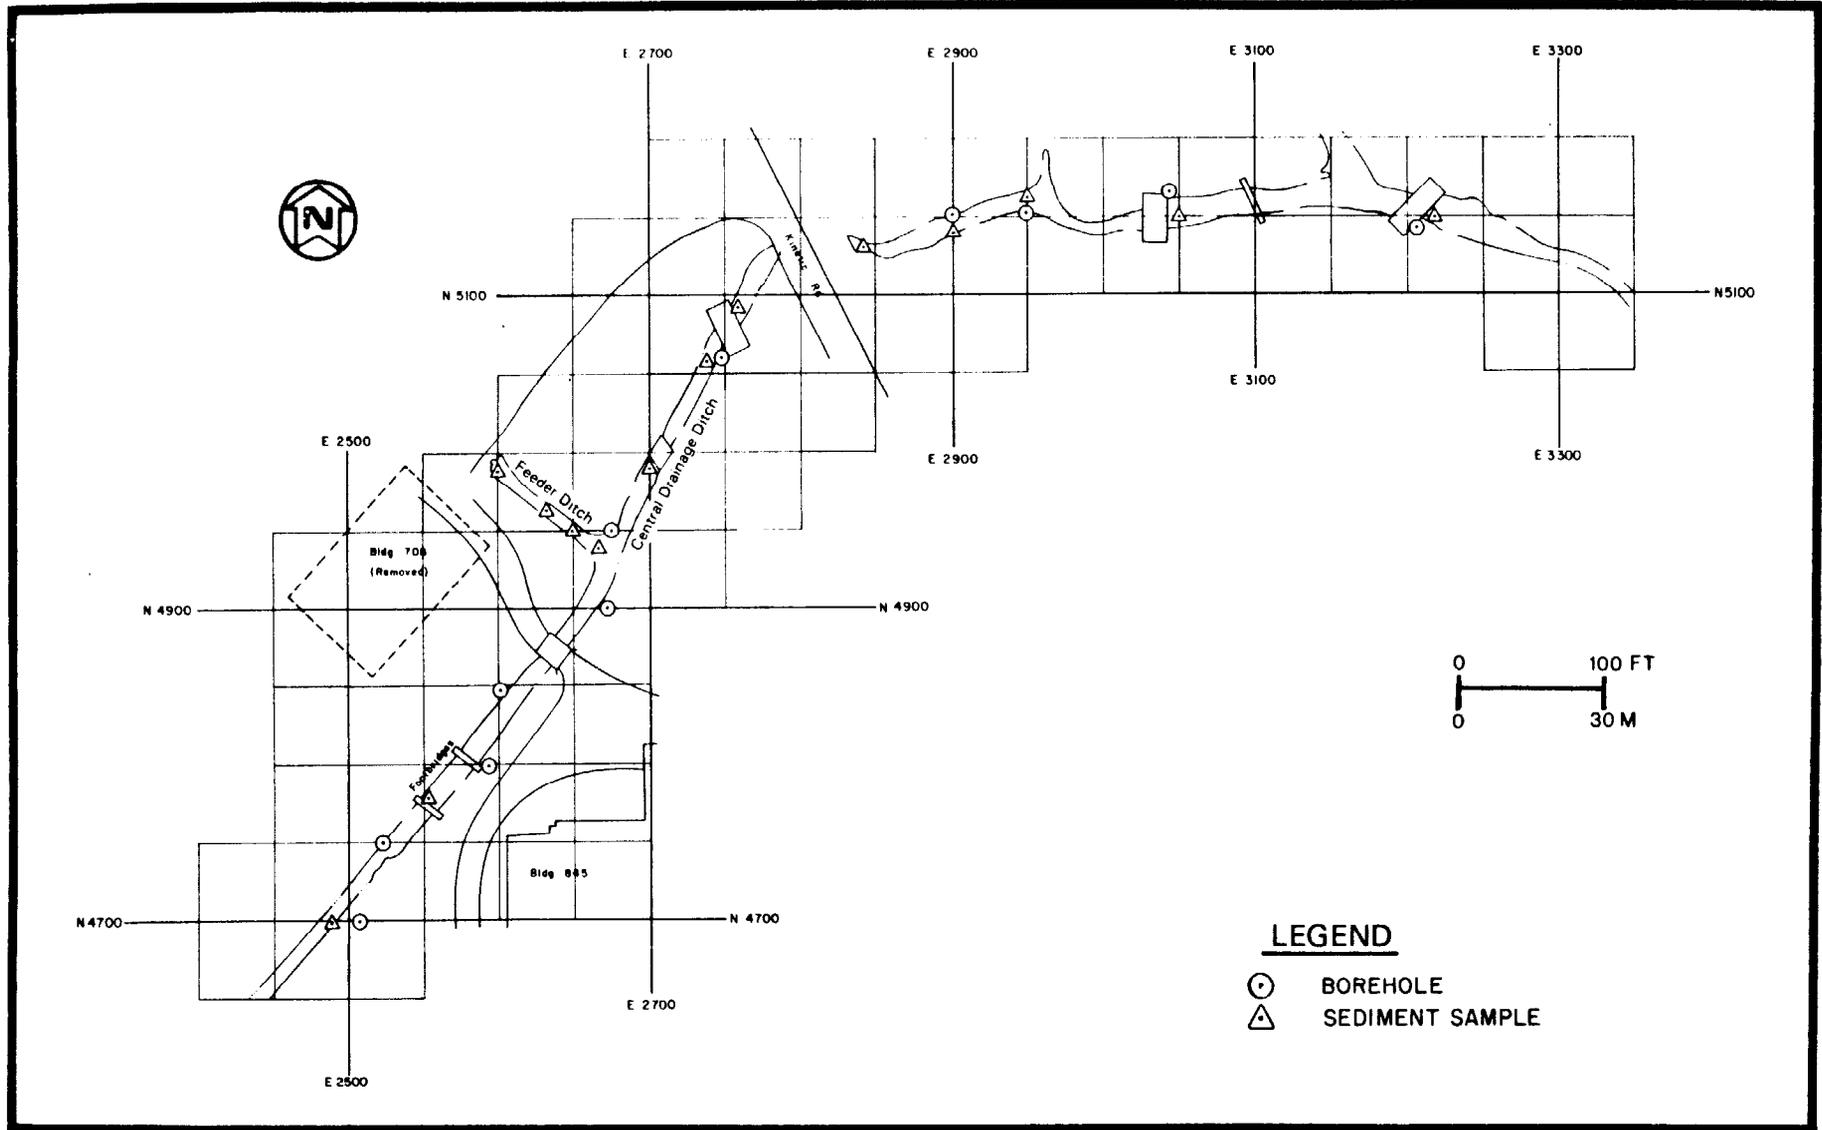
FIGURE 4-2 BOREHOLE AND SEDIMENT SAMPLE LOCATIONS, CENTRAL DRAINAGE DITCH AND FEEDER DITCH

Eleven boreholes were drilled along the sides of the Central Drainage Ditch (refer to Figure 4-2). Boreholes were gamma logged, and elevated measurements were detected along both sides of the ditch. All measurements were below but near the guideline limit.

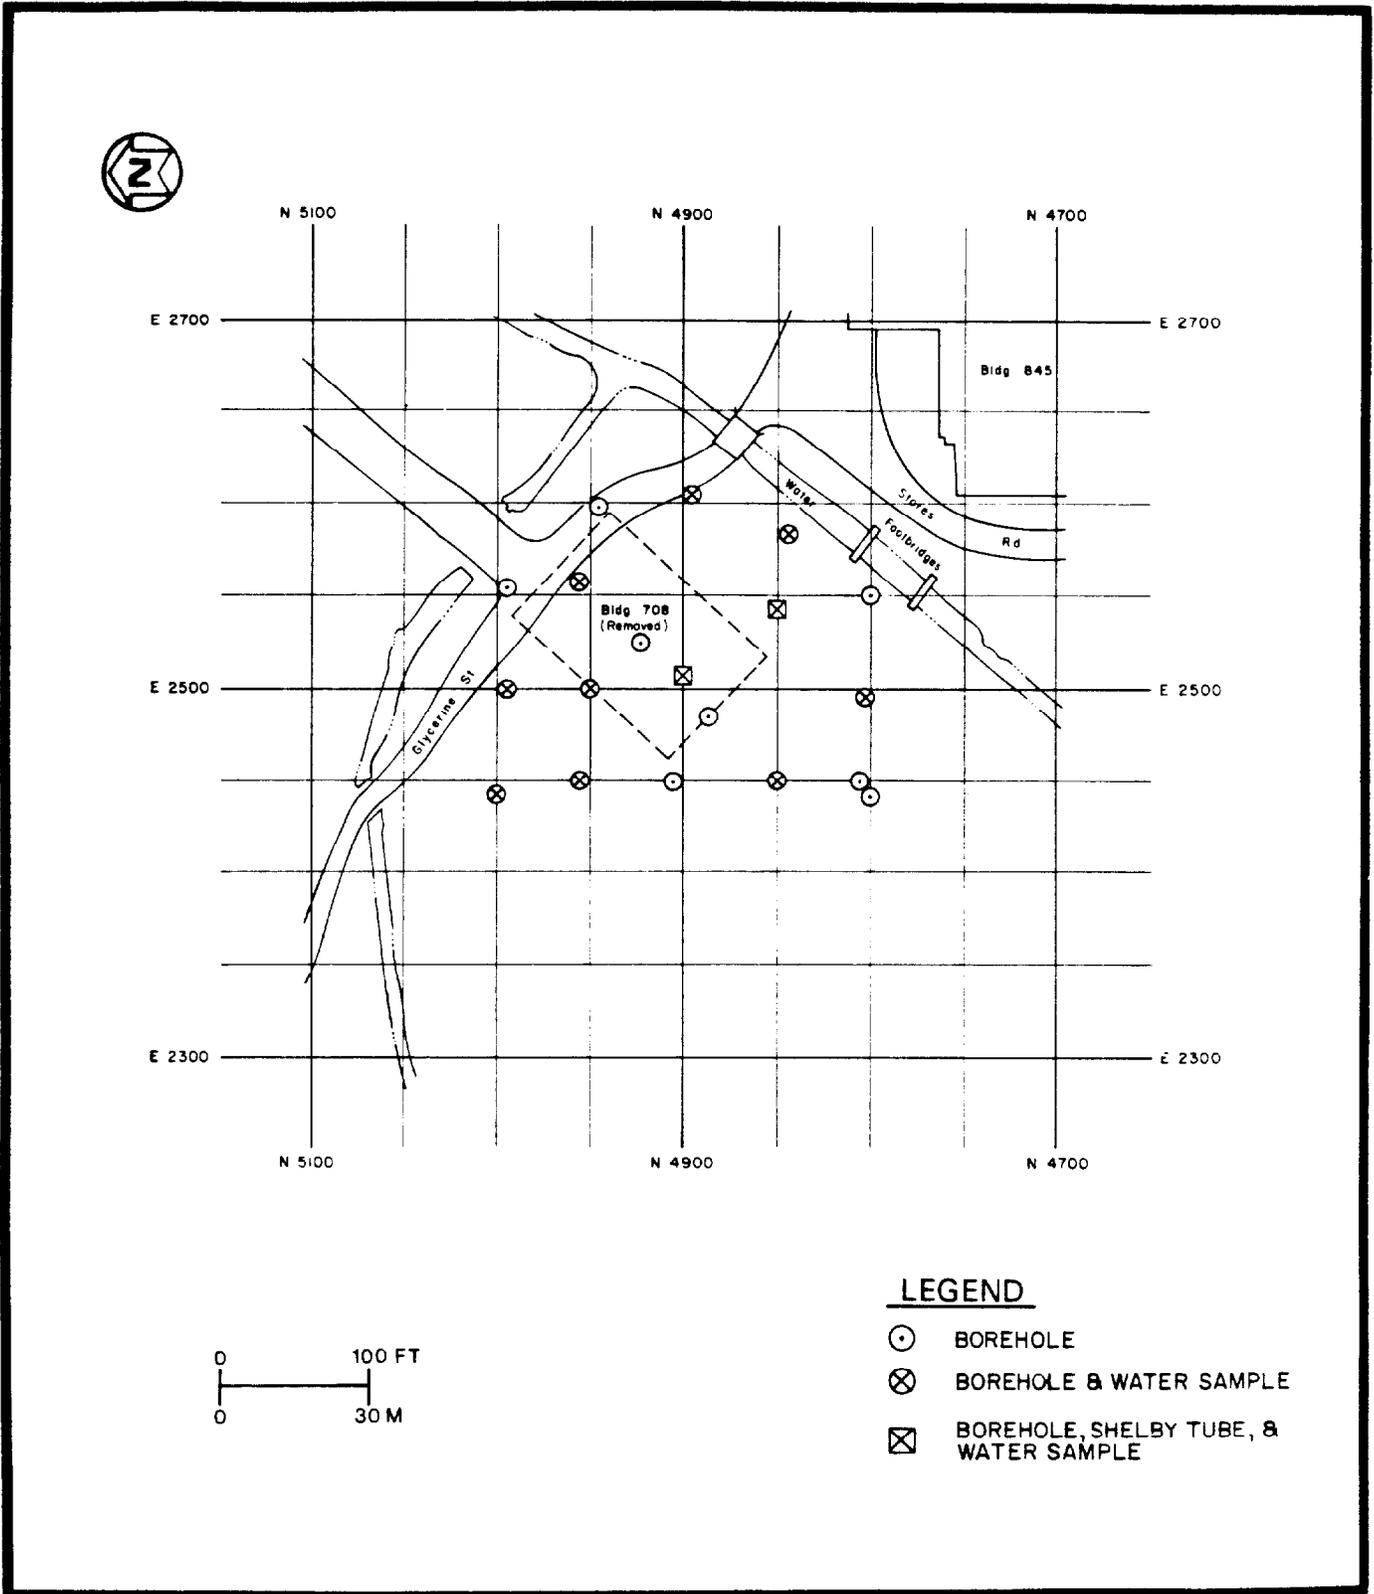
FIGURE 4-3 BOREHOLES AND SAMPLING LOCATIONS, F CORRAL AREA

Nineteen boreholes ranging from 0.6 to 2.7 m (2 to 9 ft) in depth were drilled in the F Corral area (refer to Figure 4-3). Based on gamma logs, subsurface contamination is indicated in layers to a depth greater than 2.7 m (9 ft).

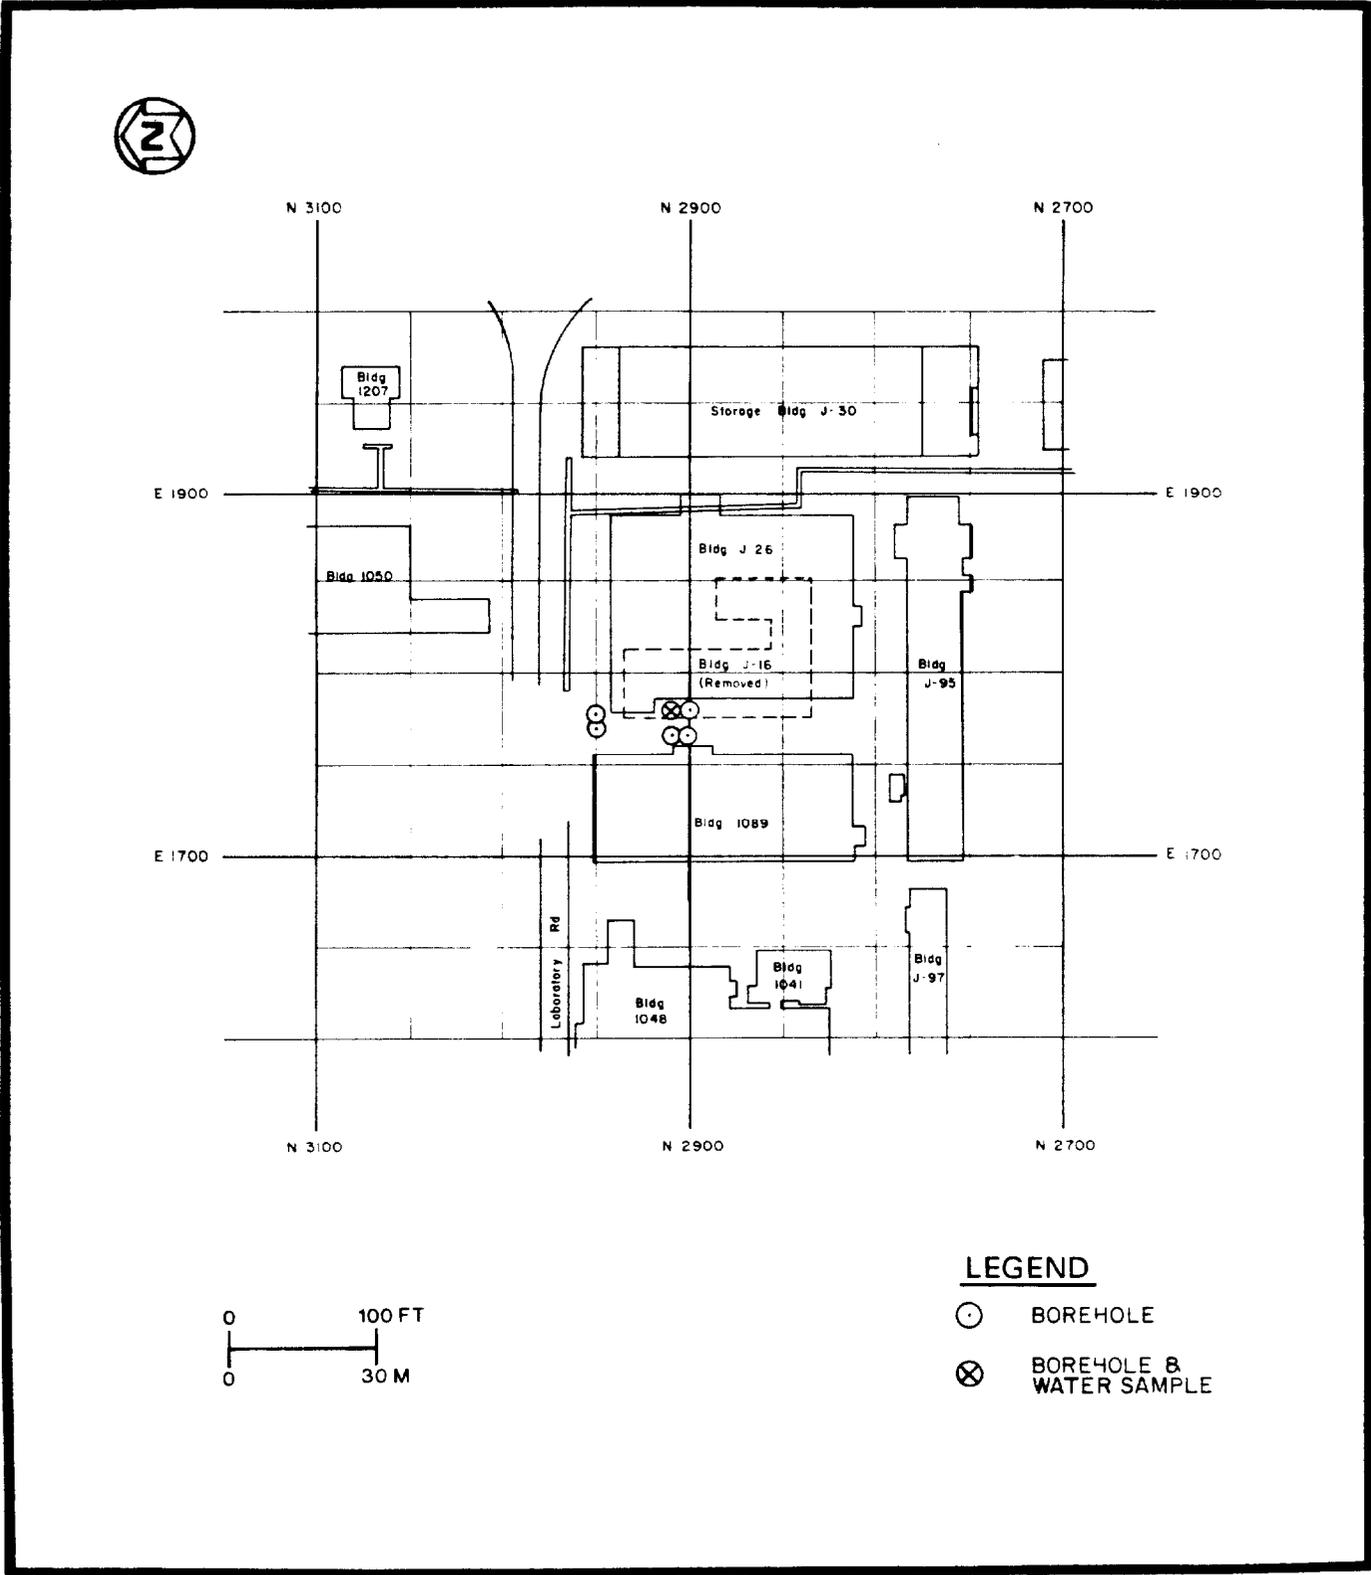
FIGURE 4-4 BOREHOLES AND WATER SAMPLING LOCATIONS, BUILDING J-26 AREA

Six boreholes were drilled in the area around Building J-26 (refer to Figure 4-4), and one water sample was collected. The total uranium concentration of the sample was 13.51 pCi/l. Analysis results are given in Table 5-7.

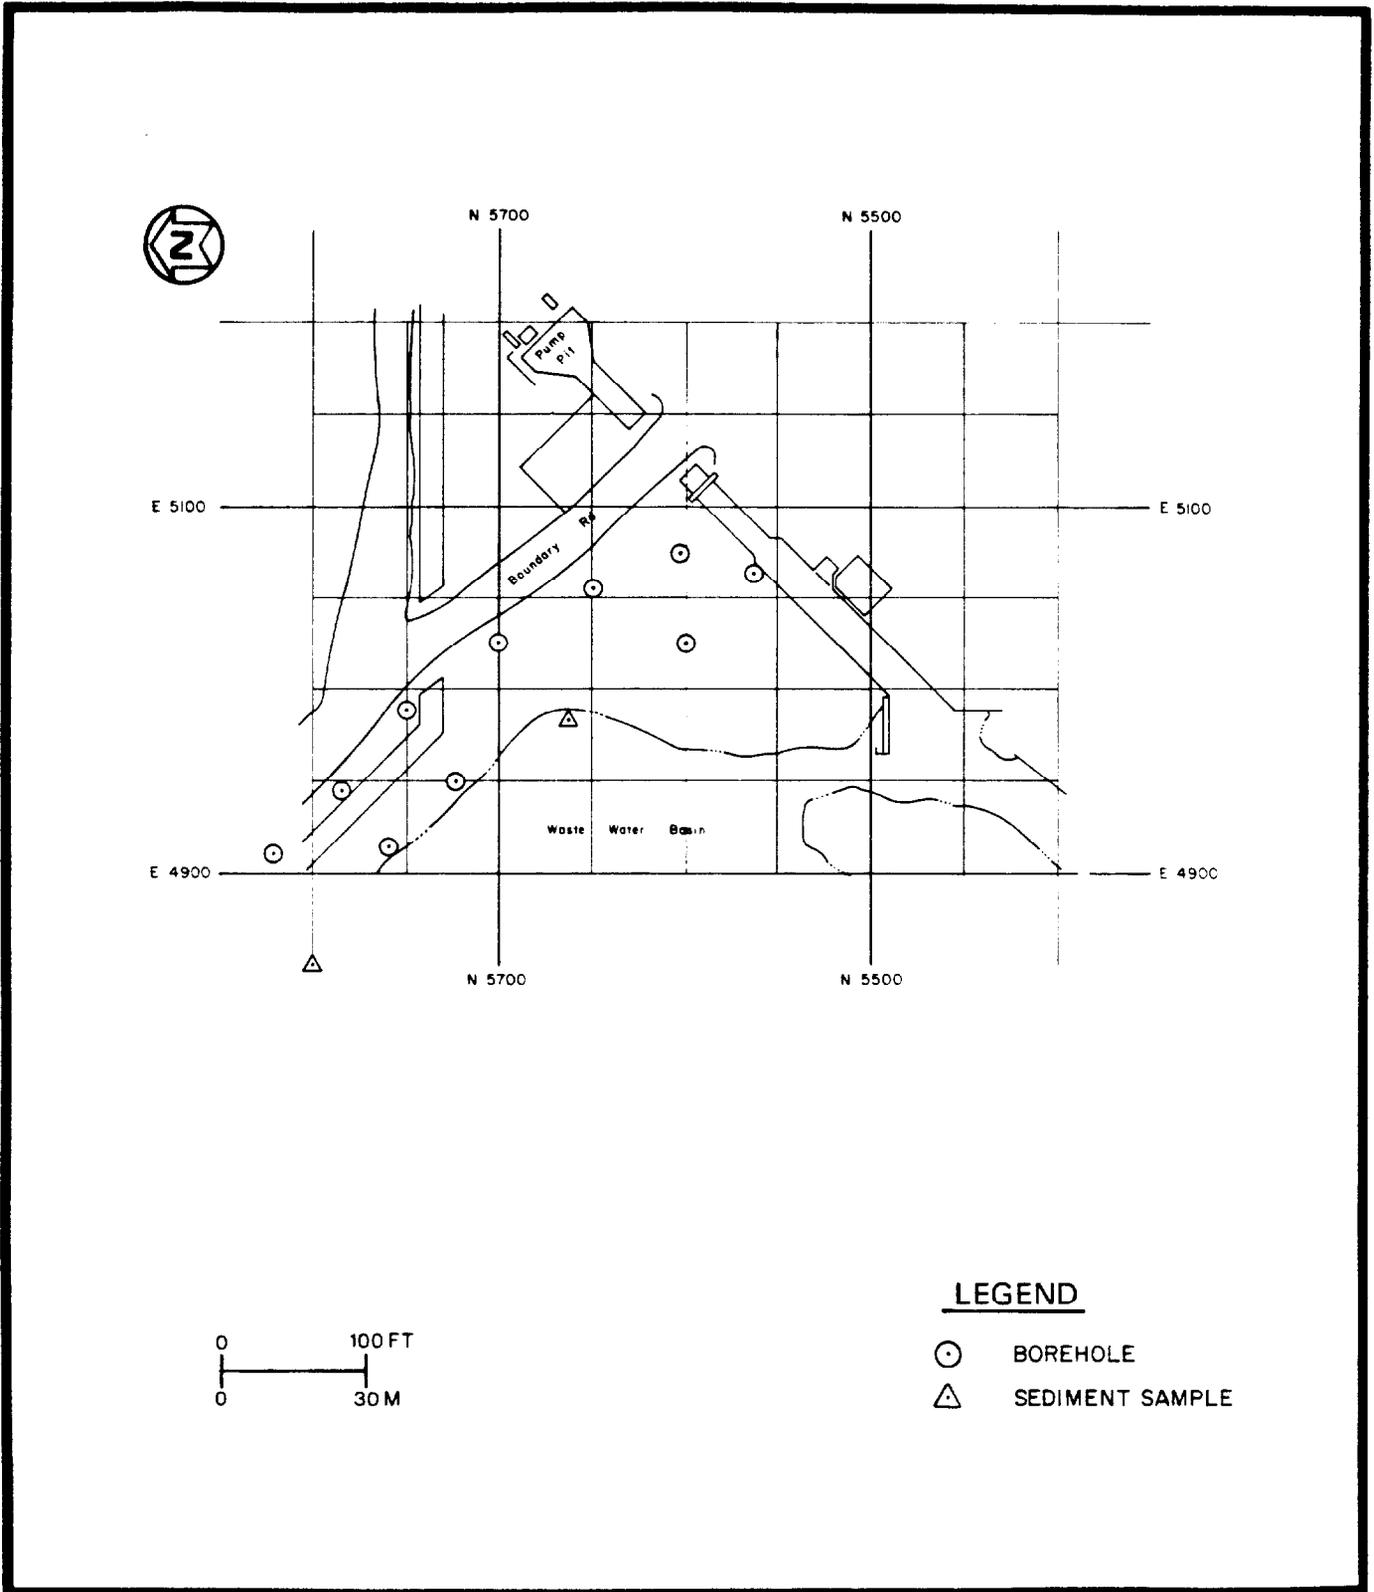
FIGURE 4-6 BOREHOLE AND SEDIMENT SAMPLING LOCATIONS, LAGOON A

Ten boreholes were drilled in the area (refer to Figure 4-6). Gamma loggings in nine boreholes exhibited readings above criteria limits and elevated readings were taken at depths greater than 2.6 m (8.5 ft).

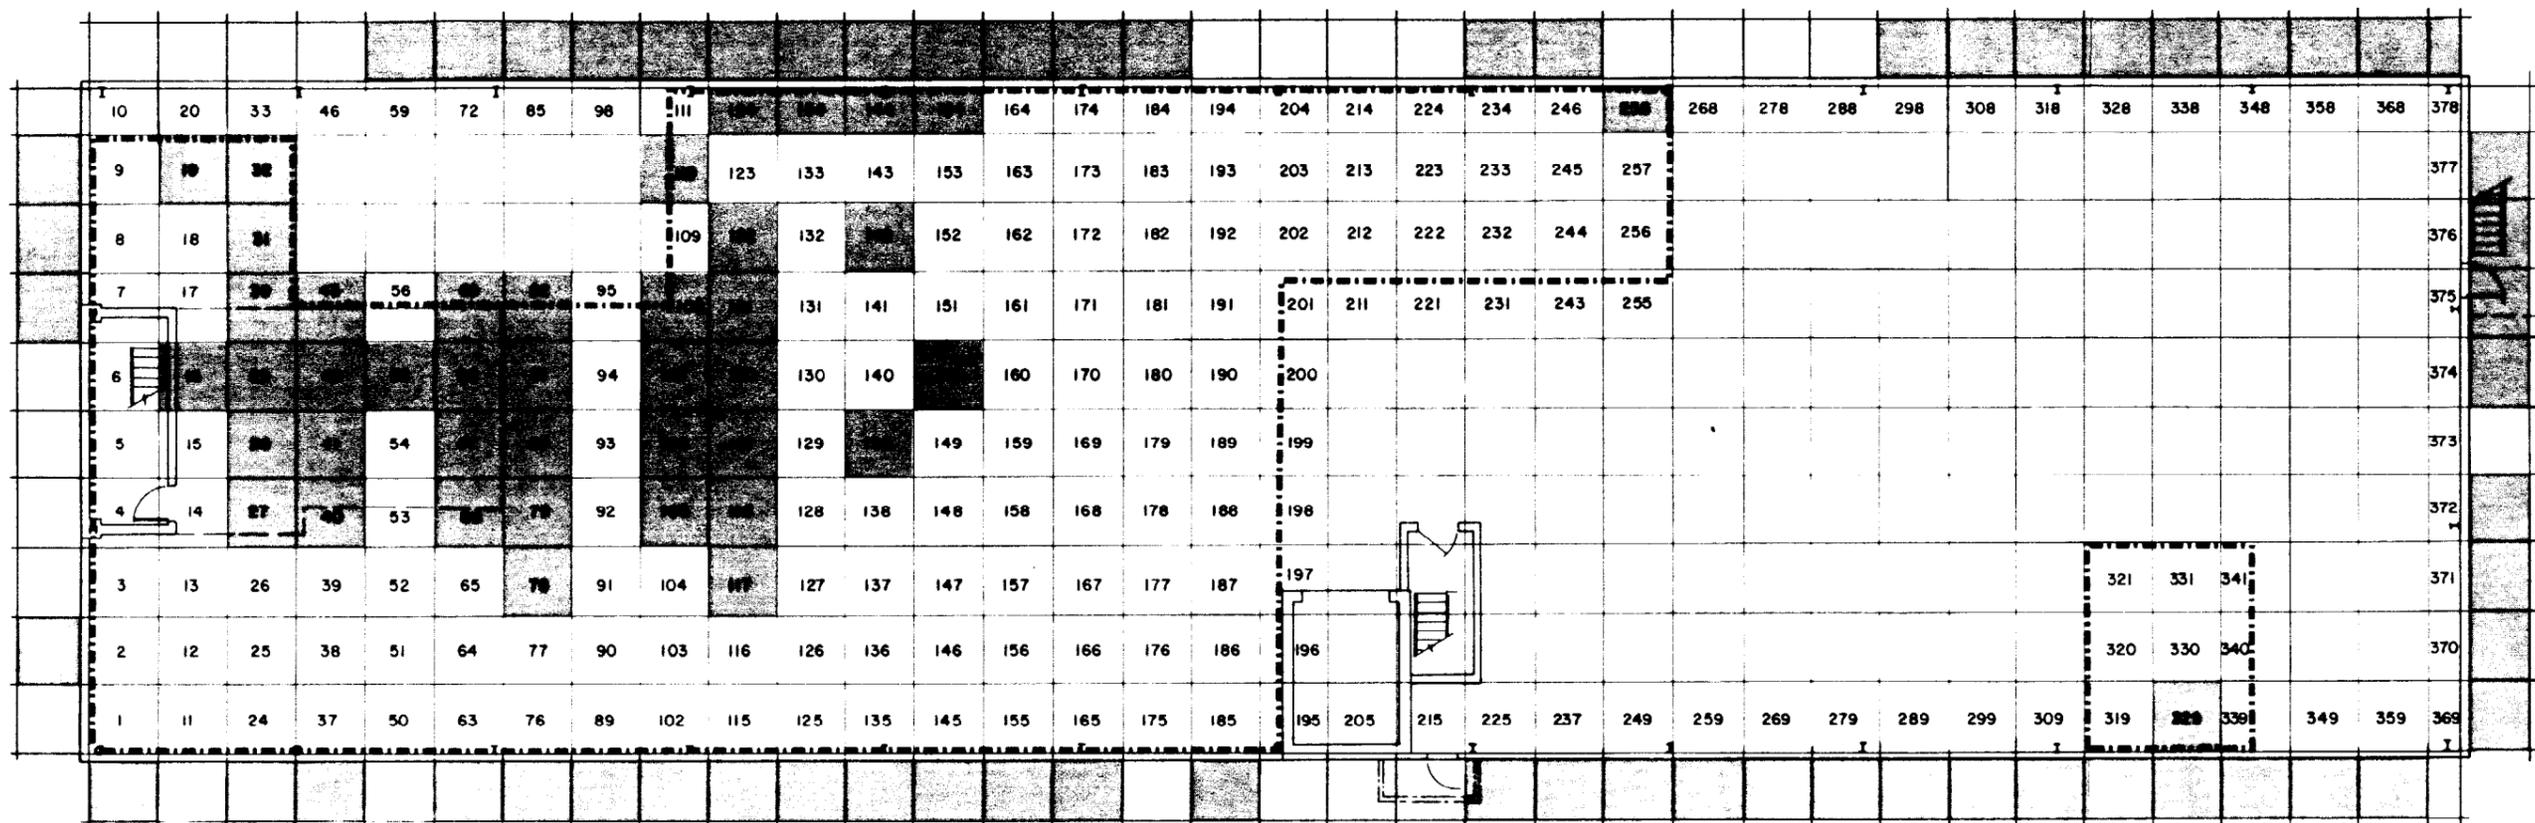
FIGURE 6-12 AREAS OF CONTAMINATION BENEATH BUILDING 845

Building 845 first floor corehole loggings, coupled with Shelby tube soil samples indicated areas of contamination beneath the building up to depths of 1.2 m (4 ft). These areas of contamination are illustrated in Figure 6-12.

Based on these results, an estimated 560 m³ (760 yd³) of soil would require removal from beneath Building 845 to comply with criteria. In addition, remedial action would include the decontamination of all areas inside Building 845 which exhibited surface measurements above remedial action criteria limits. Surface decontamination of the building would involve removal of 2.5 cm (1 in.) of material from approximately 2050 m² (22,000 ft²) of contaminated surface areas. This would result in approximately 75 m³ (100 yd³) of material which would require removal. Total demolition of Building 845 would result in approximately 2300 m³ (3000 yd³) of material.
