PRELIMINARY SITE SURVEY REPORT FOR THE
FORMER SUPERIOR STEEL MILL AT
CARNEGIE, PENNSYLVANIA

April 1981

OAK RIDGE NATIONAL LABORATORY
Oak Ridge, Tennessee 37830
operated by
UNION CARBIDE CORPORATION
for the
DEPARTMENT OF ENERGY

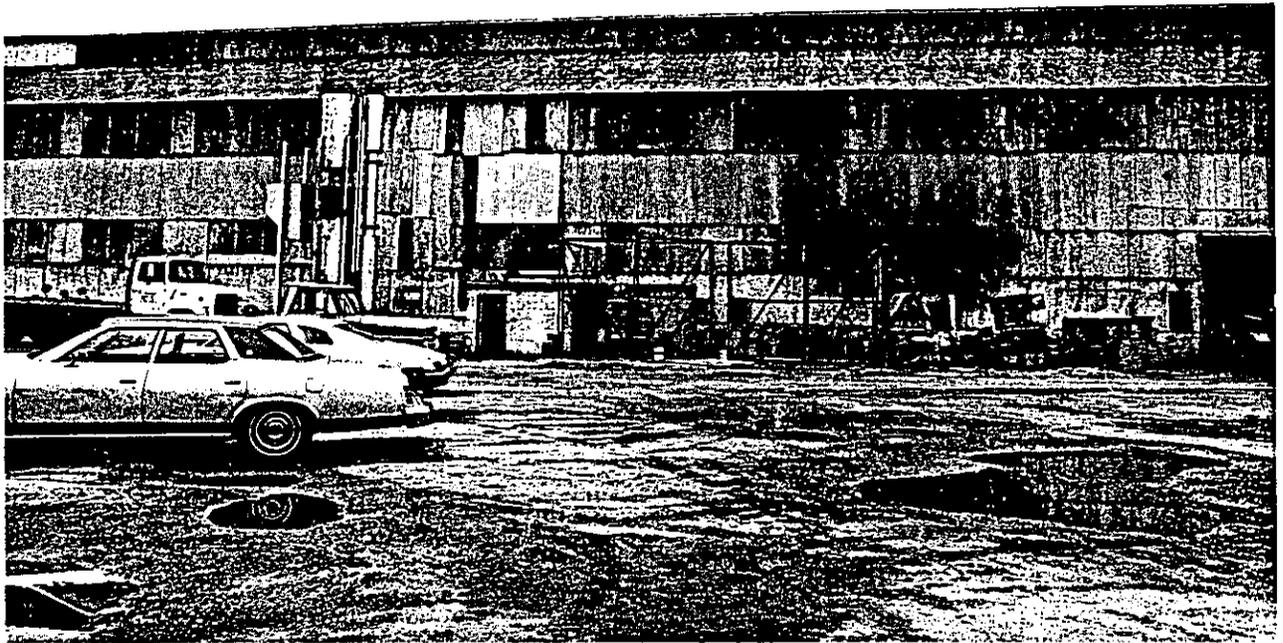
Fig. 2. Exterior view of the former uranium-handling facility at the Superior Steel Corporation Plant in Carnegie, Pennsylvania.

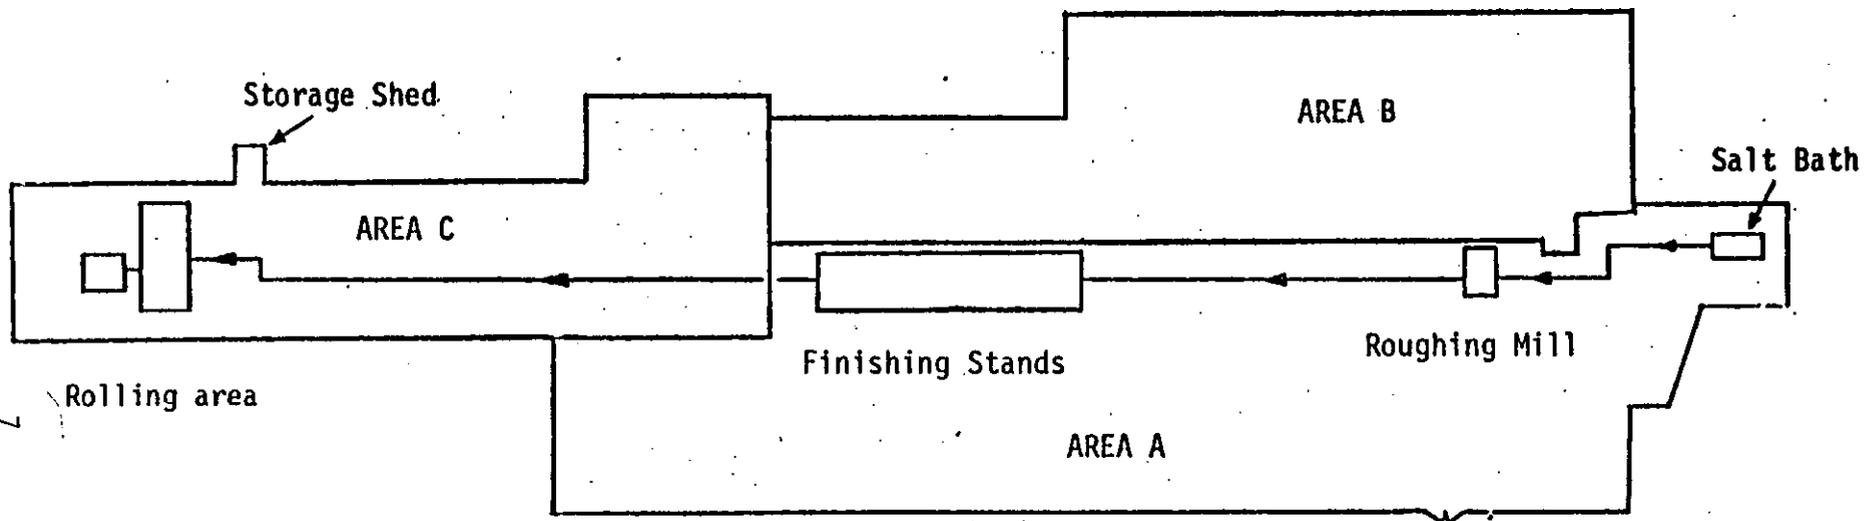
Fig. 3. Layout of former Superior Steel Facility, showing area designations and approximate locations of process line machinery.

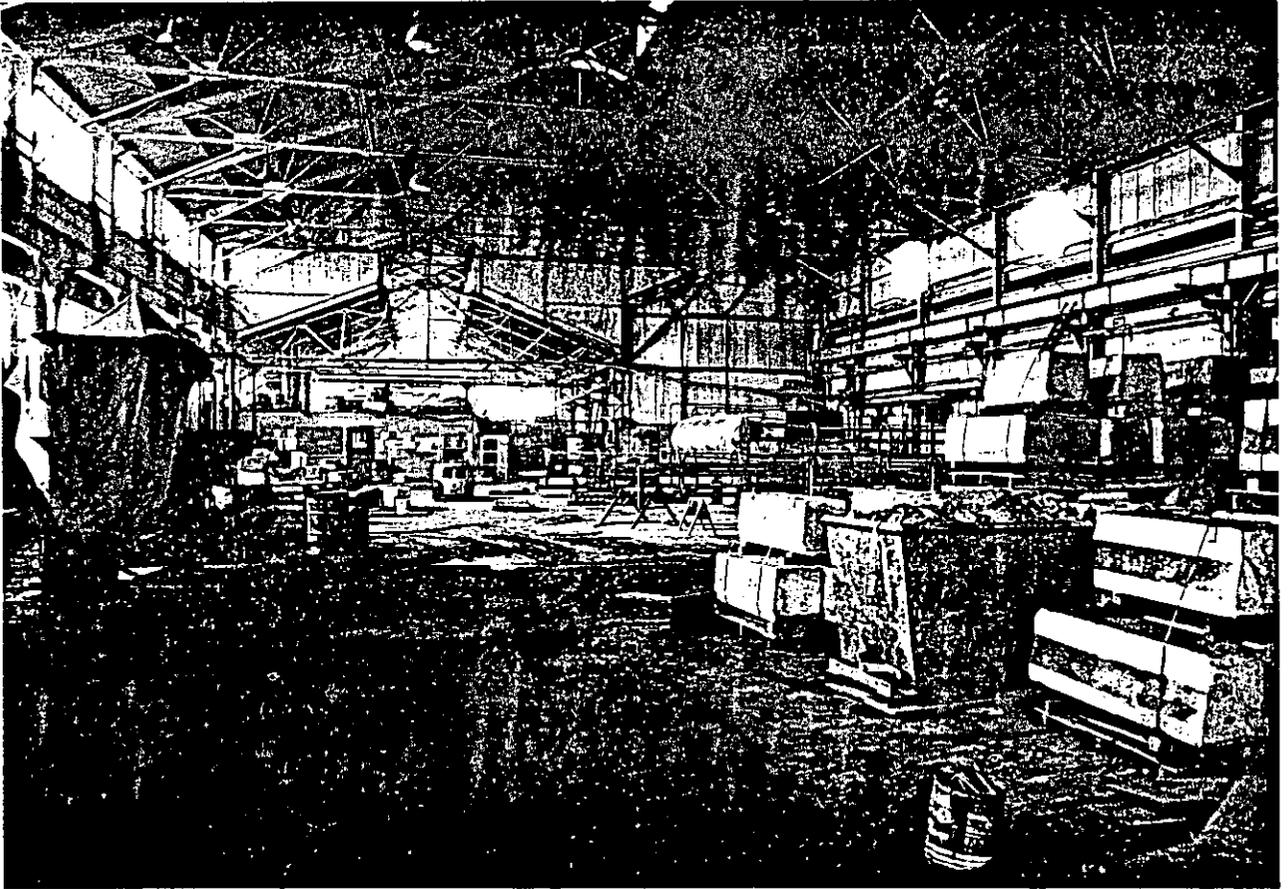
Area A (Figs. 4 and 5, approximately 24,000 sq. ft.) originally contained the salt bath, roughing mill, brushing station, finishing stands and shear, and was the location where the majority of the uranium metal handling and shaping is believed to have occurred. Only portions of the roughing (breakdown) mill were intact during this survey, all other machinery had been removed and sold or scrapped in previous years. The roughing mill has since been removed. Subfloor pits (approximately 8 ft. deep) over which the former mill, brushing station, finishing stands and shear were originally located are presently being filled in with rubble, with final plans for concreting the surfaces over at floor level.

Fig. 5. Interior of former mill area (Area A), looking south.

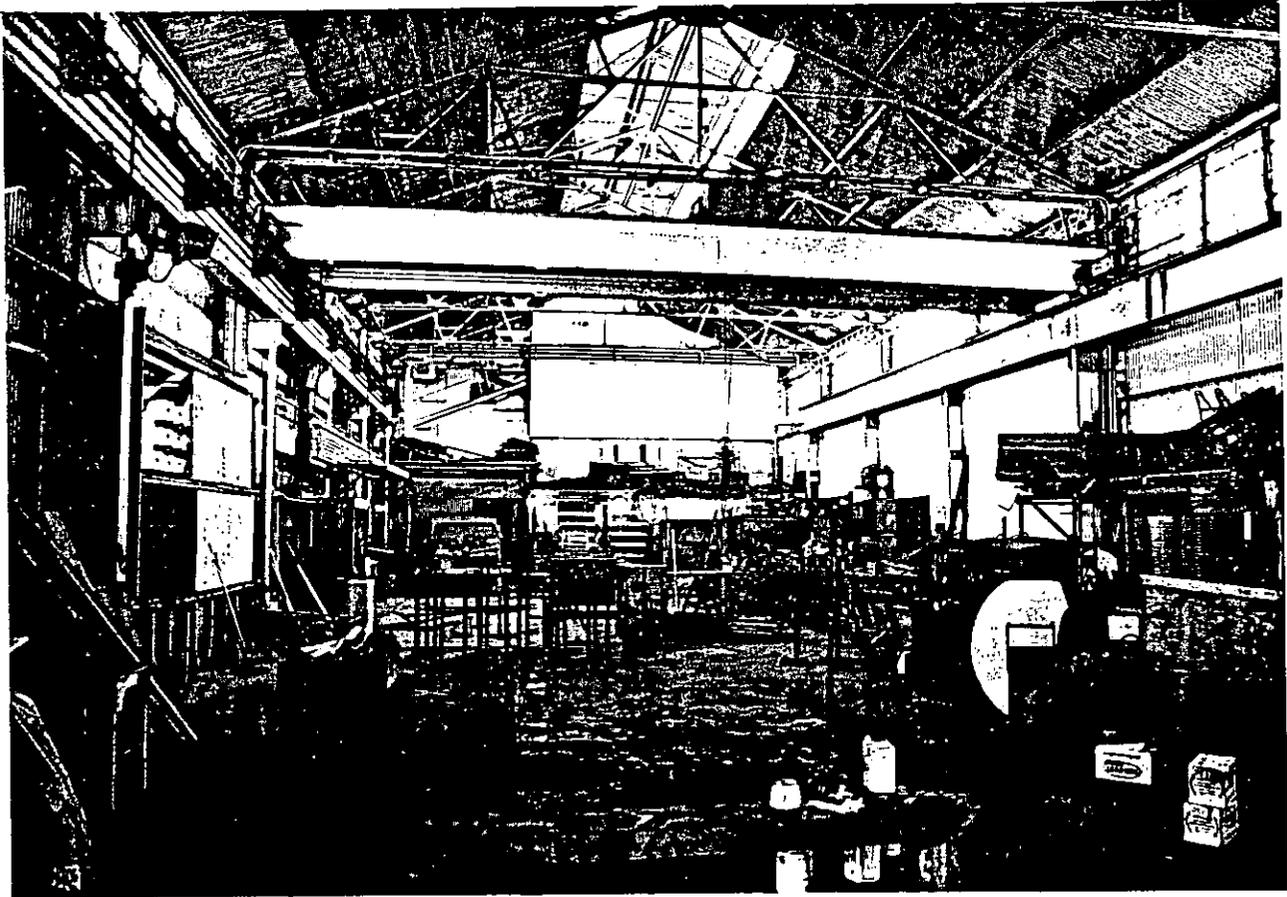
Area C (Figs. 7 and 8, approximately 12,000 sq. ft.) was originally the location of the tail end of the mill process where the metal was rolled for shipping, or prior to further handling. Two pits at the south end of the building (Fig. 9) indicate the prior locations of the bliss downcoiler and upender. Both pits are currently being filled in with rubble, with plans to concrete to floor level upon completion. The area is sealed off from the former mill area (area A) by a sheet-metal wall, and is used primarily for storage purposes. A small storage shed is attached to the west side of the building at the south end (Fig. 10).

Fig. 7. Inside view of former rolling area (Area C), looking north.

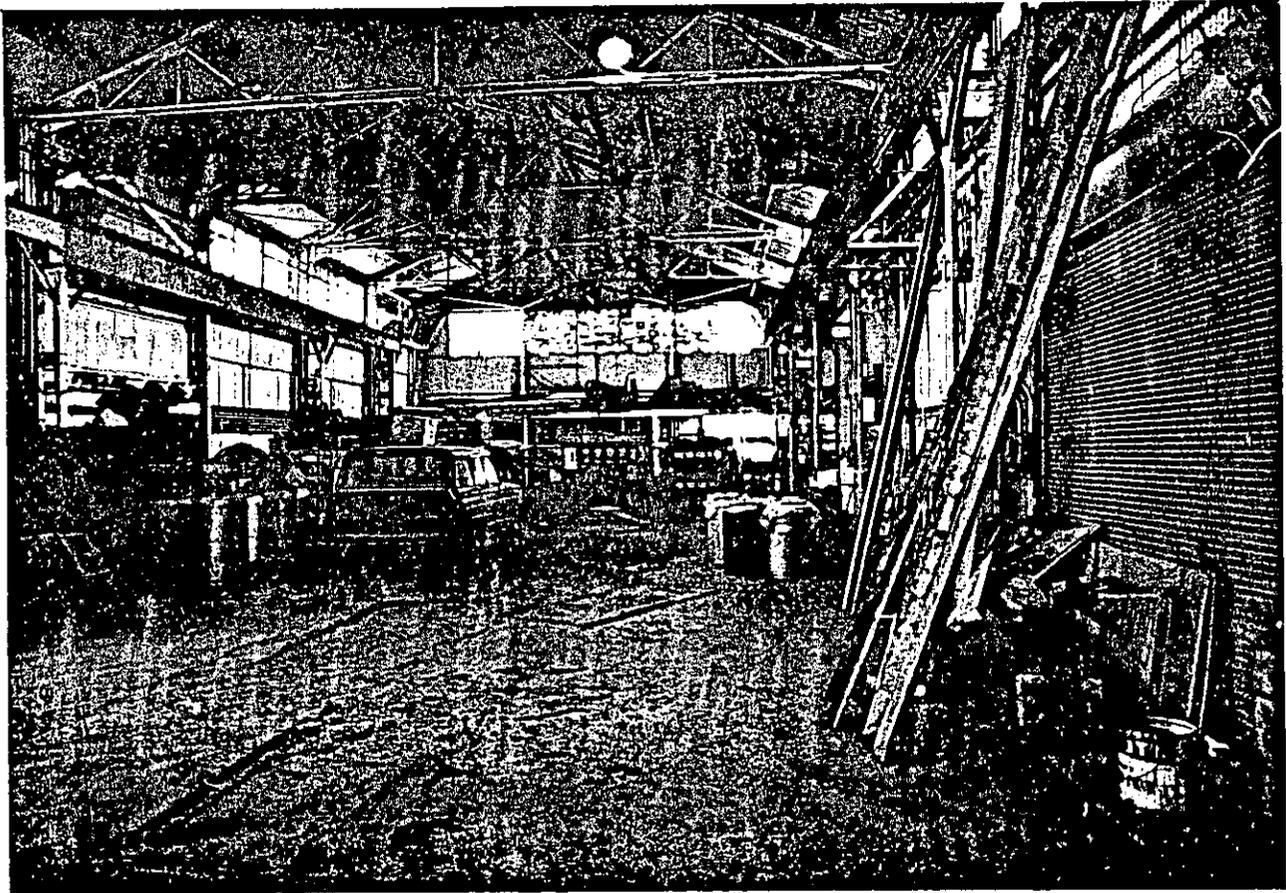
Fig. 8. Inside view of former rolling area (Area C), looking south.
