4.0 Durango, Colorado, Disposal Site

4.1 Compliance Summary

The Durango, Colorado, Uranium Mill Tailings Radiation Control Act (UMTRCA) Title I Disposal Site was inspected on May 28, 2009. The disposal cell and all associated surface water diversion and drainage structures were in good condition and functioning as designed. The water level in the disposal cell has dropped, which satisfies criteria for the permanent closure of the transient drainage water collection and treatment system. However, the U.S. Department of Energy (DOE) is evaluating an increase in the downgradient uranium concentration before decommissioning the treatment system. Vandalism, primarily theft and damage to signs, continues at the site. The bases of perimeter signs P41 and P44 have been undercut by erosion but remain stable. Infestations of noxious weeds and deep-rooted plants on the disposal cell continue to be monitored and controlled with herbicide. No other maintenance needs or cause for a follow-up or contingency inspection was identified.

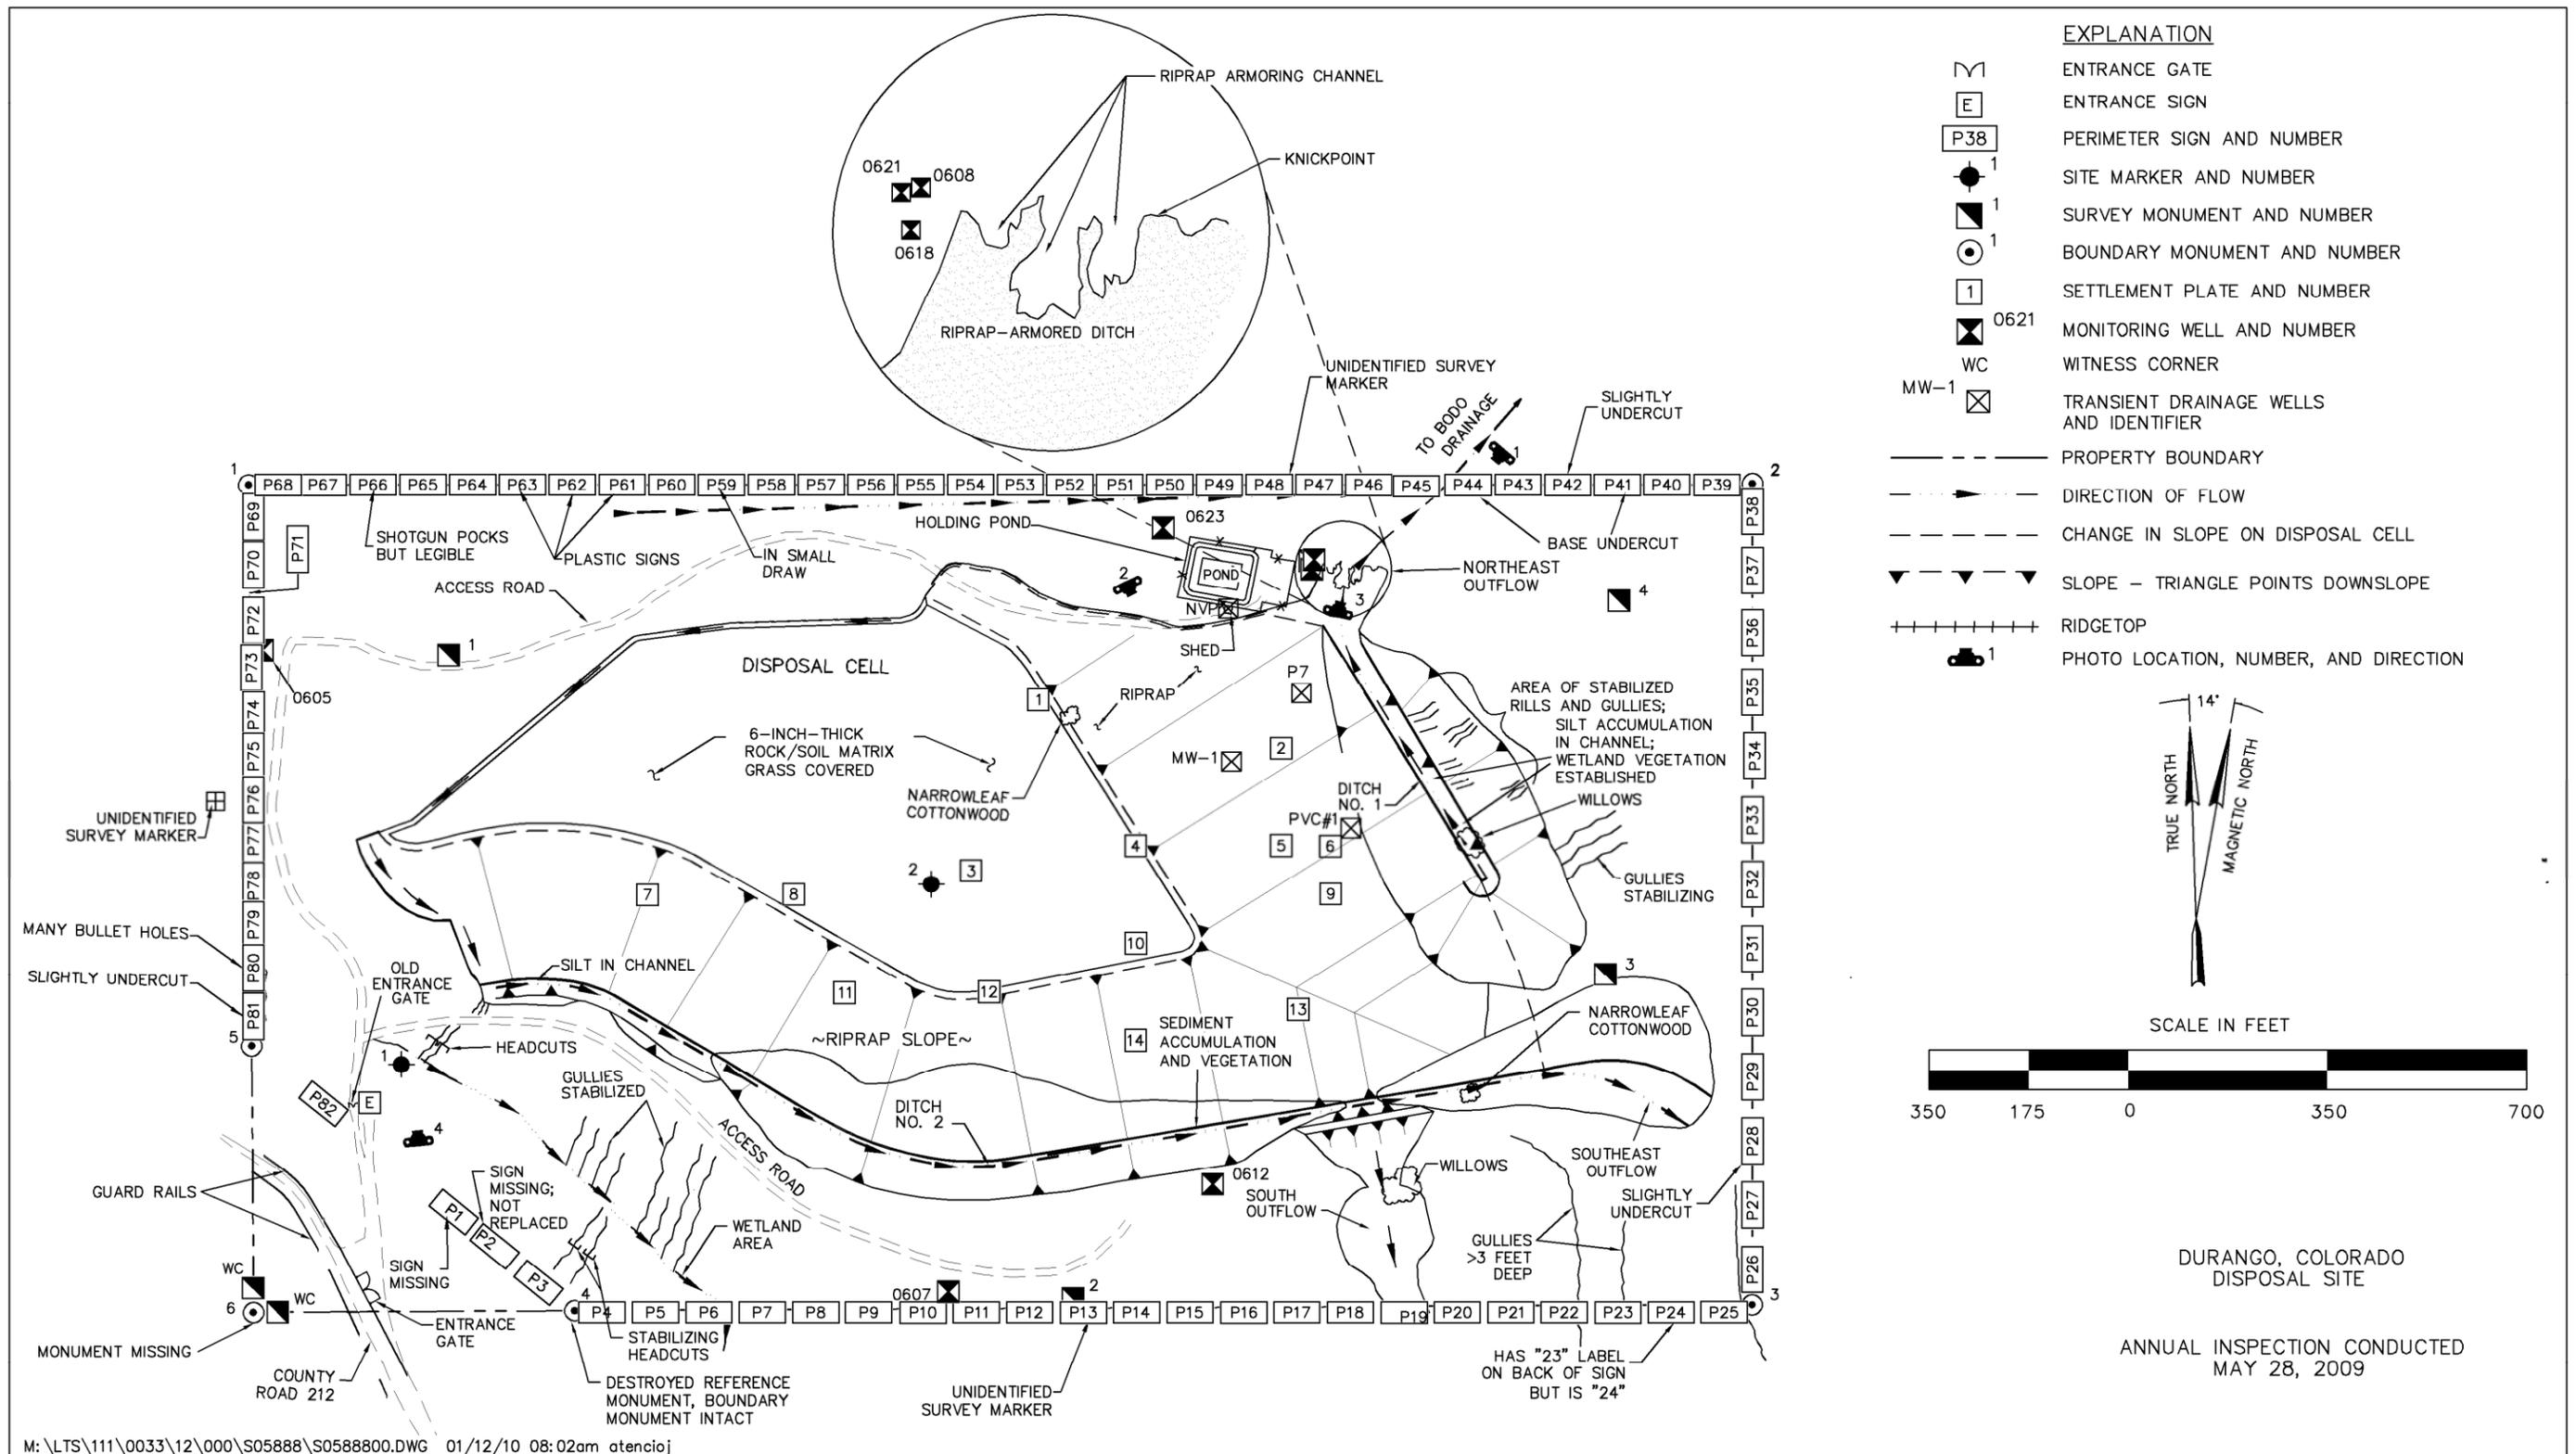
Figure 4-1. 2009 Annual Compliance Drawing for the Durango Disposal Site

The site, southwest of Durango, Colorado, was inspected on May 28, 2009. The results of the inspection are described below. Figure 4-1 shows features and photograph locations (PLs) discussed in this report. Numbers in the left margin of this report refer to items summarized in the “Executive Summary” table.

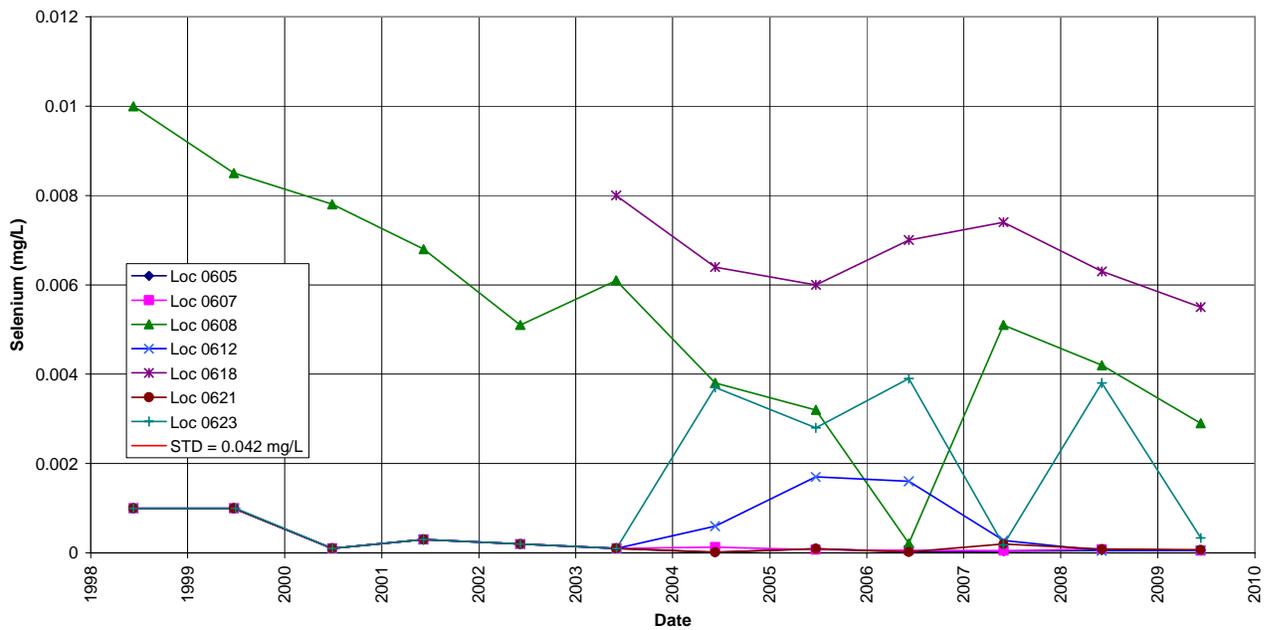
Figure 4-3. Time-Concentration Plot of Selenium in Groundwater at the Durango Disposal Site

Groundwater samples are collected annually and analyzed for three indicator parameters: molybdenum, selenium, and uranium. The site-specific standards used for the three indicator parameters are the respective maximum observed background concentrations reported in groundwater samples collected from wells completed in the bedrock aquifer as identified in Table 5-4 of the LTSP. These site-specific standards are provided below in Table 4-3. Time-concentration plots for uranium, selenium, and molybdenum monitoring results are included as Figures 4-2, 4-3, and 4-4, respectively.
