PC-000456/0

# GENERAL ATOMICS HOT CELL CHARACTERIZATION REPORT

**GA HOT CELL D&D PROJECT**  
**CONTRACT NO. DE-AC03-95SF20798**  
**PROJECT NO. 7340**

**DECEMBER 1995**

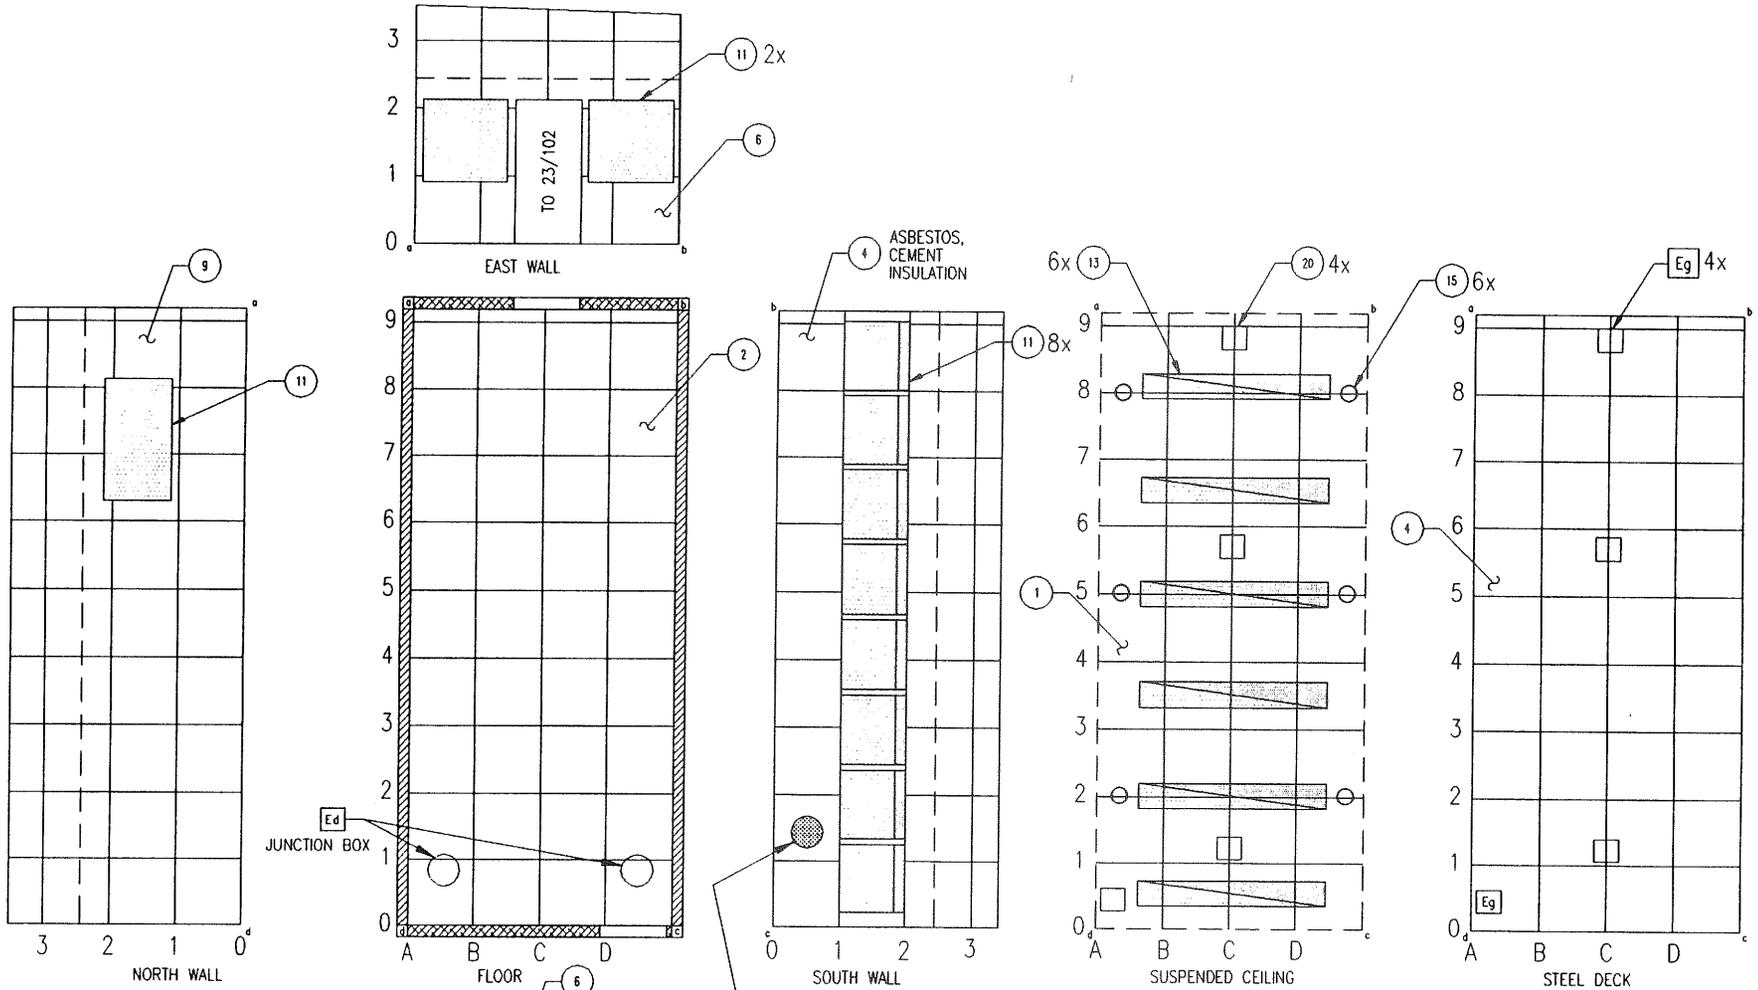
Fig. 4-4—Room 100

Sample results for this room included TCLP for Lead Paint for the West Wall. Results were less than .05 mg/l which is less than the regulatory limit of 5.0 mg/l for LDR wastes.

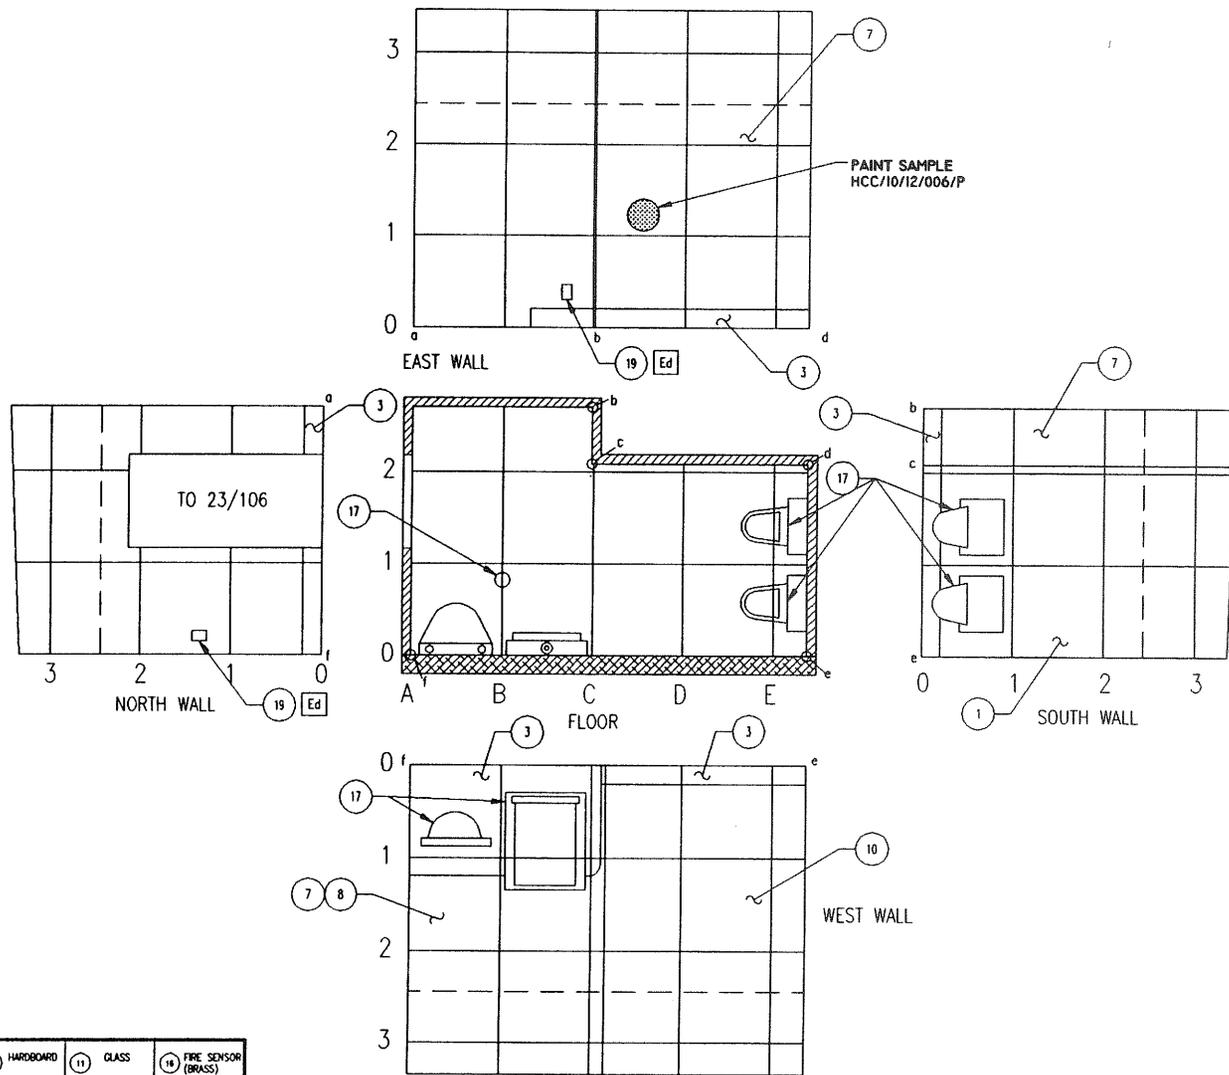
Fig. 4-7—Men's Bathroom  
4-33

Sample results for this room included TCLP for Lead Paint for the East Wall. Results were less than 0.05 mg/l which is less than the regulatory limit of 5.0 mg/l for Pb for LDR wastes.

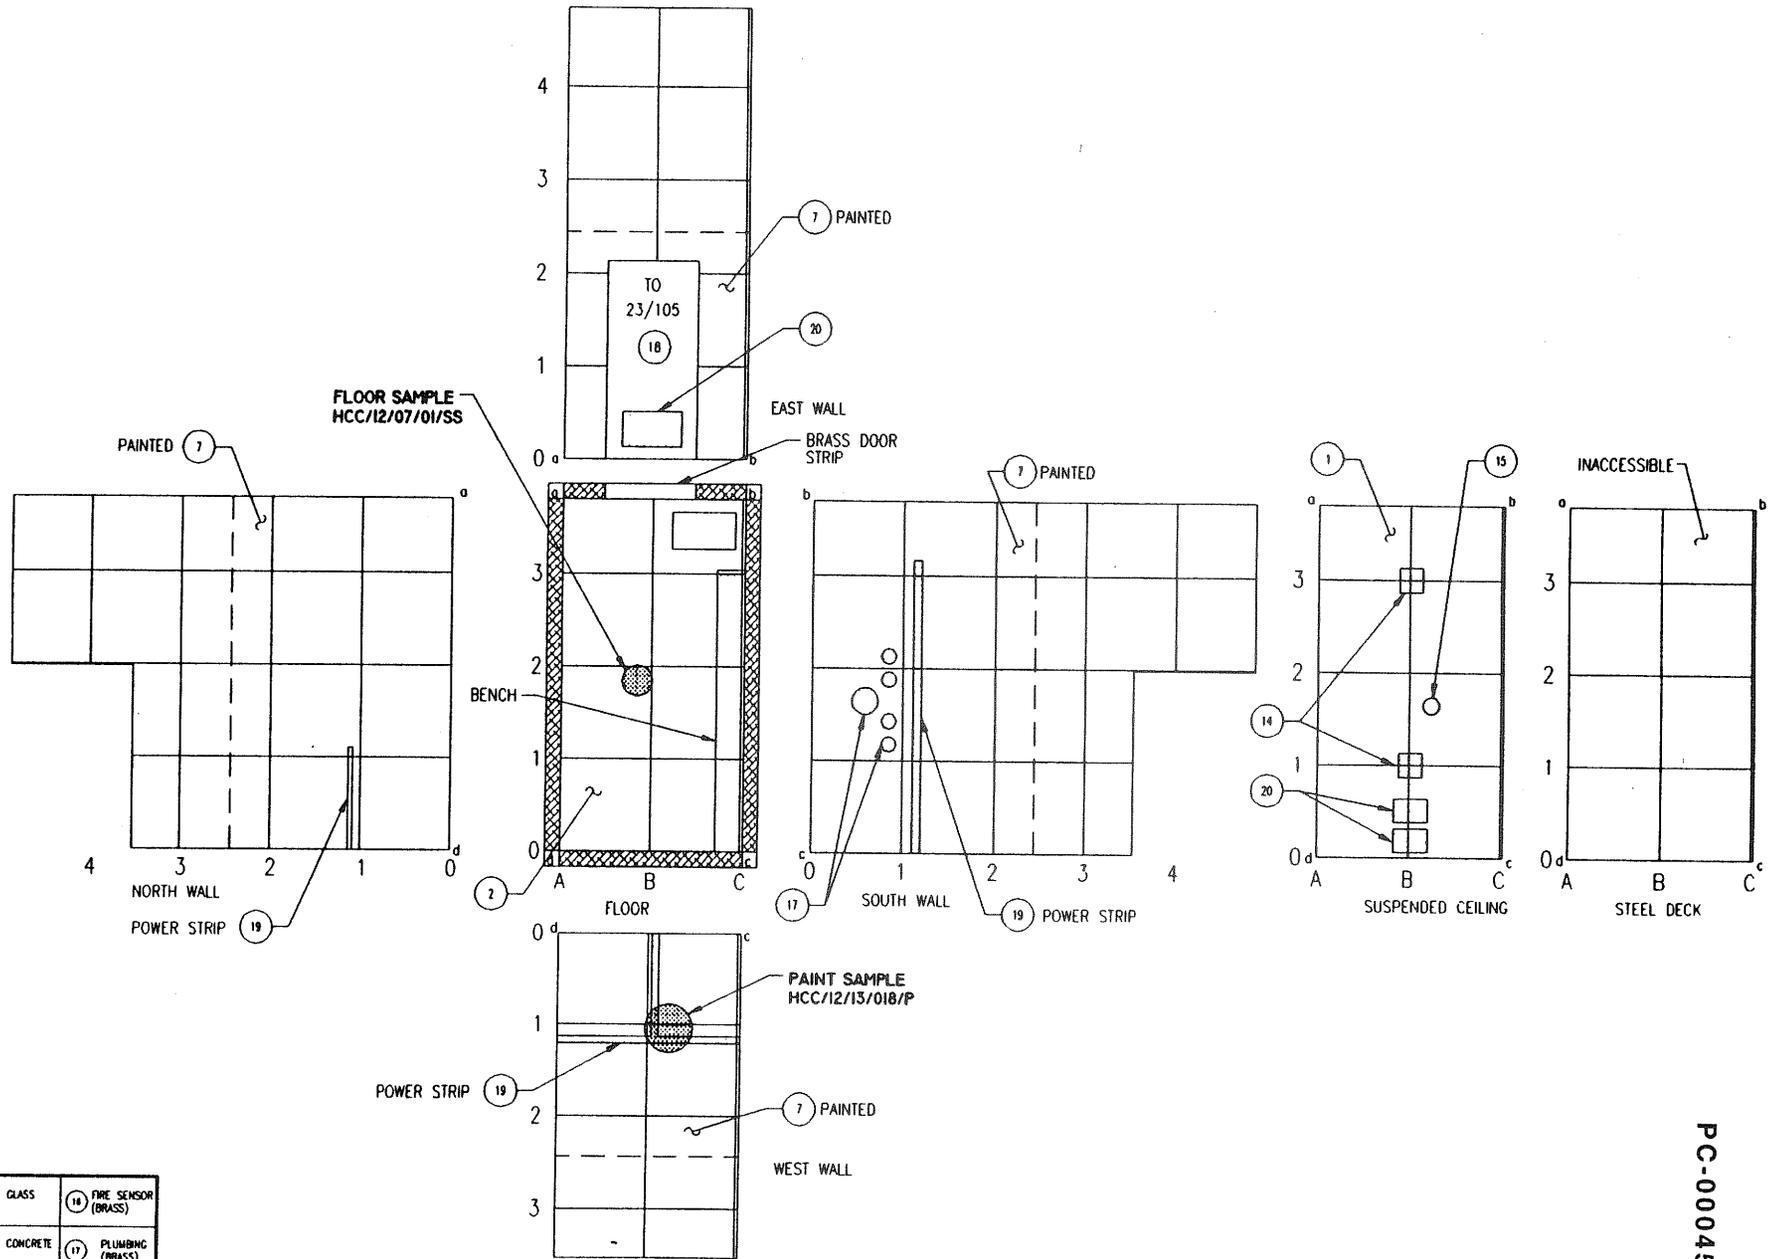
Fig. 4-10—Room 105A, Dark Room

The ceiling of this room contains six ballast within the light fixtures which are PCB-suspect.

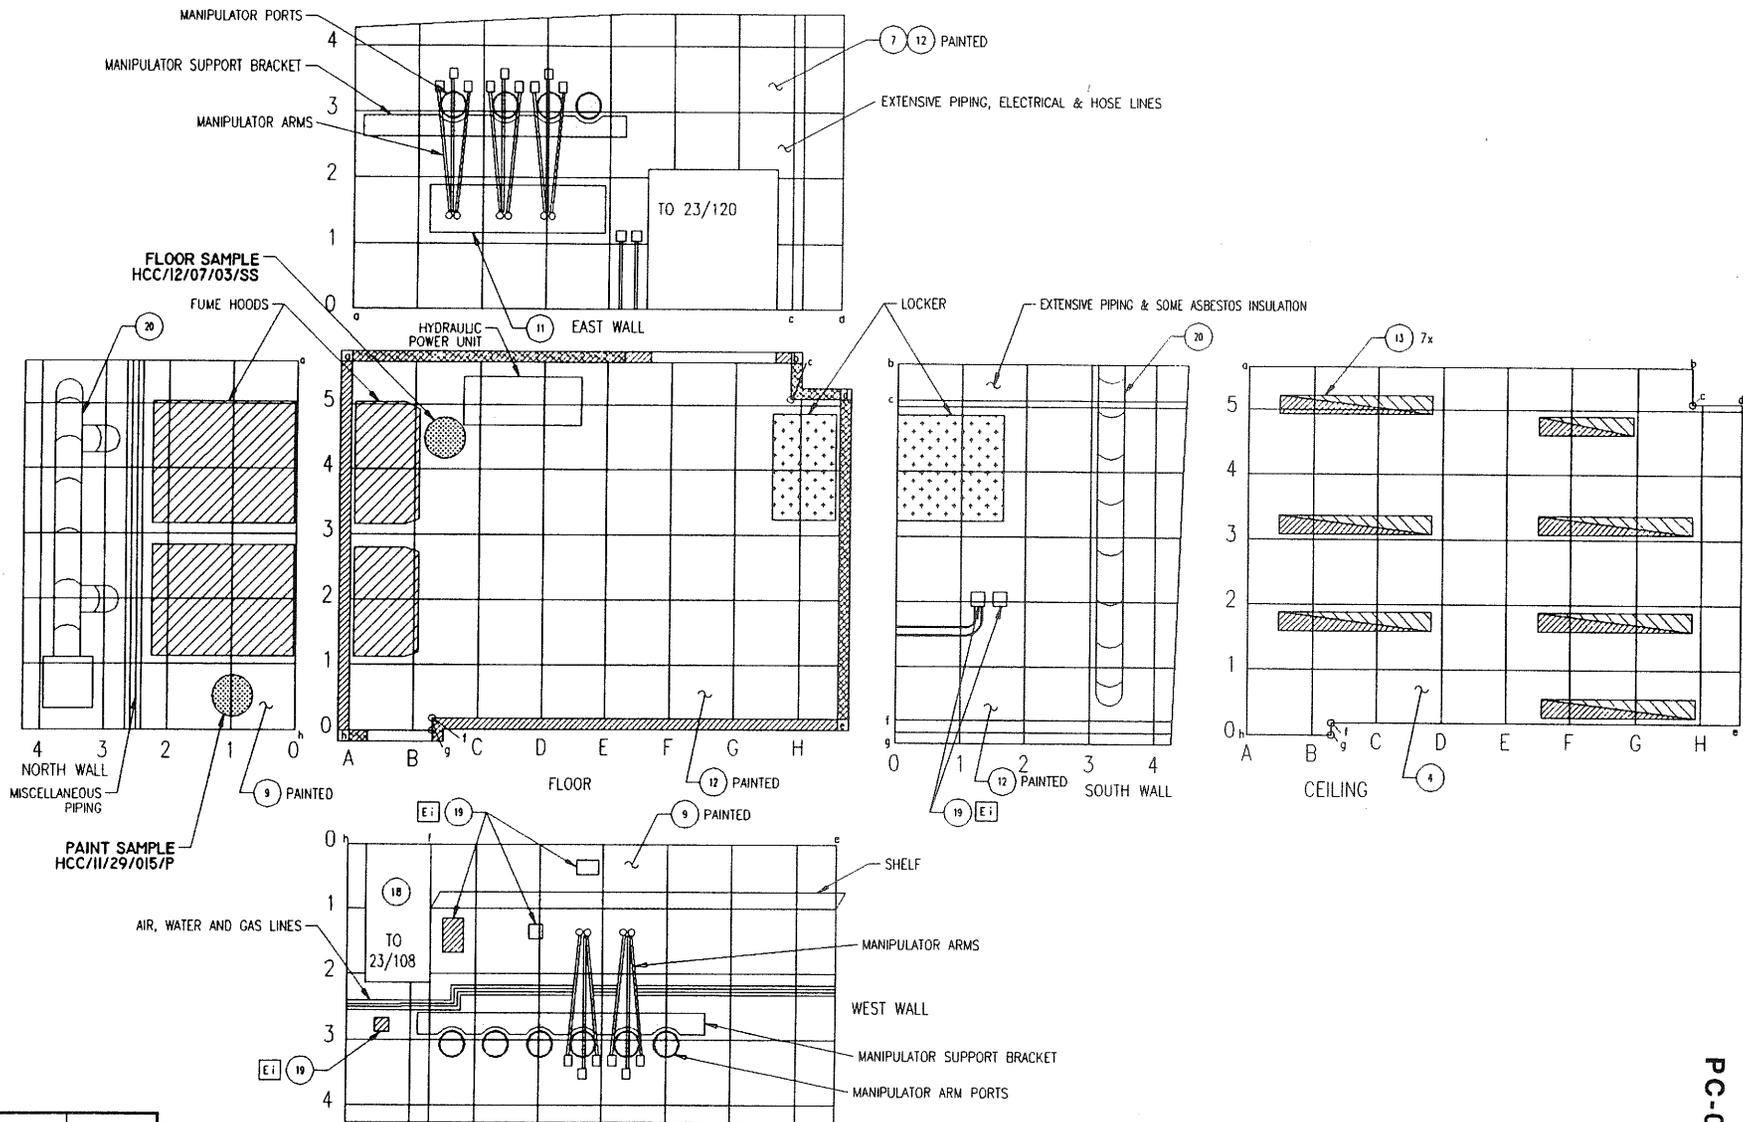
Fig. 4-12—Room 107, Warm Metallography

Refer to Table 4-4 for a complete listing of all sample results for this room. Sample results for this room included TCLP for Lead Paint for the North Wall. Results were <.04 mg/l which is below the regulatory limit of 5.0 mg/l. Samples of concrete taken from the floor indicate the presence of PCB 1254 at levels of 792 µg/l. Semi-Volatiles were present in the floor in mg/kg quantities, however, because of the presence of PCBs and lead, the floor materials removed from this room will need to re-sampled to determine if they are LDR materials. The oil from the manipulator hoist was analyzed for hazardous constituents and will be disposed of as hazardous waste when the equipment is no longer in use.

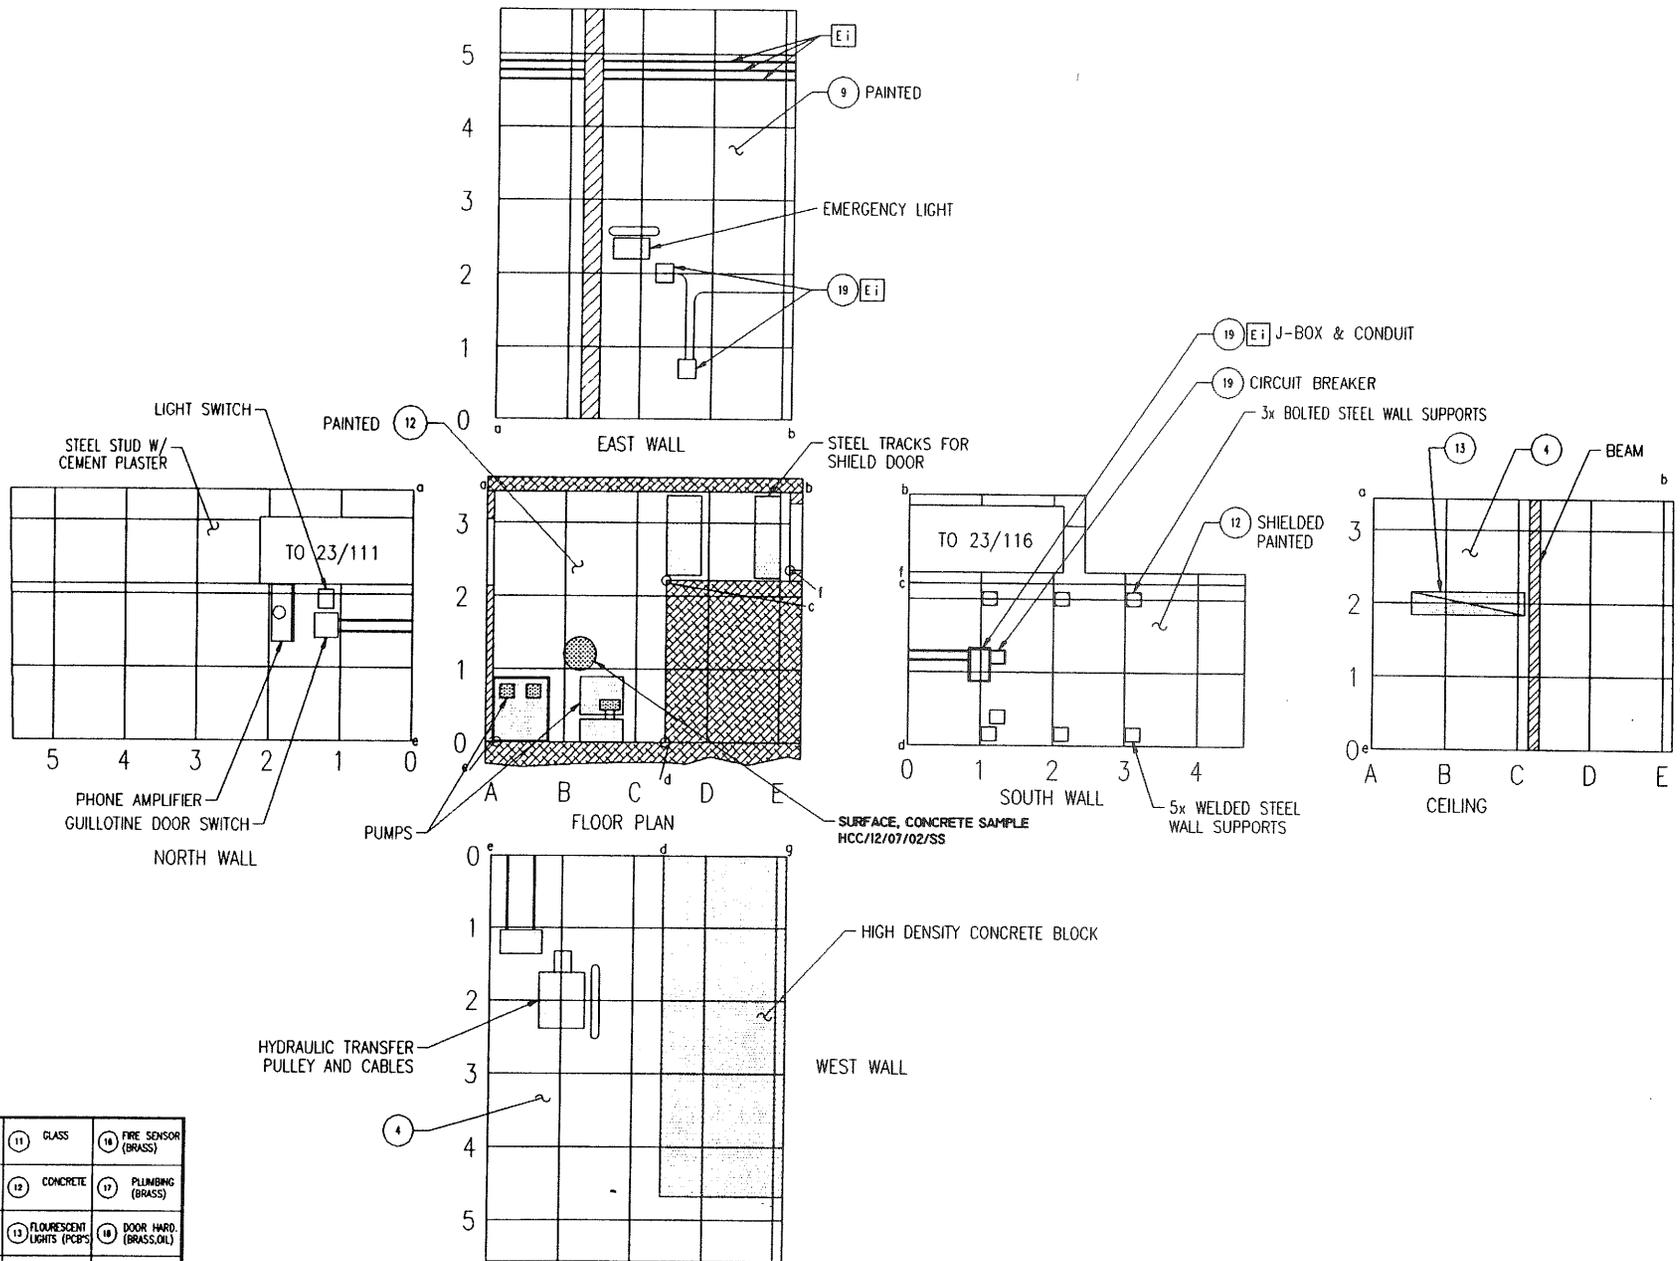
Fig. 4-17—Room 114, Hydraulic Pump Room

Refer to Table 4-4 for a complete listing of samples taken for this room. Sample results for this room included TCLP for Lead Paint for the floor. Results were less than 0.04 mg/l which is less than the regulatory limit of 5.0 mg/l. Trace amounts of PCB 1254 were found at 1140 µg/kg. Semi-Volatiles were non-detectable, however there were several Tentatively Identified Compounds (TICs) found in mg/kg quantities. These results indicate that the floor surface is contaminated with hydrocarbons which will need to be evaluated with regard to Land Disposal Restrictions when this material is removed. The wall paint in this room is the same as in 116A which had a TCLP value for lead of 0.06 mg/l.

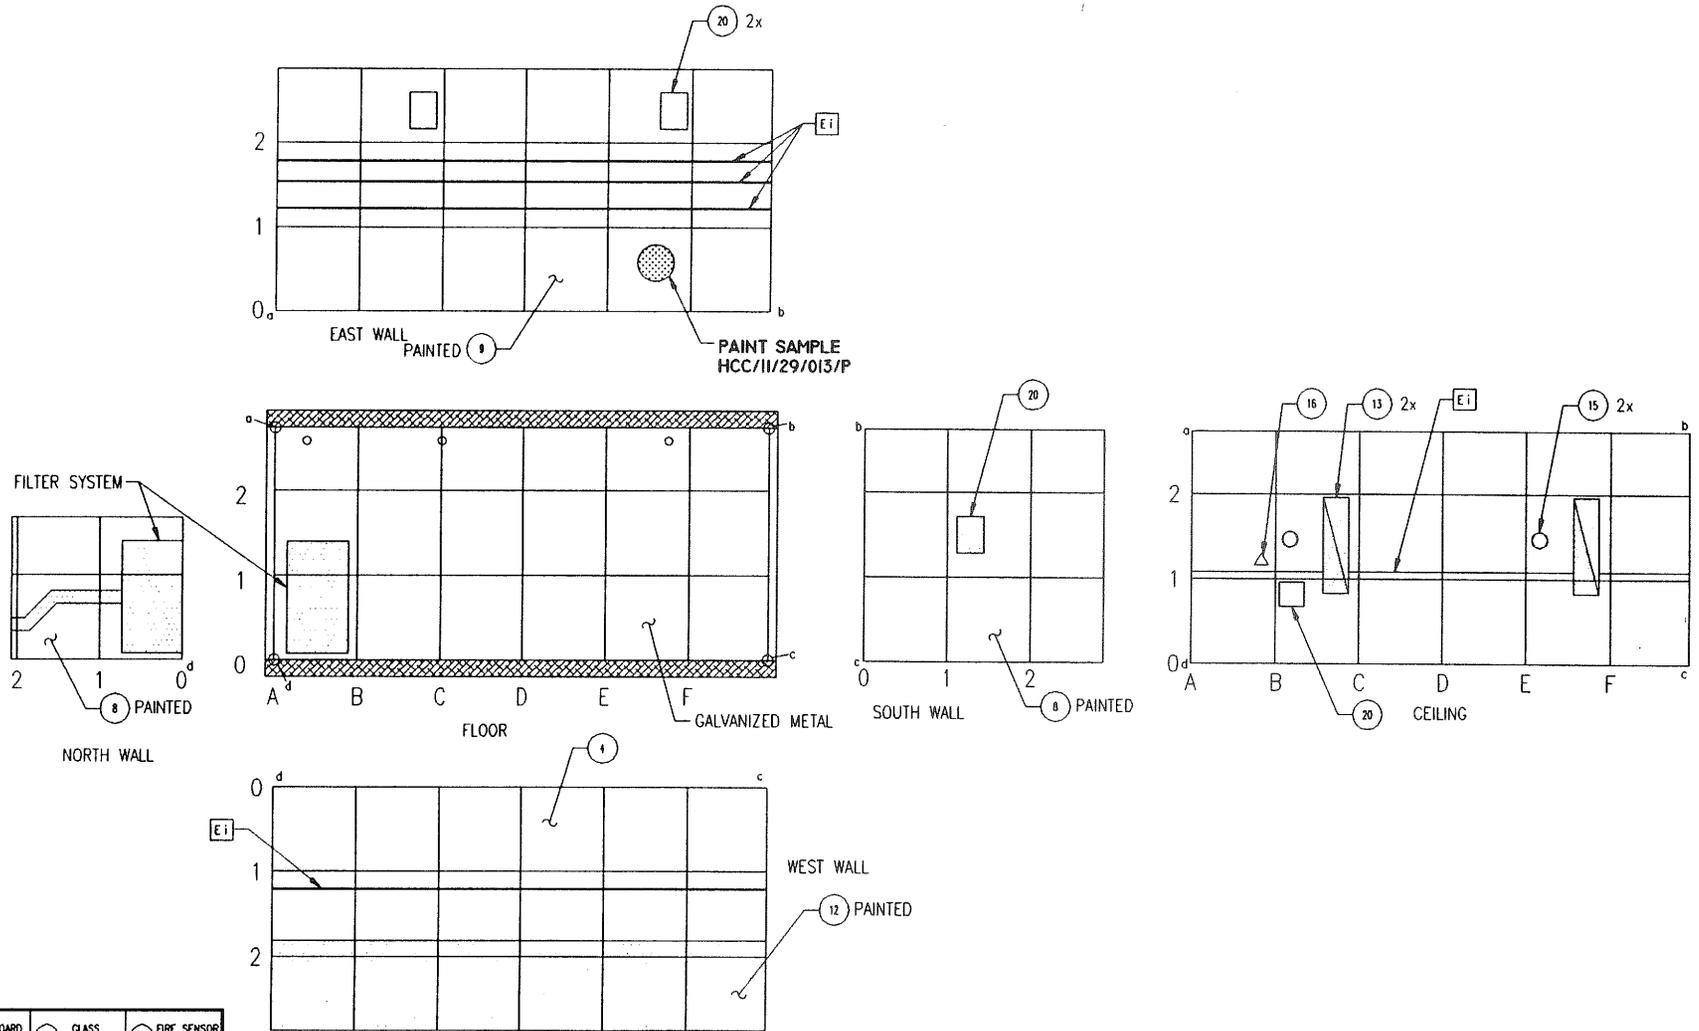
Fig. 4-19—Room 116A, Plutonium Lab/X-Ray Room Mezzanine

A sample of paint and wall scraping was taken from the west wall. The results indicate TCLP lead levels of 0.06 mg/l which is below the 5.0 mg/l regulatory limit.

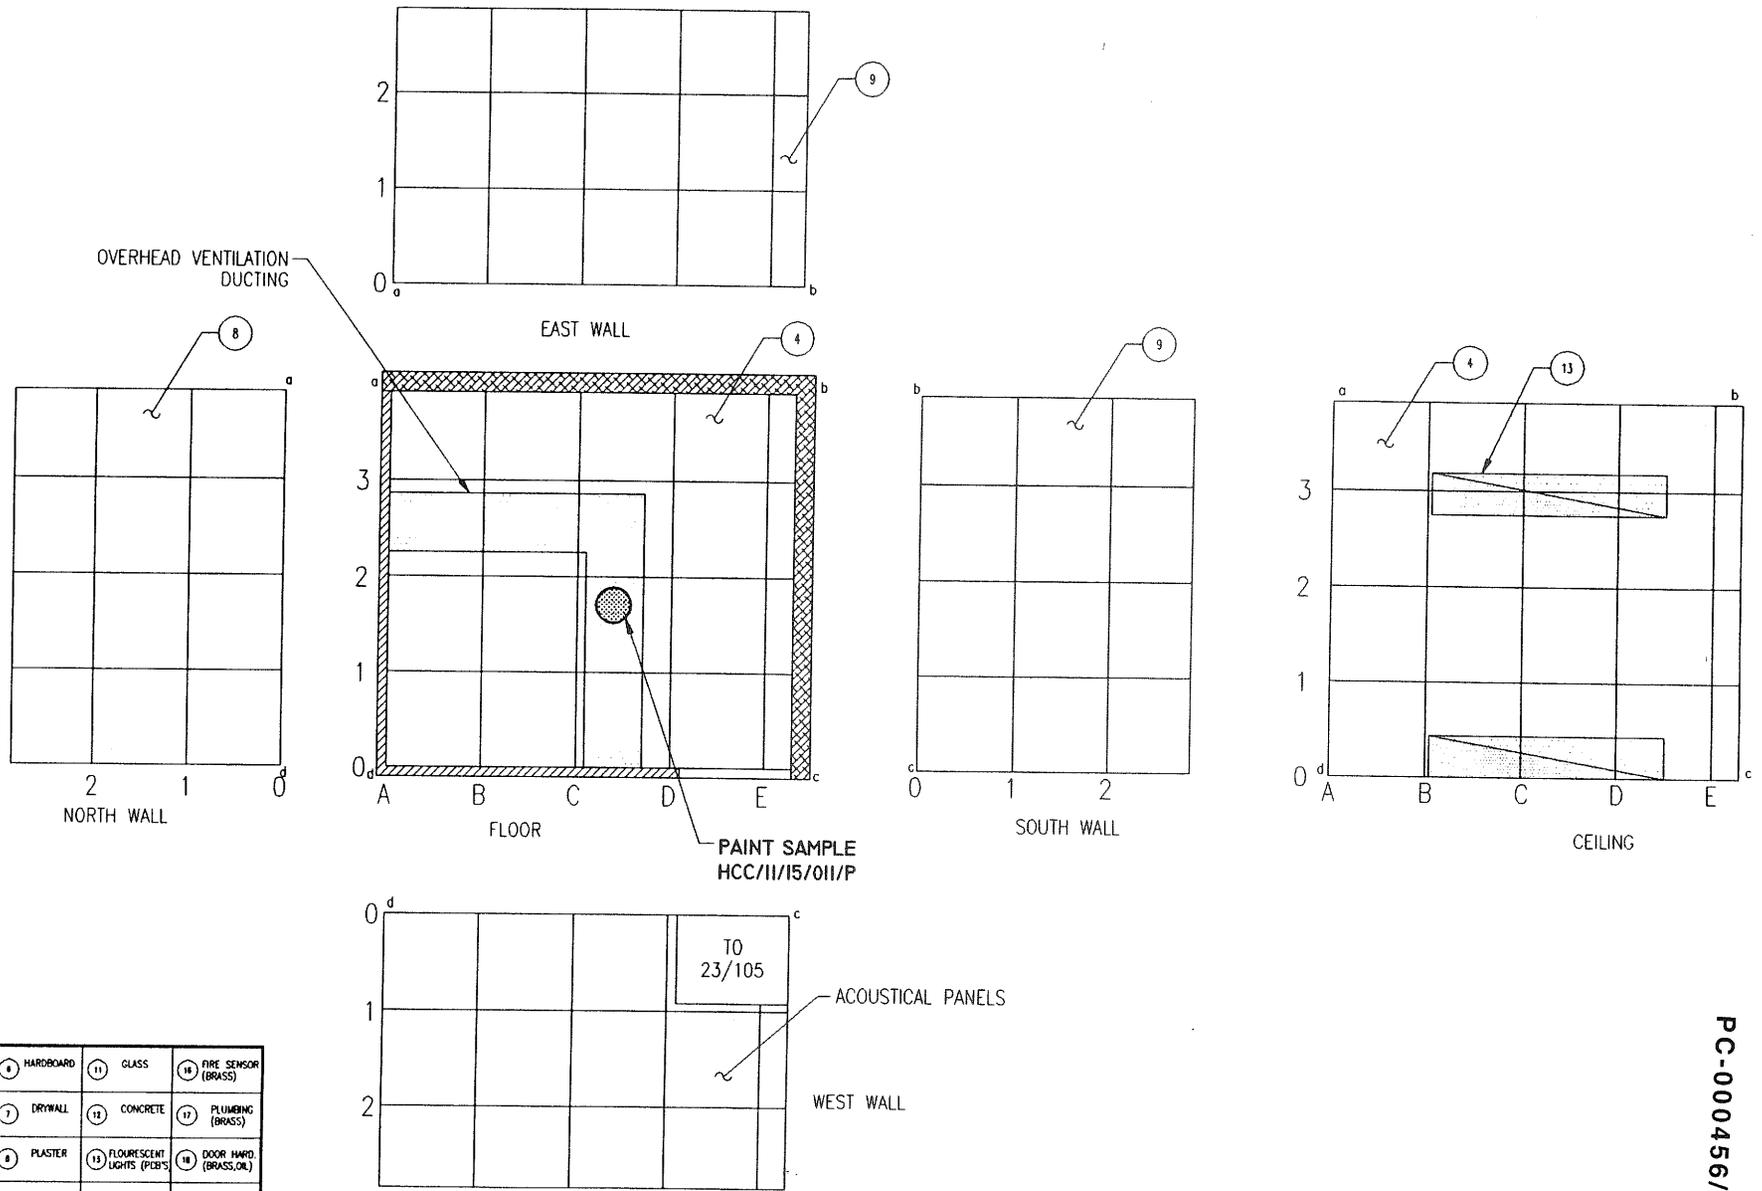
Fig. 4-22—Room 117A, Tool Room Mezzanine

This area was classified as a "hazardous exception area" (refer to Table 4-5), therefore no samples were taken in this room. Paint on the floor is the same as in the corridor which resulted in TCLP lead detection levels of .13 mg/l, below the 5.0 mg/l regulated limit. The wall paint is the same as that used in 116A which has a TCLP lead limit of 0.06 mg/l which is below the regulatory limit of 5.0 mg/l.

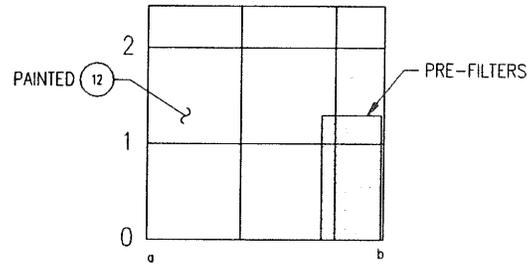
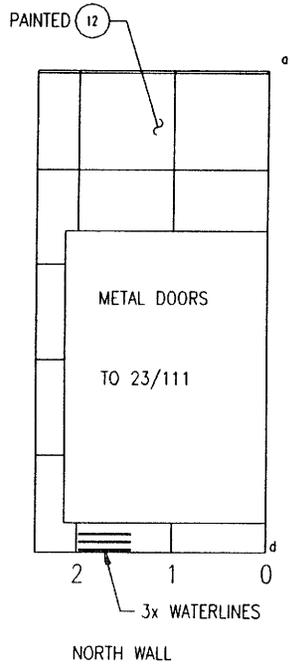
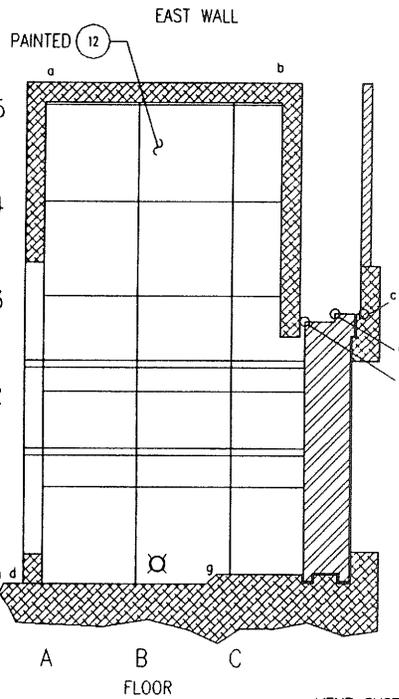
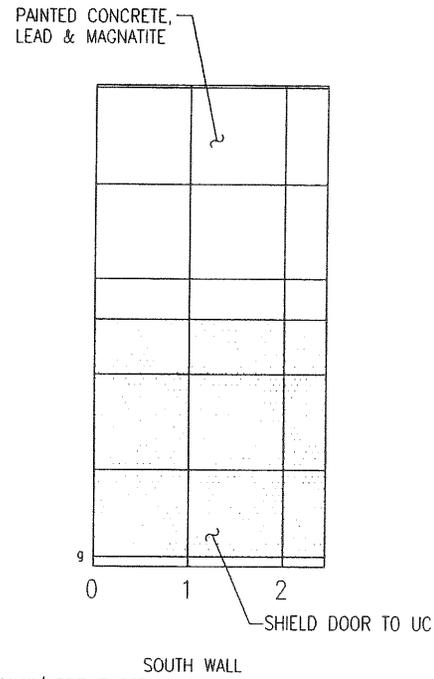
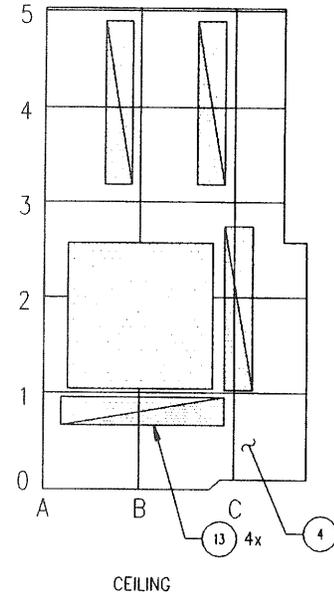
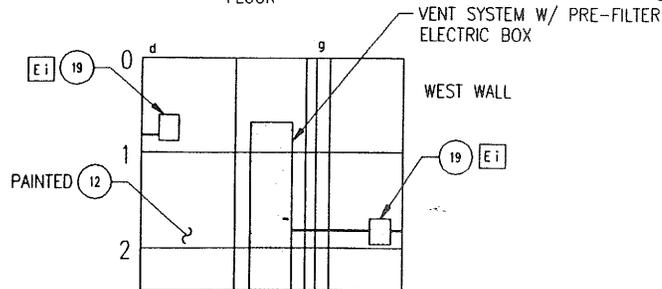
Fig. 4-23—Room 118, Decon Room

This area was classified as an "unaffected" hazardous area, therefore no samples were taken. The floor in this room is painted with the same paint used in the corridor which has a TCLP for lead of .13 mg/l which is below the 5.0 mg/l. The wall paint in this room is the same as that used in room 116A which has a TCLP for lead of 0.06 mg/l.

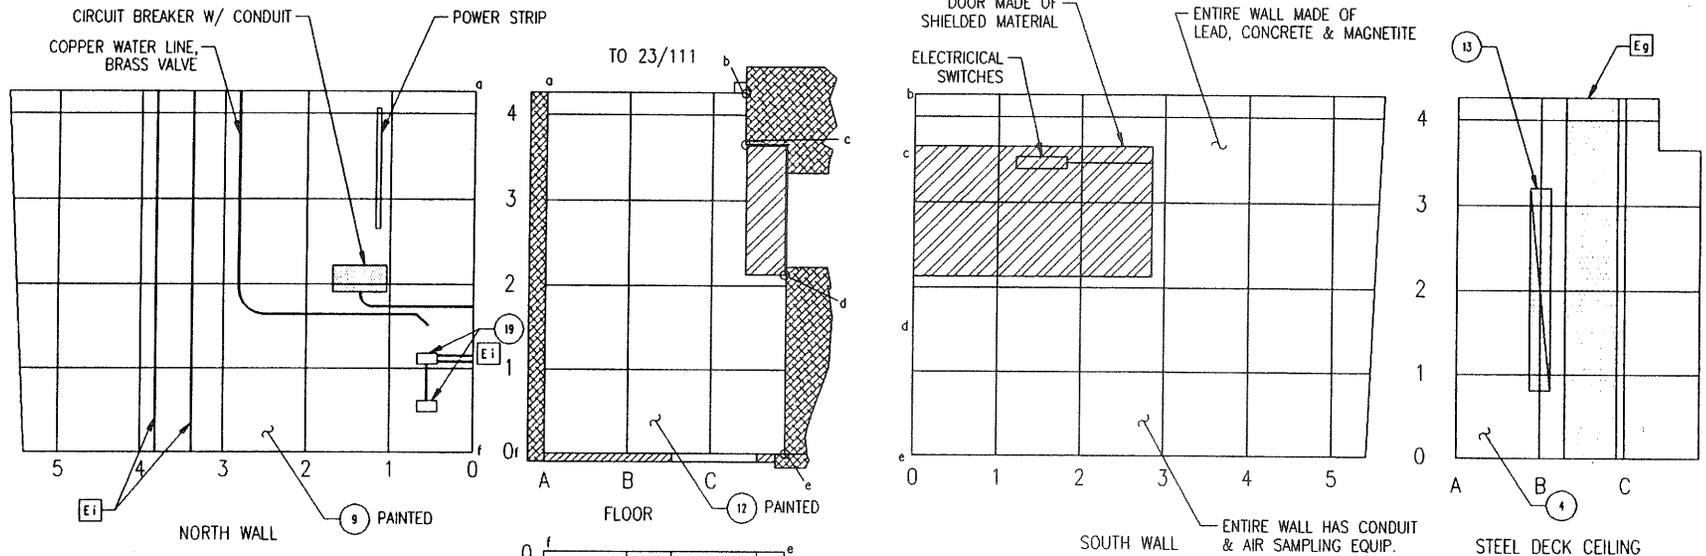
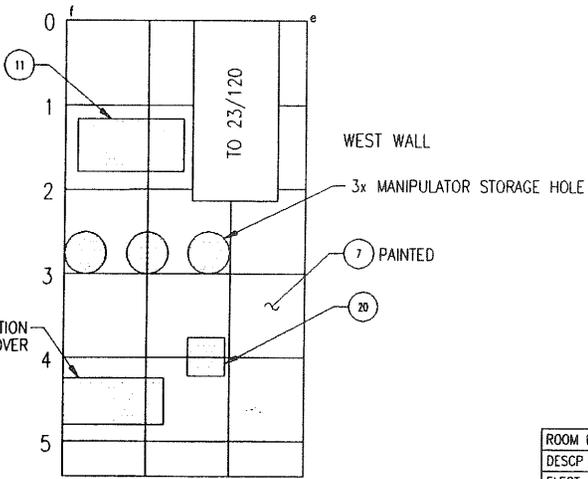
Fig. 4-24—Room 119, ESTES Effluent System

This area was classified as an "unaffected" hazardous area, therefore no samples were taken. The floor in this room is painted with the same paint used in the corridor which has a TCLP for lead of .13 mg/l which is below the 5.0 mg/l. The wall paint in this room is the same as that used in room 116A which has a TCLP for lead of 0.06 mg/l.

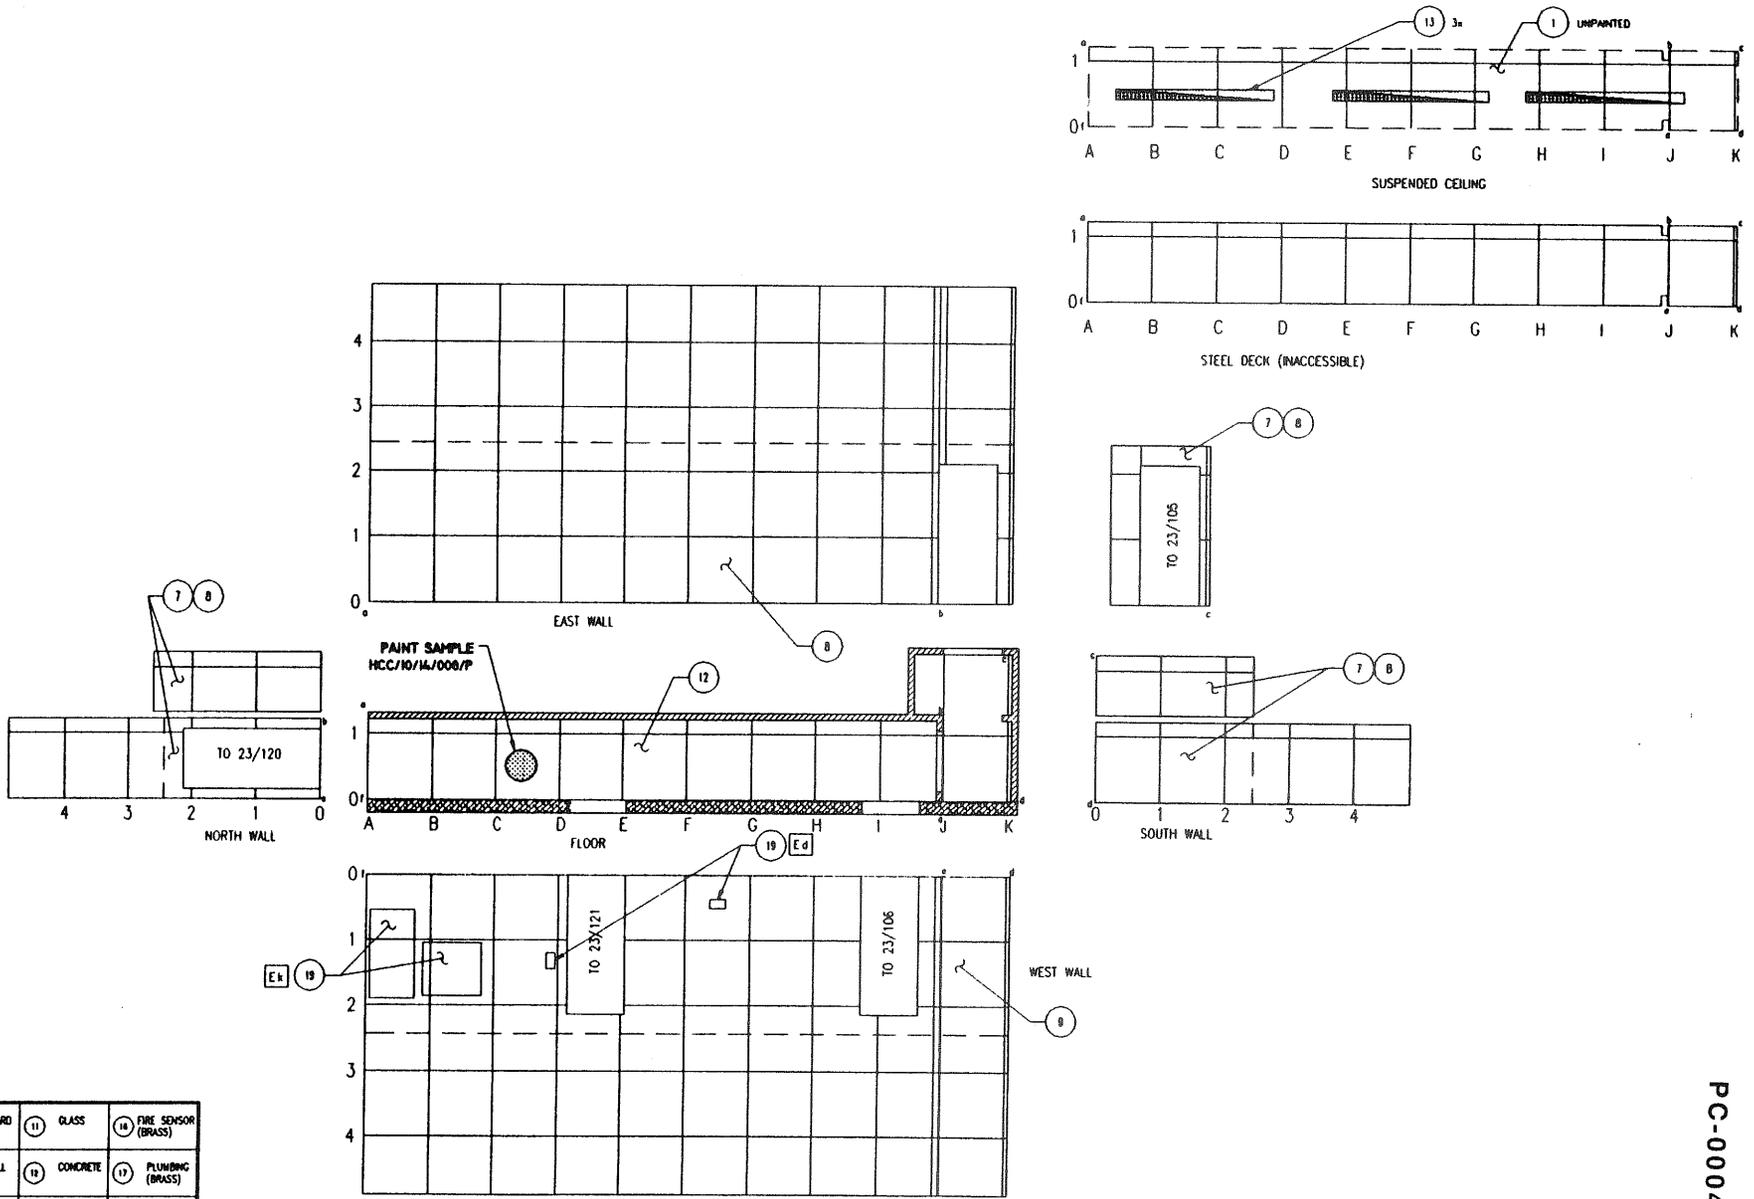
Fig. 4-26—Corridor/Ladies Change Room

The ceiling of this room has four light ballasts that are PCB-suspect. The transformers were in service and could not be sampled, however manufacturer's information regarding the construction of the HCF indicates that they are dry type transformers and are not PCB-suspect.

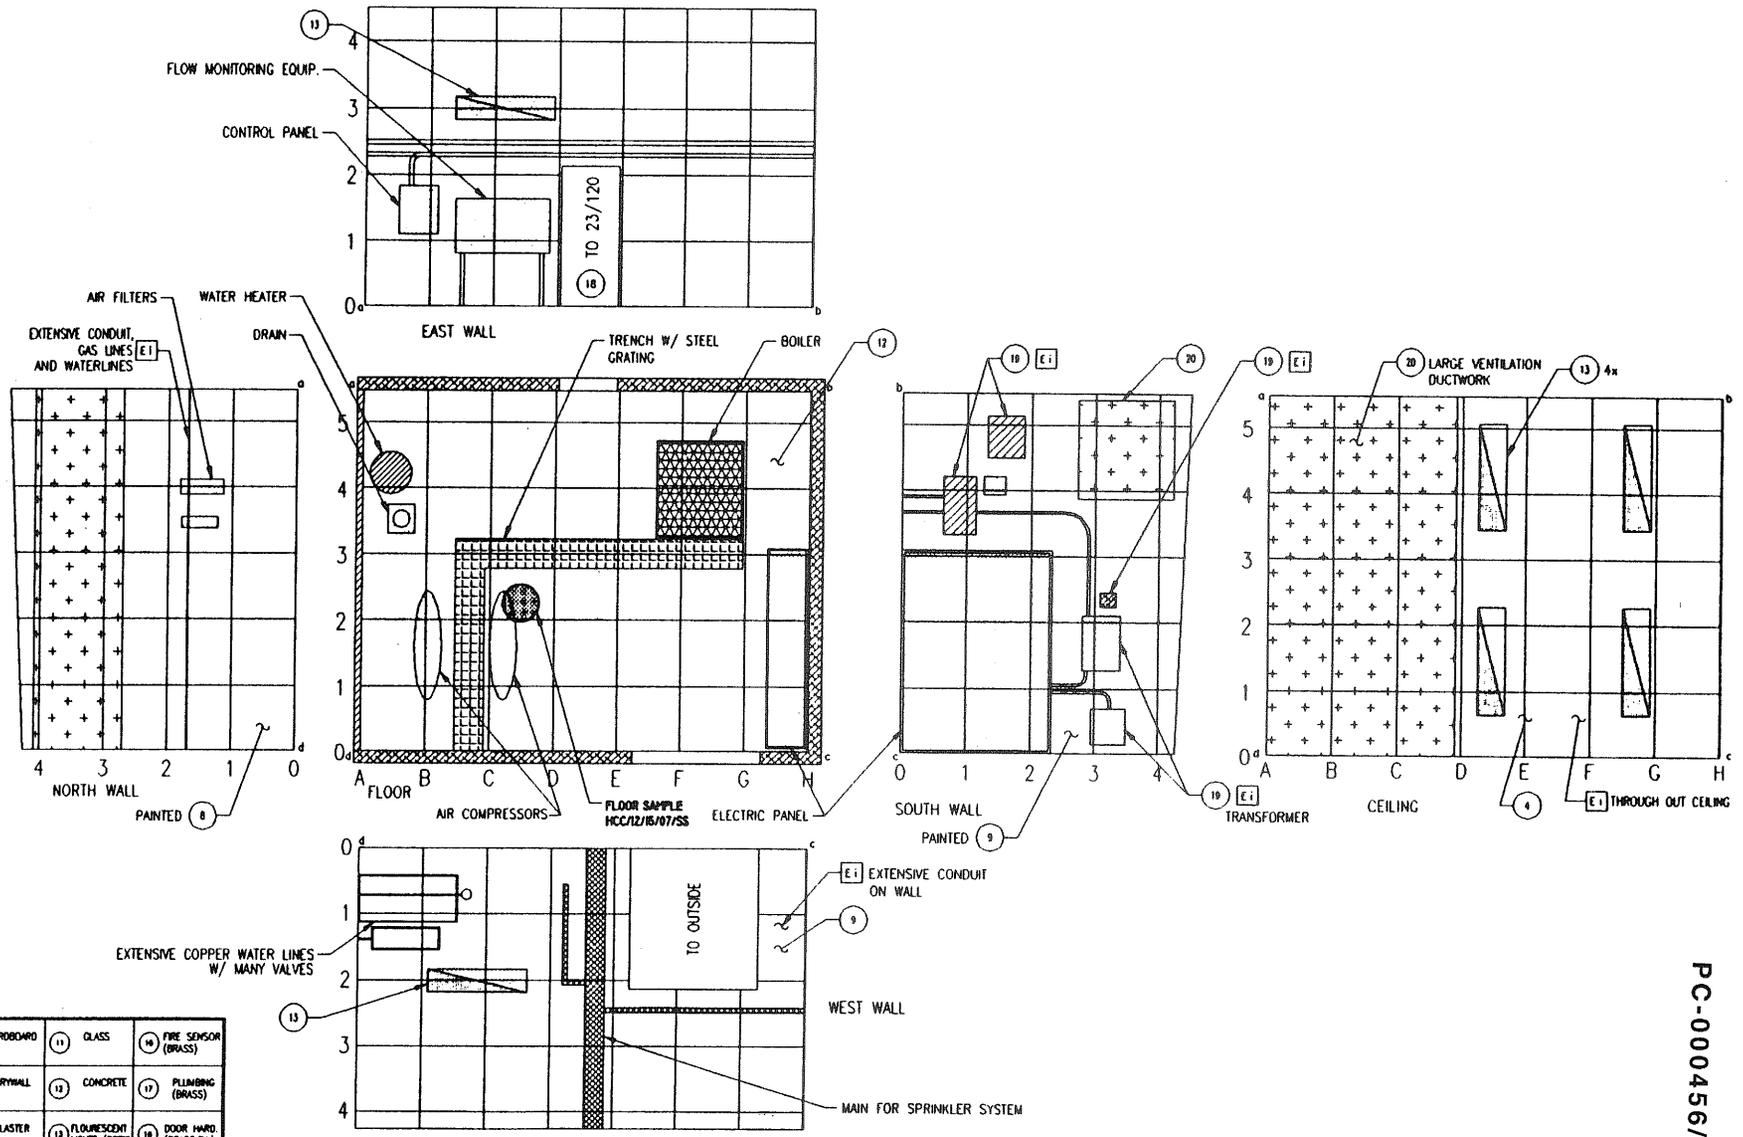
Fig. 4-27—Room 121, Boiler/Utility Room

Table 4-4 contains a complete listing of the sample results associated with this room. A sample of the floor surface concrete was taken and analyzed for various hazardous constituents. TCLP values for metals were below regulated limits, and PCBs were non-detectable. Semi-volatiles were detected in  $\mu\text{g}/\text{kg}$  levels, however the Tentatively Identified Compounds (TICs) were identified in  $\text{mg}/\text{kg}$  quantities, the highest was an unknown alcohol which was detected at a level of 128.8  $\text{mg}/\text{kg}$  and 4-hydroxy-4-methyl-2-pentanone at 9872  $\text{mg}/\text{kg}$ . Various levels of hydrocarbons and alkanes were detected and these results are also listed in Table 4-4. The levels are high enough to require re-sampling of materials removed from the floor to determine if they will exceed LDR limitations for disposal as hazardous debris.
