PC-000456/0

# GENERAL ATOMICS HOT CELL CHARACTERIZATION REPORT

**GA HOT CELL D&D PROJECT**  
**CONTRACT NO. DE-AC03-95SF20798**  
**PROJECT NO. 7340**

**DECEMBER 1995**

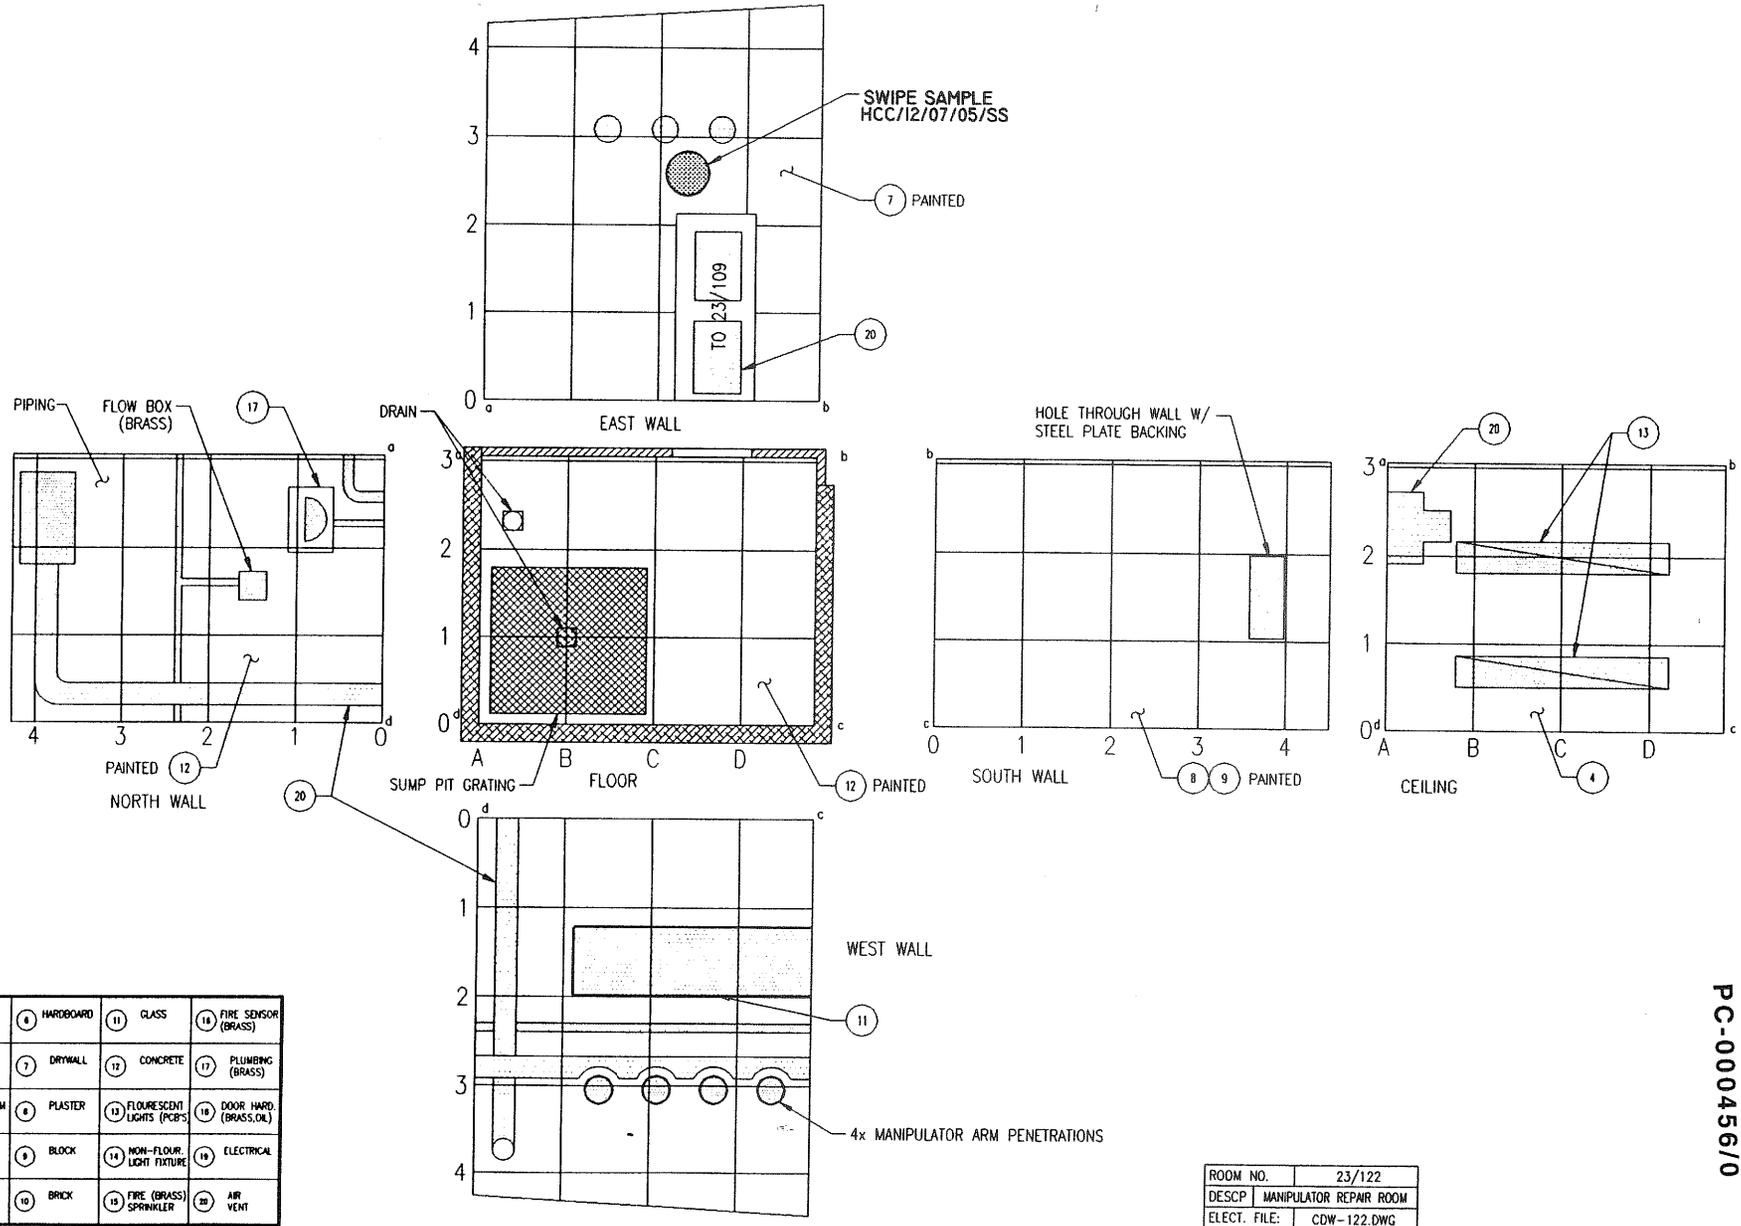
Fig. 4-28—Room 122, Manipulator Repair Room

Table 4-4 lists the results for swipe samples taken in this room. cadmium, chromium, lead and zinc were all detected at  $\text{mg}/\text{kg}$  levels. The swipe suggests that this contamination is removable. PCBs were also detected including 1254 at 1040  $\mu\text{g}/\text{kg}$  and 1260 at 750  $\mu\text{g}/\text{kg}$ . The swipe results suggest that this is also removable contamination. Samples of the paint on the walls were not taken for this room as this is the same paint sampled in Room 107 which has a TCLP lead value of  $<0.04$   $\text{mg}/\text{l}$ . Debris removed from the walls during D&D will need to be evaluated with regard to LDR for hazardous debris. The floor paint is the same as that sampled in the corridor which has a TCLP value of .13  $\text{mg}/\text{l}$  which is below the 5.0  $\text{mg}/\text{l}$  regulatory limit.

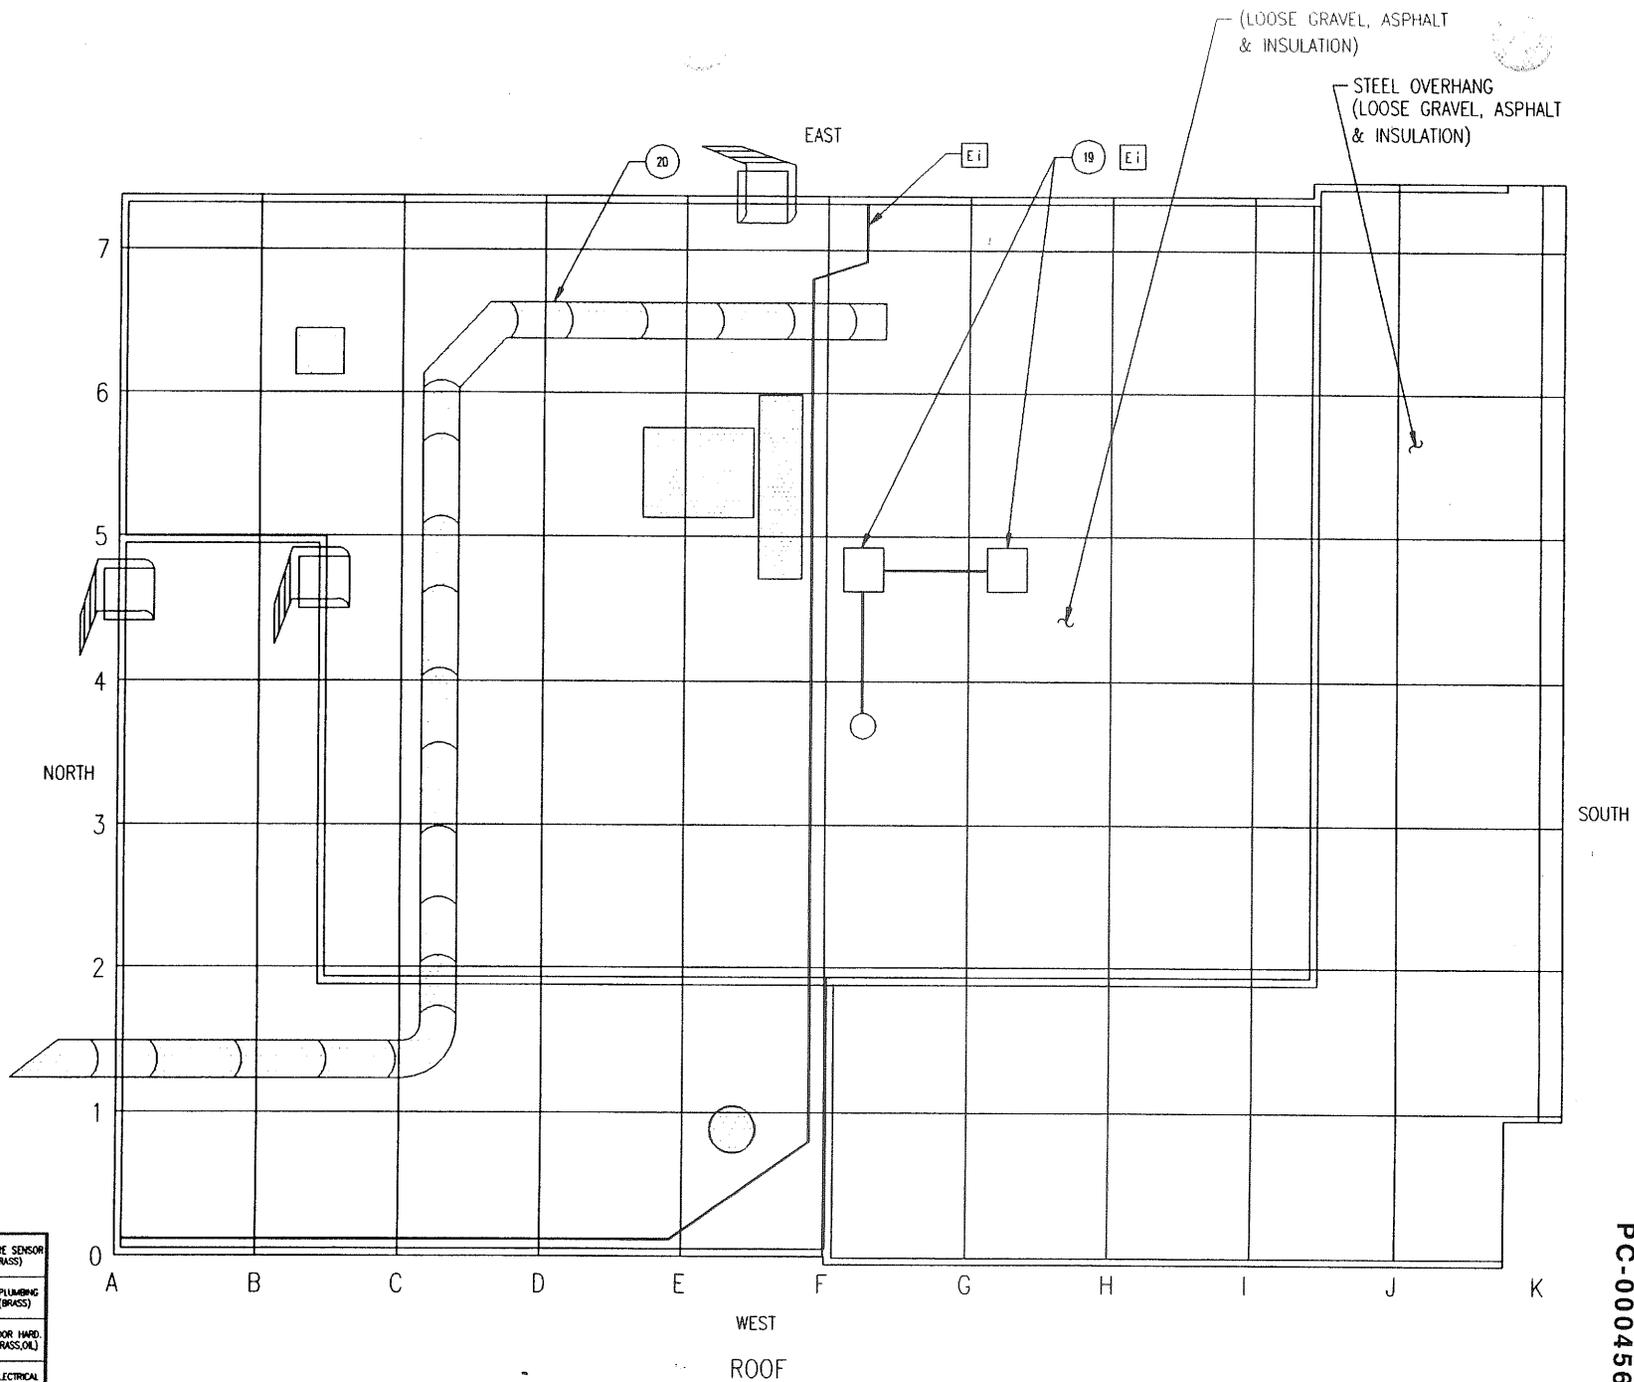
Fig. 4-30—Roof

There were no hazardous samples taken from the roof except for those associated with the asbestos investigation which is described in detail in Section 5.0.

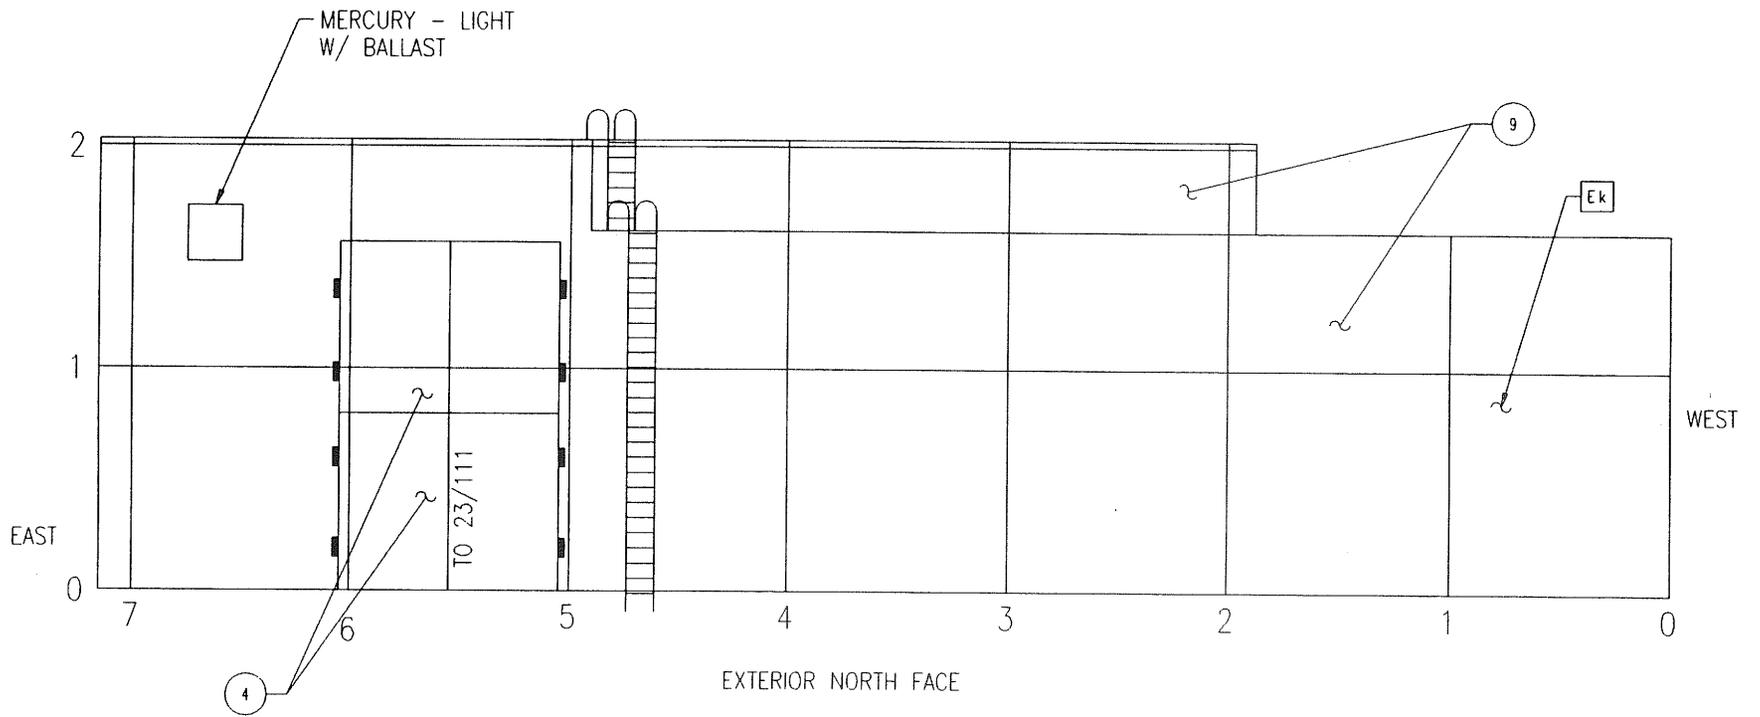
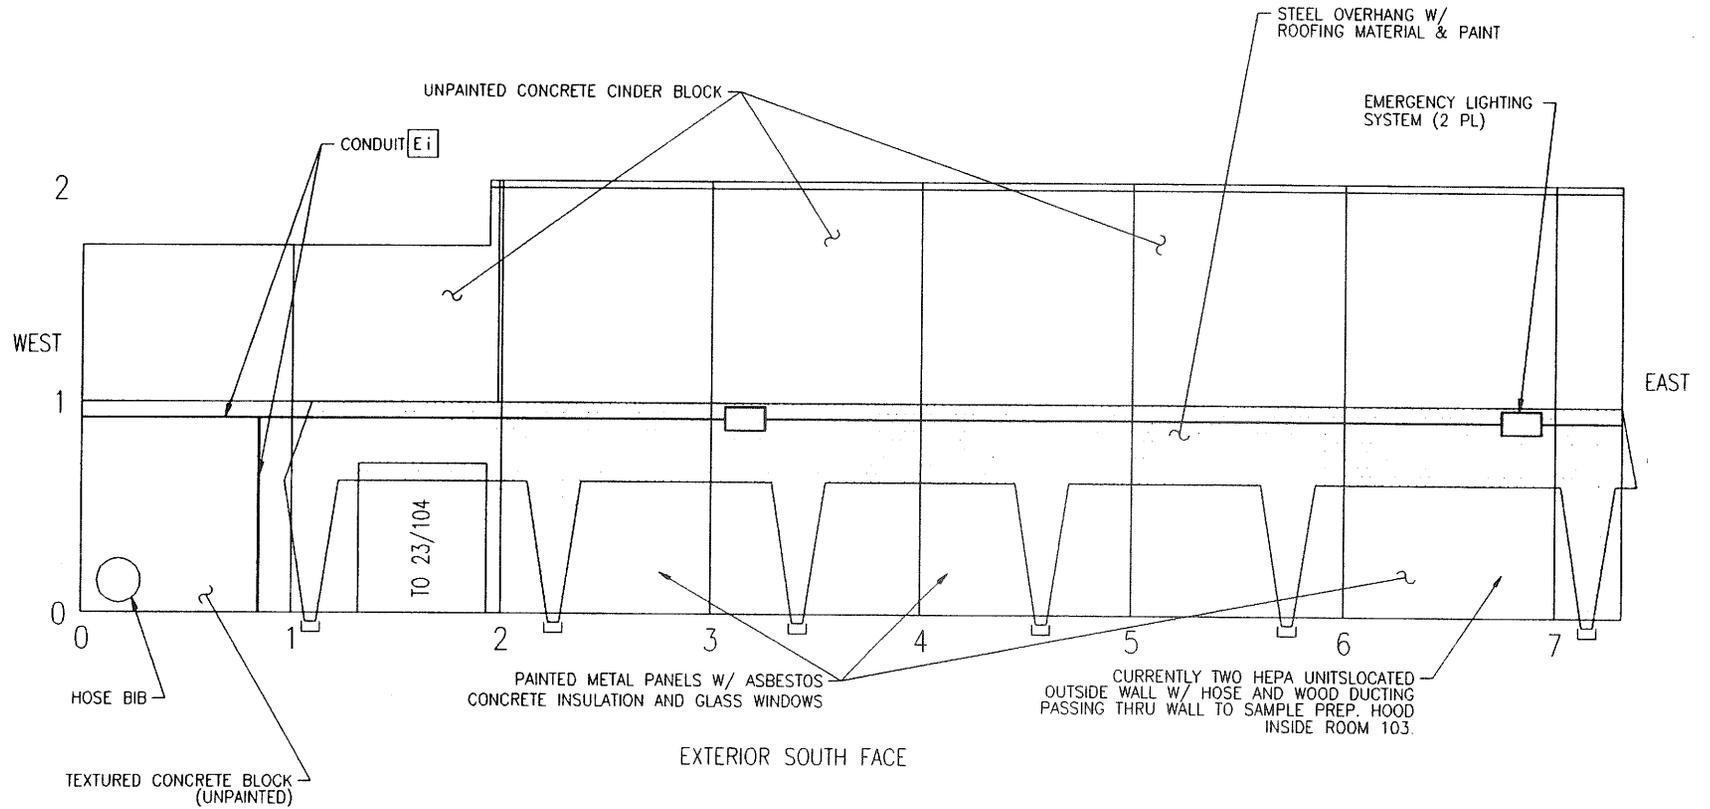
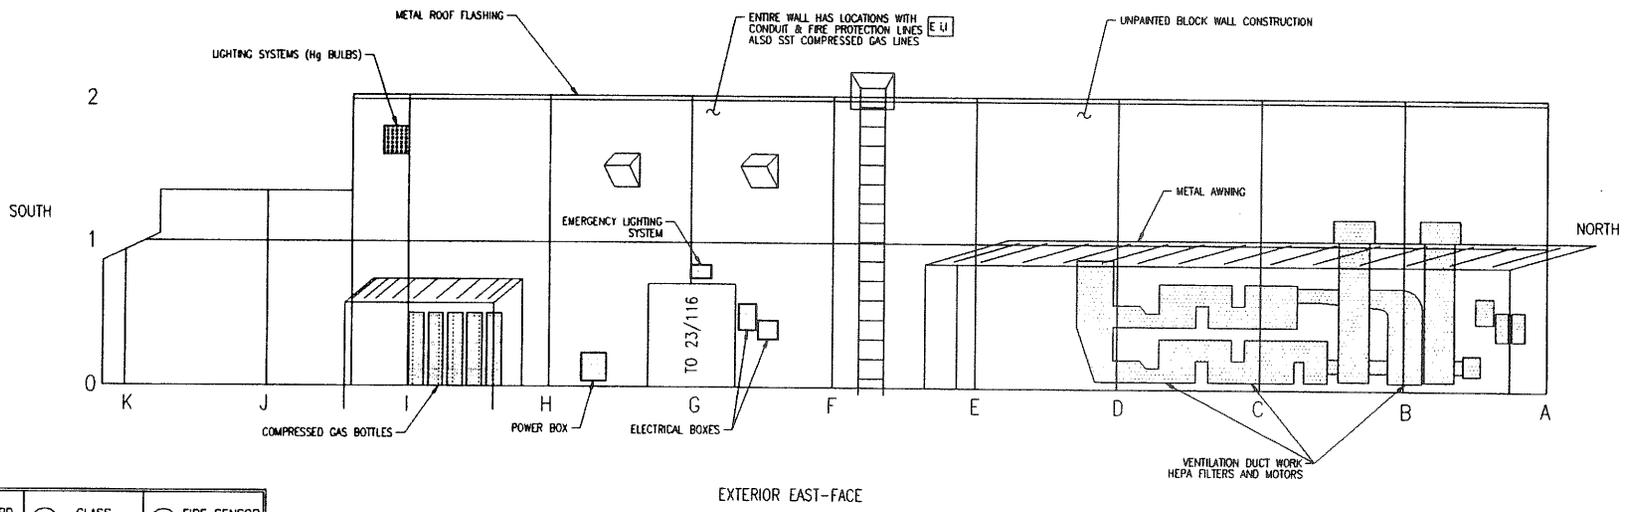
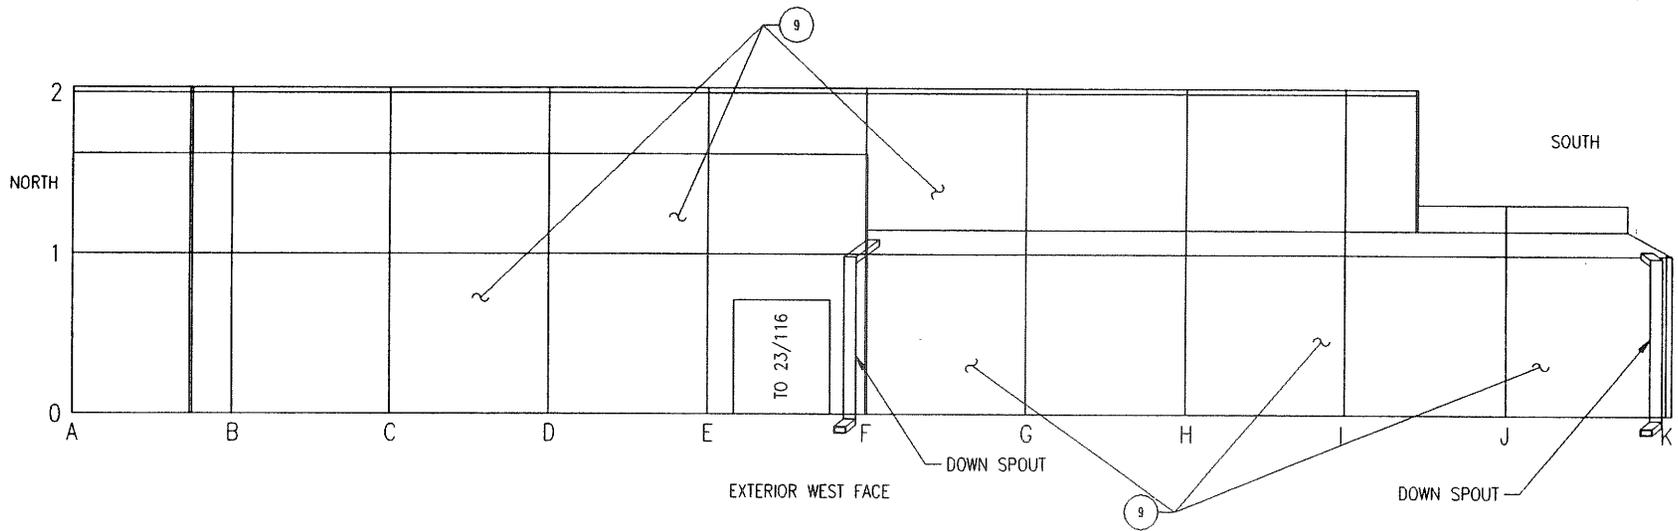
This area was classified as an "unaffected" hazardous area, therefore no hazardous samples other than those associated with asbestos were collected.

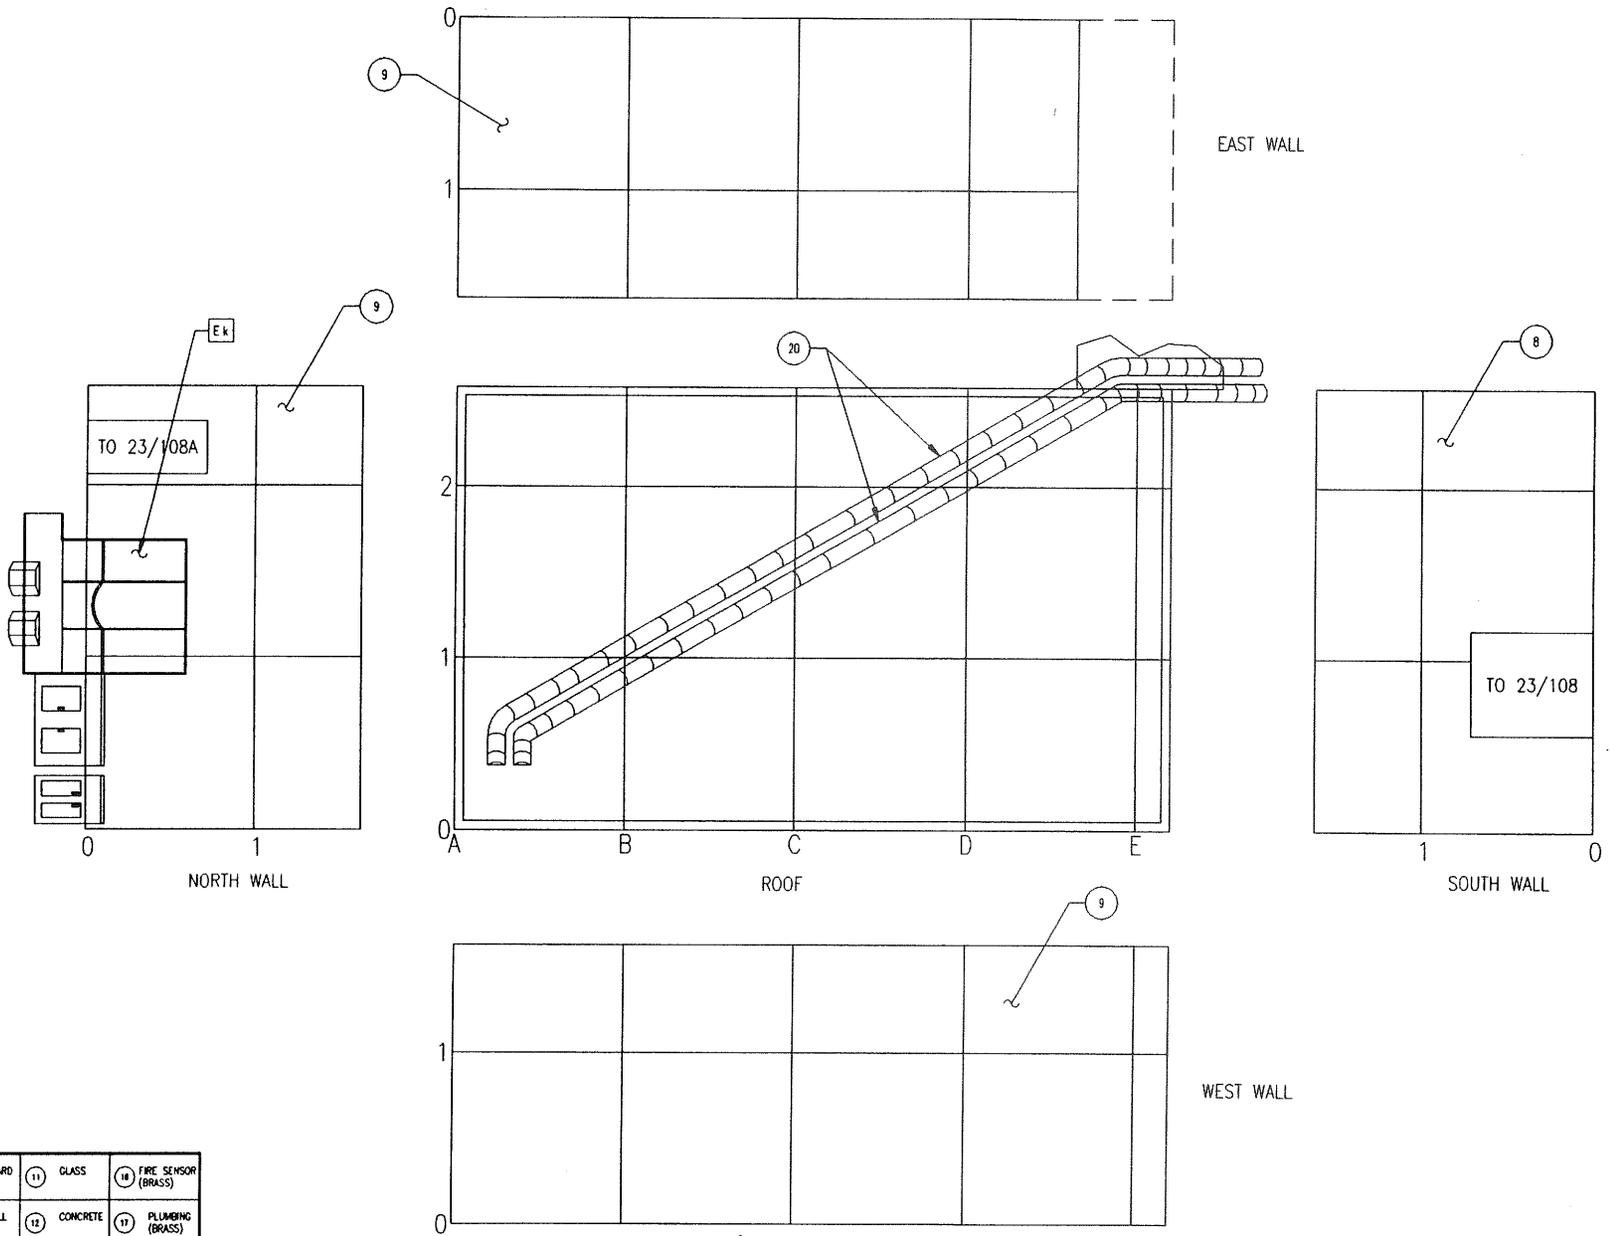
Fig. 4-35—Room 108 Roof and Exterior

This area was classified as an “unaffected” hazardous area, therefore no hazardous samples other than those associated with asbestos were collected.

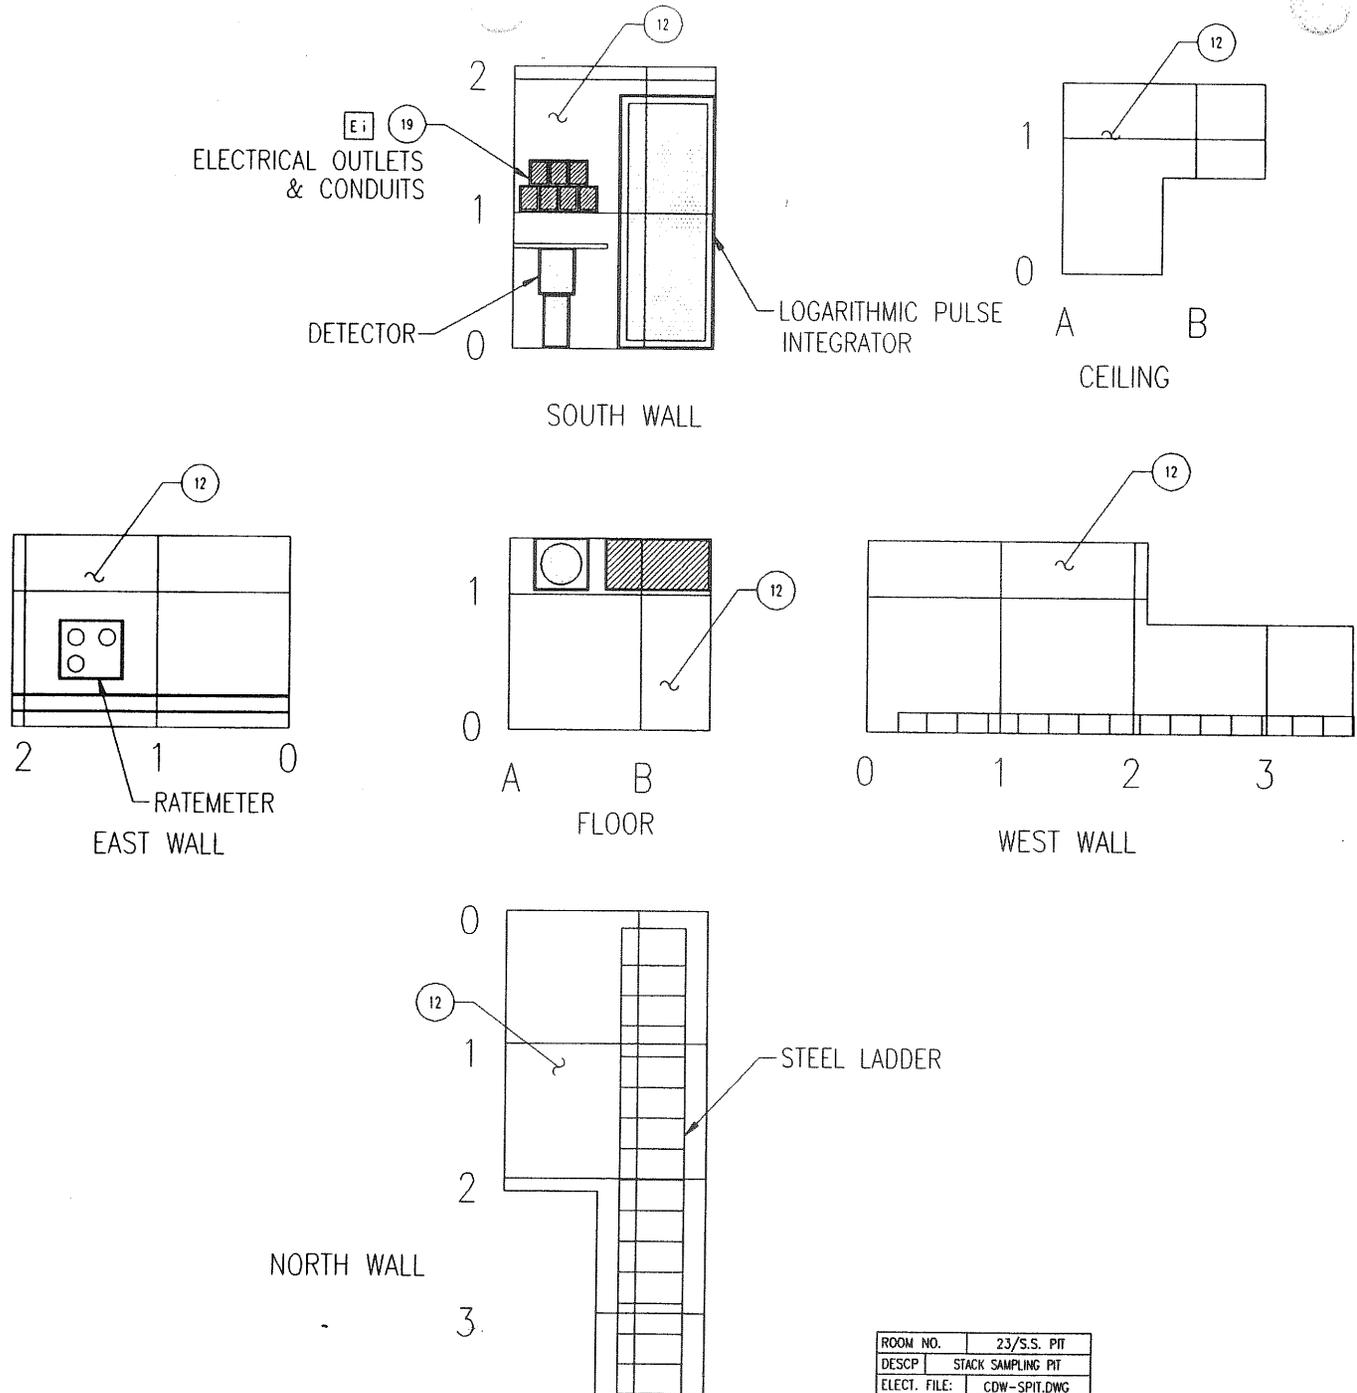
Fig. 4-36—Stack Sampling Pit

This area was classified as an “unaffected” hazardous area, therefore no hazardous samples other than those associated with asbestos were collected.

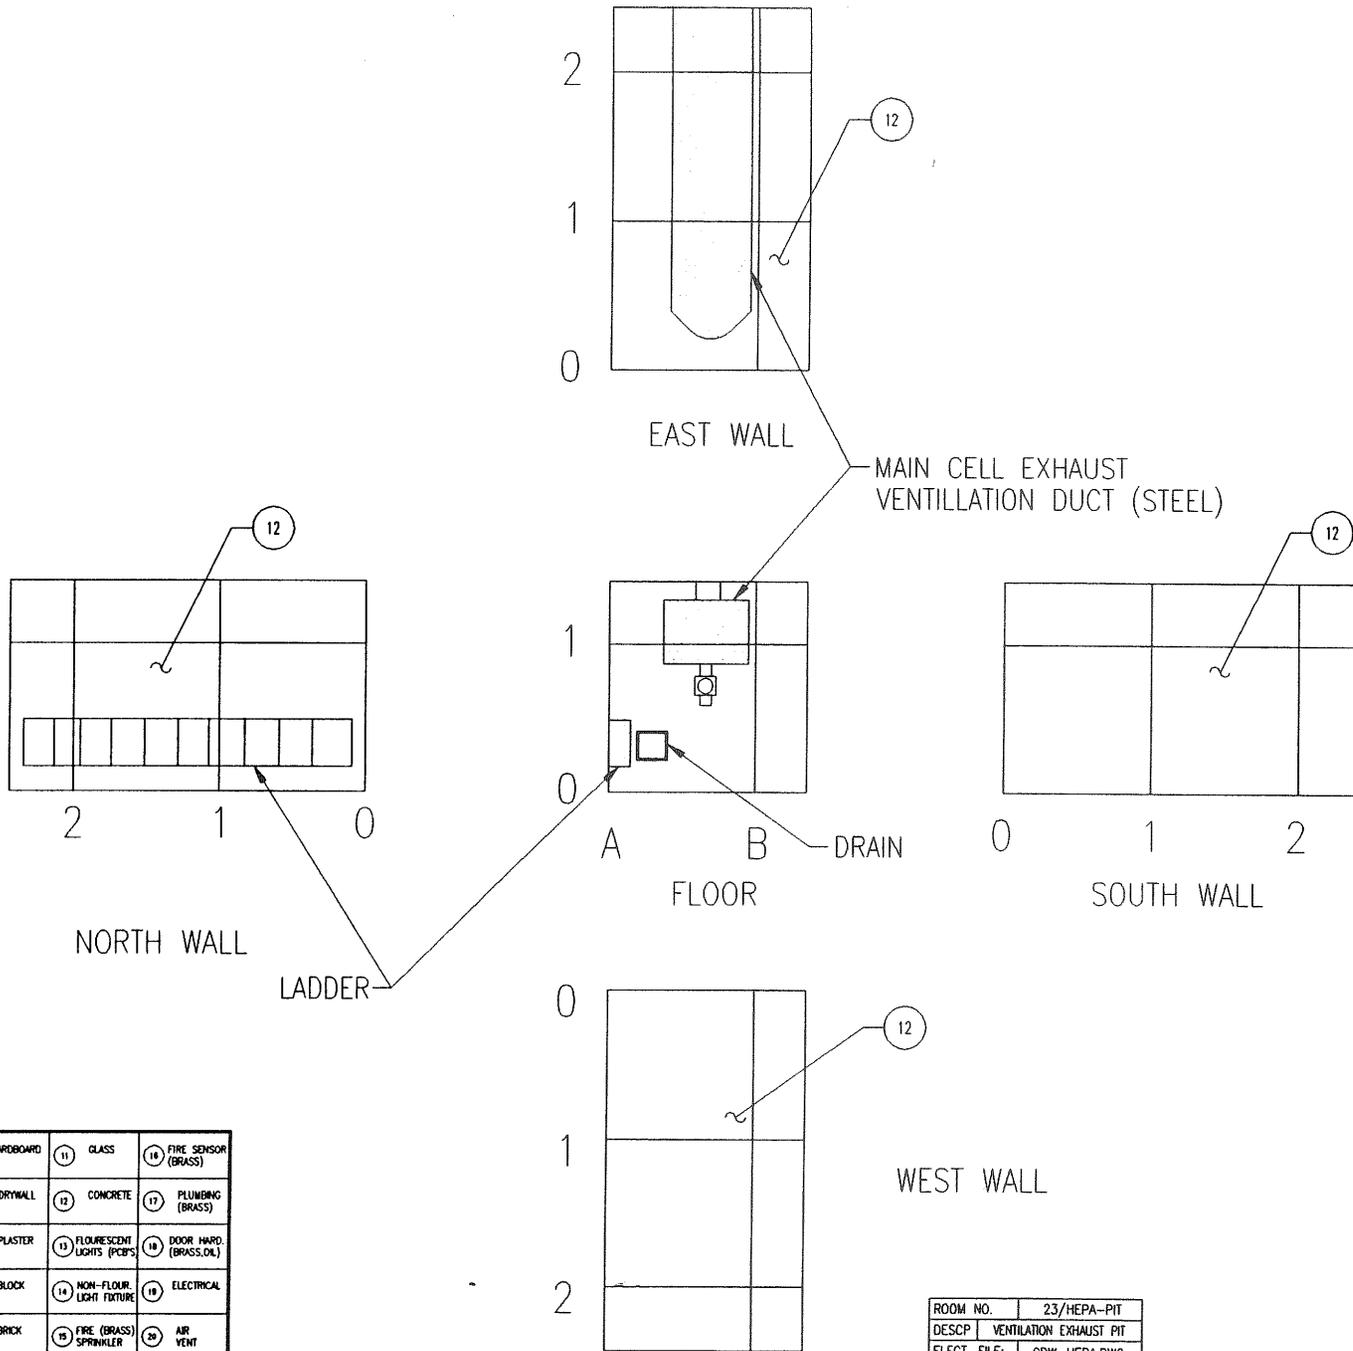
Fig. 4-37—Ventilation Exhaust Pit

This area was classified as an "unaffected," hazardous area, therefore no hazardous samples were collected.

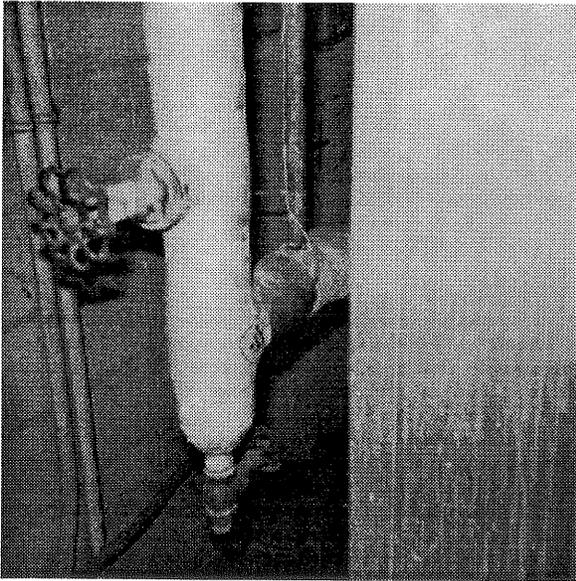
Asbestos Sample No. 1—Boiler Room

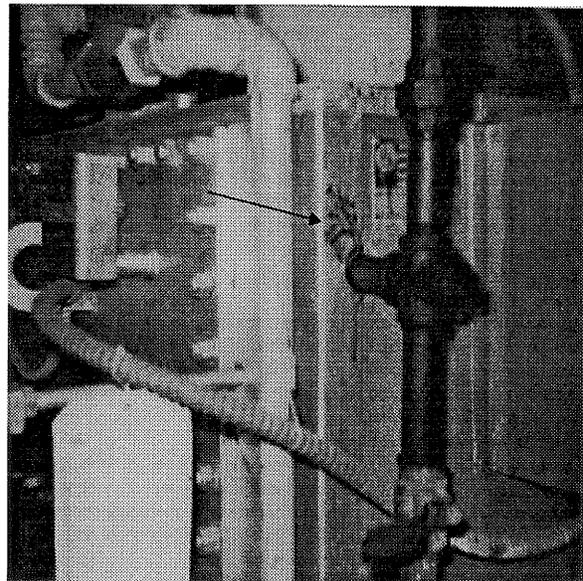
Asbestos Sample No. 2—Boiler Room

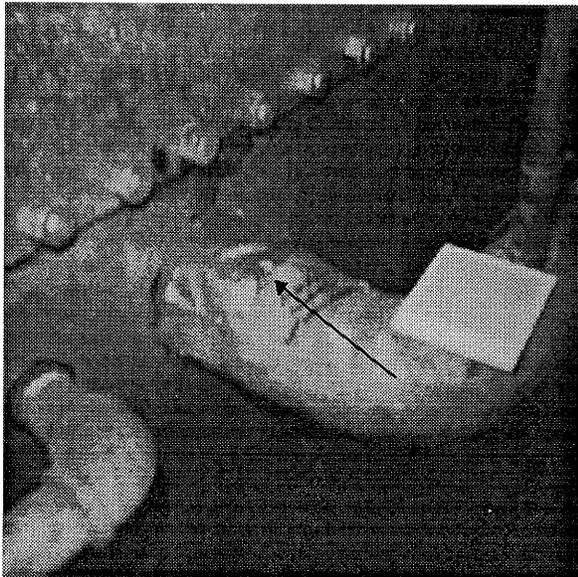
Asbestos Sample No. 3—Boiler Room (Under Duct Tape)

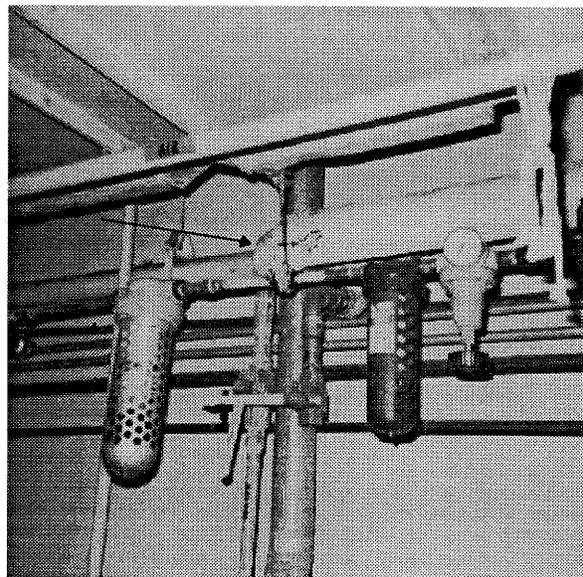
Asbestos Sample No. 4—Boiler Room

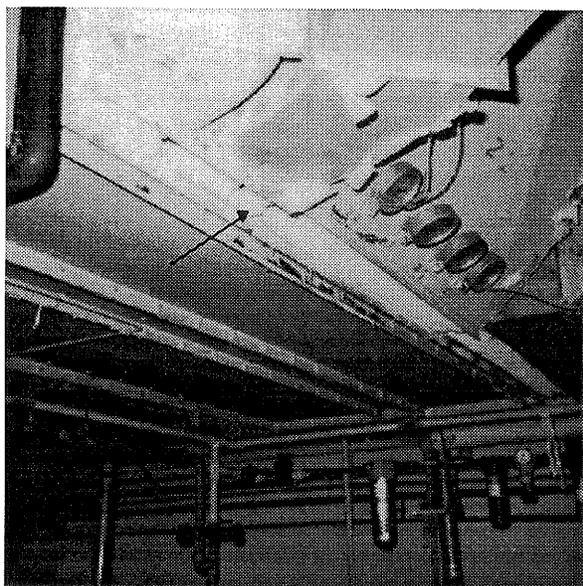
Asbestos Sample No. 5—Boiler Room

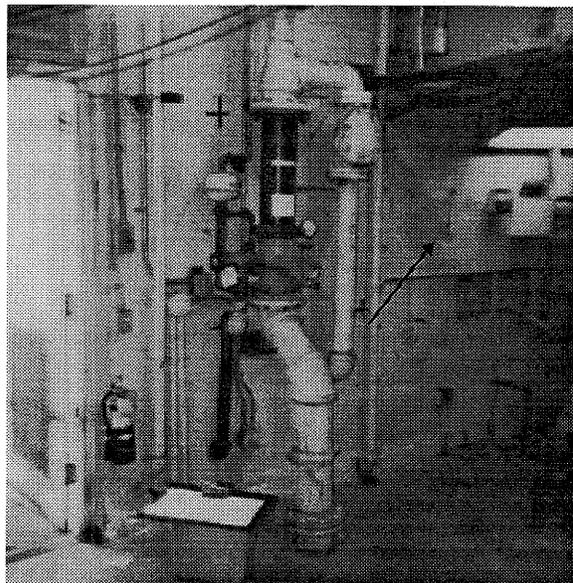
Asbestos Sample No. 6—Boiler Room (West Wall)

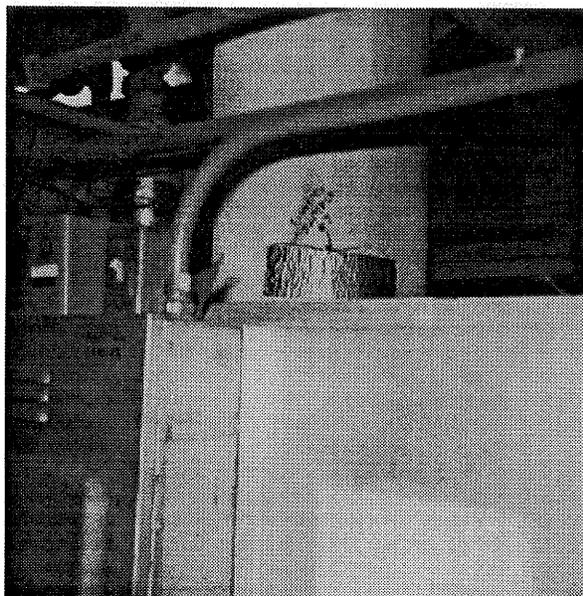
Asbestos Sample No. 7—Boiler Room

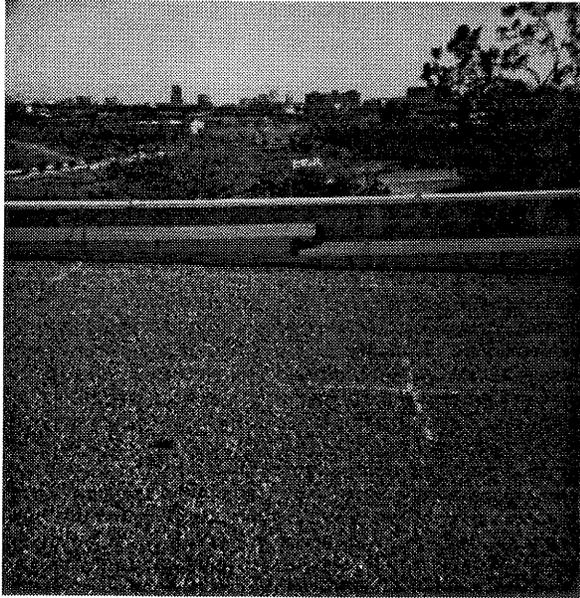
Asbestos Sample No. 9—Roof

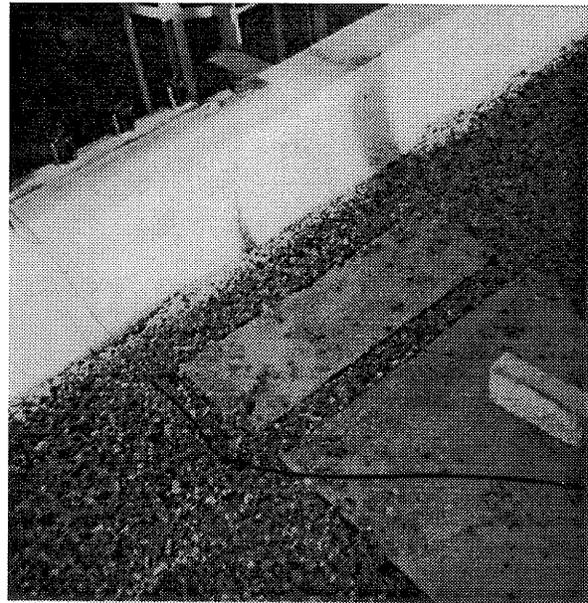
Asbestos Sample No. 10—Roof

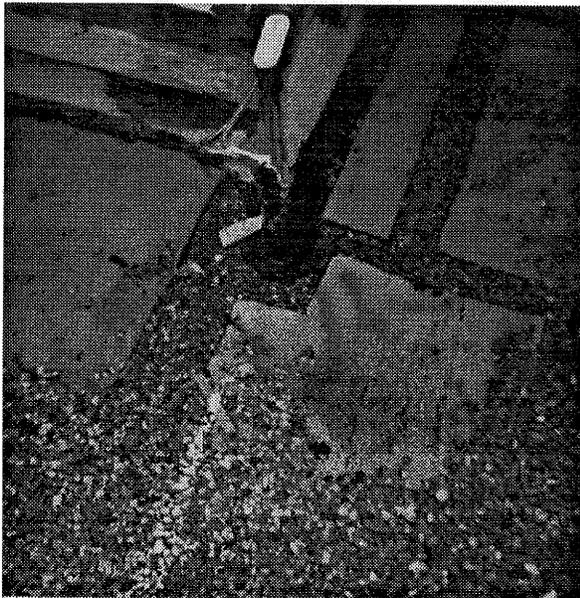
Asbestos Sample No. 11—Roof

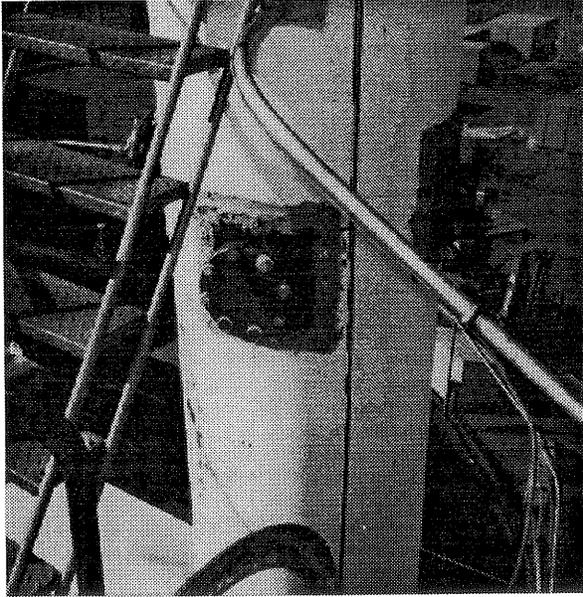
Asbestos Sample No. 13—Roof

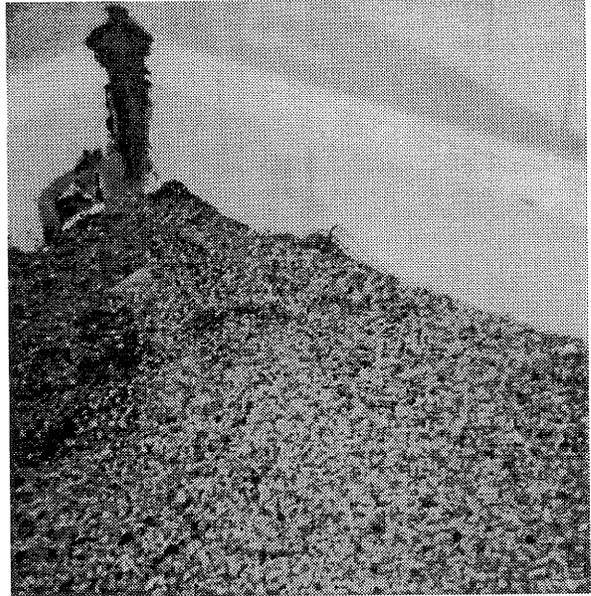
Asbestos Sample No. 14—Roof

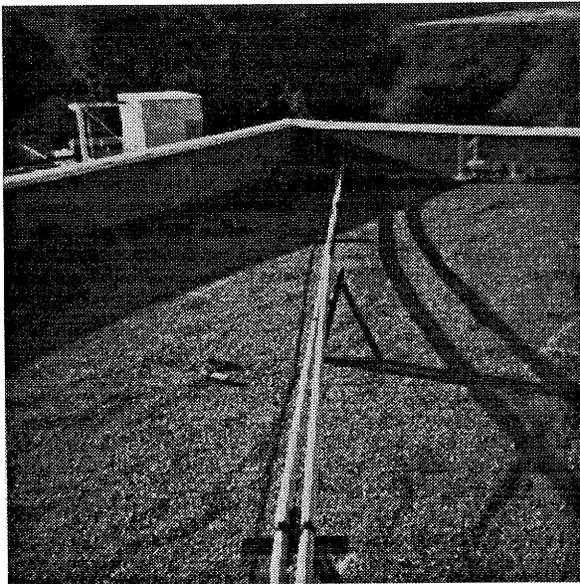
Asbestos Sample Nos. 15 & 16—Roof

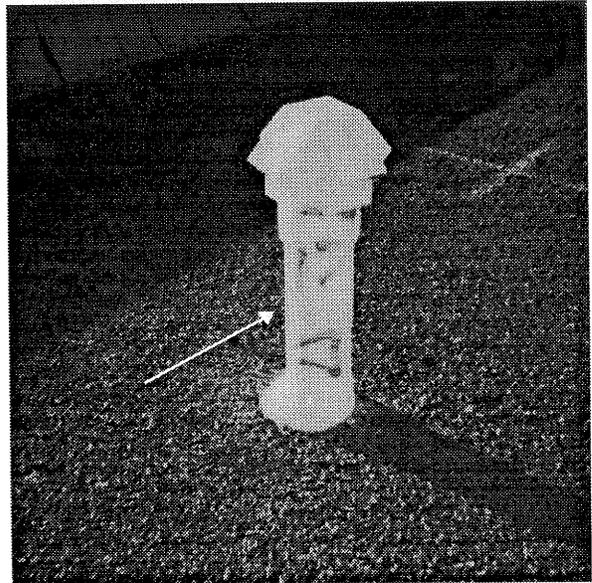
Asbestos Sample No. 17—Roof

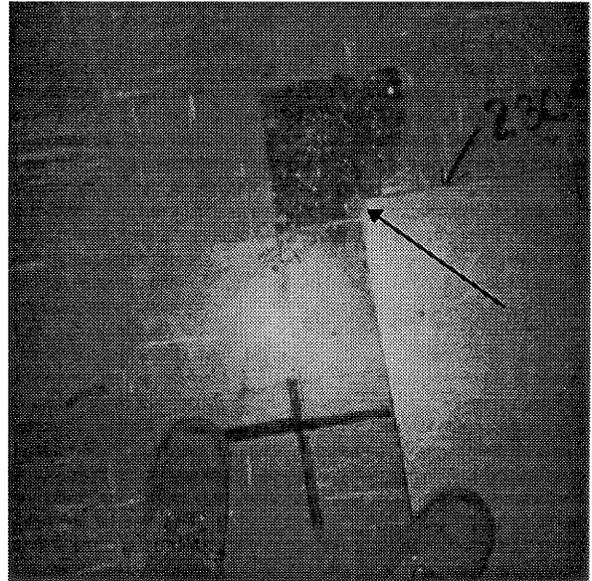
Asbestos Sample Nos. 20 & 21—Room 117

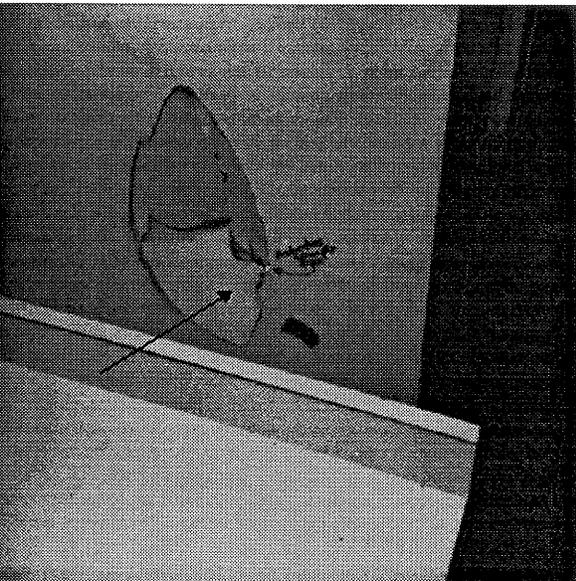
Asbestos Sample No. 22—Room 117 (West Wall)

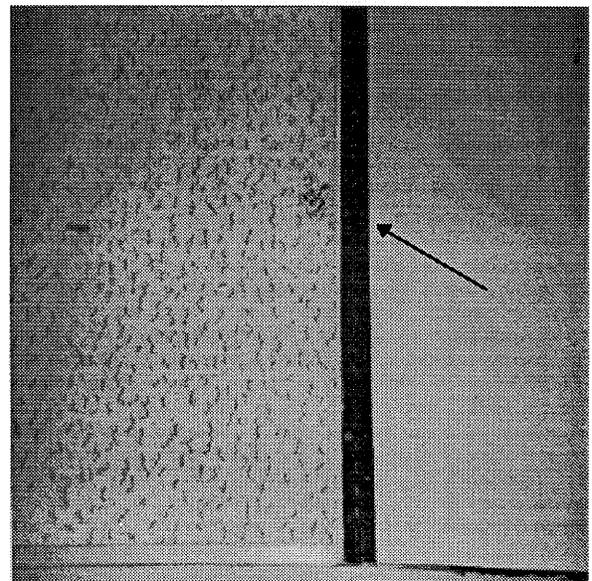
Asbestos Sample No. 23—Room 105 (East Wall Outside Room 117A)

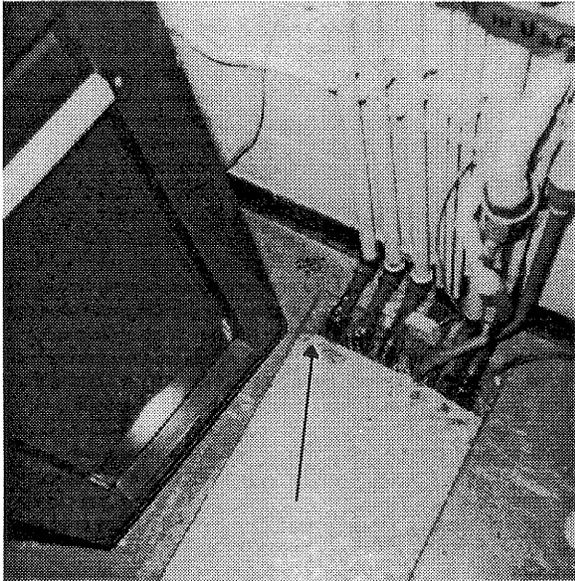
Asbestos Sample No. 24—Room 105 (South Wall/  
Floor)

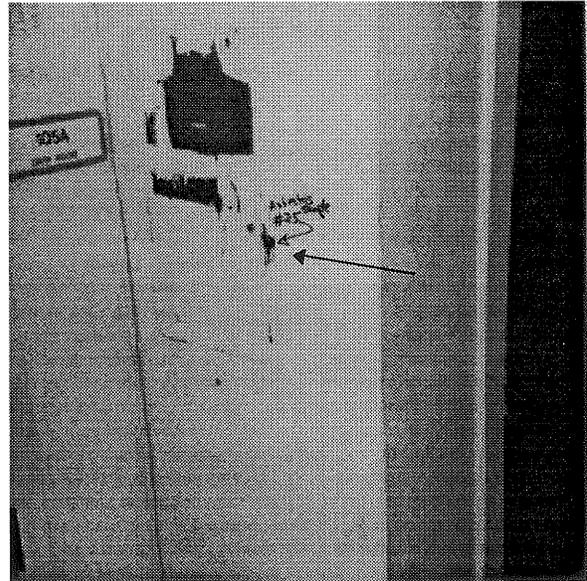
Asbestos Sample No. 25—Room 105 (West Wall)

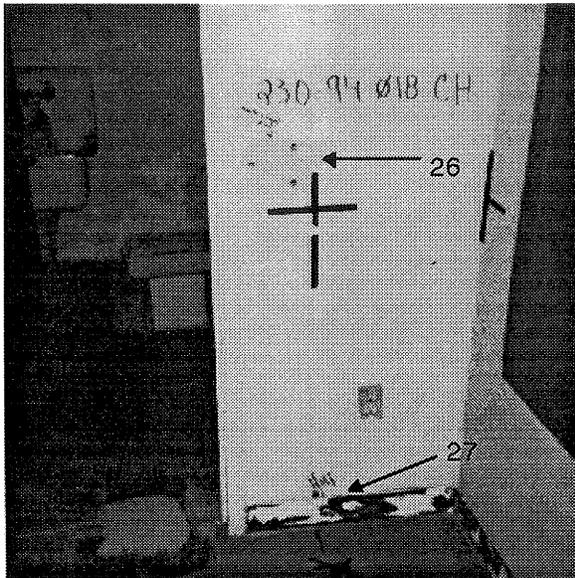
Asbestos Sample Nos. 26 & 27—Room 104

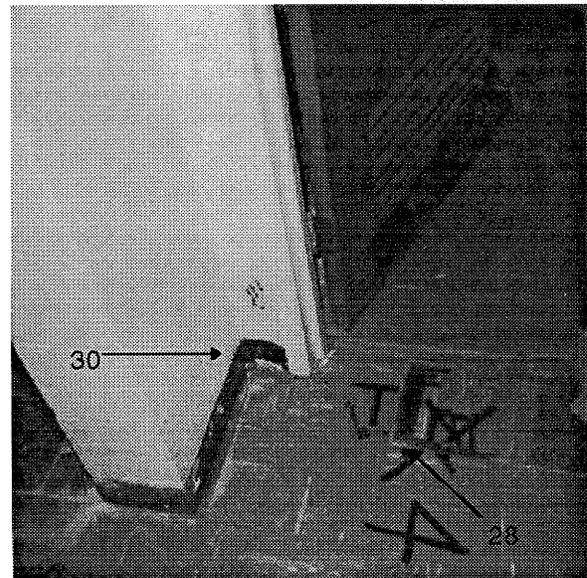
Asbestos Sample Nos. 28 & 30—Room 104

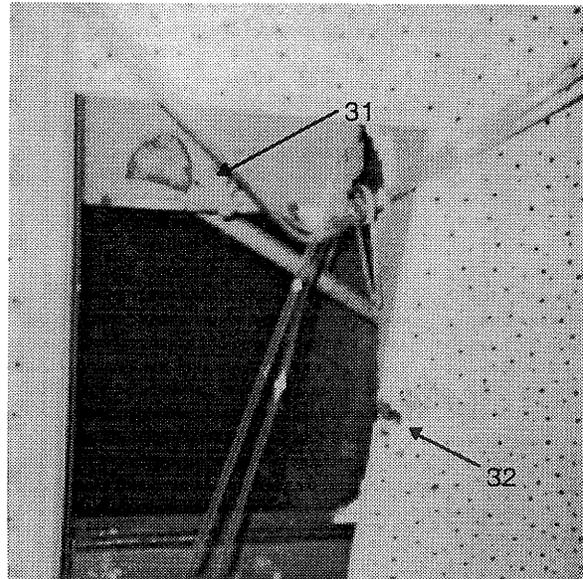
Asbestos Sample Nos. 31 & 32—Room 104

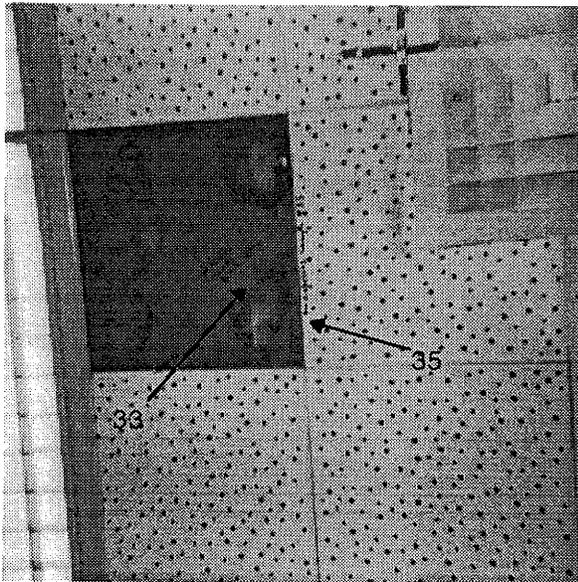
Asbestos Sample Nos. 33 & 35—Room 100
