PC-000456/0

# GENERAL ATOMICS HOT CELL CHARACTERIZATION REPORT

**GA HOT CELL D&D PROJECT**  
**CONTRACT NO. DE-AC03-95SF20798**  
**PROJECT NO. 7340**

**DECEMBER 1995**

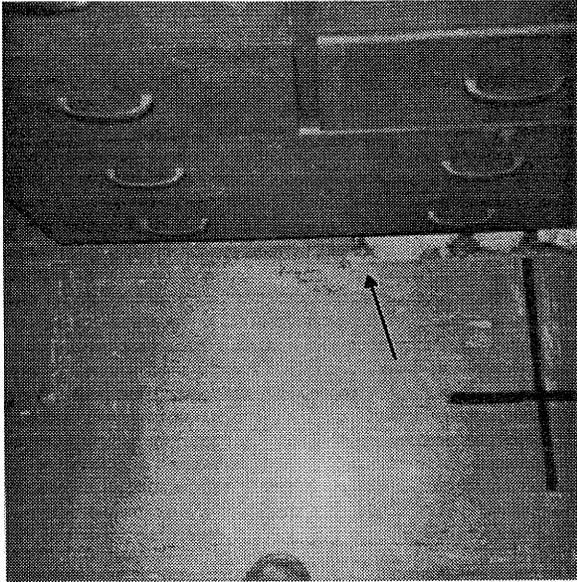
Asbestos Sample No. 36—Room 100

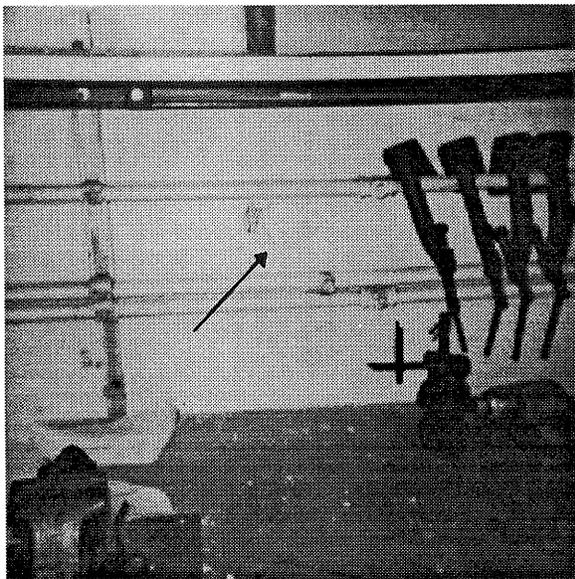
Asbestos Sample No. C2—Room 108

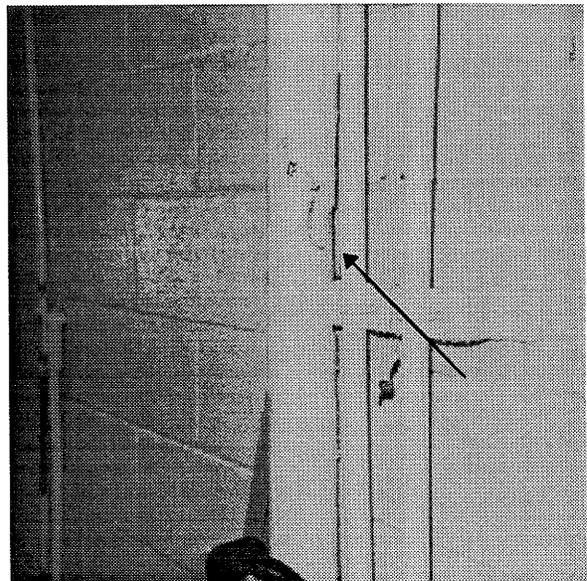
Asbestos Sample No. C3—Room 111

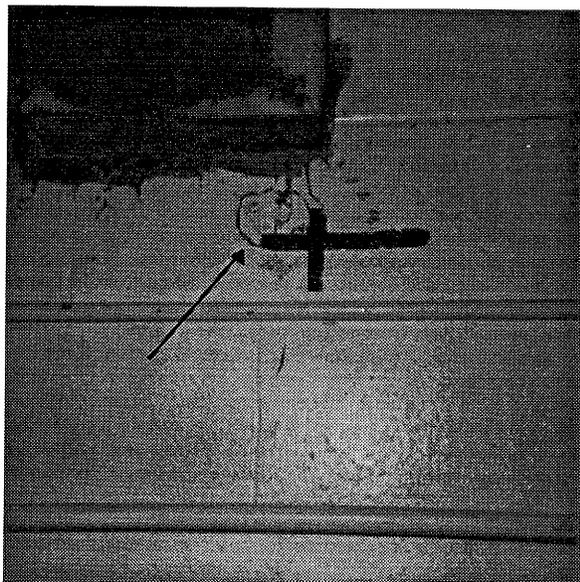
Asbestos Sample No. C4—Room 116A

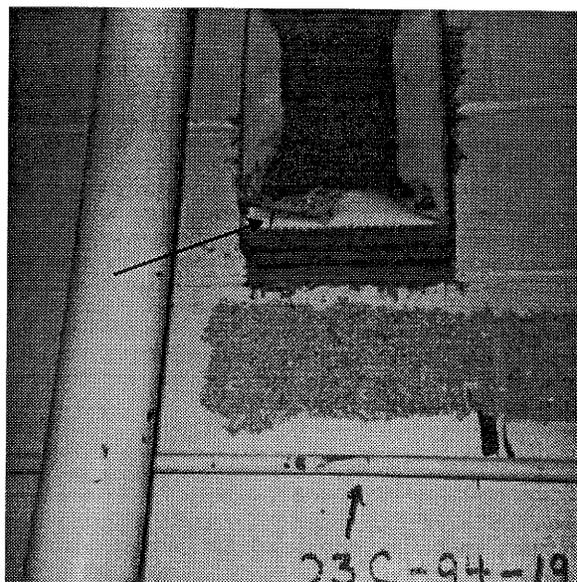
Asbestos Sample No. C5—Room 116A

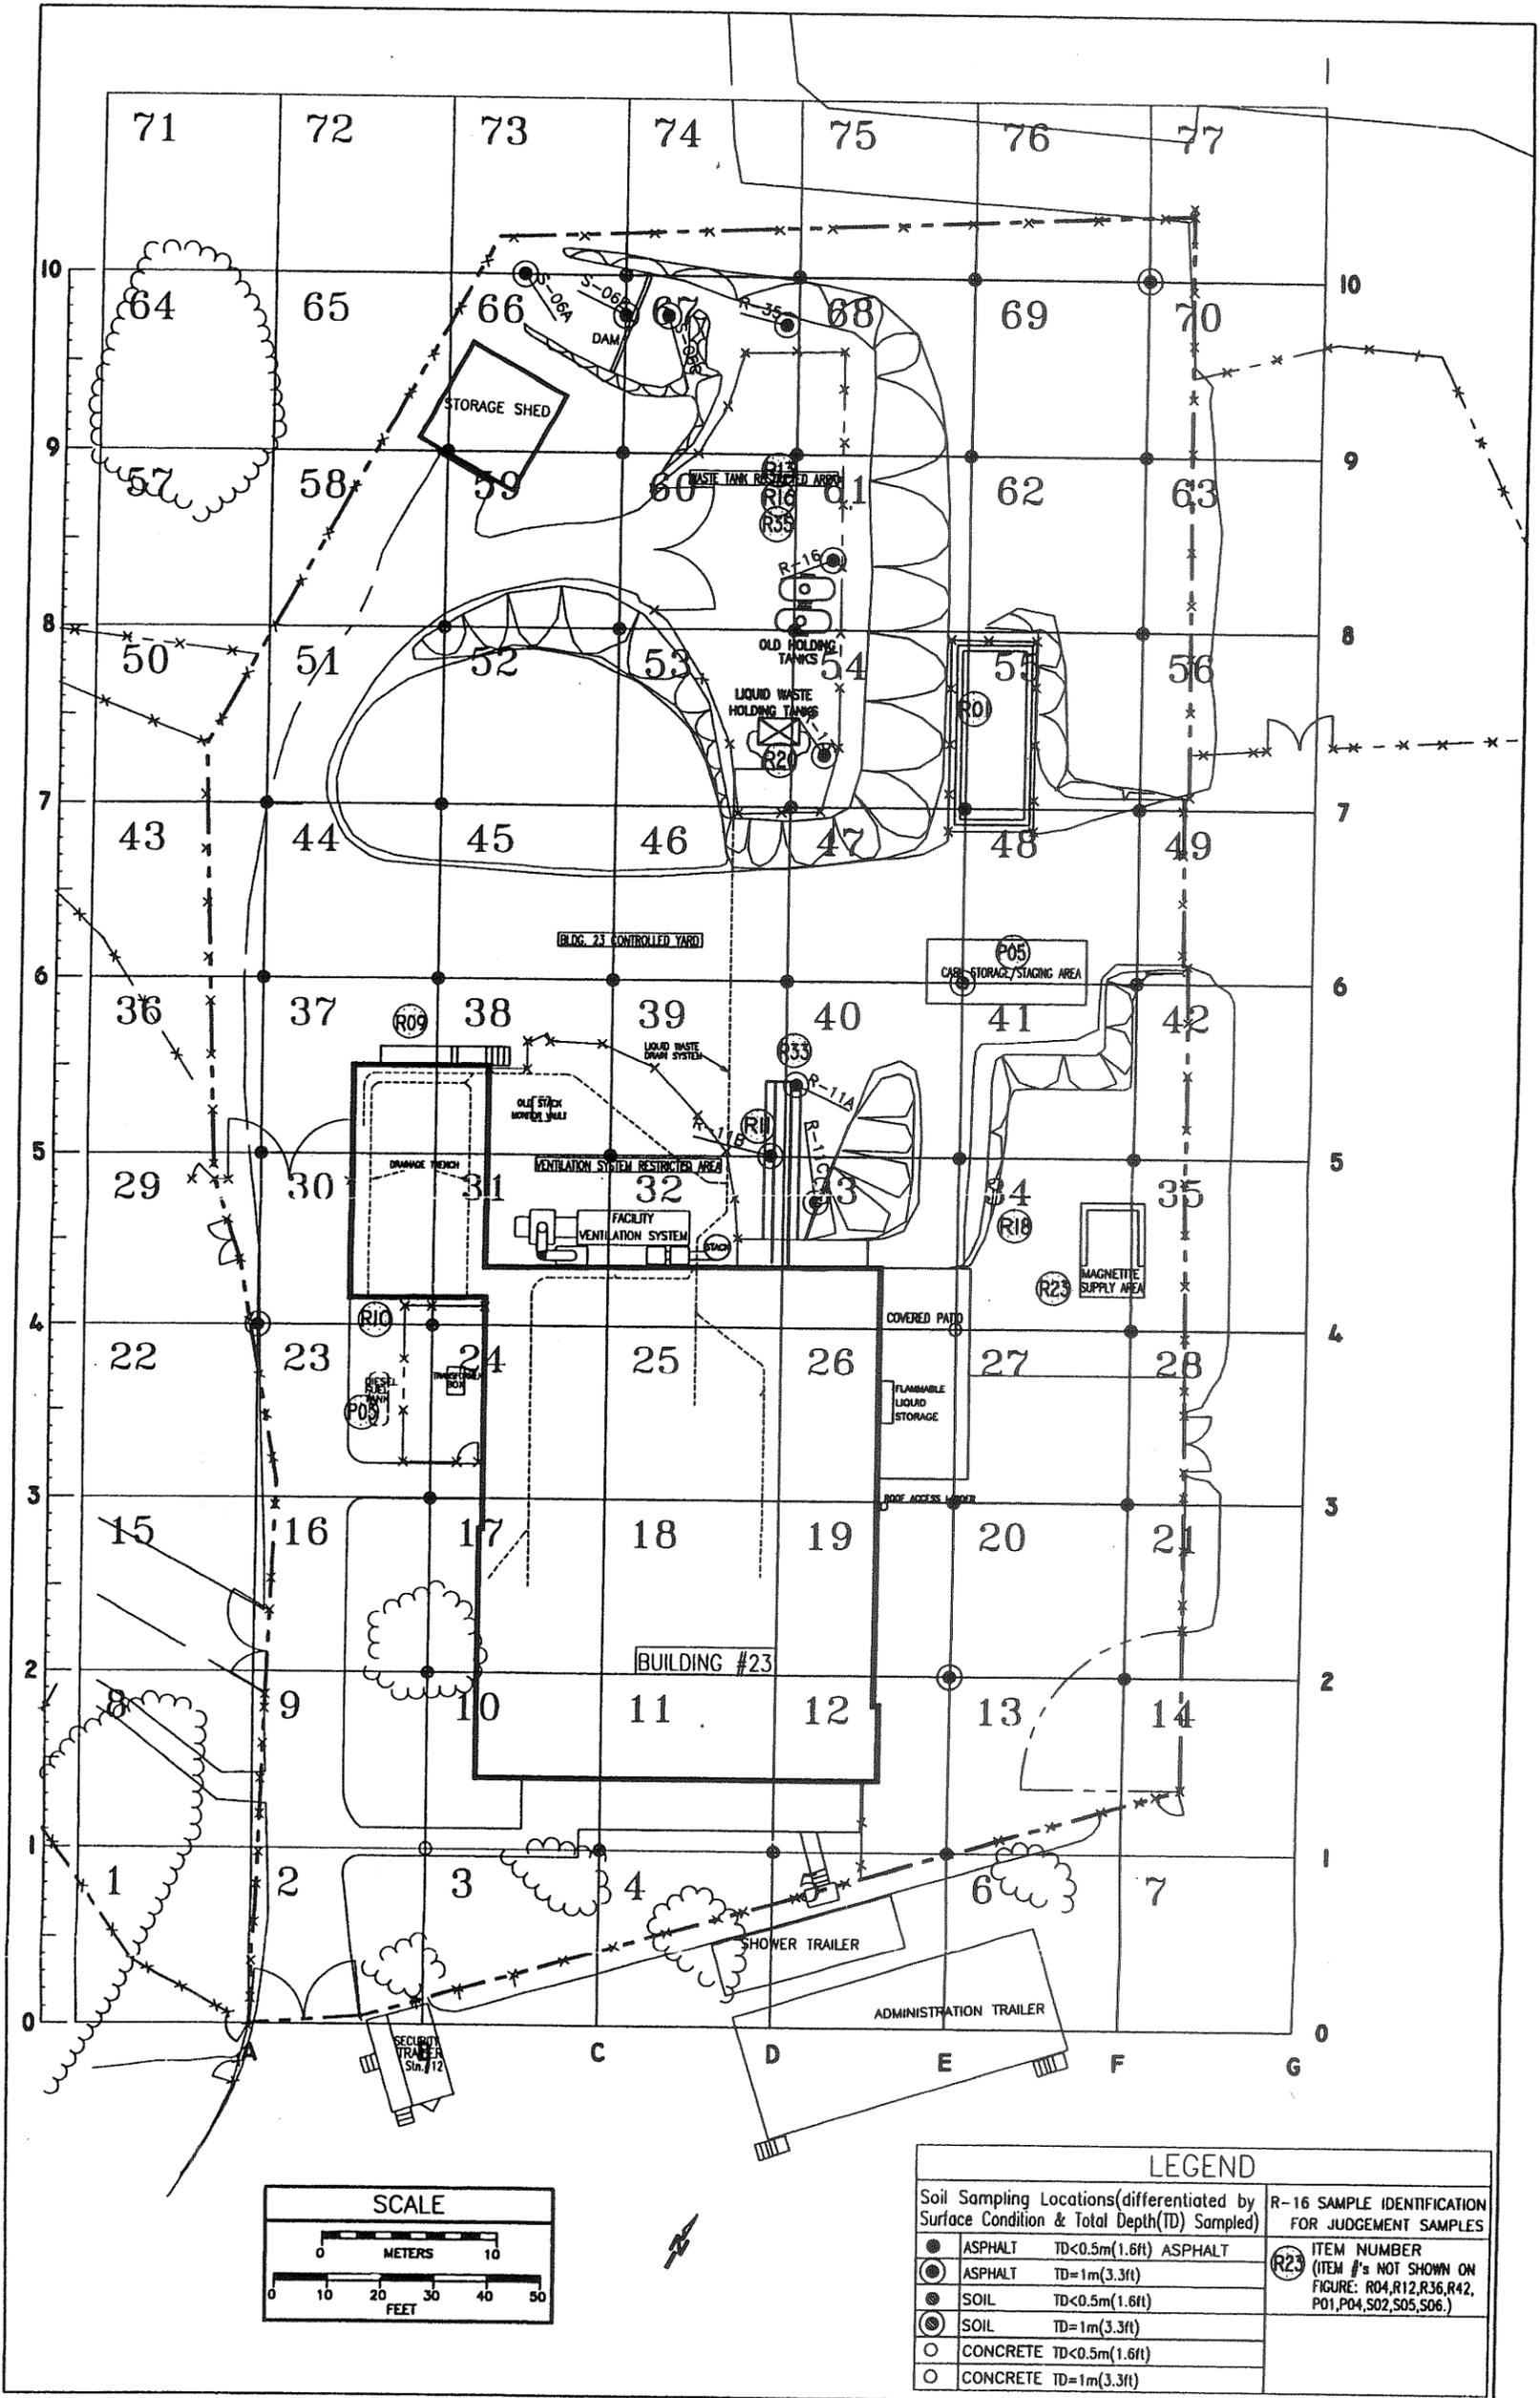
Fig. 6-1—General Locations for Items of Interest and Soil Sampling Locations at the Hot Cell Facility Yard

Systematic sampling of the unpaved and paved areas was completed at the nodes of the 10 m by 10 m grid system (see Figure 6-1). A total of 42 node locations were sampled. Of these 42 systematic sampling locations, 19 locations were unpaved and 23 locations were paved (or concrete surfaced). Deeper soil samples were collected from systematic sampling locations A-4, E-2 and F-10 for the purposes of lithologic characterization. The lithologic characterization samples were collected and evaluated to provide data on subsurface conditions across the HCF. Collection of lithologic characterization samples was attempted at sampling location C-6, however, the presence of spongy soil conditions prevented collection of samples at this location to depths greater than 11.5 in. (28.2 cm).

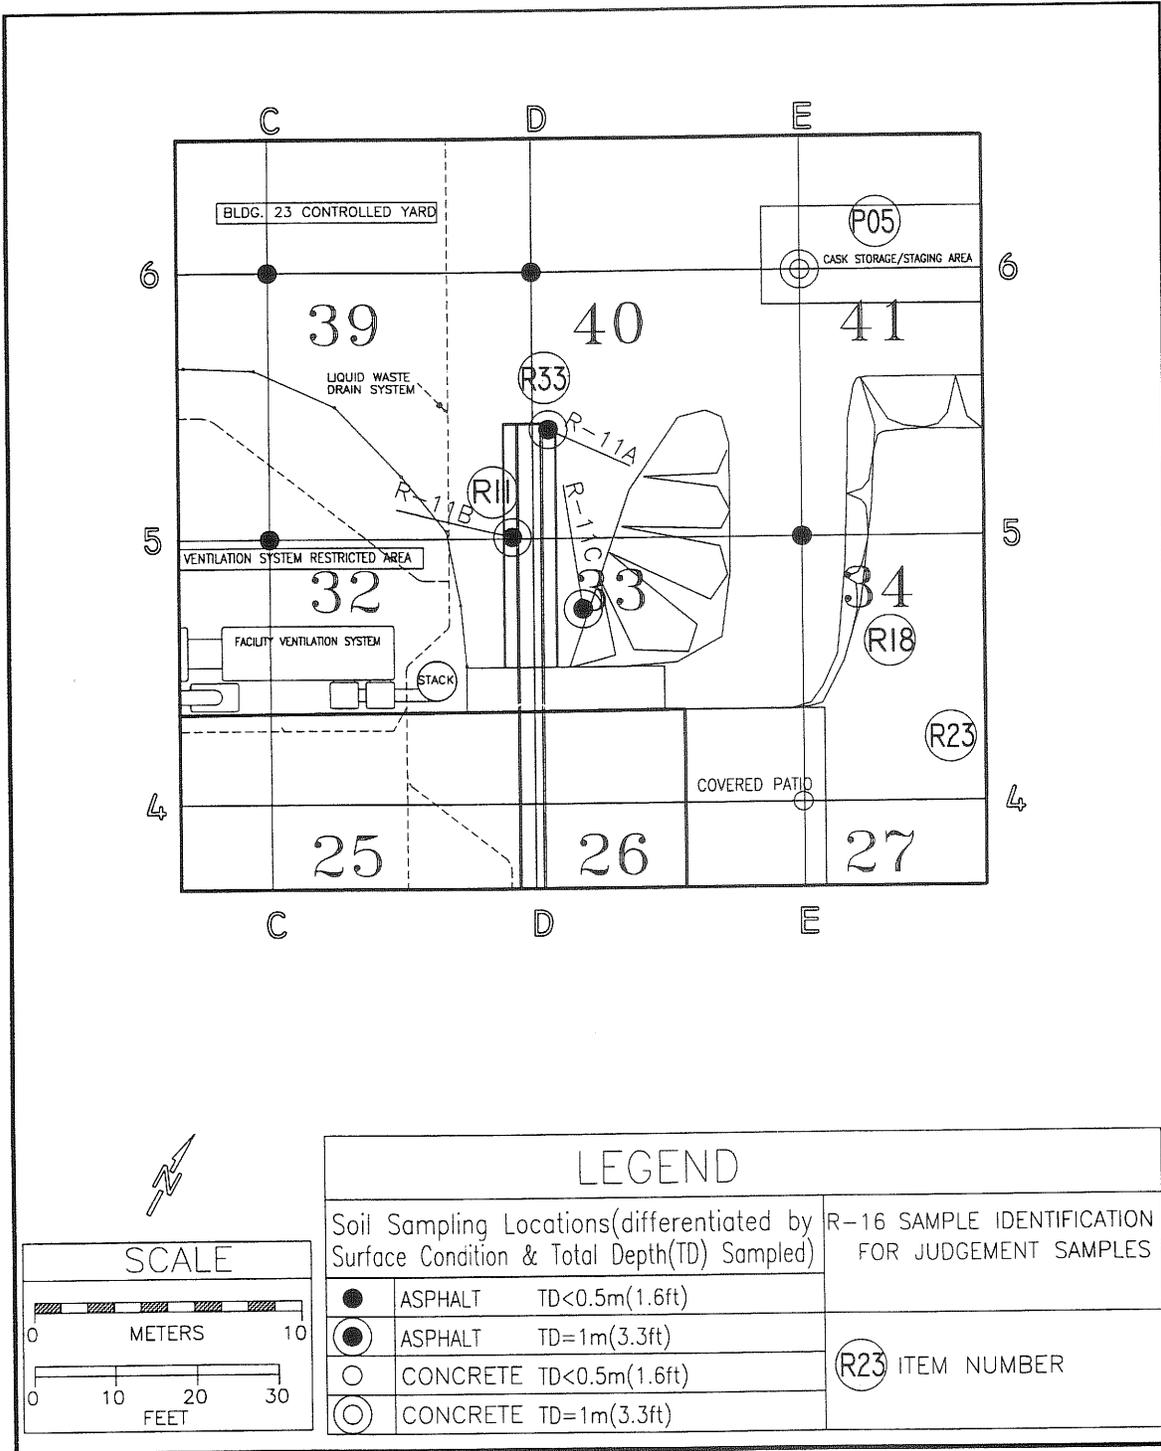
Fig. 6-2—Details of Soil Sampling Locations Near Trestle Area Within Fenced Yard

Judgement samples were collected in the three highest ranked areas (Item R11—General Trestle Area; Item R13, R16, R35—Liquid Waste Tanks Area; and S06—Drainage Path from Liquid Waste Tanks Area) (see Figure 6-2 and Figure 6-3). With the exception of samples collected in the Liquid Waste Tanks Area (sample locations R-13, R-16 and R-35), the three judgement sampling locations in each of three areas were selected in the accessible portion of features showing highest field scanning results. The field scanning was performed over surface features that tend to accumulate and retain particles or liquids and/or would provide a conduit for contaminant migration into the subsurface (e.g., cracks, joints, unpaved surfaces and surfaces showing evidence of puddling and accumulation of fine-grained sediments). Due to the relatively high background radiation in the Liquid Waste Tanks Area, field scanning was not performed.

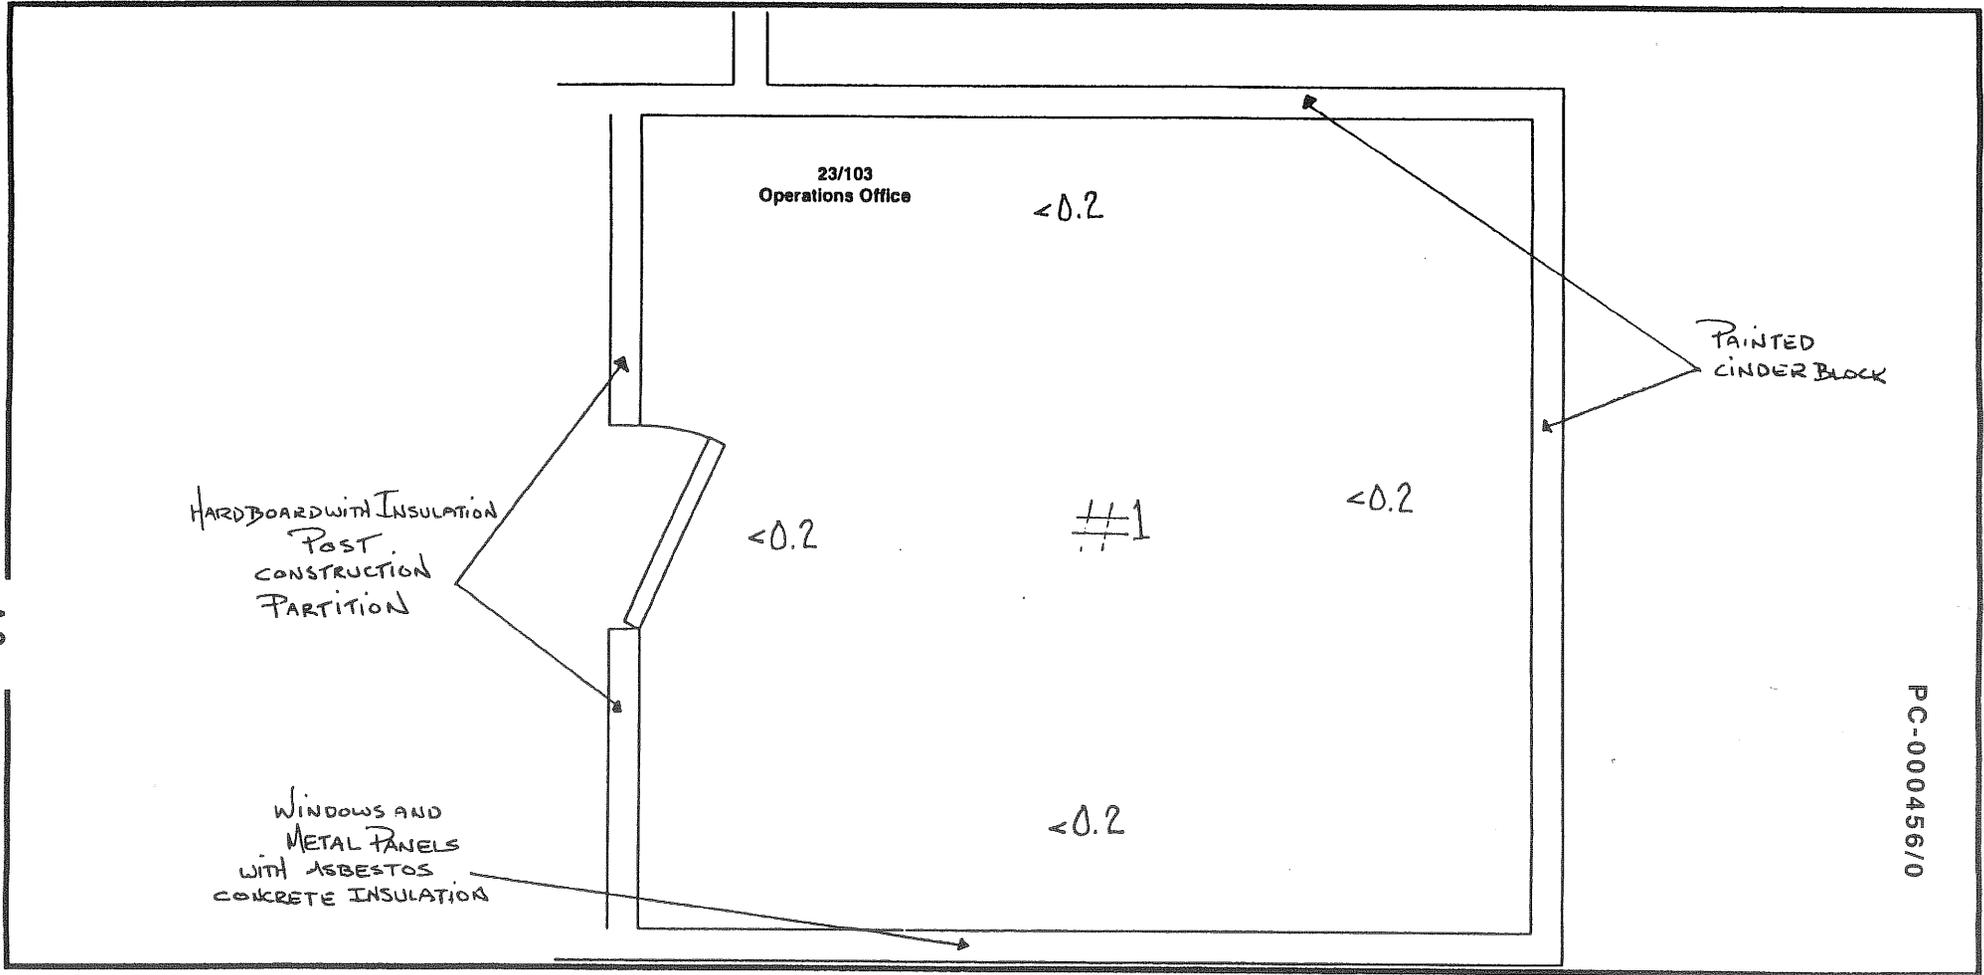
MAP#: 23-103	LOCATION: Operations Office	DATE: 09-06-94	TIME: 1200	SURVEY # 23-94-0-0-4-1-1-CH
--------------	-----------------------------	----------------	------------	-----------------------------

○	SMEAR	◆	H <sup>3</sup> SMEAR			#1	<1000	A TOTAL OF 84 SMEARS TAKEN IN ROOM 103 FOR CHARACTERIZATION PURPOSES. ALL SMEARS WERE <1000 dpm/100cm <sup>2</sup> . DIRECT FRISK SURVEY RESULTS WERE <1000 dpm/PROBE AREA. THE 5% OF SMEARS COUNTED FOR ALPHA WERE <200 dpm/100cm <sup>2</sup> .
#	LARGE AREA SMEAR	***	BOUNDARY	N	A			#1 LARGE AREA MASSLIN SMEAR. NO HOT PARTICLES FOUND.
□	AIR SAMPLE LOCATION		(Show sample Id in Remarks)			N	A	
*	CONTACT DOSE RATE	+	12" DOSE RATE			N	A	
β	BETA DOSE RATE ONLY	α	ALPHA ONLY					
HS	HOT SPOT	Δ	NEUTRON DOSE RATE			N	A

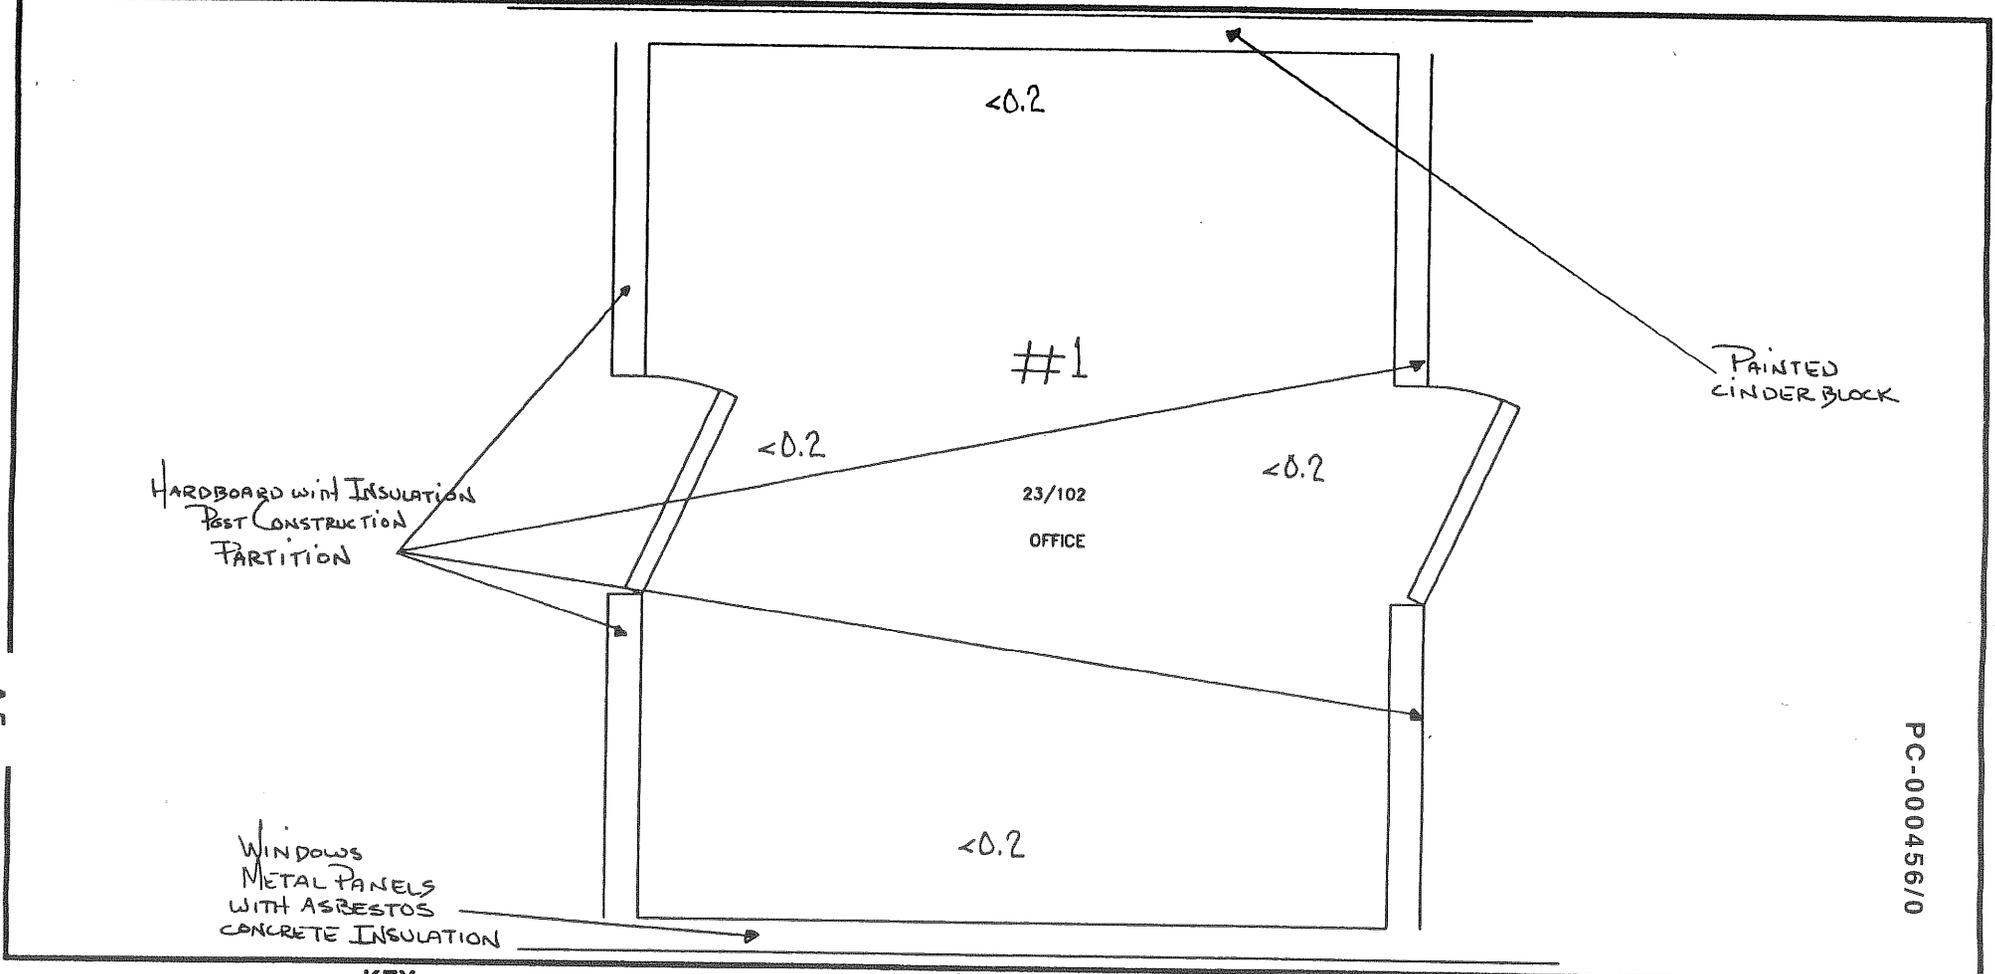
MAP#: 23-102	LOCATION: HP/Operations Office Area	DATE: 09-07-94	TIME 1300	SURVEY # 23-94-0-0-4-1-2-CH
--------------	-------------------------------------	----------------	-----------	-----------------------------

KEY		No. dpm/100 cm <sup>2</sup>	No. dpm/PROBE AREA	Remarks (see Note 4 below)
○	SMEAR	◆	H <sup>3</sup> SMEAR	A TOTAL OF 86 SMEARS TAKEN FOR CHARACTERIZATION PURPOSES. ALL SMEARS WERE <1000 dpm/100cm <sup>2</sup> B'Y. 5% OF SMEARS WERE COUNTED FOR ALPHA CONTAMINATION. RESULTS WERE <200 dpm/100cm <sup>2</sup> α. ALL DIRECT FRISK SURVEY RESULTS WERE <1000 dpm/PROBE AREA.
#	LARGE AREA SMEAR	***	BOUNDARY	
□	AIR SAMPLE LOCATION	(Show sample Id in Remarks)		
*	CONTACT DOSE RATE	+	12" DOSE RATE	
β	BETA DOSE RATE ONLY	α	ALPHA ONLY	
HS	HOT SPOT	Δ	NEUTRON DOSE RATE	#1 LARGE AREA MASSLIN SMEAR. NO HOT PARTICLES FOUND.

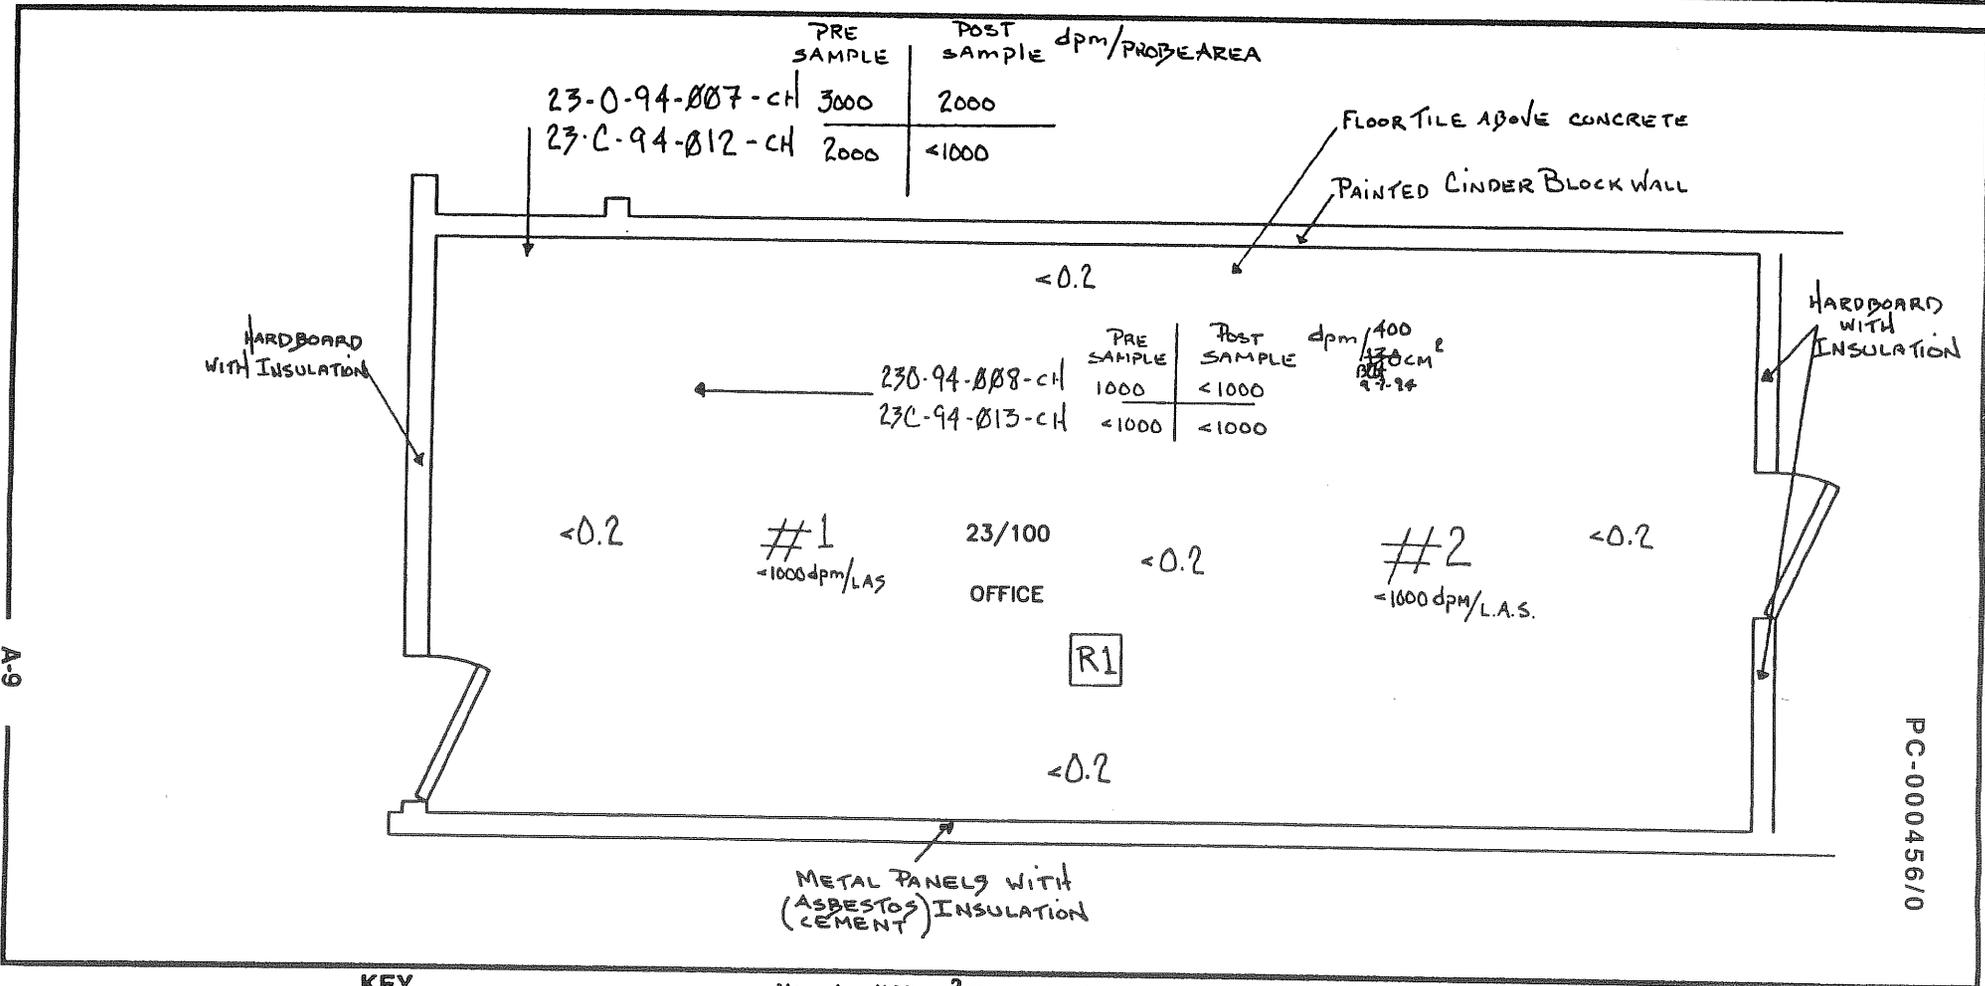
MAP#: 23-100	LOCATION: Hot Cell HP Office Area	DATE: 09-7-94	TIME: 1400	SURVEY # 23-94-0-0-4-1-3-ct
--------------	-----------------------------------	---------------	------------	-----------------------------

○	SMEAR	◆	H <sup>3</sup> SMEAR					ALL SMEARS TAKEN, INCLUDING AIR VENTS, JUNCTION BOXES AND LIGHT FIXTURES WERE <1,000 dpm/100 cm <sup>2</sup> . ALL SMEARS, 5%, COUNTED FOR ALPHA WERE <200 dpm/100 cm <sup>2</sup> . DIRECT FRISK SURVEY RESULTS WERE <1000 dpm EXCEPT WHERE NOTED ON ABOVE MAP PRIOR TO SAMPLE EXTRACTION.
#	LARGE AREA SMEAR	***	BOUNDARY					
□	AIR SAMPLE LOCATION		(Show sample Id in Remarks)	N	A			
*	CONTACT DOSE RATE	+	12" DOSE RATE					
β	BETA DOSE RATE ONLY	α	ALPHA ONLY					
HS	HOT SPOT	Δ	NEUTRON DOSE RATE

R1 TWO LARGE AREA MASSLIN SMEARS TAKEN ON FLOOR WERE BOTH  $<1000 \text{ dpm}/\text{PROBE AREA}$  WITH NO LOOSE HOT PARTICLES FOUND.

R4 THE FOUR AIR VENTS <sup>COVERS</sup> IN DROPPED CEILING WERE REMOVED AND SURVEYED FOR <sup>(6"12" INTERNALLY)</sup> LOOSE AND CONTAMINATION. ALL VENTS  $<1000 \text{ dpm}/\text{PA}$ . <sup>FIXED</sup>  $<1000 \text{ dpm}/100 \text{ cm}^2$

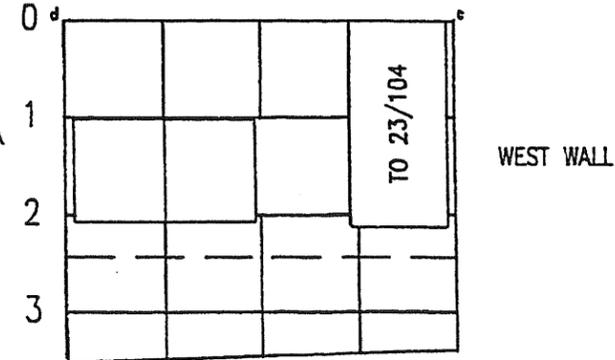
23L-95-320-CH  
 <1,000 dpm/PA.  
 23L-95-319-CH  
 <1,000 dpm/PA

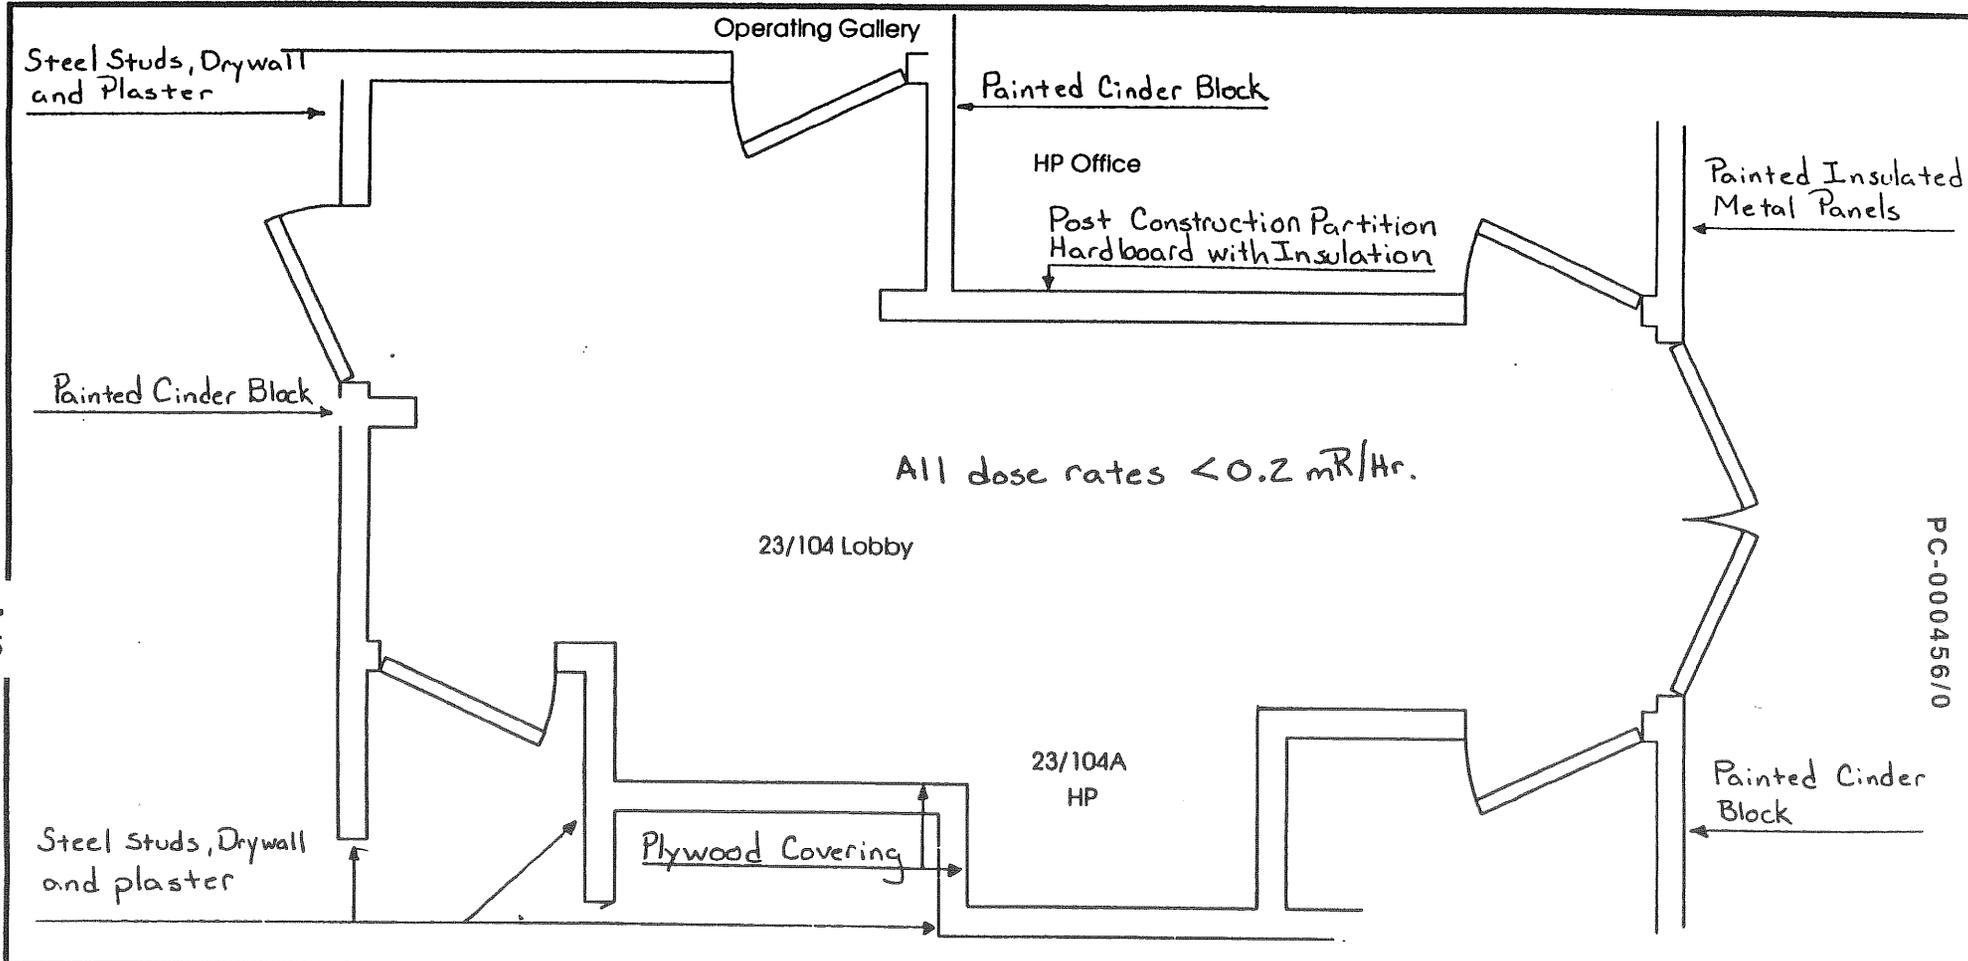
MAP#: 23-104	LOCATION: Building 23 Lobby	DATE: 9-14-94	TIME: 1500	SURVEY #: 23-94-0-0-4-2-1-CH
--------------	-----------------------------	---------------	------------	------------------------------

KEY		No. dpm/100 cm <sup>2</sup>	No. dpm/	Remarks (see Note 4 below)
○	SMEAR	◆	H <sup>3</sup> SMEAR	84 8K
#	LARGE AREA SMEAR	***	BOUNDARY	
	AIR SAMPLE LOCATION (Show sample Id in Remarks)			
*	CONTACT DOSE RATE	+	12" DOSE RATE	
β	BETA DOSE RATE ONLY	α	ALPHA ONLY	
HS	HOT SPOT	Δ	NEUTRON DOSE RATE	
				Smears 1 thru 175 < LLD Except #84
				Air sample pulled during sample removal
				23A-94-417 6.15E-13 uCi/cc
				10% of smears counted for α. All < LLD
				SAC-4
				MDCR 19326
				3-18-95

- R1 Vent removed and put into a rad bag. Area around vent checked. No fixed or loose detected.
- R2 Wooden wall removed from mens bathroom side into old doorway. Area checked. No fixed or loose detected.

- R3 50K dpm/pa removed with sample 23C-94-018-CH.
- R4 3K dpm/pa removed with sample 23C-94-019-CH.
- R5 Smear #174 taken on top of dropped ceiling through a hole. Small area direct frisked. No fixed or loose detected.

- R6 Smear #175 taken on top of dropped ceiling through a hole. Small area direct frisked. No fixed or loose detected.
- R7 No access to the top of the dropped ceiling, walls above dropped ceiling, steel deck ceiling and other items in this area. Area will be listed as an exception.

- R8 All vents in ceiling removed and checked. No fixed or loose detected.
- R9 Two pieces of baseboard were found to be contaminated in room 104. [6K & 8K] dpm/pa

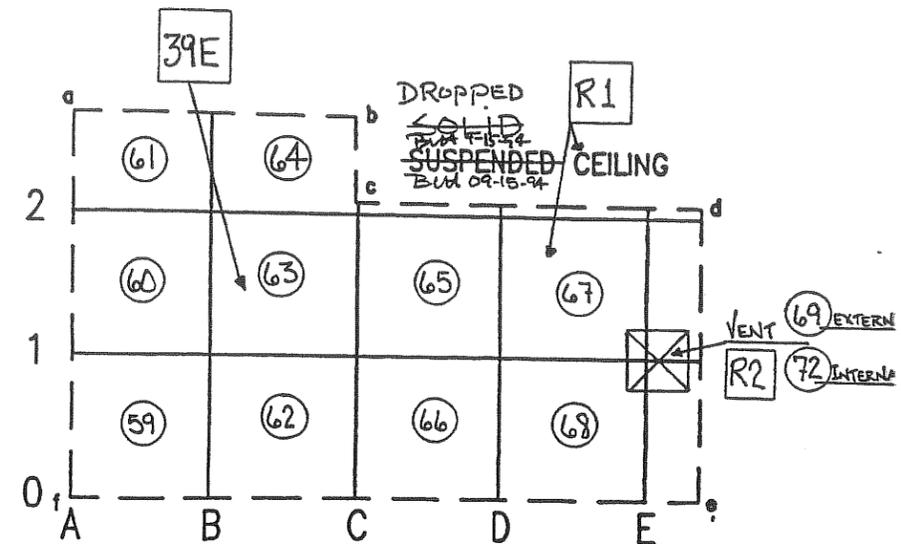
ROOM NO.	23/MENS
MEMO NO.	HCI:267:YB:94

R4  
SMEARS TAKEN  
BENEATH PARTIAL  
BOARD WALL  
(PLYWOOD-PRINTED)

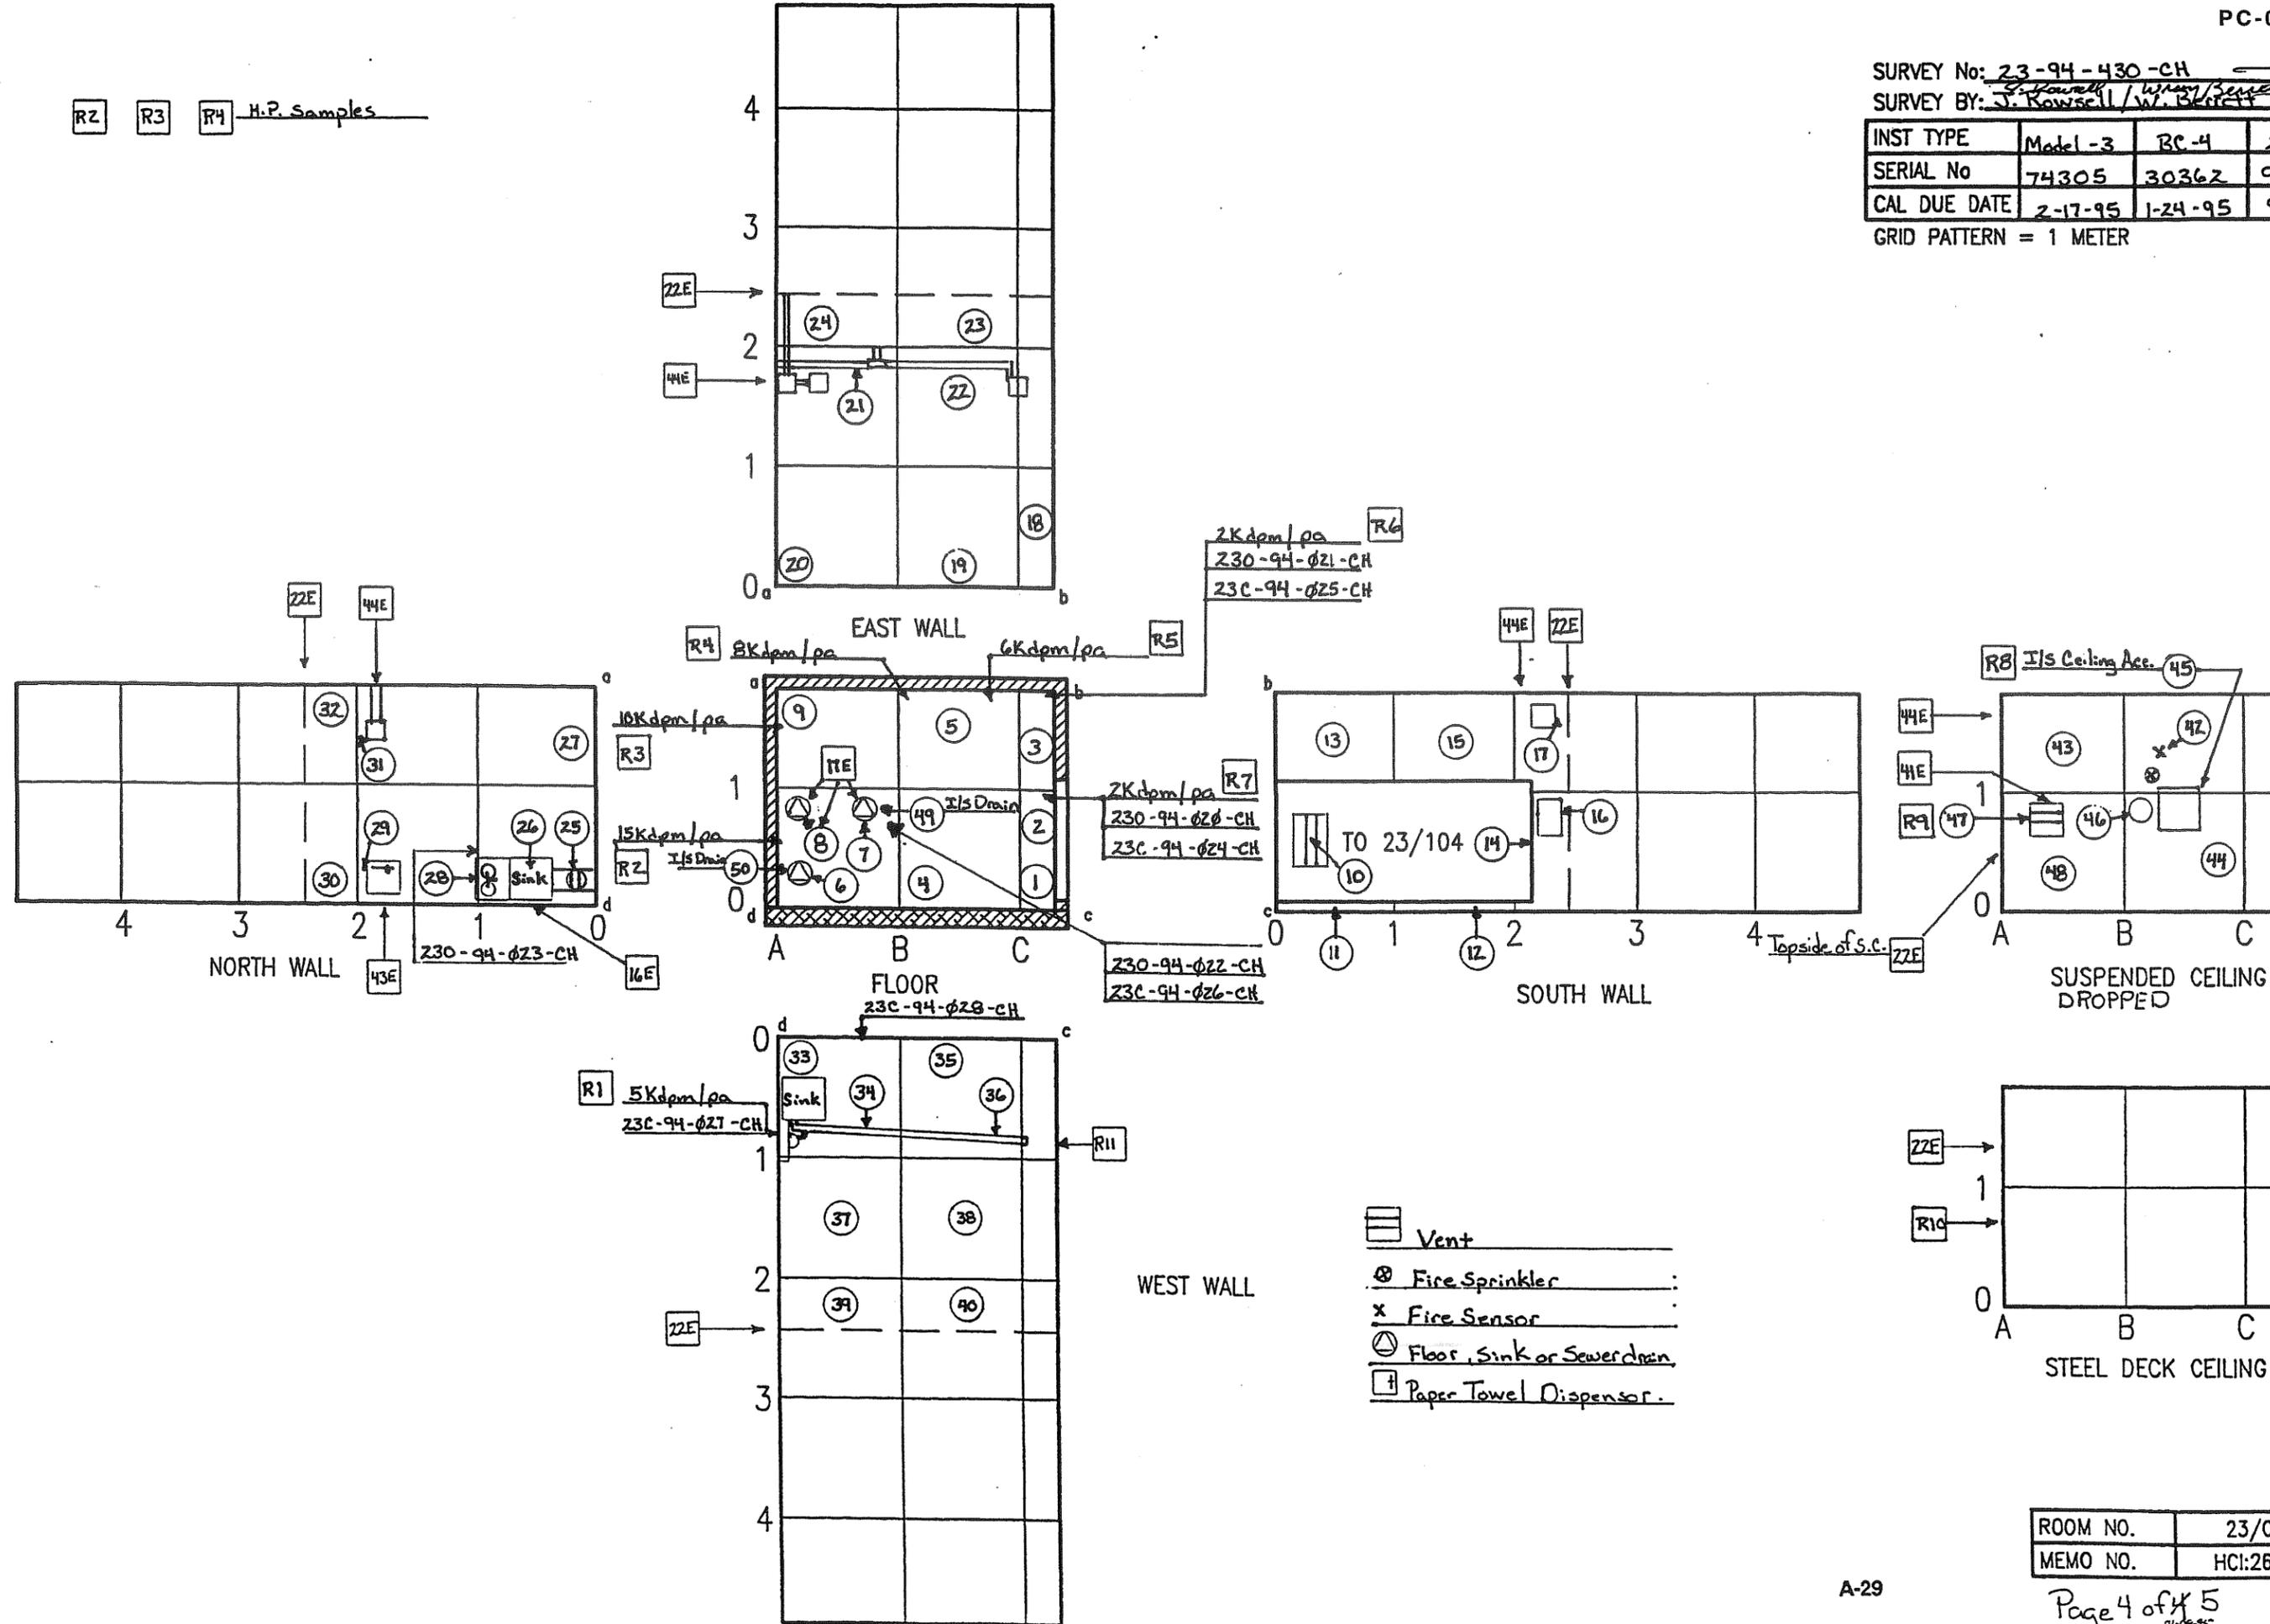
ROOM NO.	23/COFFEE
MEMO NO.	HCI:267:VB:94

R2 R3 R4 H.P. Samples
