PC-000456/0

# GENERAL ATOMICS HOT CELL CHARACTERIZATION REPORT

**GA HOT CELL D&D PROJECT**  
**CONTRACT NO. DE-AC03-95SF20798**  
**PROJECT NO. 7340**

**DECEMBER 1995**

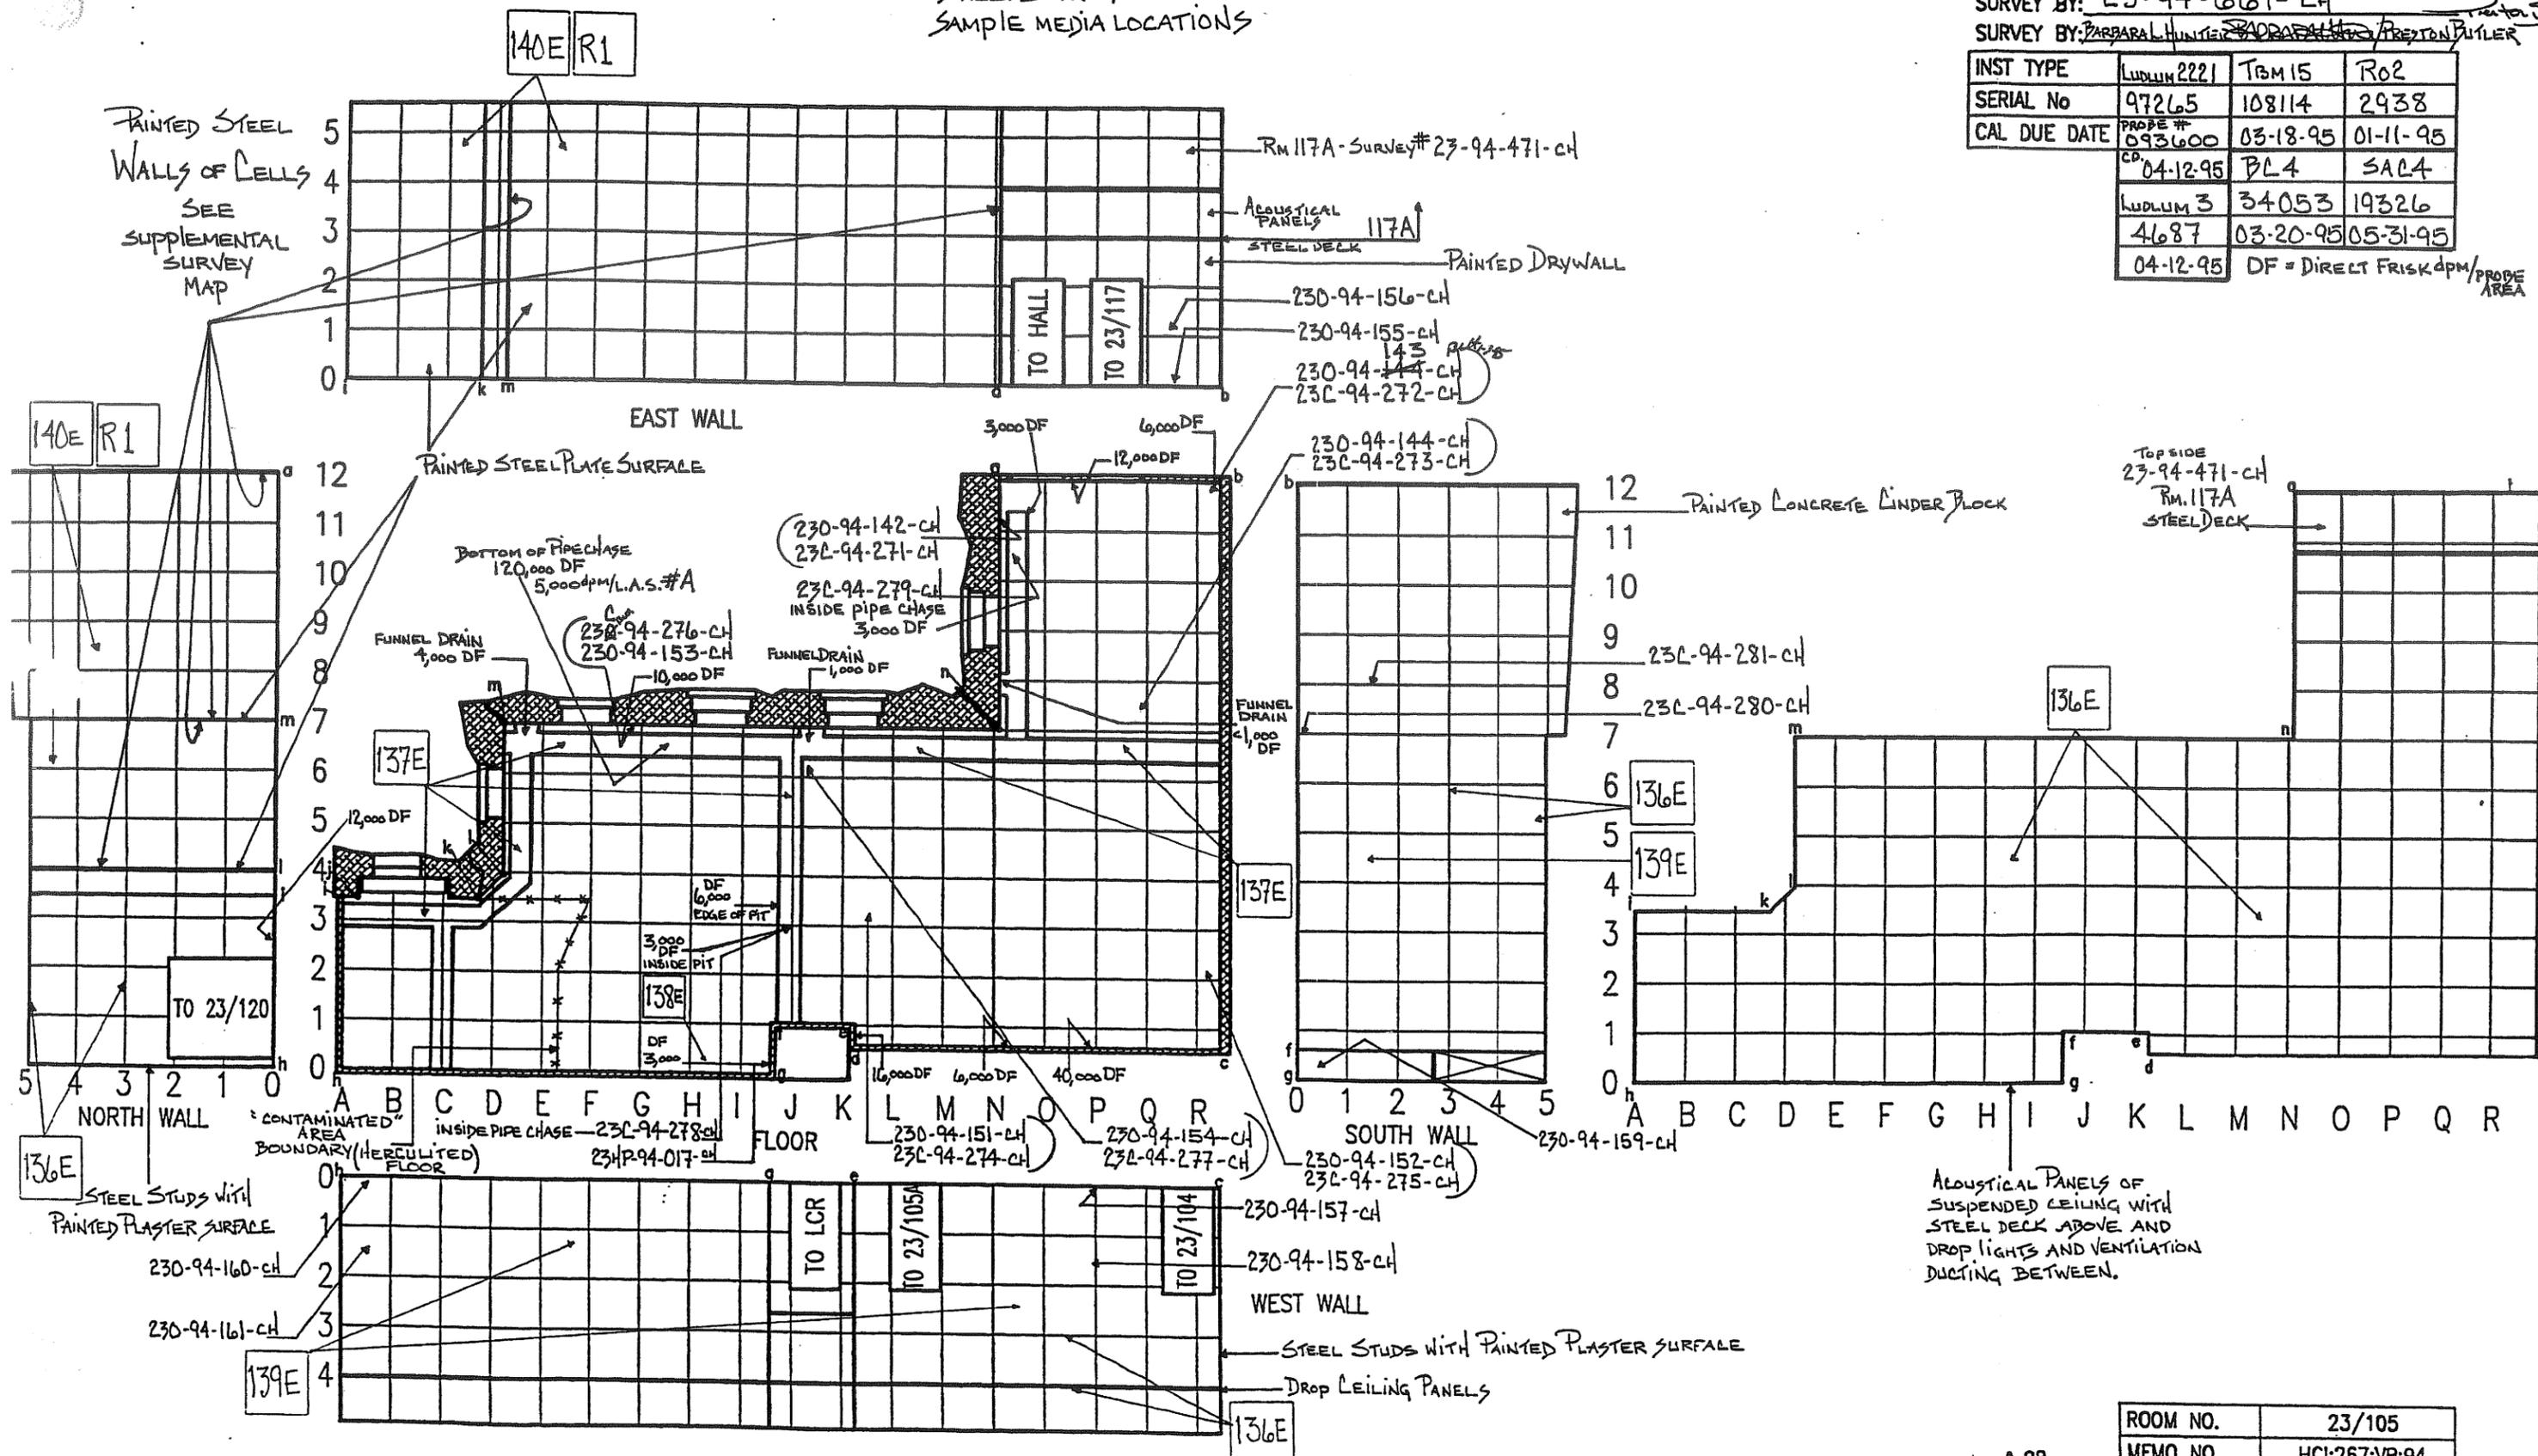
ROOM NO.	23/105
MEMO NO.	HCI:267:VB:94

ACROUSTICAL PANELS OF SUSPENDED CEILING WITH STEEL DECK ABOVE AND DROP LIGHTS AND VENTILATION DUCTING BETWEEN.

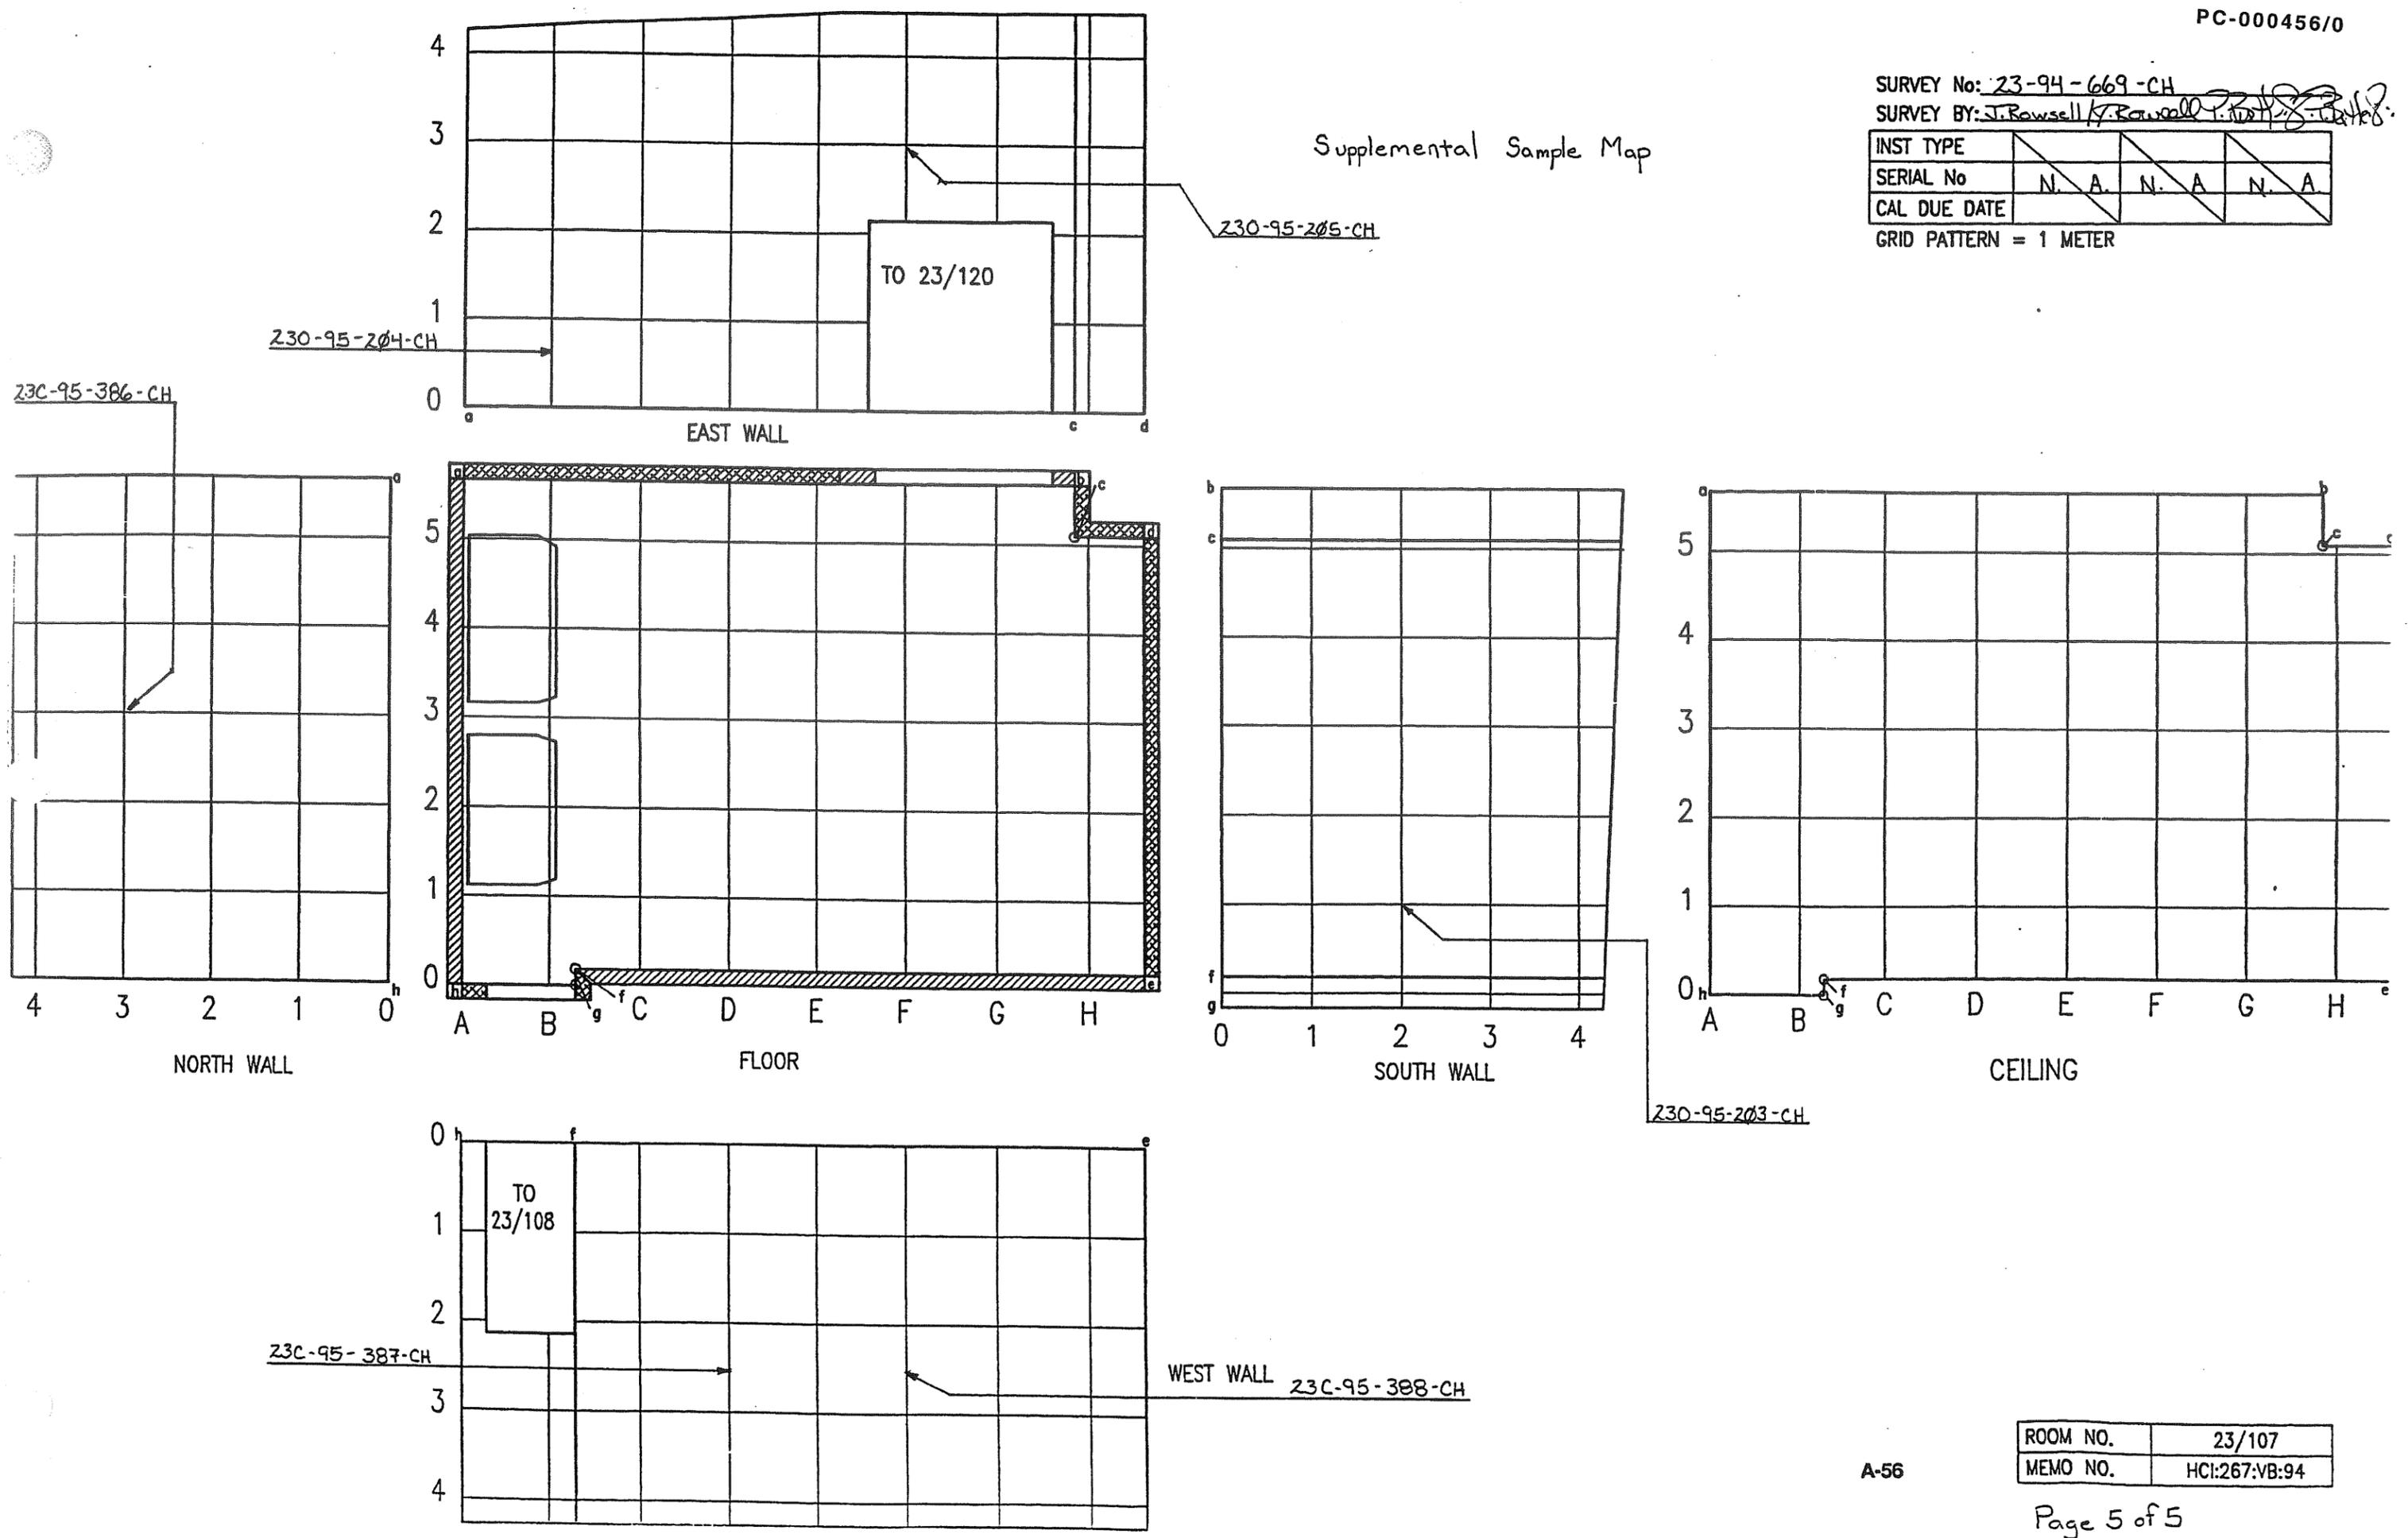
ROOM NO.	23/107
MEMO NO.	HCI:267:VB:94

- R4 15K dpm/100cm<sup>2</sup> in joints of floor tile. Removed with sample 230-94-149-CH
- R5 14K dpm/P.A. Removed from tile before sampling
- R6 Numerous high contamination particles and a few hot particles detected on the floor. Most of the particles are found in the joints where the tile meet. Most are fixed. Range

- R7 Numerous high contamination particles and a few hot particles detected in the overhead. Most of the particles are loose. Range from 150K dpm/P.A. and less. General area on large area smears is 1K dpm to 2K dpm

- R8 Drain was opened, direct frisk and smeared. 3K dpm/100cm<sup>2</sup> loose in pipe. No detectable direct in drain.
- R9 Drain in sink was direct frisk and smeared. 3K dpm/100cm<sup>2</sup> loose in pipe. No detectable direct in sink  
Floor around sink 1K to 10K dpm/P.A. in joints of floor tile. Small spot of 30K dpm/100cm<sup>2</sup>

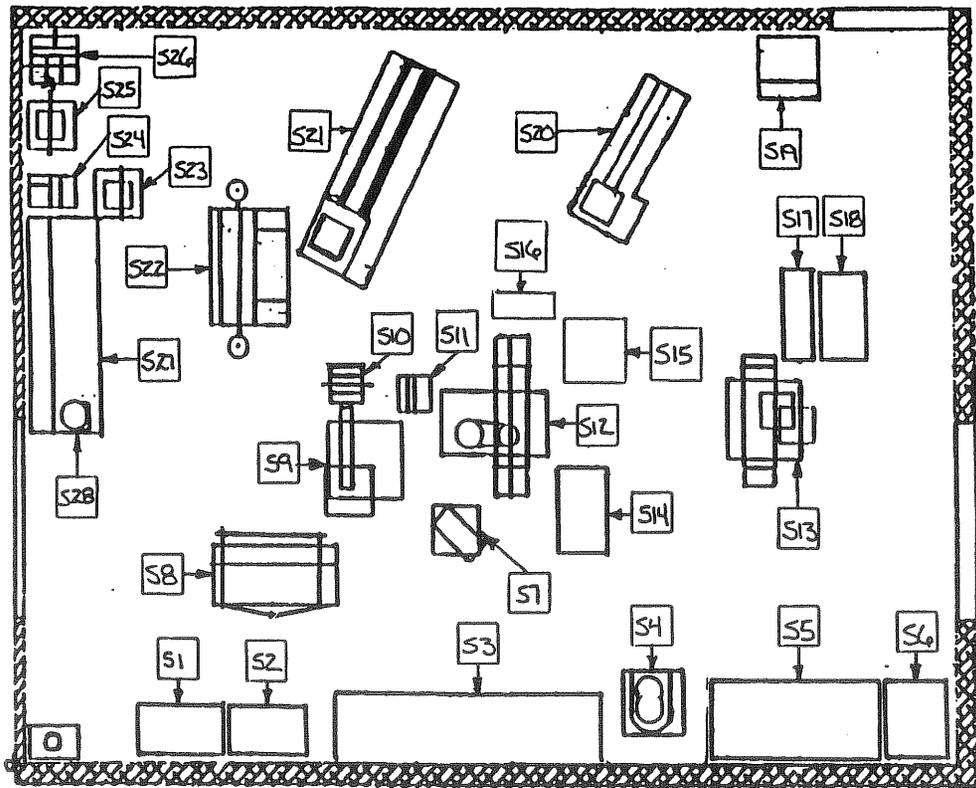
Equipment Survey

- 514 White Tool Cabinet. Smears (3) <MDCR (3) MDCR to 1K. LAS 2K dpm Direct 2K<sup>+</sup>100K dpm/P.A. Tools have loose high contamination particles and a few hot particles. Survey and release clean tools. Part of cabinet is radioactive waste.

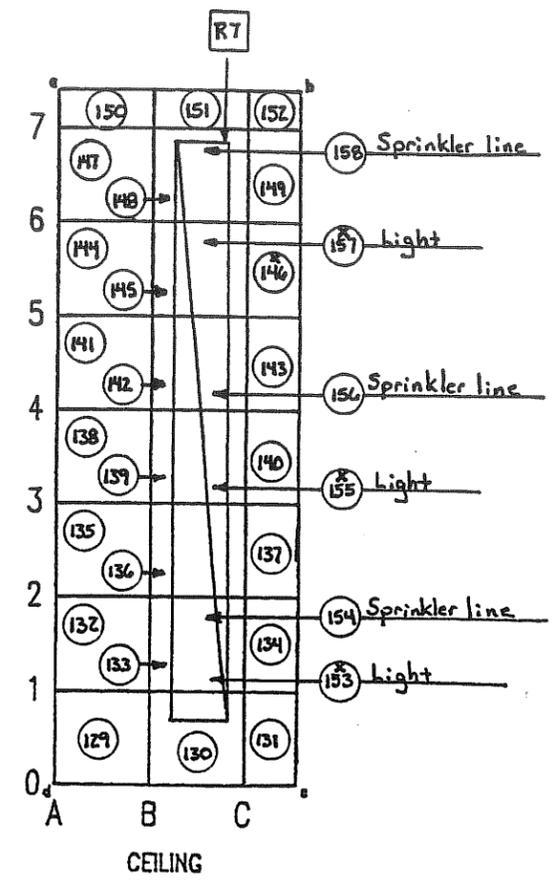
ROOM NO.	23/108A
MEMO NO.	HCI:267:VB:94

- R5 Joints in floor tile in this area are generally 6K dpm/100cm<sup>2</sup> in this area.
- R6 Numerous high contamination particles and a few hot particles detected on the floor. Most of the particles are found in the joints where the tiles meet.

- R7 Numerous high contamination particles found on top of light by direct frisk and large area smears. All particles found by direct frisk were removed with mass linn.

- R8 Four high contamination particles (30K-80K dpm/P.A.), one hot particle (110K dpm/P.A.) found on large area smears or direct frisk of conduit, pipes and electrical boxes on north, west and east walls. All particles found by direct frisk were loose.

- R9 Wall added at some time after machine shop was built.
- R10 Loose H.P. saved for sample.
- R12 5K to 35K dpm/100cm<sup>2</sup>  $\alpha$  direct on tile, 0-5K dpm/100cm<sup>2</sup>  $\alpha$  direct on concrete under floor tile.

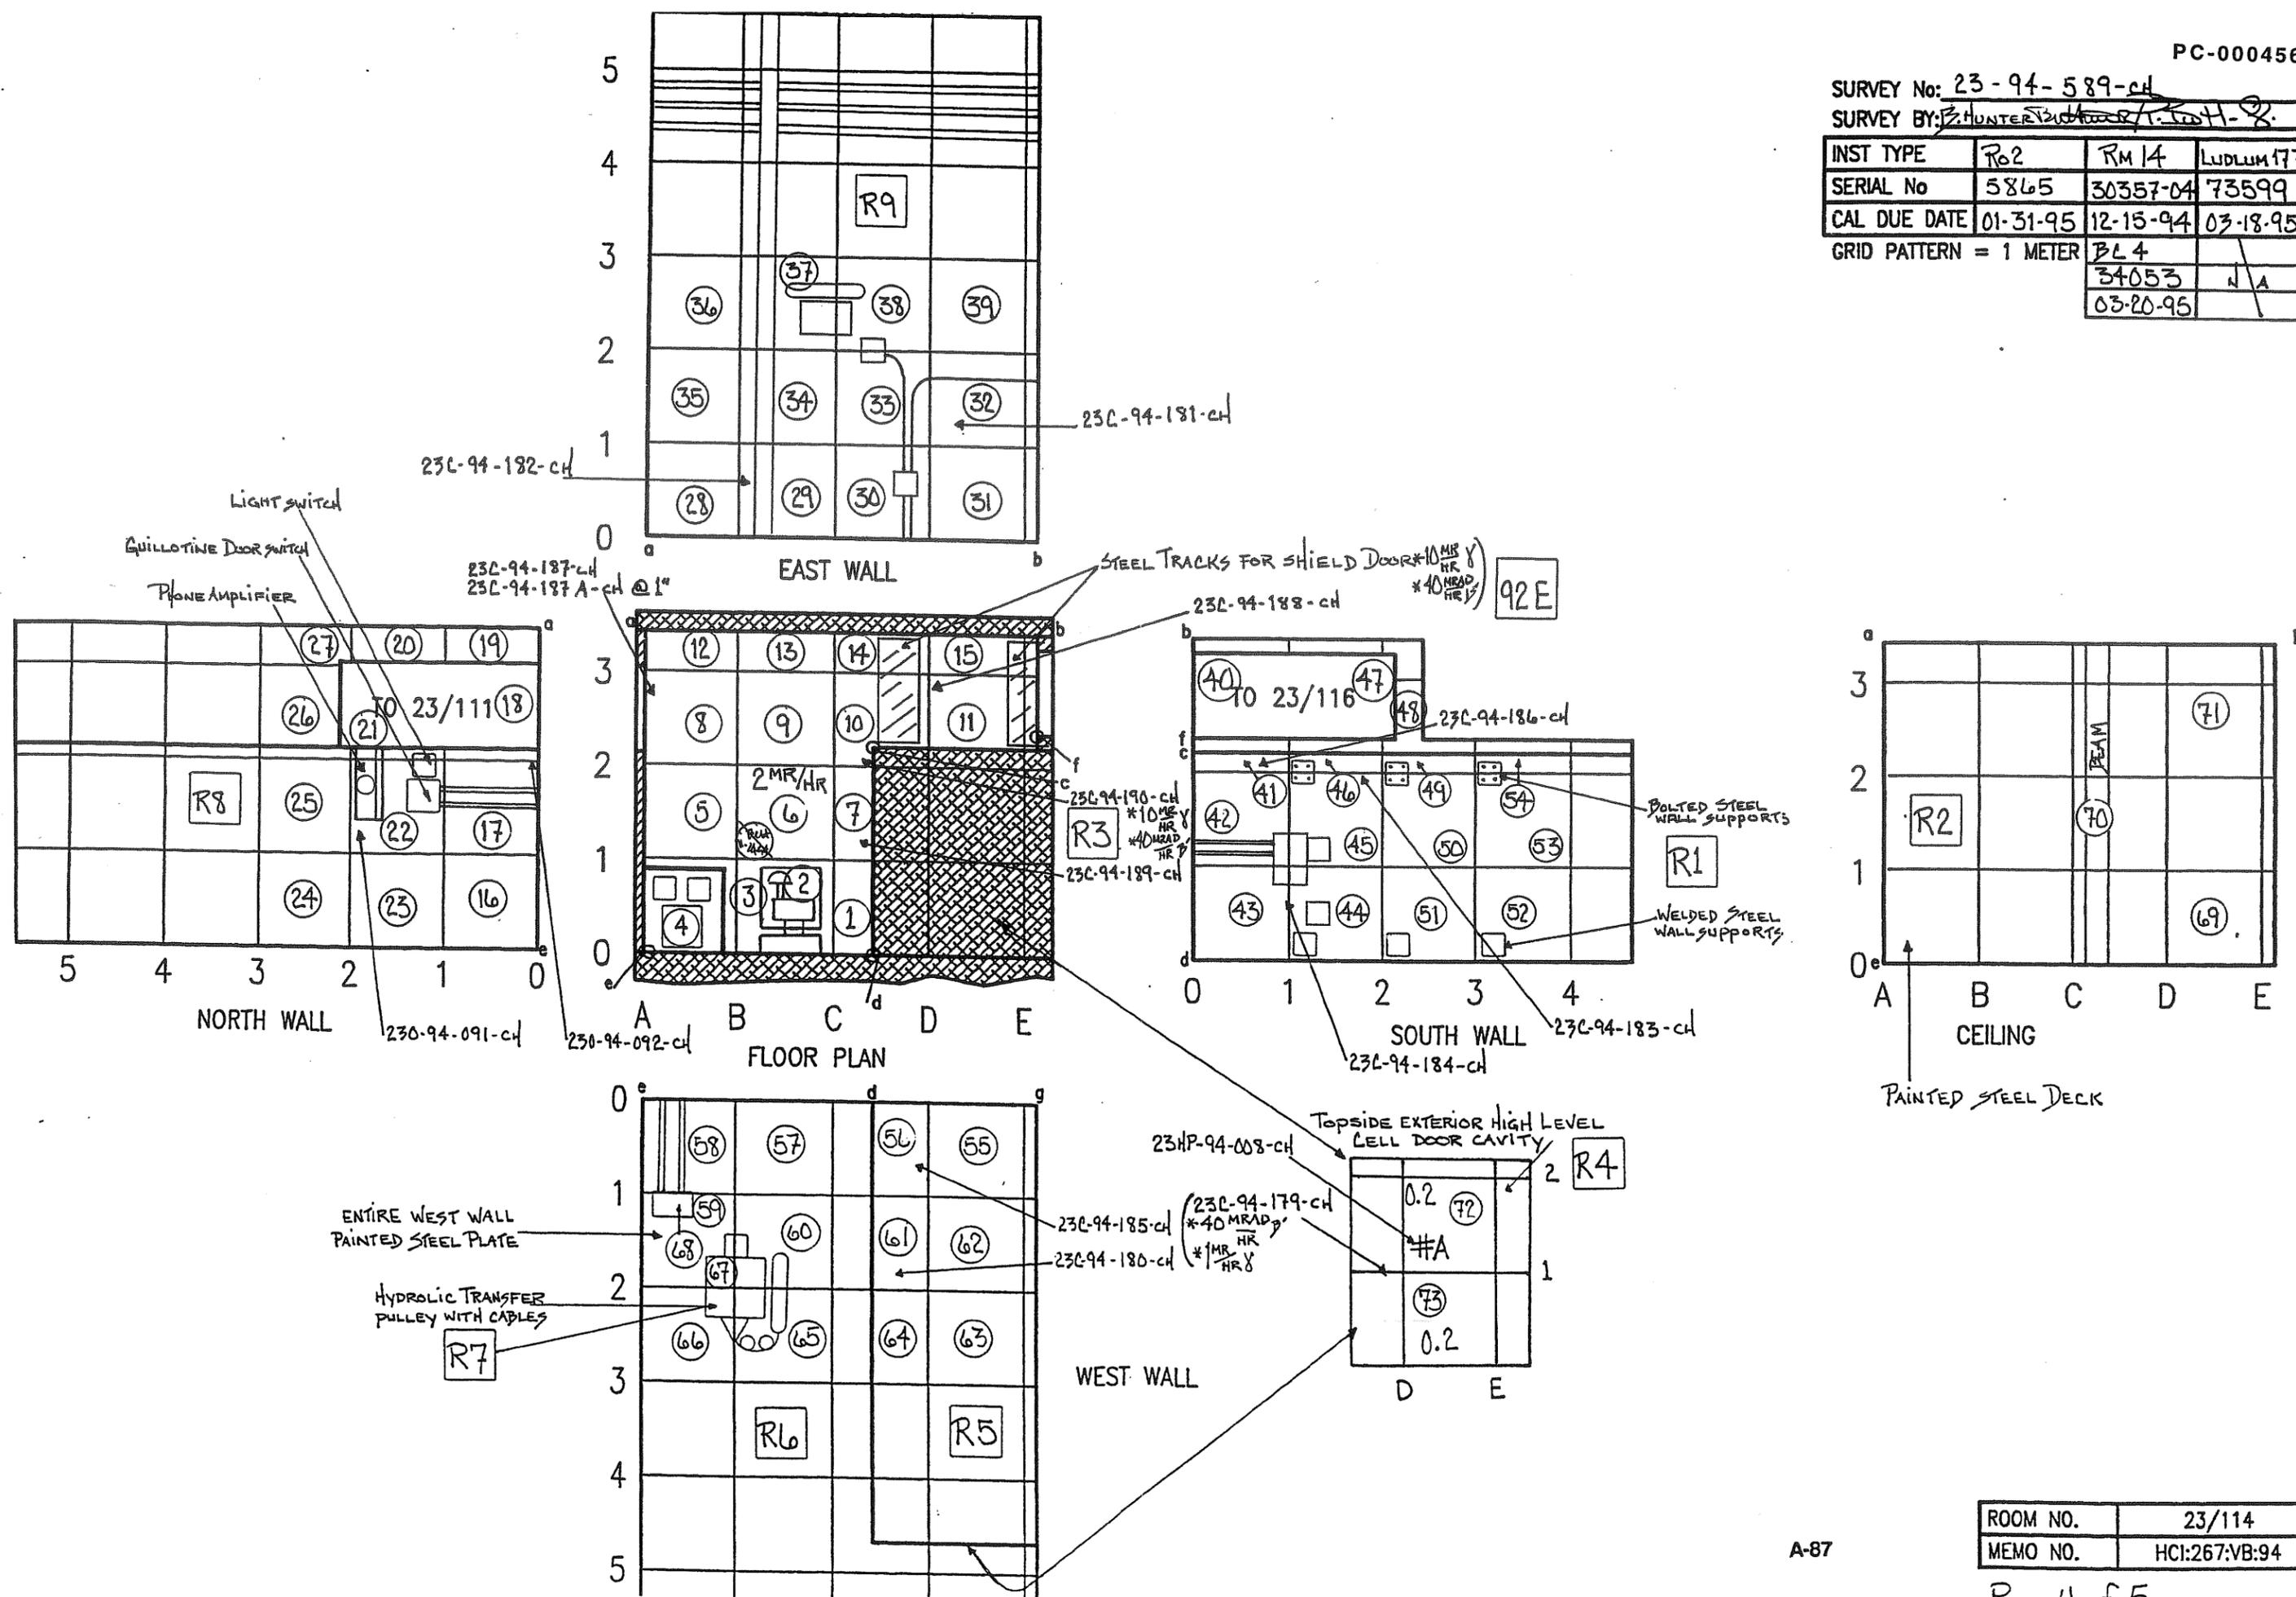
ROOM NO.	23/114
MEMO NO.	HCI:267:VB:94

R1 SEE SUPPLEMENTAL MAP 23-116 FOR SPECIFIC RADIOLOGICAL CONDITIONS OF FUME HOOD. NO SAMPLE MEDIA COLLECTED FROM WALL OR FLOOR BEHIND FUME HOOD DUE TO THE UNKNOWN ORIGIN OF EXISTING DOSE RATES AROUND FLOOR AREA ALONG WITH ELEVATED LOOSE CONTAMINATION LEVELS. THERE EXISTS A HIGH POTENTIAL FOR HOT PARTICLES BENEATH FUME HOOD AND BEHIND BASEBOARDS DUE TO PREVIOUS WATER OVERFLOW FROM HIGH LEVEL CELL.

R3 THE FLOOR TILE HAS BOTH LOOSE AND FIXED CONTAMINATION THROUGHOUT ROOM. DECONTAMINATION IS NOT POSSIBLE SO THE ENTIRE ROOM HAS BEEN COVERED WITH HERCULITE IN ORDER TO MAINTAIN ACCESS TO HOT CELL YARD. HENCE THE RADIOLOGICAL SURVEY OF FLOOR IS LIMITED TO THE FOUR SAMPLE LOCATIONS AND TWO OTHER RANDOM LOCATIONS.

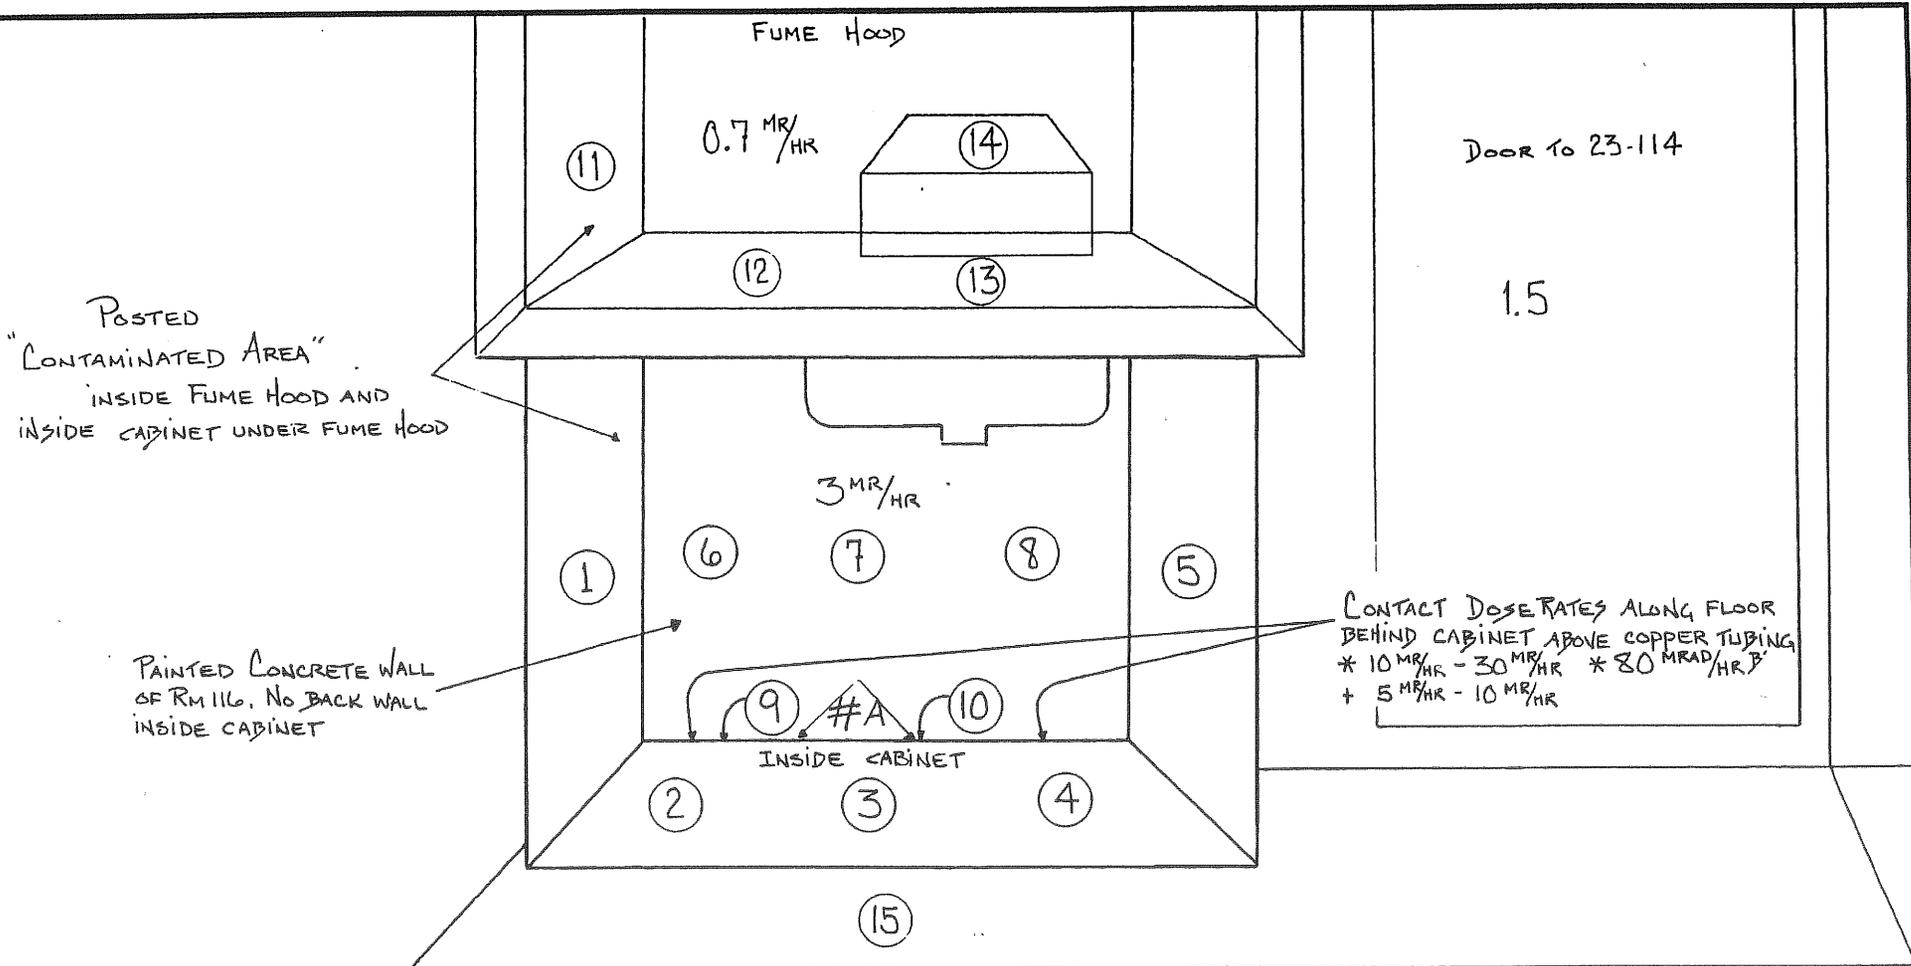
POSTED "CONTAMINATED AREA" INSIDE FUME HOOD AND INSIDE CABINET UNDER FUME HOOD

PAINTED CONCRETE WALL OF RM 116. NO BACK WALL INSIDE CABINET

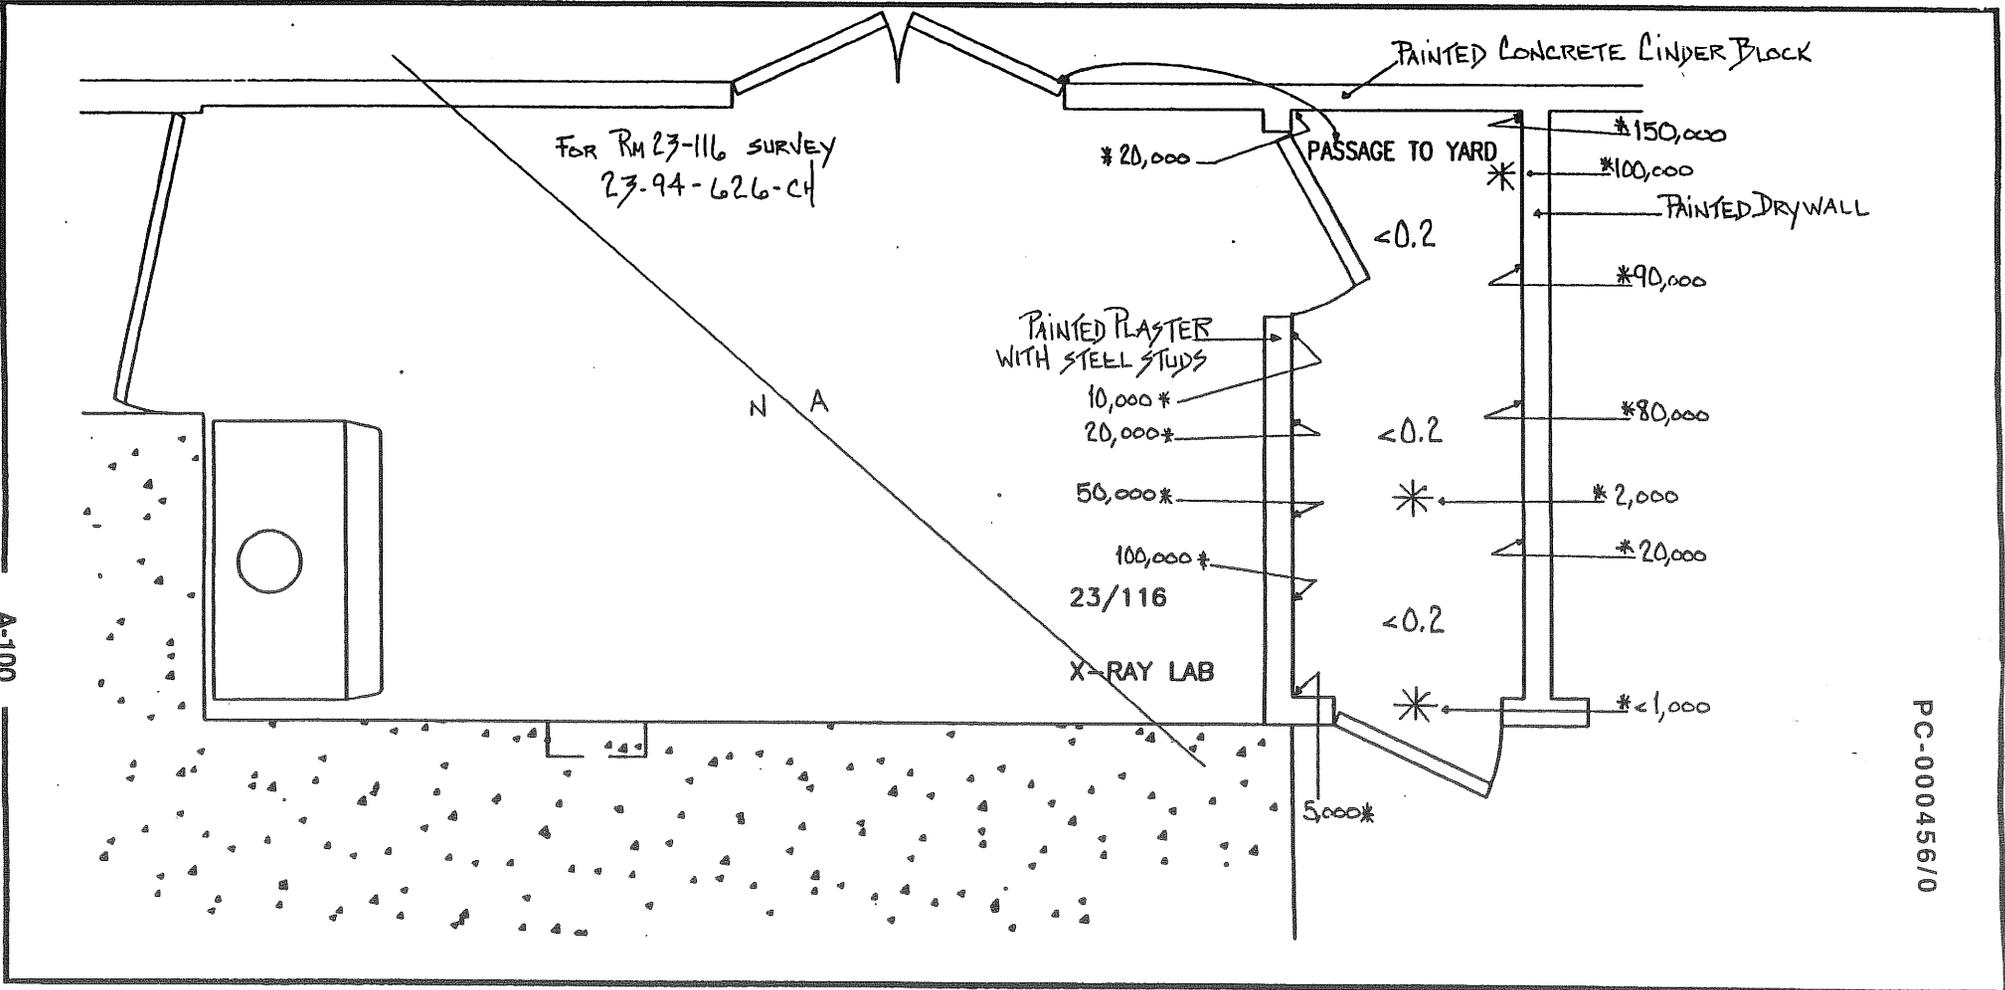
ROOM NO.	23/116A
MEMO NO.	HCI:267:VB:94

R1 THE FLOOR IS CONCRETE WITH FLOOR TILES AND COVERED WITH HERCULITE. THERE ARE NUMEROUS AREAS WITH BOTH LOOSE AND FIXED CONTAMINATION DUE TO WATER HAVING OVERFLOWED <sup>INTO</sup> ~~FROM~~ HIGH LEVEL CELL, <sup>INTO</sup> ~~INTO~~ Rm. 116, HALLWAY AND Rm. 117. DECONTAMINATION WAS NOT POSSIBLE SO HERCULITE WAS USED TO MAINTAIN ACCESS THROUGH Rm 116 AND INTO OUTSIDE YARD. THE DIRECT AND INDIRECT SURVEY OF FLOOR AREA WAS LIMITED TO THE THREE SAMPLE LOCATIONS AND BORDERING FLOOR/BASEBOARD JUNCTIONS.

R2 BECAUSE OF WATER HAVING OVERFLOWED FROM THE HIGH LEVEL CELL INTO Rm 116, Rm. 117 AND THE ADJOINING HALLWAY THE BASEBOARDS WERE NOT REMOVED DUE TO THE LIKELIHOOD OF EXPOSING HOT PARTICLES AND HIGH CONTAMINATION. THIS IS EVIDENCED BY THE CONTAMINATION LEVELS FOUND <sup>ALONG</sup> ~~AROUND~~ AND BENEATH THE <sup>(RM 23 HALL)</sup> ~~(SOUTH)~~ SHARED WALL OF Rm. 117 <sup>(NORTH WALL)</sup> AND DIRECT FRISK SURVEY RESULTS ALONG BASEBOARDS.

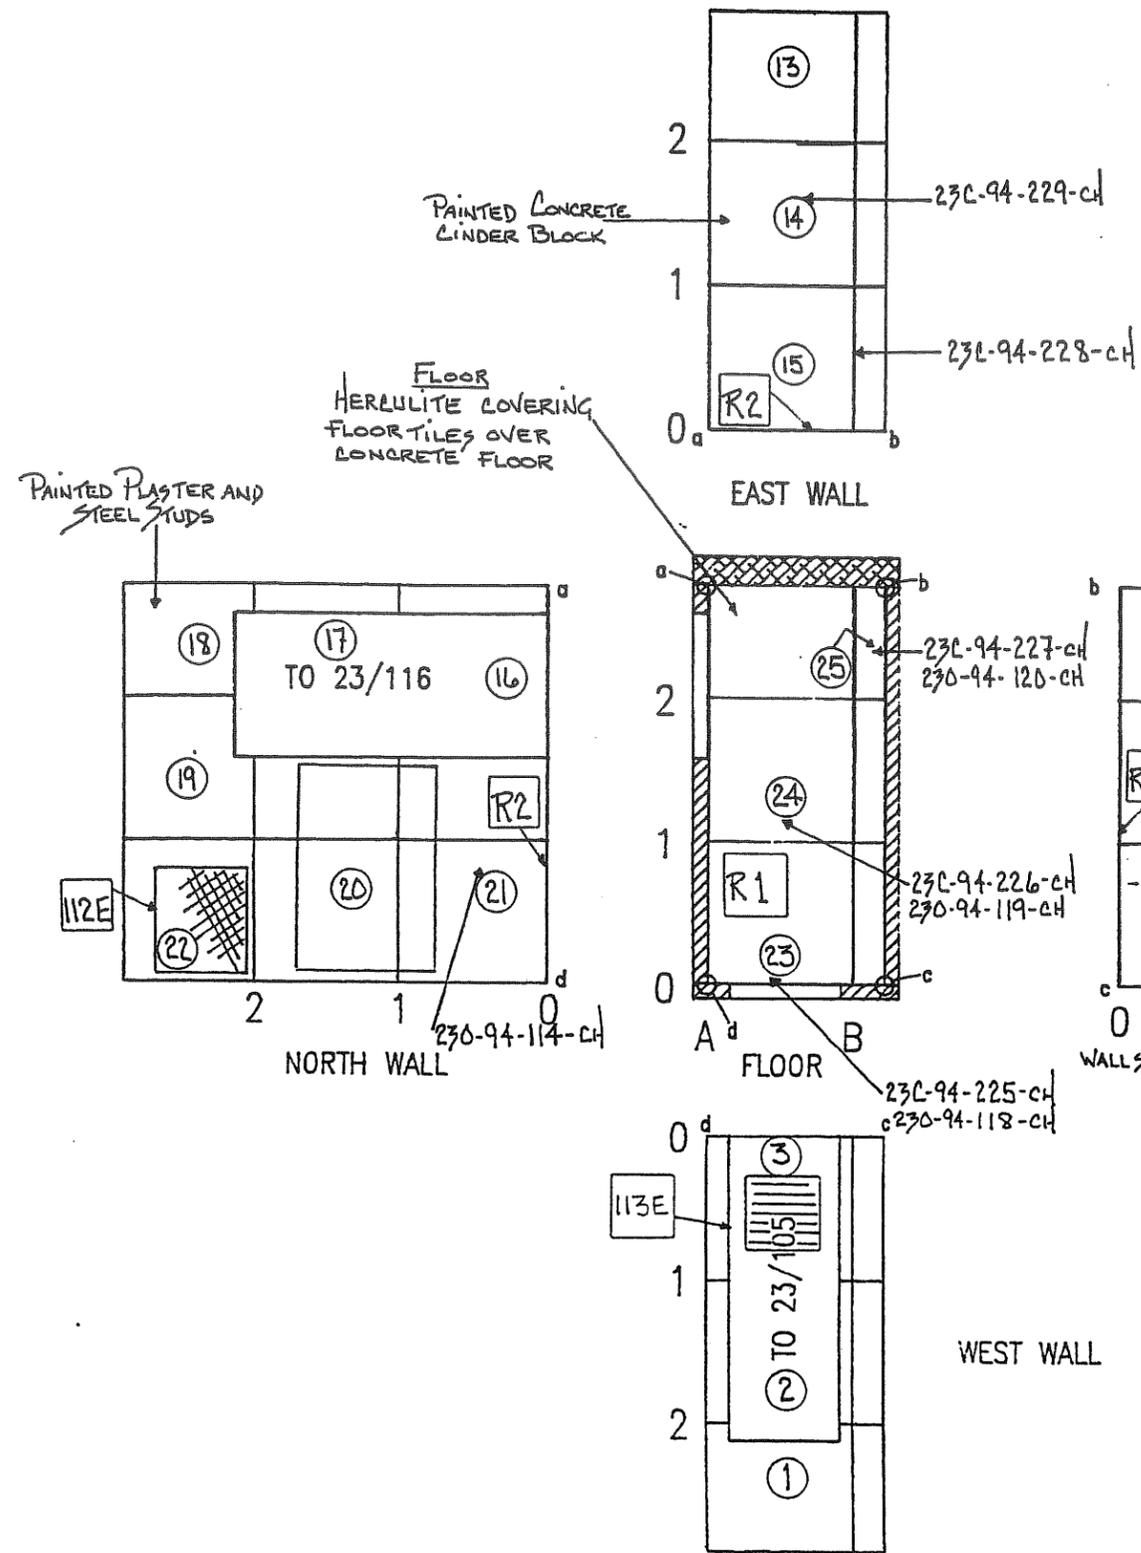
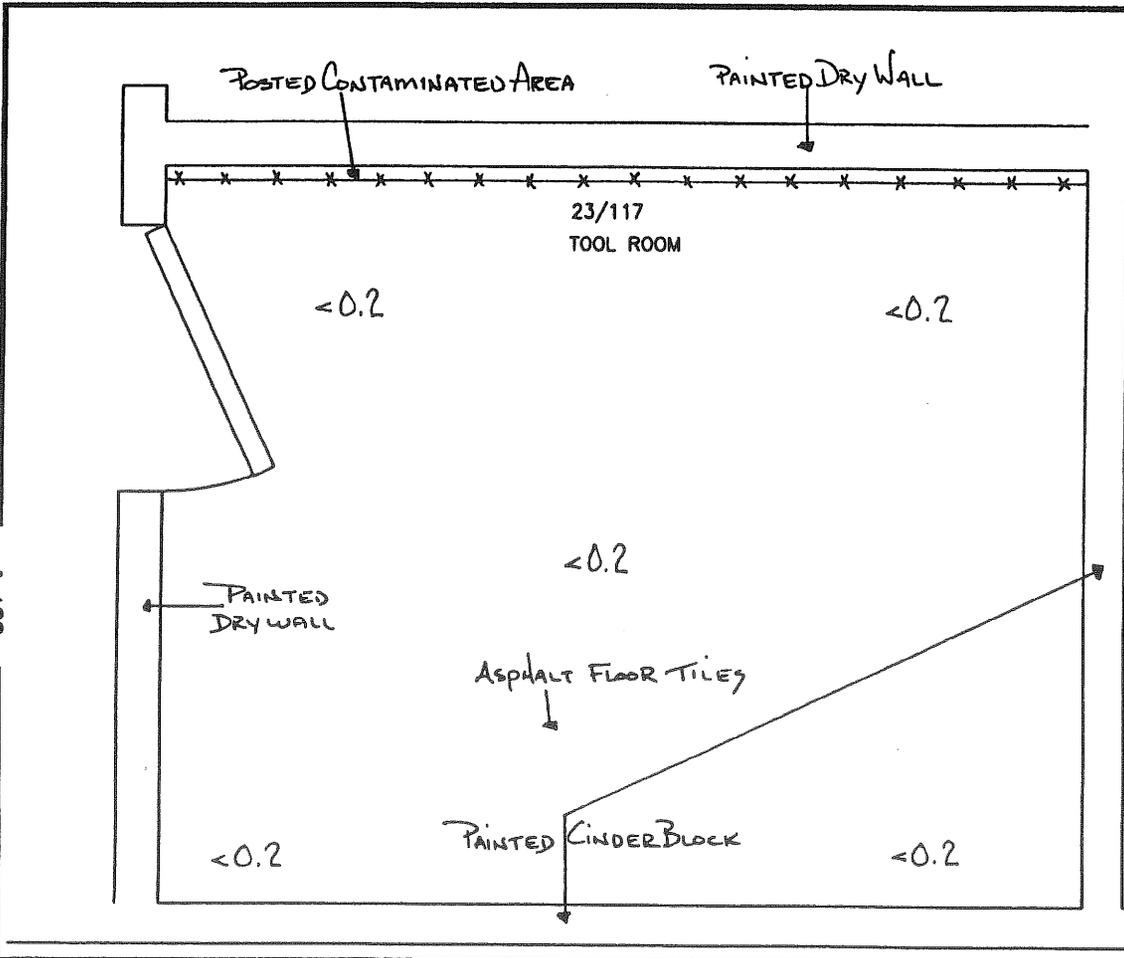
MAP#: 23-117      LOCATION: Tool Room      DATE: 09-22-94      TIME 0700      SURVEY # 23-94-0-0-4-5-3-cl

Additional Remarks:  
 R1 NORTH EAST CORNER OF ROOM HAS NUMEROUS FIXED HOT PARTICLES RANGING FROM 1000 dpm/PROBE AREA TO 20,000 dpm/PROBE AREA.

R1 NORTH/EAST CORNER OF ROOM HAS NUMEROUS FIXED HOT PARTICLES RANGING FROM 1,000 dpm/p.a. TO 20,000 dpm/p.a. (PARTICLES FOUND PRIMARILY IN CRACKS BETWEEN ASPHALT FLOOR TILES)
