PC-000456/0

# GENERAL ATOMICS HOT CELL CHARACTERIZATION REPORT

**GA HOT CELL D&D PROJECT**  
**CONTRACT NO. DE-AC03-95SF20798**  
**PROJECT NO. 7340**

**DECEMBER 1995**

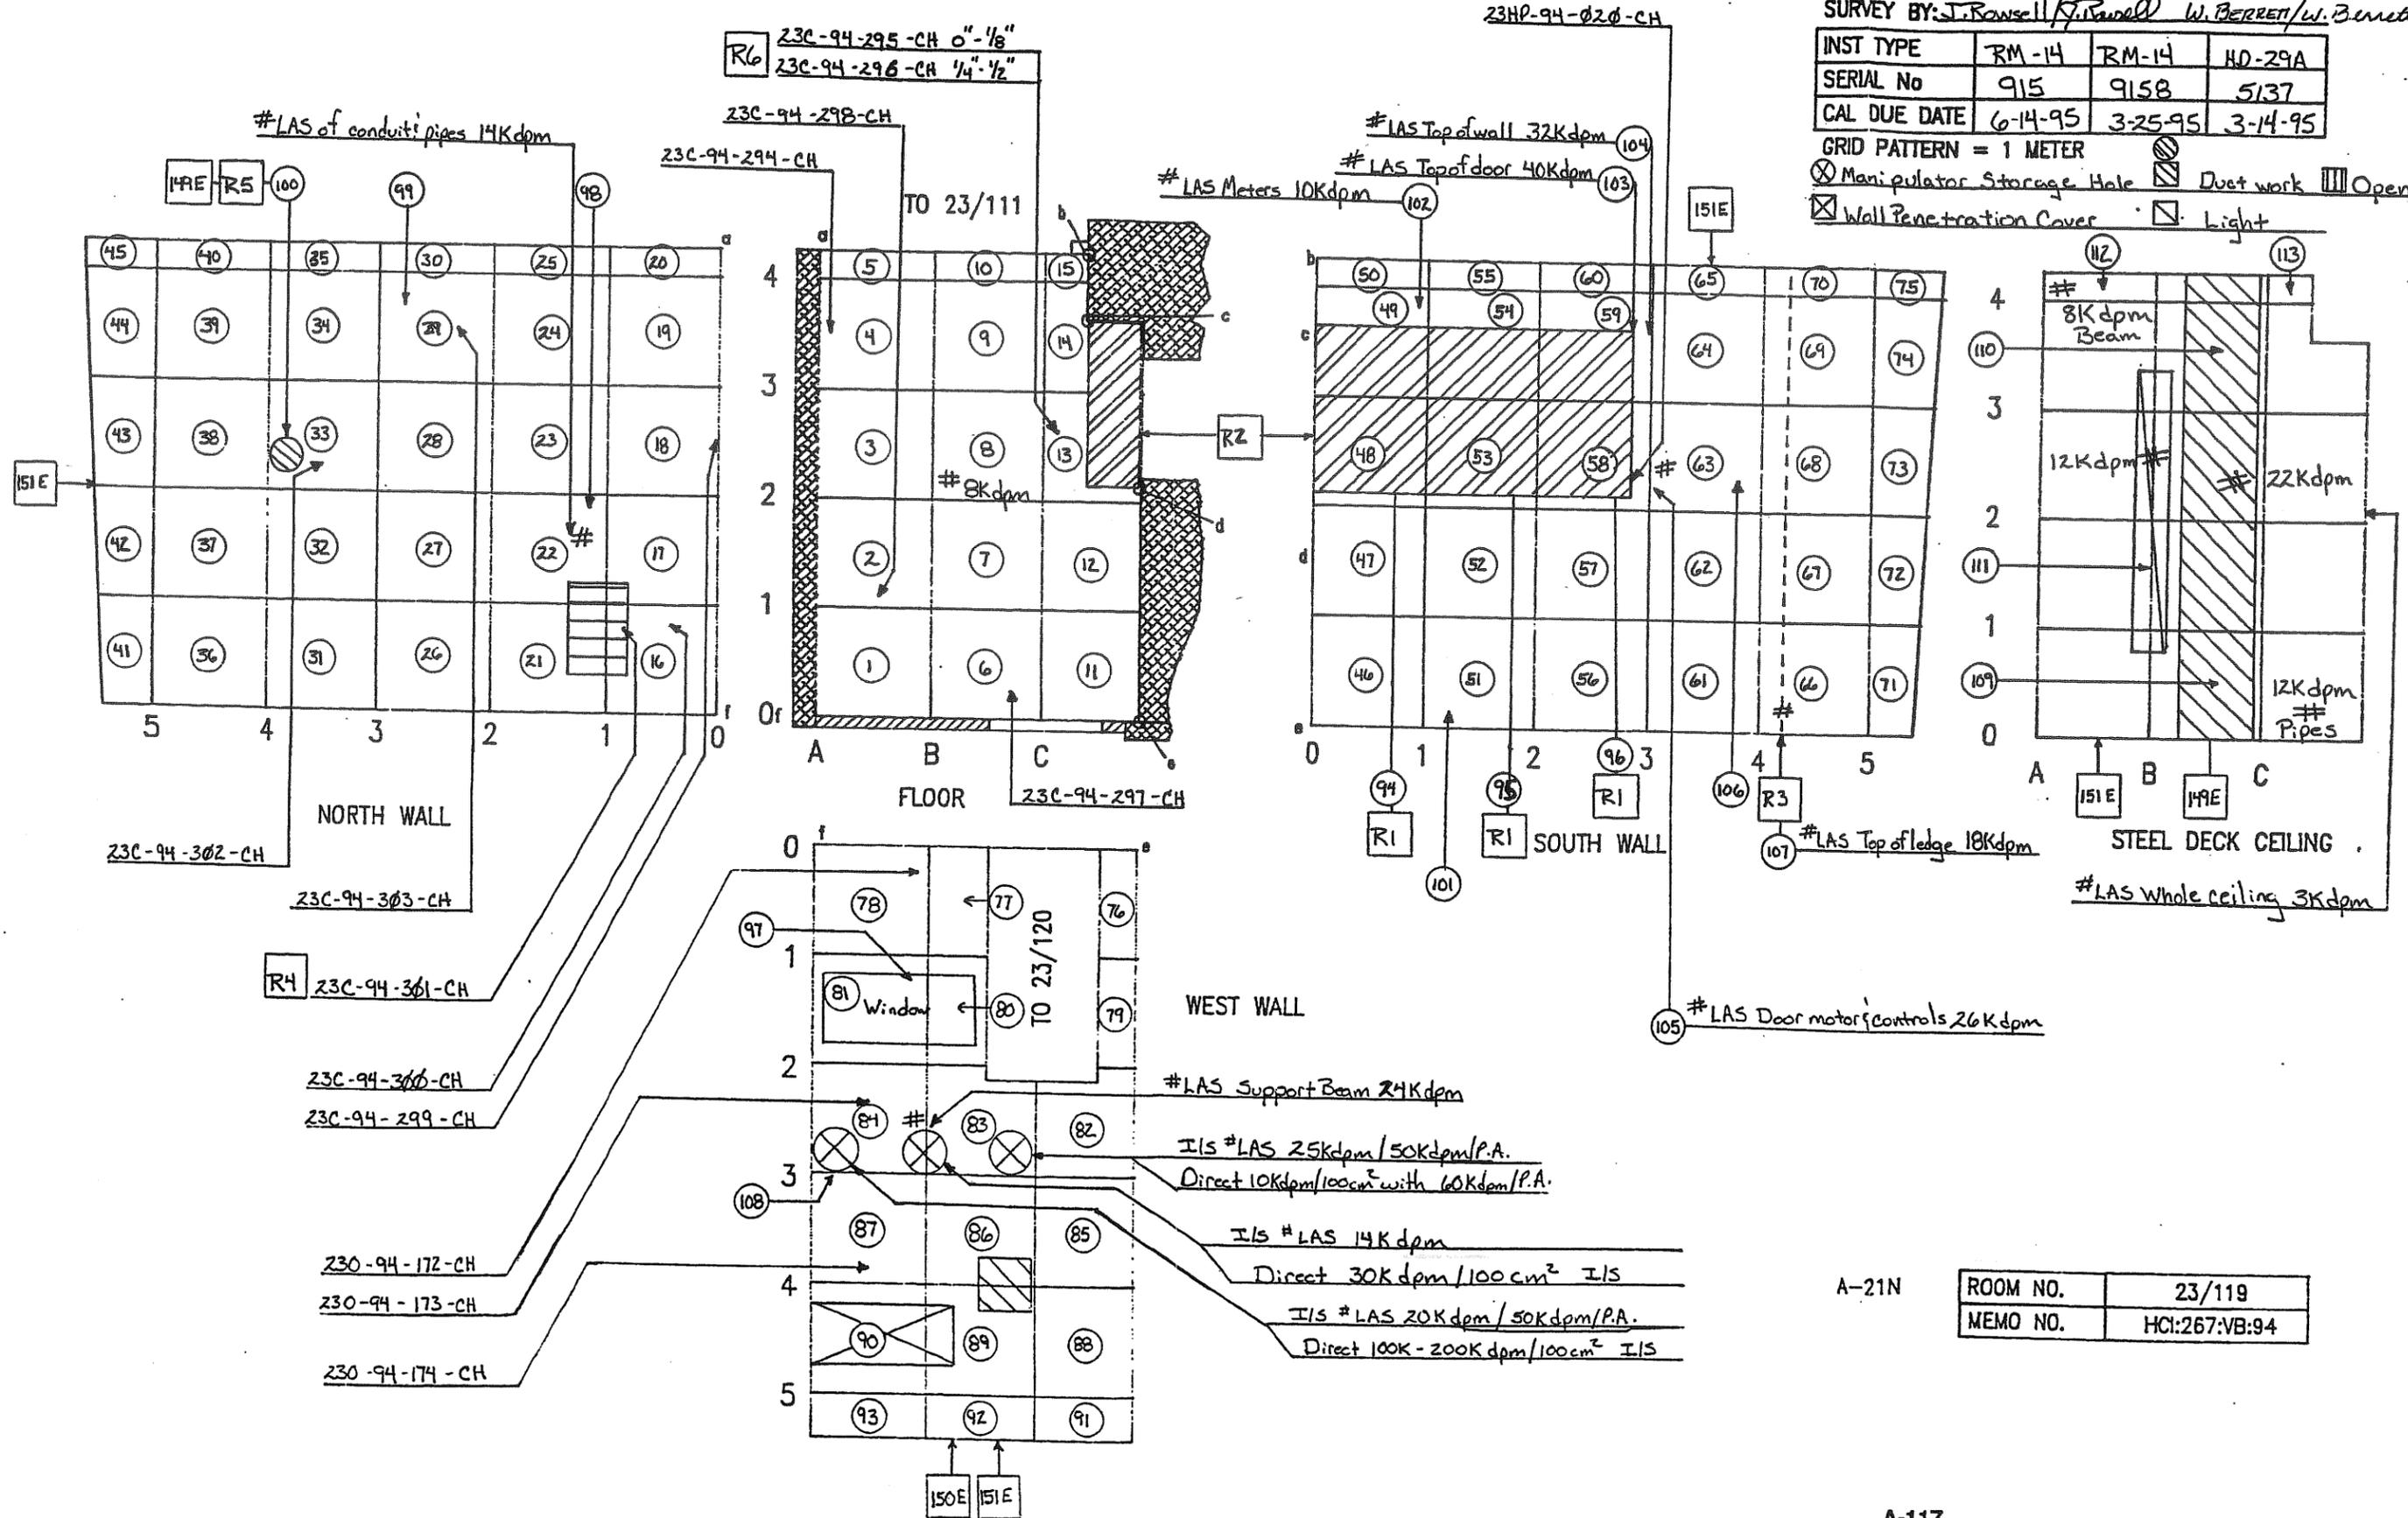
ROOM NO.	23/119
MEMO NO.	HCI:267:VB:94

- R1 Smear taken on side of cell door
- R2 Met cell door.
- R3 Ledge that runs the length of the wall
- R4 Sample 23C-94-301-CH was removed from bottom of opening. (Inside)
- R5 Duct was opened and checked. No detectable loose or fixed above background.
- R6 Samples 23C-94-295-CH & 23C-94-296-CH removed along concrete/metal interface.

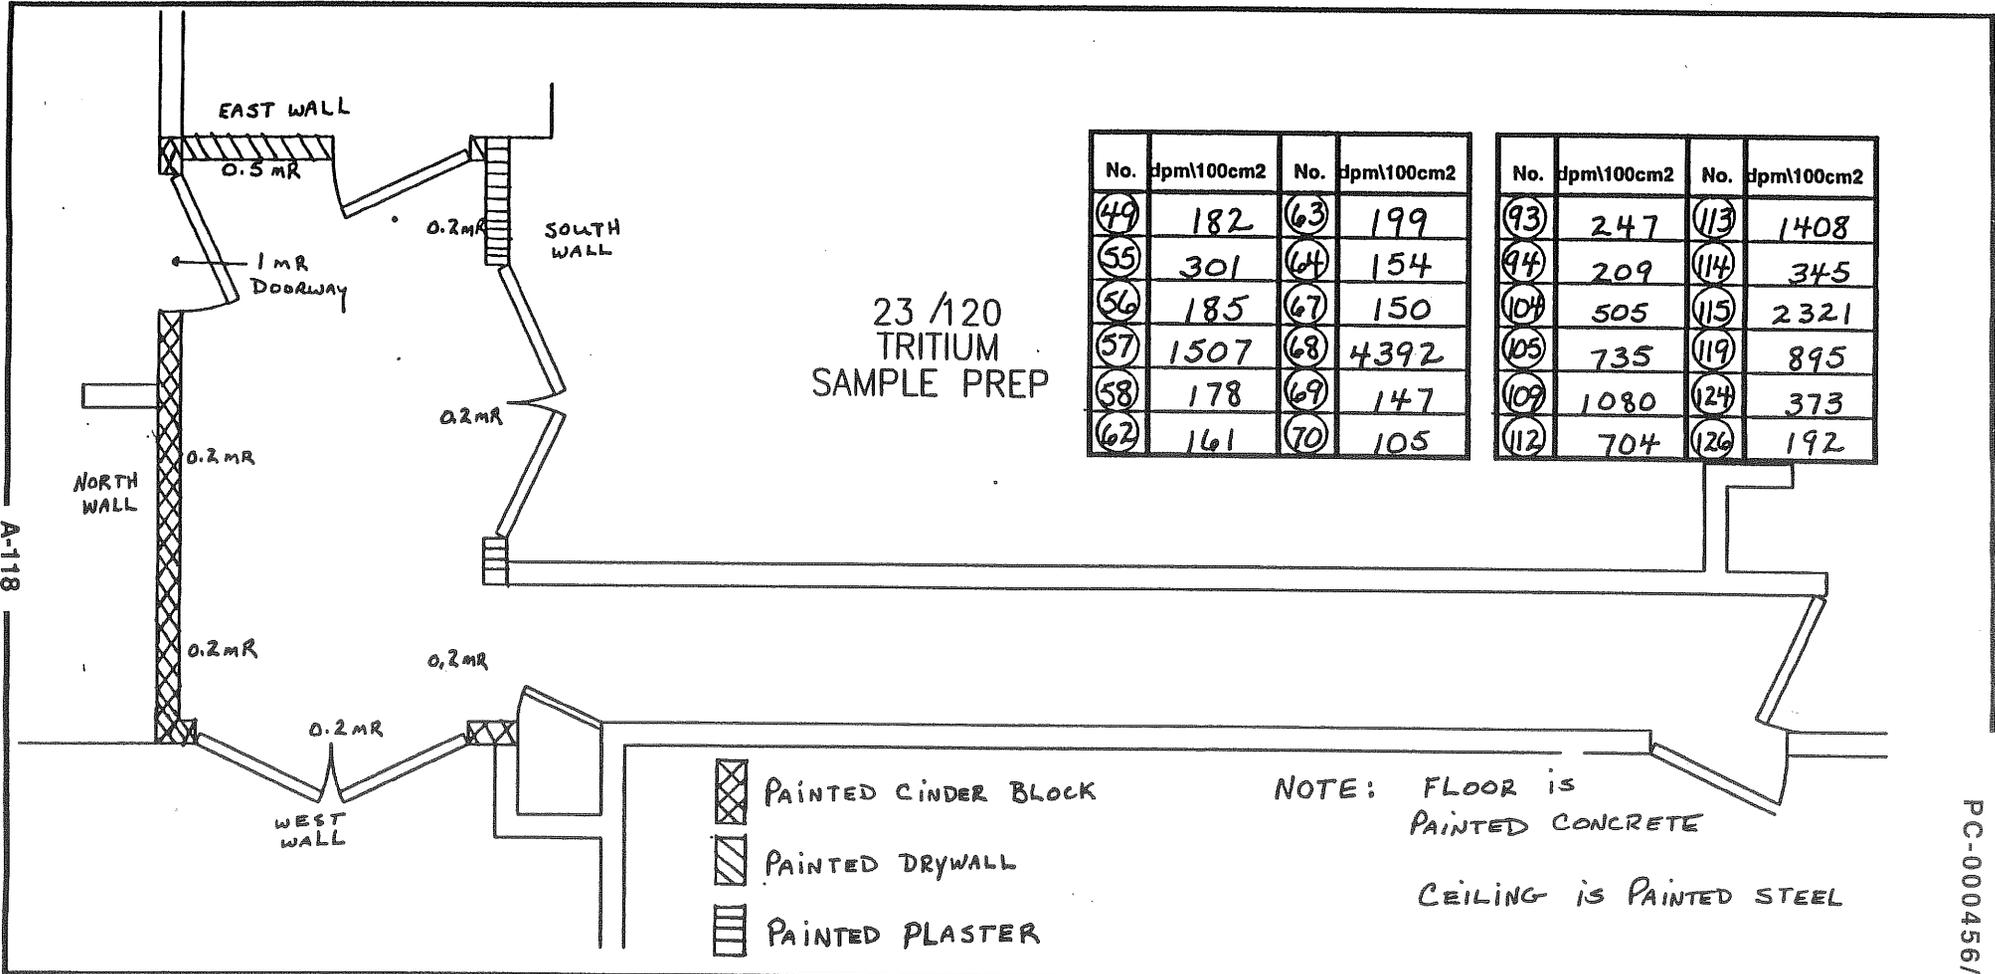
No.	dpm/100cm <sup>2</sup>	No.	dpm/100cm <sup>2</sup>	No.	dpm/100cm <sup>2</sup>	No.	dpm/100cm <sup>2</sup>
(49)	182	(63)	199	(93)	247	(113)	1408
(55)	301	(64)	154	(94)	209	(114)	345
(56)	185	(67)	150	(104)	505	(115)	2321
(57)	1507	(68)	4392	(105)	735	(119)	895
(58)	178	(69)	147	(109)	1080	(124)	373
(62)	161	(70)	105	(112)	704	(126)	192

KEY		No.	dpm/100 cm <sup>2</sup>	No.	dpm/100 cm <sup>2</sup>	Remarks (see Note 4 below)		
○	SMEAR	◆	H <sup>3</sup> SMEAR	(21)	437	(32)	91	SMEARS < MDCR NOT LISTED.
#	LARGE AREA SMEAR	xxx	BOUNDARY	(22)	367	(33)	517	
□	AIR SAMPLE LOCATION	(Show sample Id in Remarks)		(24)	77	(36)	196	NO ALPHA DETECTED.
*	CONTACT DOSE RATE	+	12" DOSE RATE	(25)	206	(37)	245	
β	BETA DOSE RATE ONLY	α	ALPHA ONLY	(27)	157	(38)	175	AIR SAMPLES TAKEN DURING SAMPLE MEDIA COLLECTION
HS	HOT SPOT	Δ	NEUTRON DOSE RATE	(28)	80	(39)	276

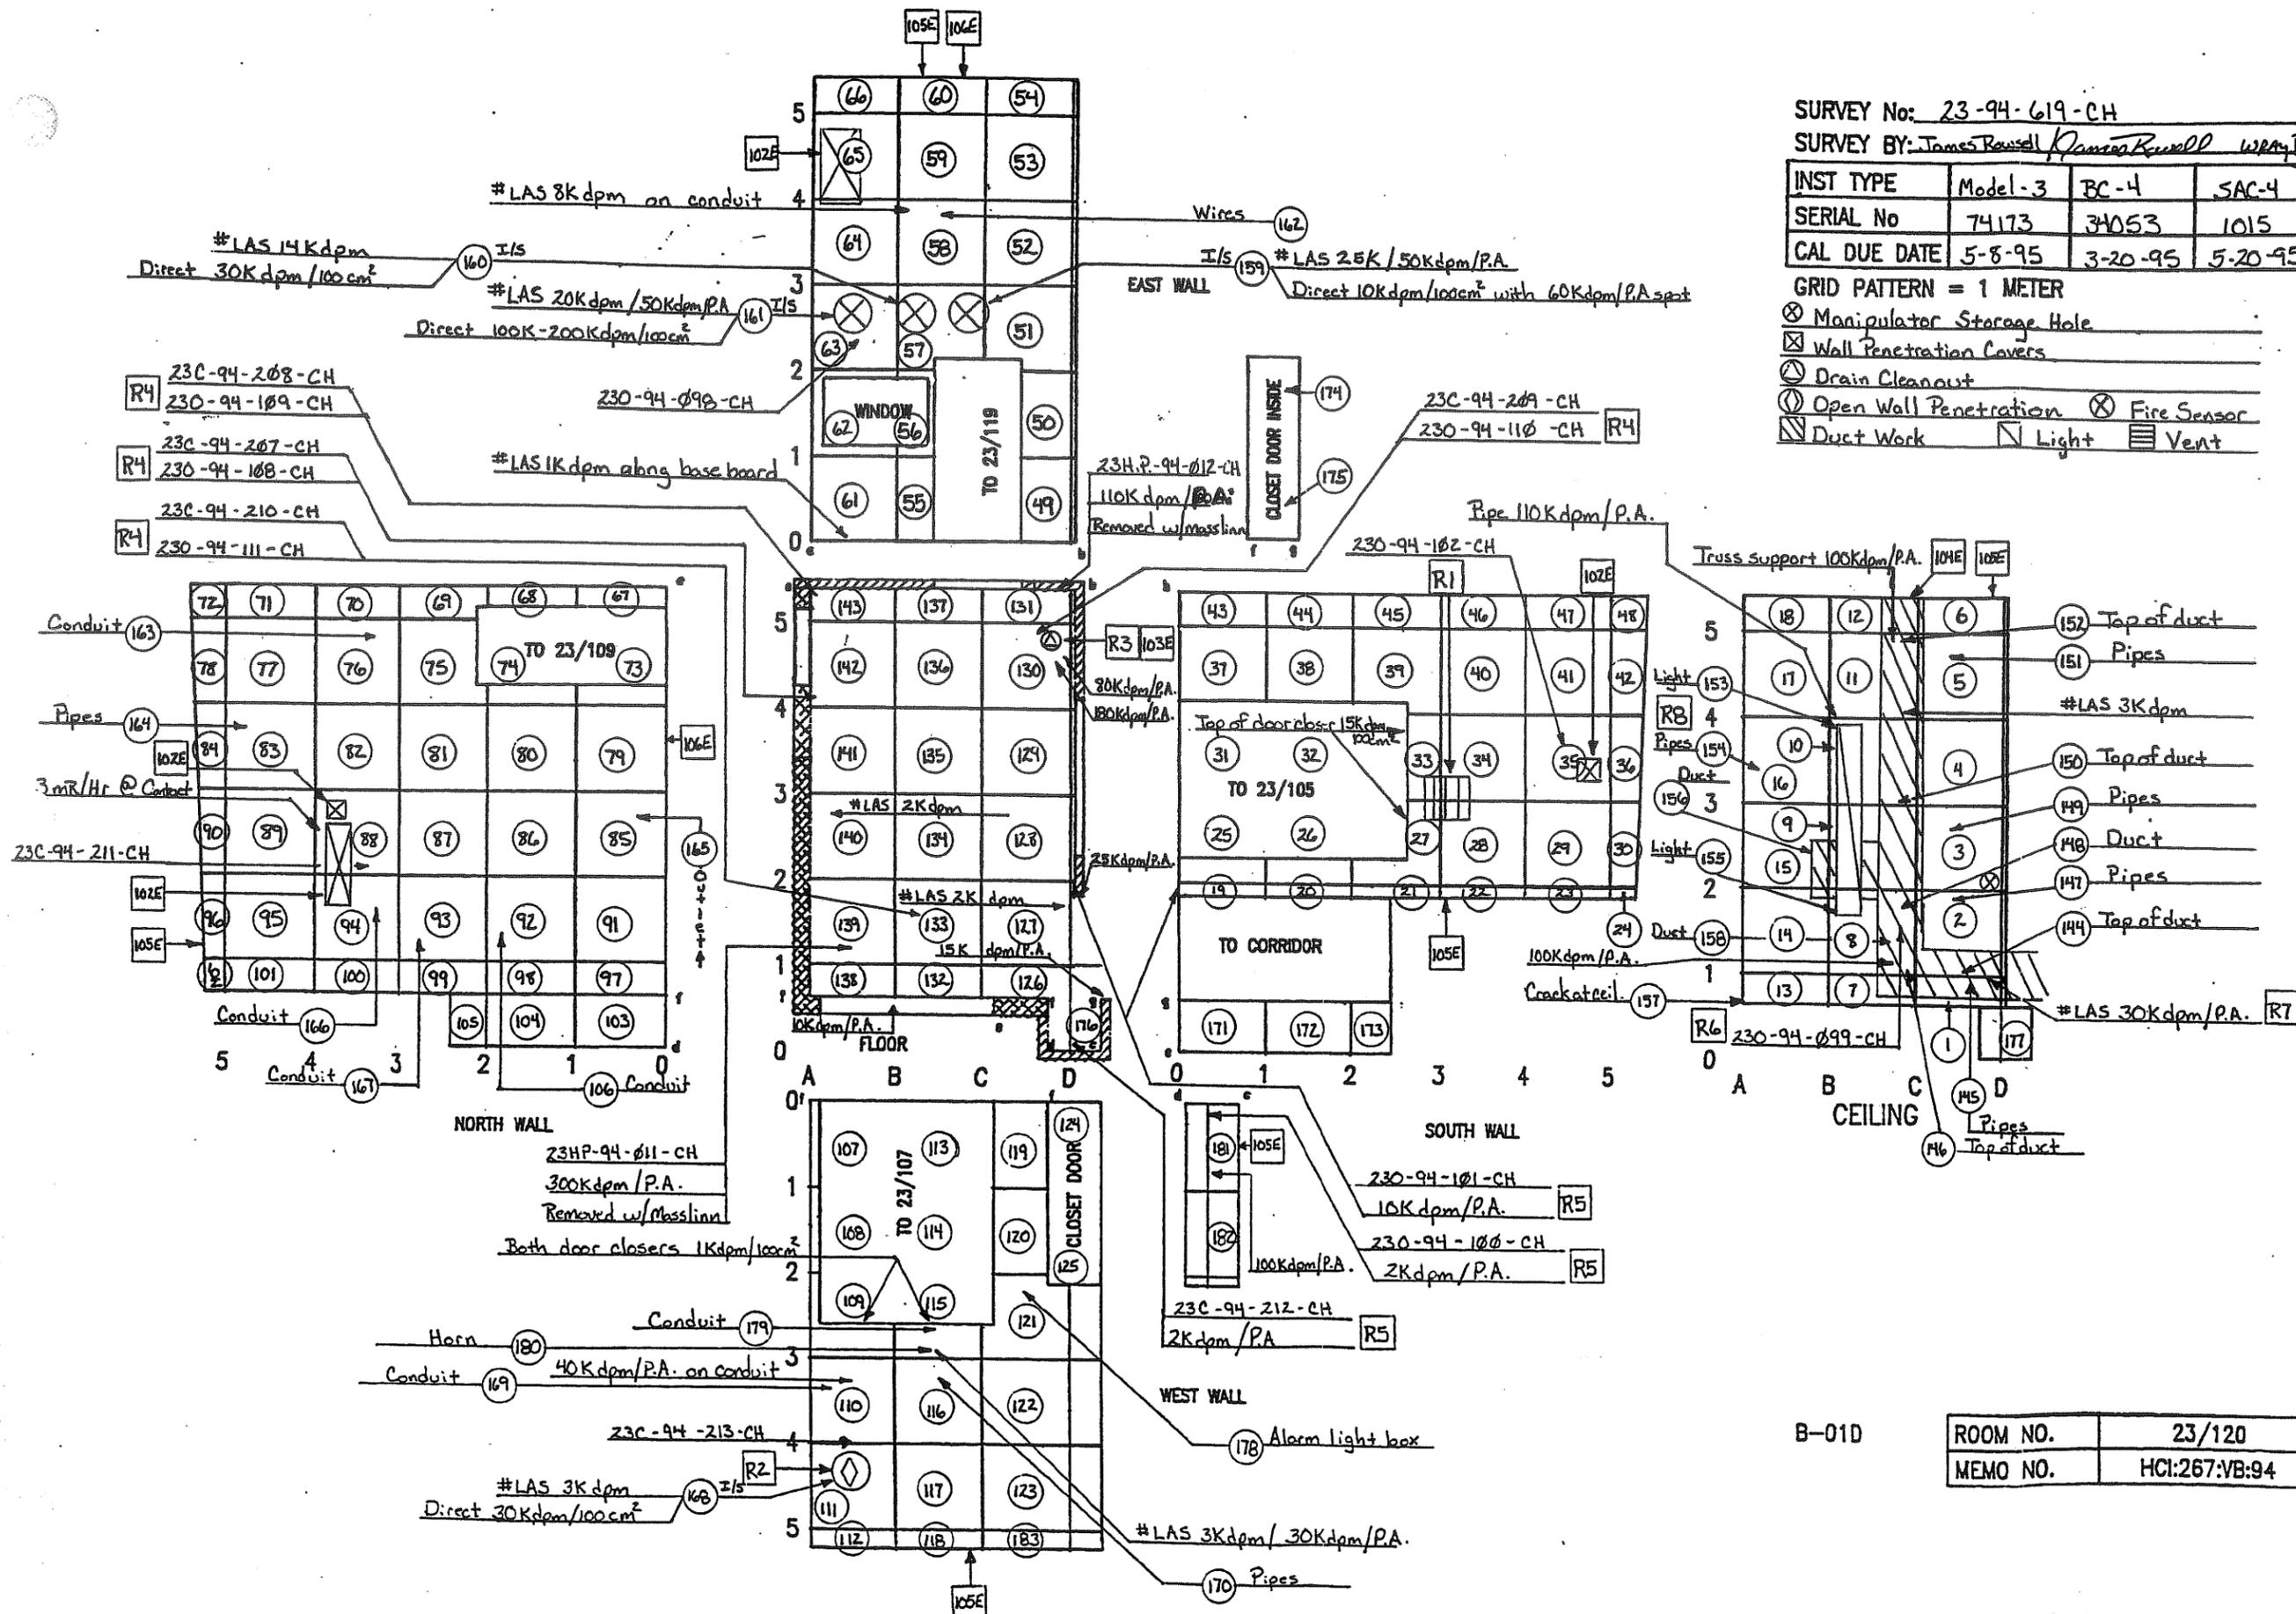
ROOM NO.	23/120
MEMO NO.	HCI:267:VB:94

R1 Vent (damper) cover removed. Frisked and smeared. No detectable found.

R3 Drain cover was removed. Opening frisked and inside of pipesmeared. No detectable fixed or loose.

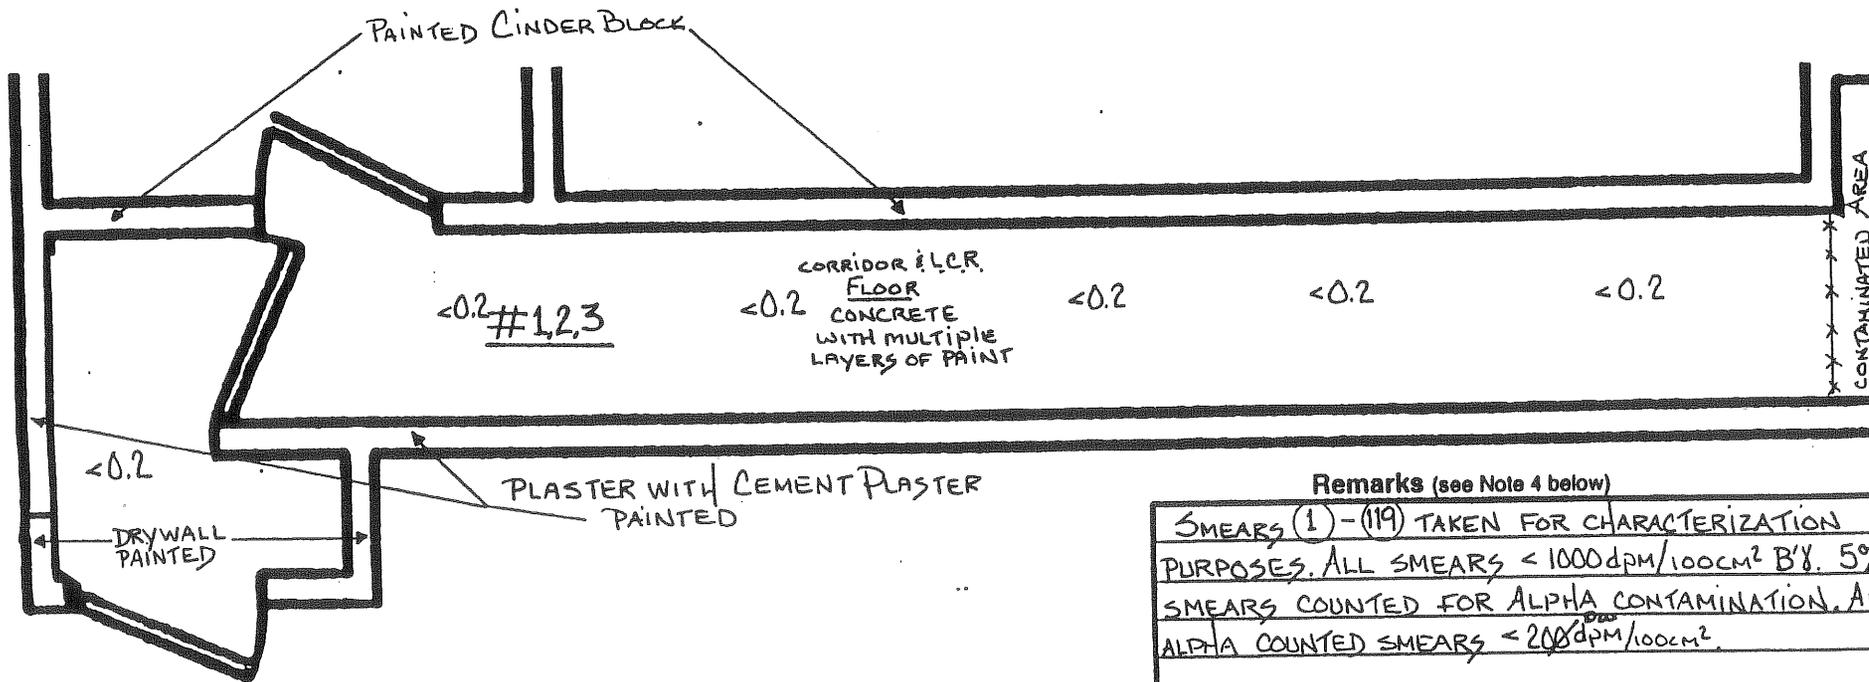
Remarks (see Note 4 below)  
SMEARS (1)-(119) TAKEN FOR CHARACTERIZATION PURPOSES. ALL SMEARS < 1000 dpm/100cm<sup>2</sup> B'Y. 5% OF SMEARS COUNTED FOR ALPHA CONTAMINATION. ALL ALPHA COUNTED SMEARS < 200 dpm/100cm<sup>2</sup>.

R3 3 LARGE AREA MASSLIN SMEARS WERE TAKEN ON FLOOR. #1-8,000 dpm/PROBE AREA #2-4,000 dpm/PROBE AREA #3 <1,000 dpm/PROBE AREA. TWO MORE LARGE AREA MASSLIN SMEARS WERE TAKEN ON EAST AND WEST WALLS. BOTH SMEARS <1,000 dpm/PROBE AREA NO HOT PARTICLES FOUND.
