Annual Inspection of the Grand Junction, Colorado, Site

1.1 Inspection Summary

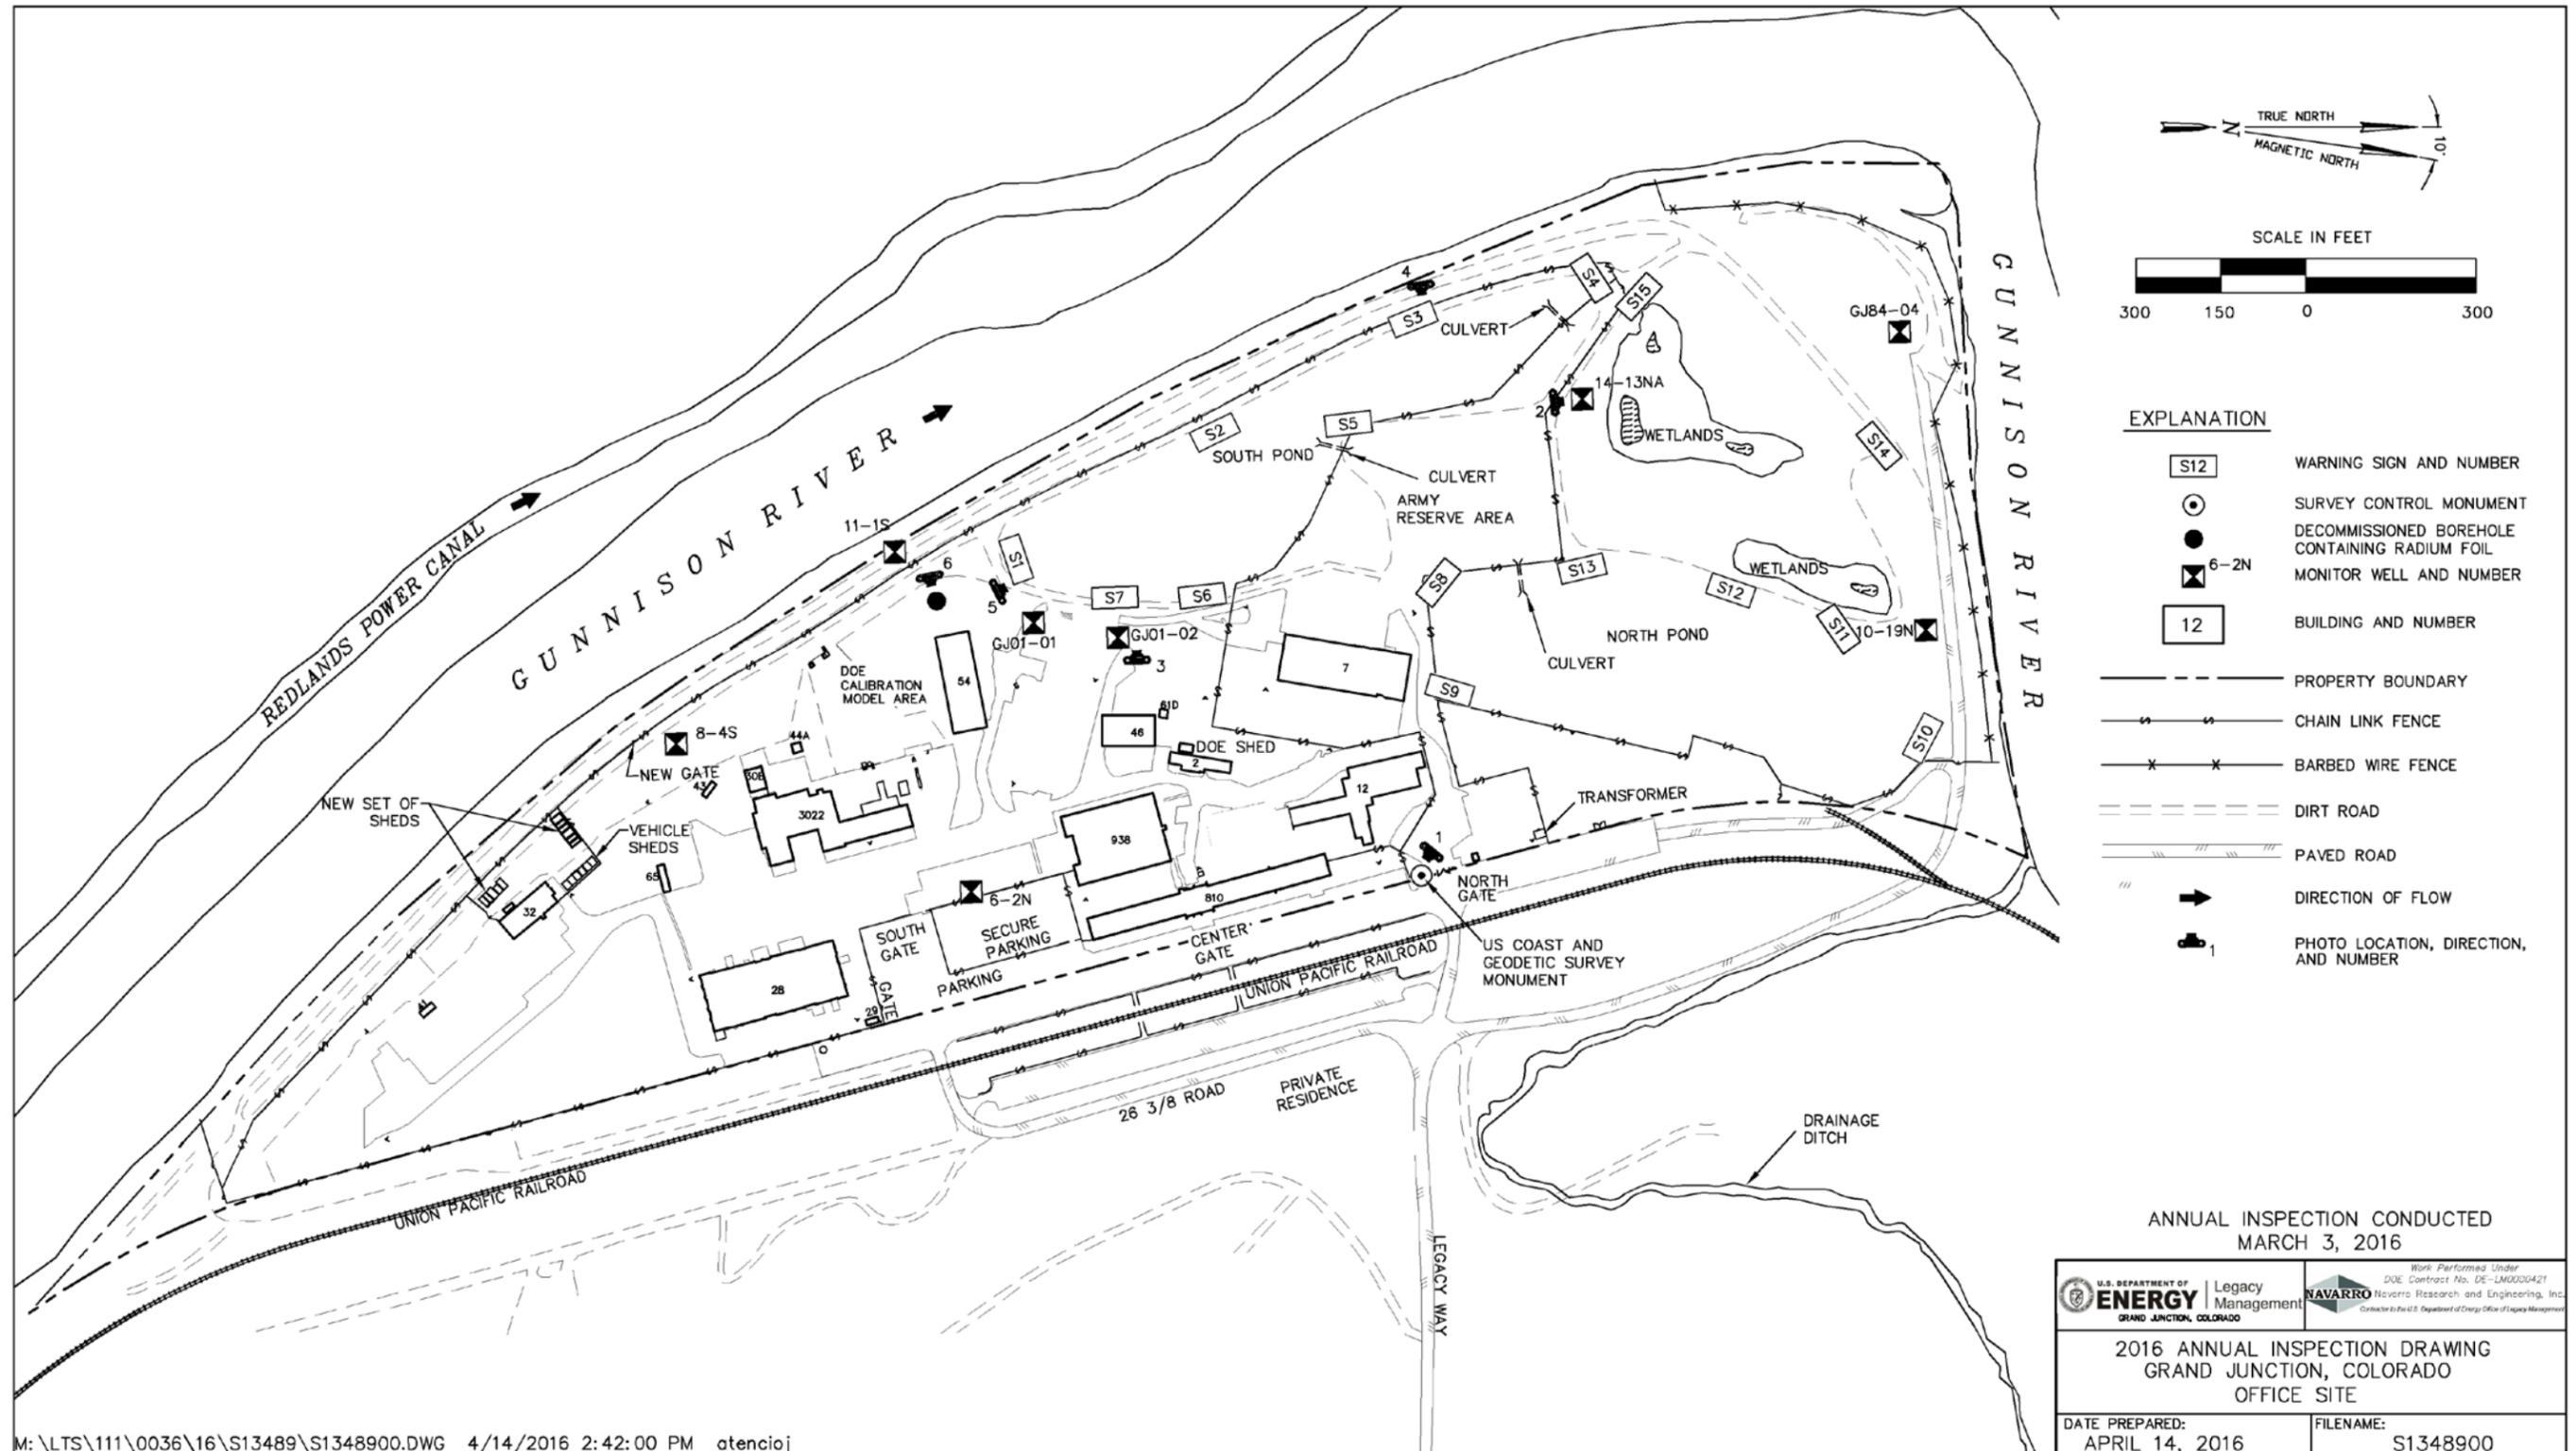
Figure 1. 2016 Annual Inspection Drawing for the Grand Junction Site

Figure 1 shows the locations of site surveillance features. Inspection results and recommended maintenance activities associated with site surveillance features are included in the following subsections.

1. Warning sign S7 – needs to be tightened to post.
2. Well 11-1S – re-stamp/label well on the well-vault lid.
3. Pick up fence post lying on the ground on the east side of the South Pond.
4. Broken pipe sticking out of the ground in the dirt road that loops around Building 46 needs to be removed or cut to be level with the surrounding surface.
5. The panel on the electrical box located east of the South Pond needs to be closed and secured.
