## 8.0 Gunnison, Colorado, Disposal Site

### 8.1 Compliance Summary

Figure 8-1. 2013 Annual Inspection Drawing for the Gunnison Disposal Site

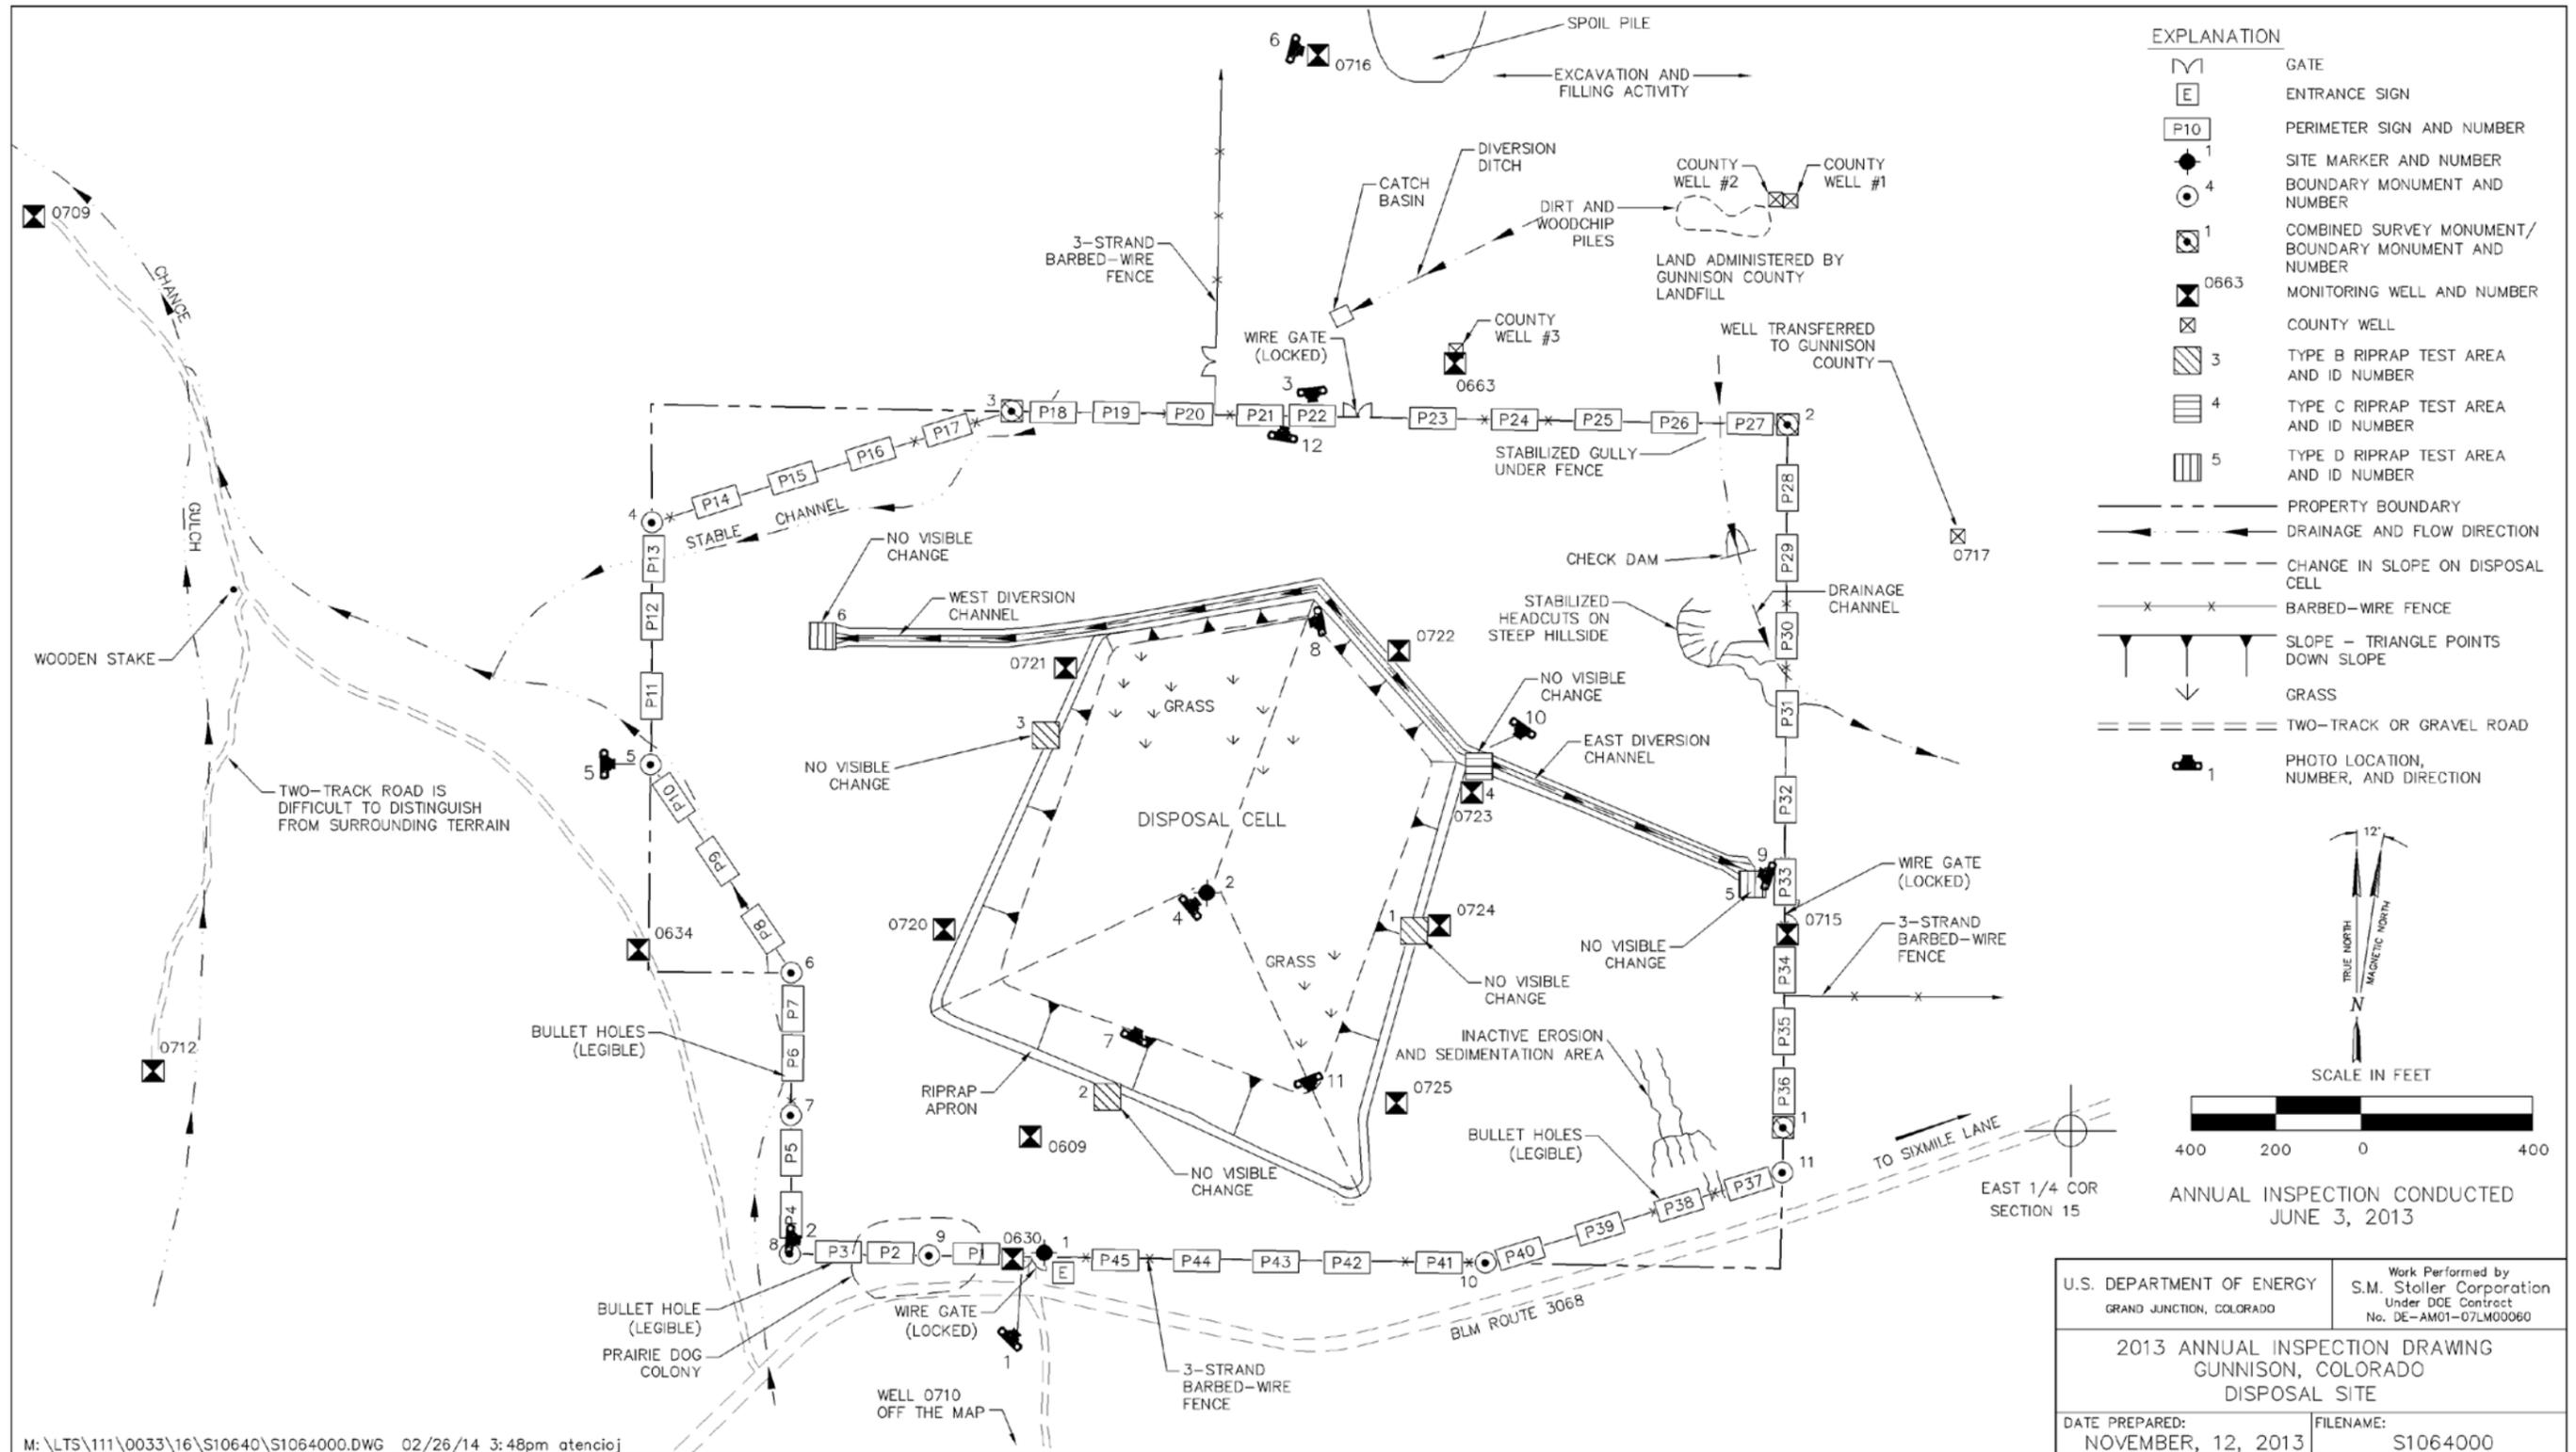
Figure 8-1 shows the locations of site surveillance features. Inspection results and recommended maintenance activities associated with site surveillance features are included in the following subsections. Photographs to support specific observations are identified in the text and on Figure 8-1 by photograph location (PL) numbers.
