8.0 Gunnison, Colorado, Disposal Site

8.1 Compliance Summary

The Gunnison, Colorado, Uranium Mill Tailings Radiation Control Act (UMTRCA) Title I Disposal Site was inspected on June 7, 2011. The disposal cell and all associated surface water diversion and drainage structures were in excellent condition and functioning as designed. Six riprap test areas on the cell apron and diversion ditches were visually inspected; no apparent rock degradation was noted when compared to previous photos. A broken fence strand was repaired. No other maintenance needs or cause for a follow-up or contingency inspection was identified.

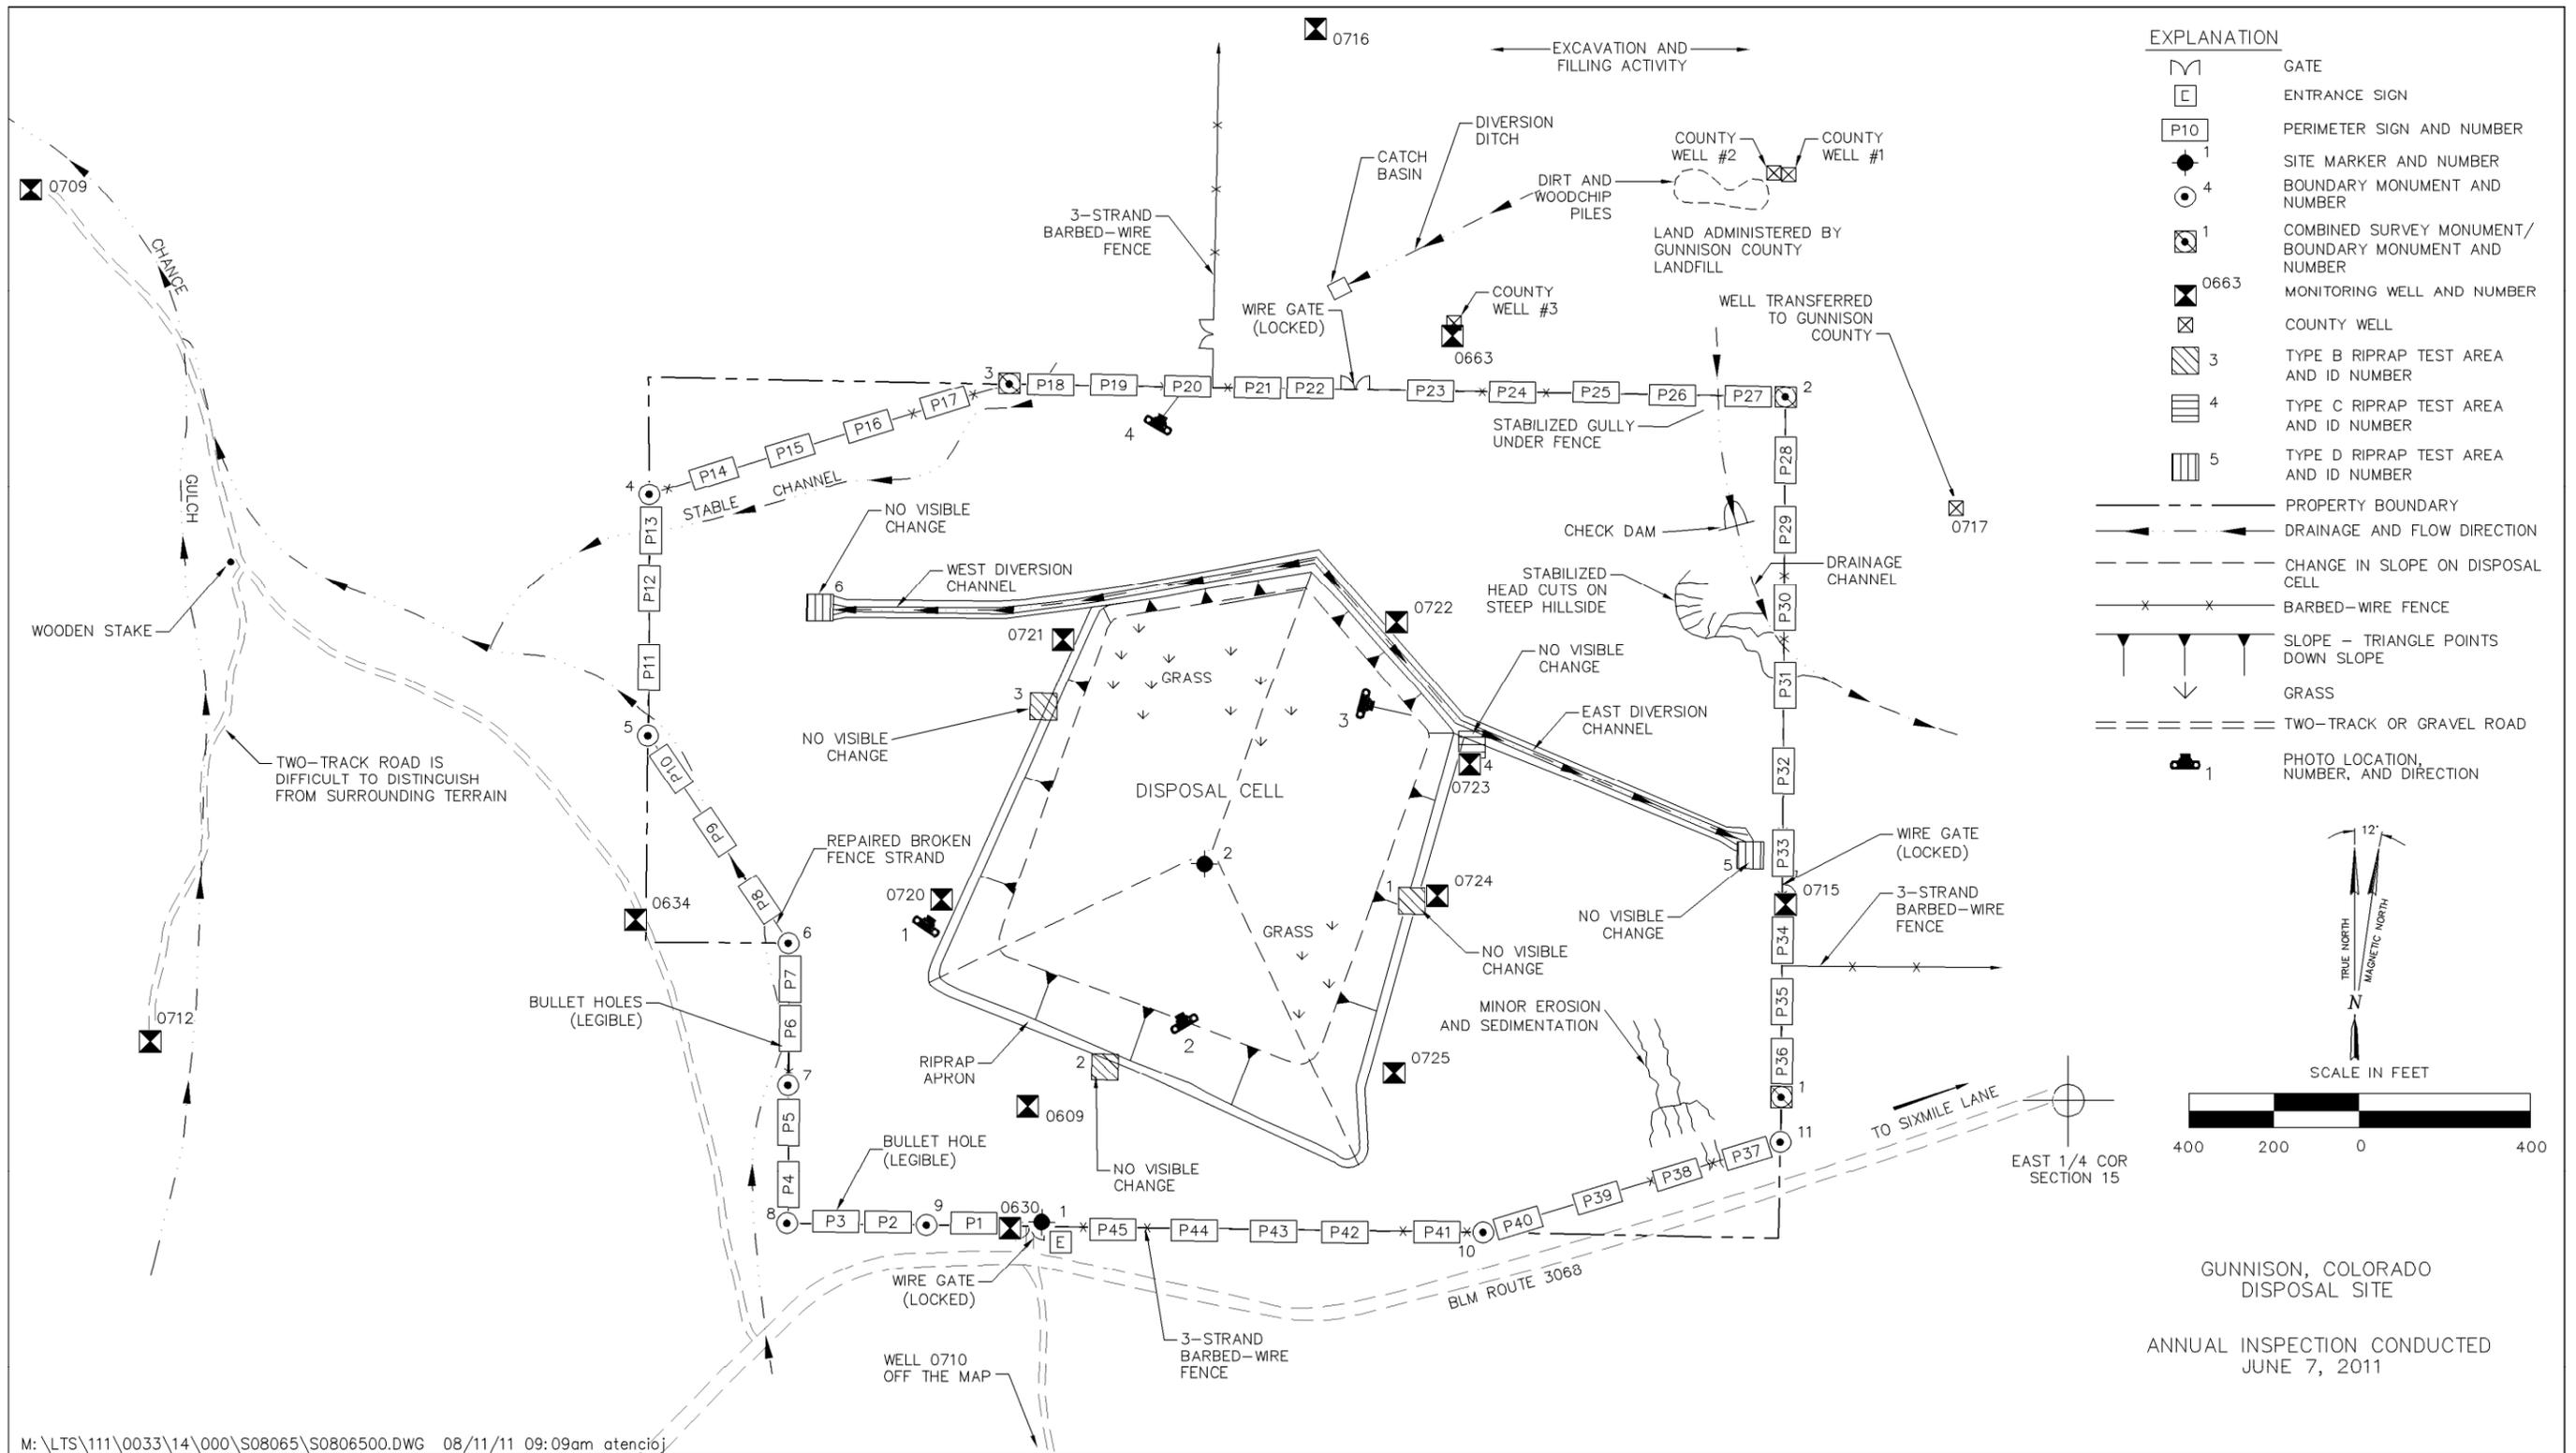
Figure 8-1. 2011 Annual Compliance Drawing for the Gunnison Disposal Site

8A A three-strand, barbed-wire fence delineates the site; most of it is set along the property boundary. A broken strand near perimeter sign P8 was repaired. Otherwise, the fence was in good condition.

At the southeast corner of the cell apron, water draining off the cell occasionally ponds in a low-lying area along the edge of the riprap. The riparian-type vegetation that has become established in this area indicates that the area retains moisture much of the time. Water collection in this area does not pose a problem because the cell is designed to drain to the southeast, and any water that ponds there is below the elevation of the entombed tailings material. This location was dry at the time of the inspection.
