11.0 Maybell, Colorado, Disposal Site

11.1 Compliance Summary

Figure 11-1. 2015 Annual Inspection Drawing for the Maybell Disposal Site

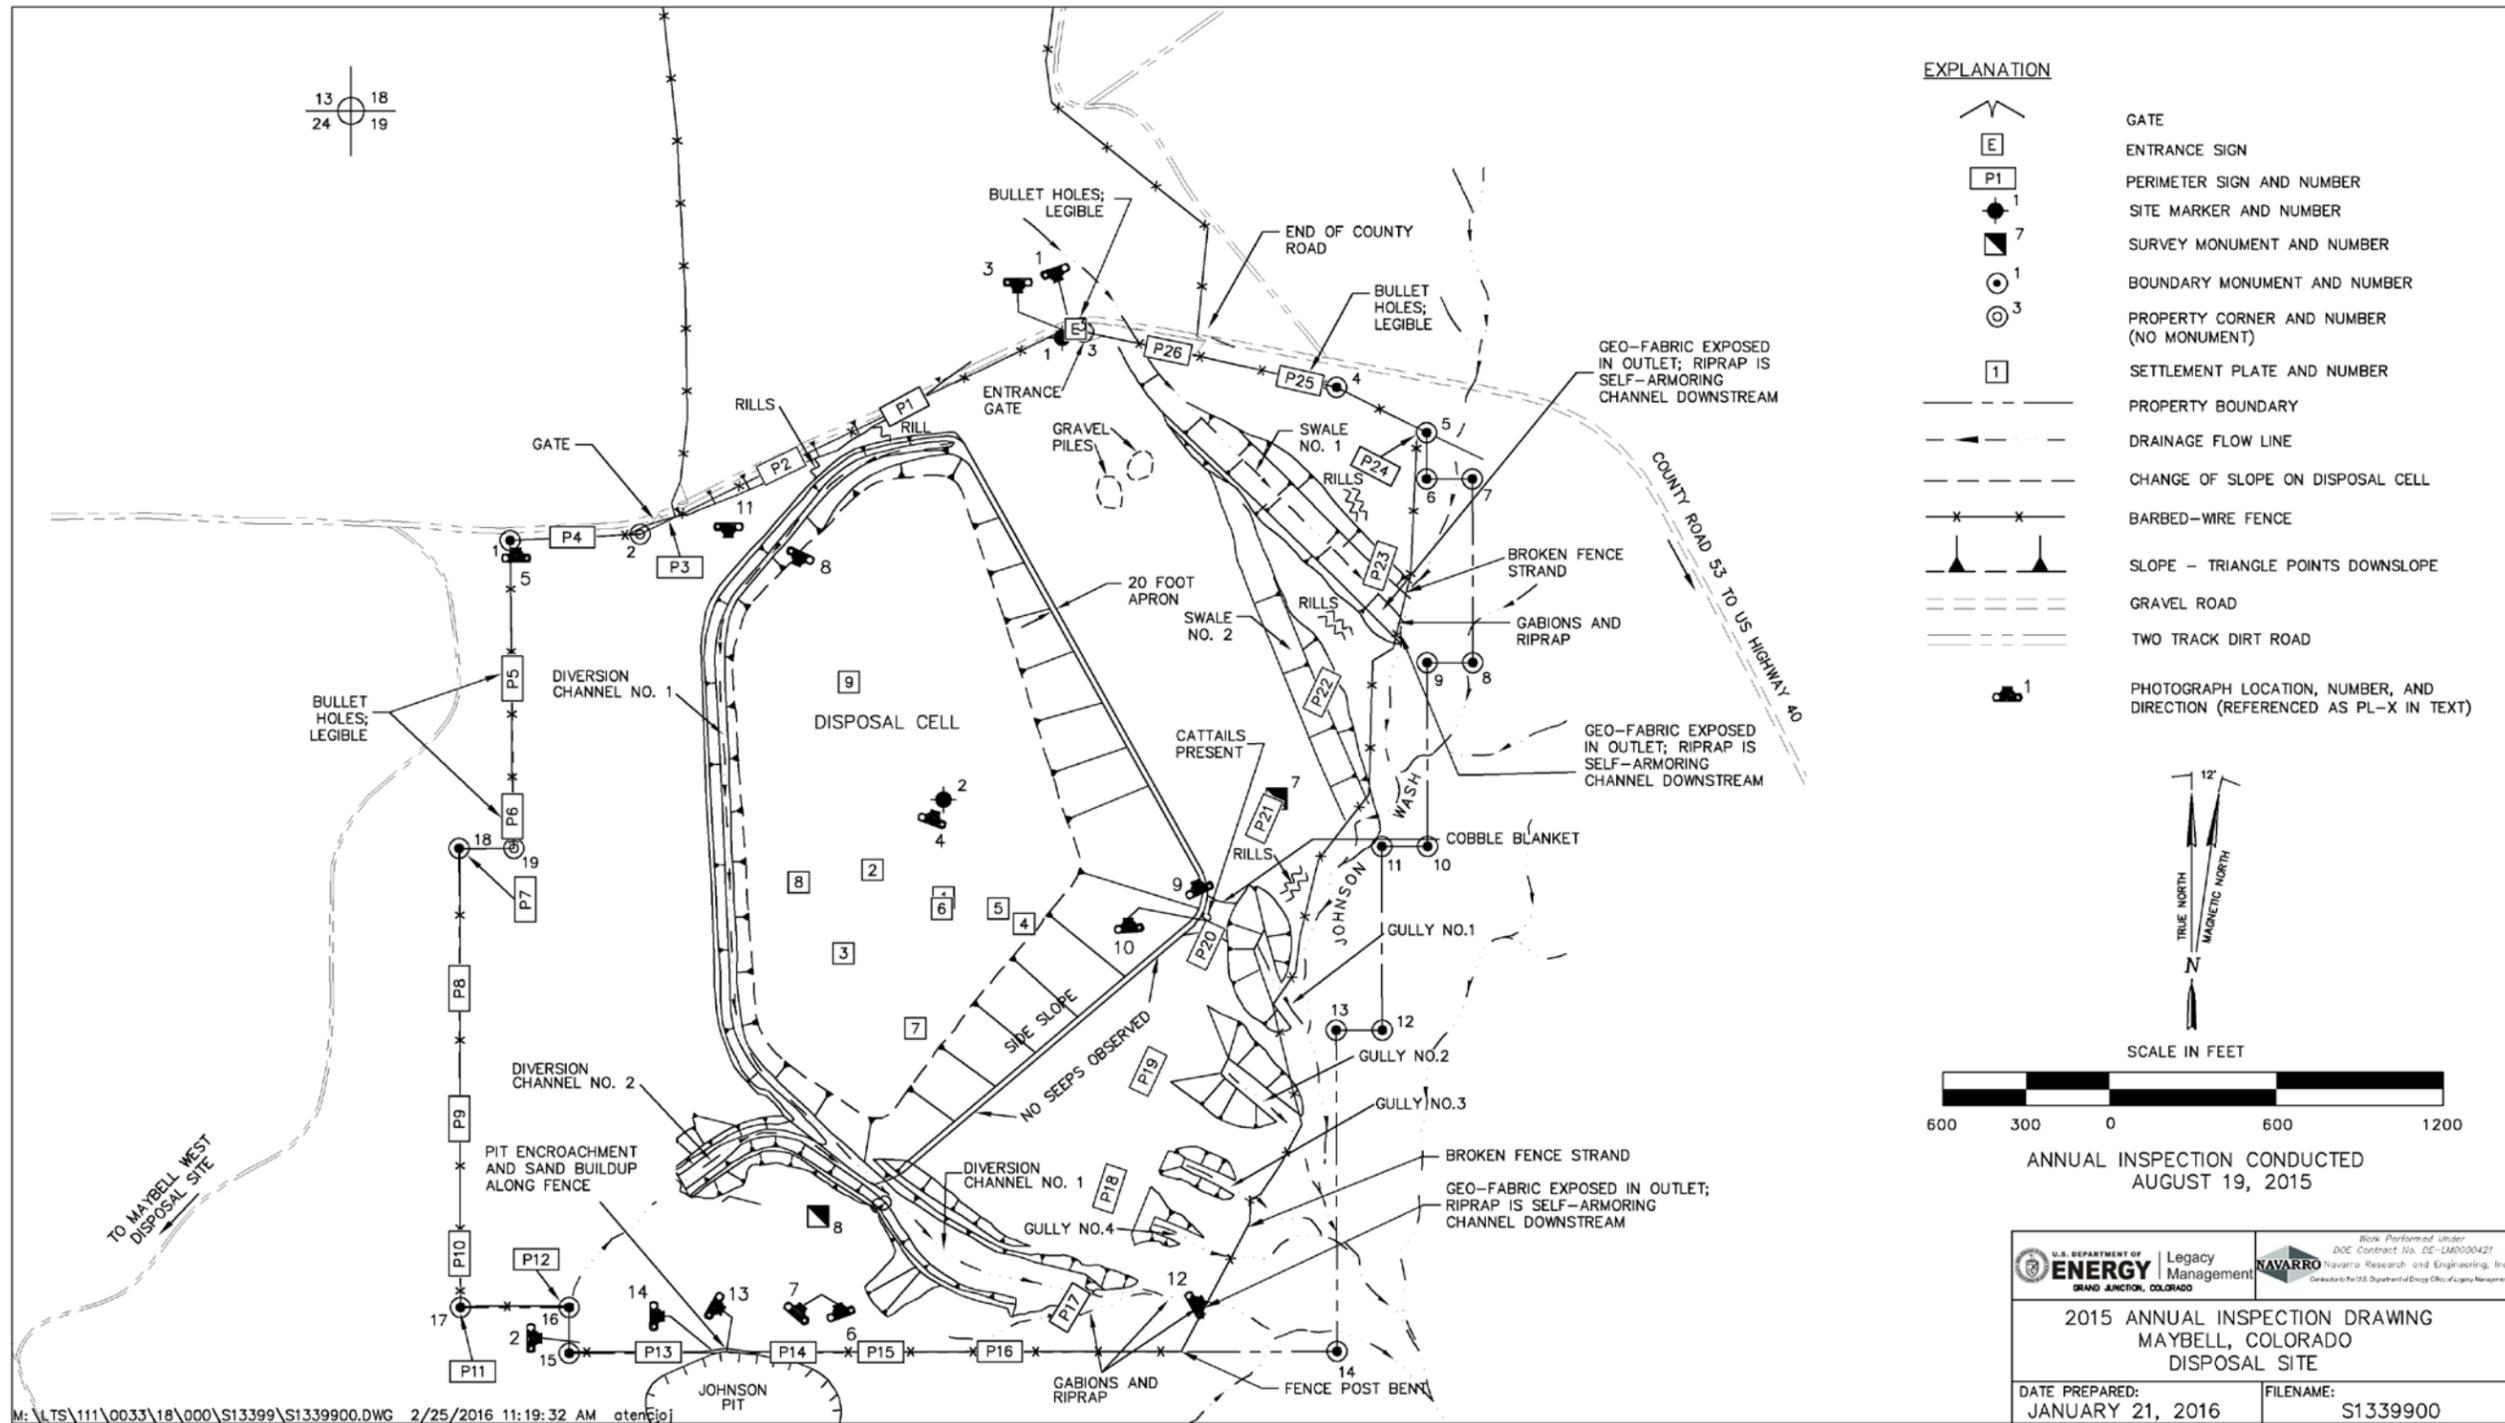
Figure 11-1 shows the locations of site surveillance features. Inspection results and recommended maintenance activities associated with site surveillance features are included in the following subsections. Photographs to support specific observations are identified in the text and in Figure 11-1 by photograph location (PL) numbers.
