4.0 Maybell West, Colorado, Disposal Site

Figure 4-1. 2015 Annual Inspection Drawing for the Maybell West, Colorado, Disposal Site

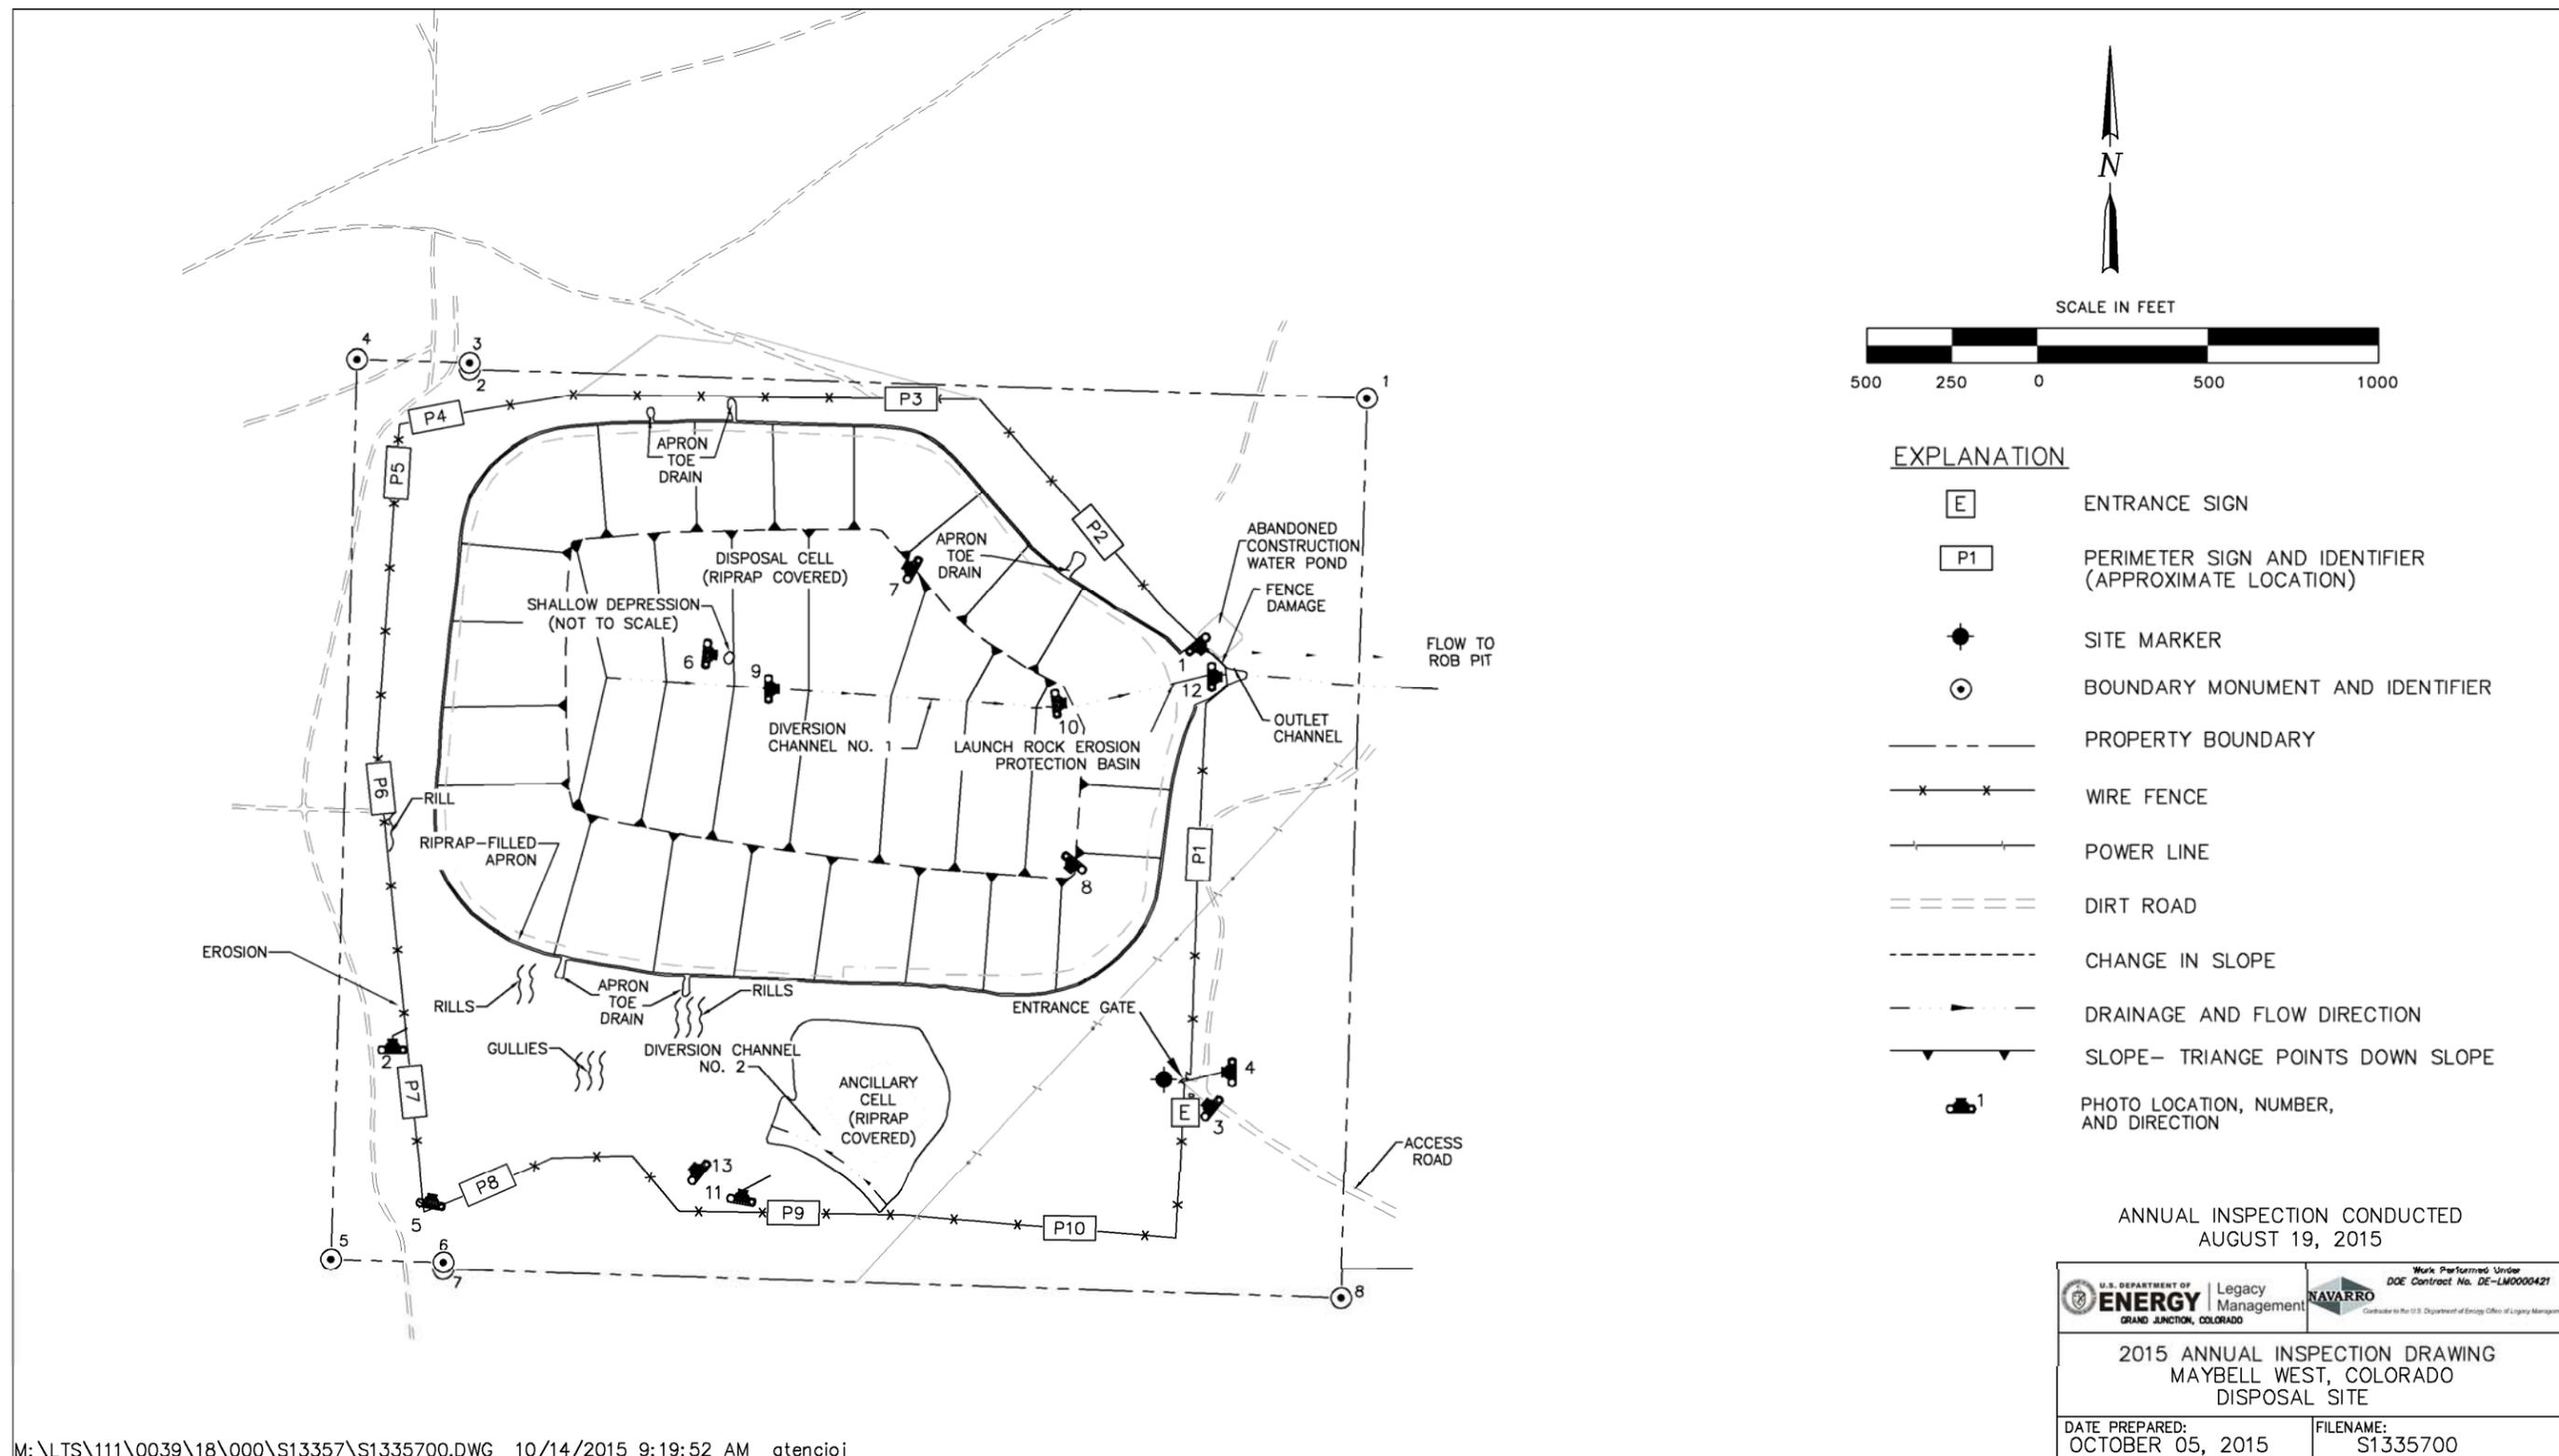
The locations of site surveillance features are shown on Figure 4-1. Inspection results and recommended maintenance activities associated with site surveillance features are included in the following subsections. Photographs to support specific observations are identified in the text and on Figure 4-1 by photograph location (PL) numbers. Numbers in the left margin of this report refer to items summarized in Table ES-1 of the “Executive Summary.”
