2007 Annual Inspection of the Monticello Mill Tailings (USDOE) and Monticello Radioactively Contaminated Properties Sites

December 2007

Office of Legacy Management

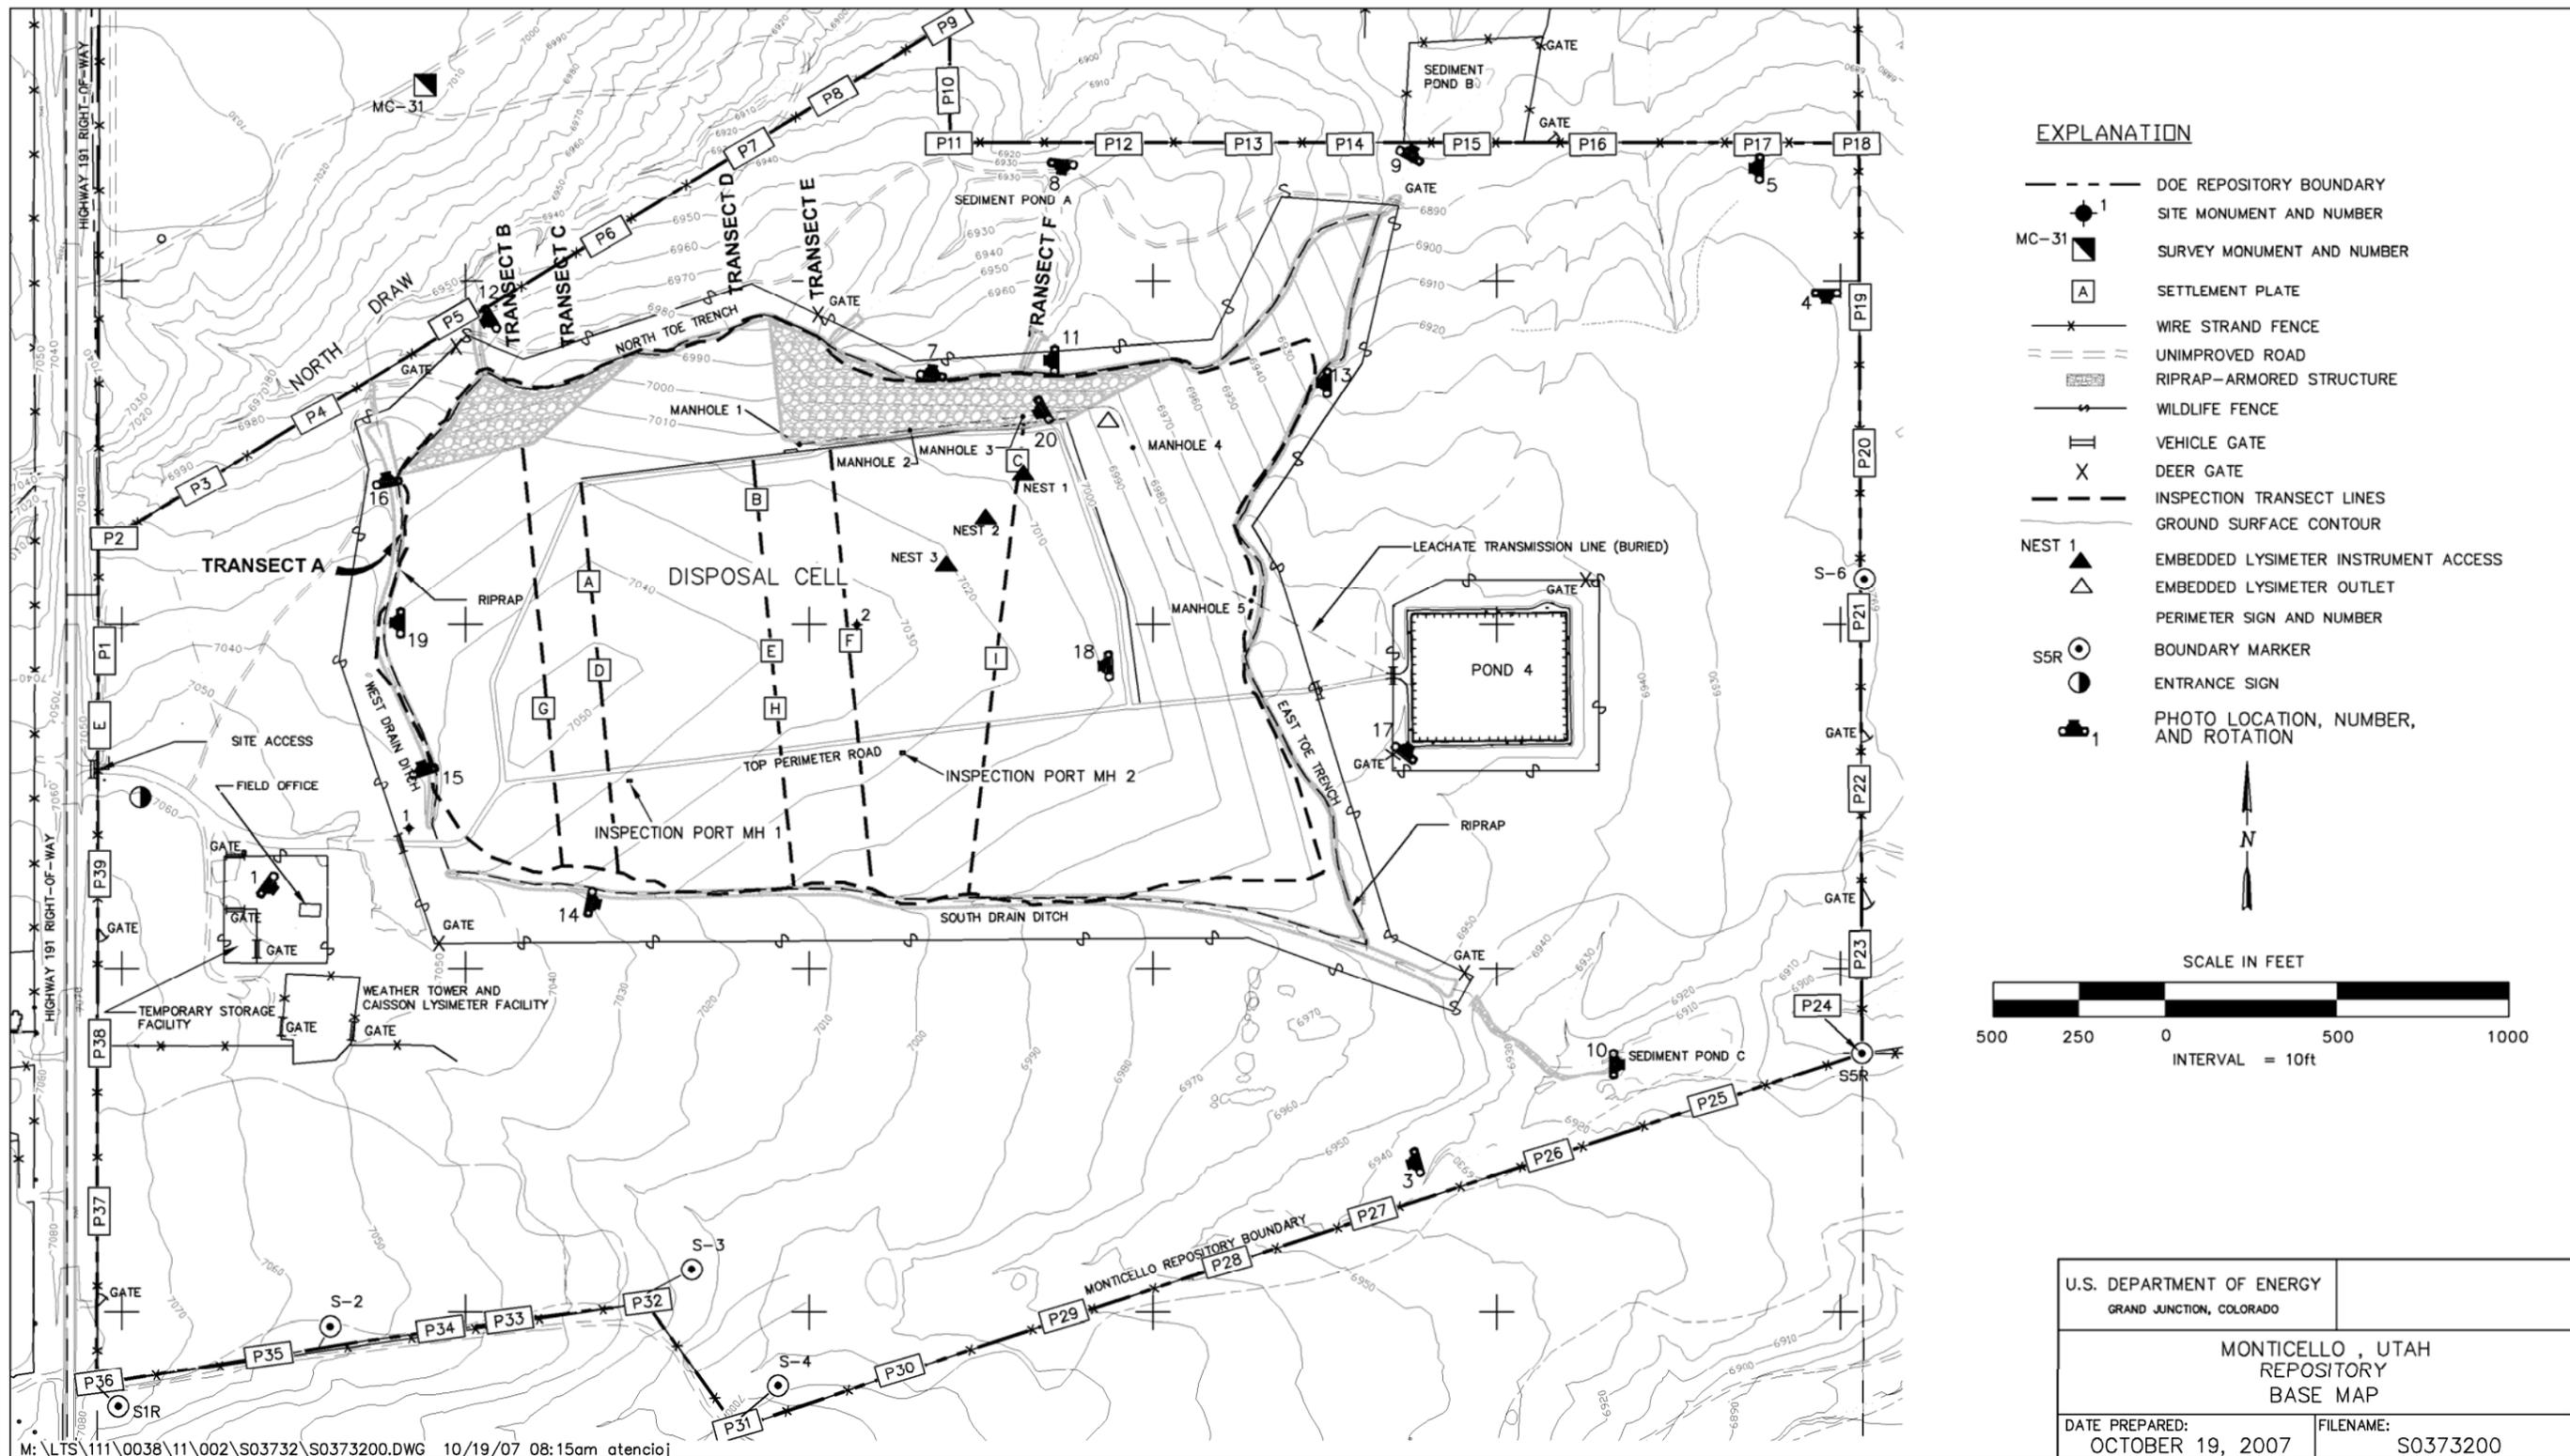
Figure 3. Monticello, Utah, Repository Base Map

The steepest sides of the repository are lined with rock (see Figure 3 or 5 for location of rock lined slopes). These slopes show no evidence of rock movement or degradation, settling, slumping, or erosion.

Action Item: The covers of the video ports (inspection ports MH 1 and MH 2, Figure 3) are presently not locked. On-site staff will secure the video ports with locks.
