# 2012 Annual Inspection Report for the DOE Monticello, Utah, Mill Tailings Site and Monticello Vicinity Properties

December 2012

**2012 Annual Inspection Report for the  
DOE Monticello, Utah, Mill Tailings Site and  
Monticello Vicinity Properties**

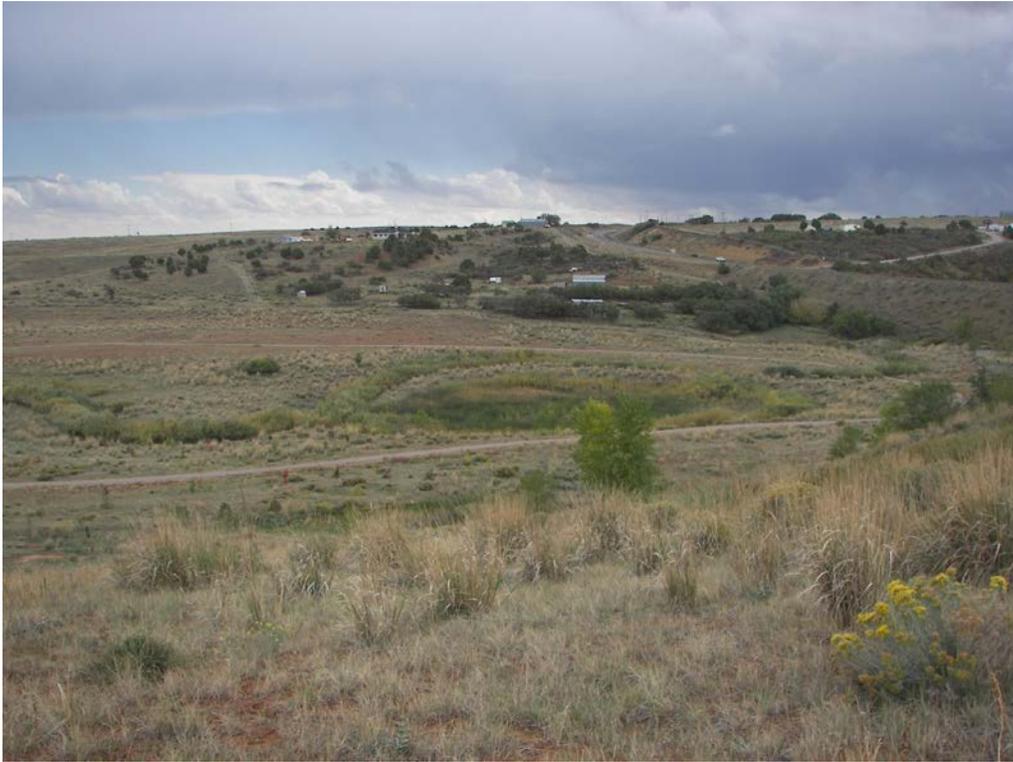
City-owned properties MP-00181, MP-00391, MS-00893, MP-01040 (north), MP-01041, MP-01042, and MP-01077 were transferred from DOE to the City of Monticello in 2000. Specific restrictions on these properties are summarized in Section 1.3 (City-owned and Private Properties). Photos 15 and 16 show the wetlands, creek, and vegetated slopes of the former mill site during the 2012 inspection. Property MP-00211 (Photo 17) was always City-owned and is subject only to zoning restrictions on excavation and construction.

Photo 15. View of Wetland 1 from City-owned property MP-00211.

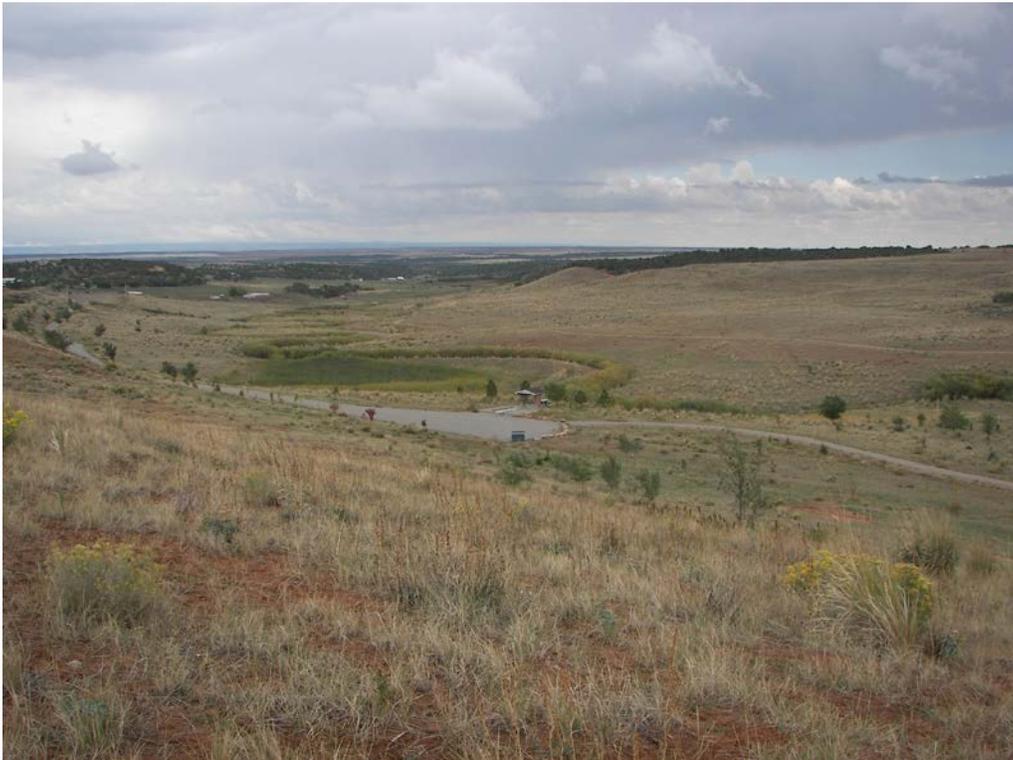
Photo 16. View of Wetland 2 from City-owned property MP-00211.

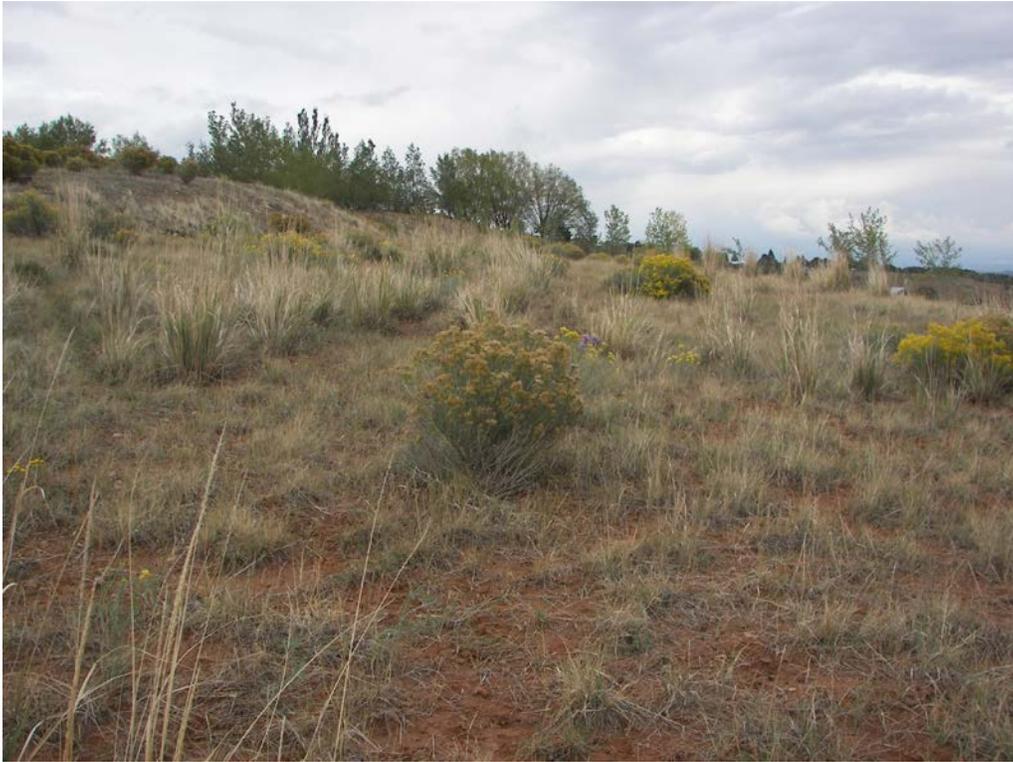
Photo 17. Property MP-00211, view to the northeast.

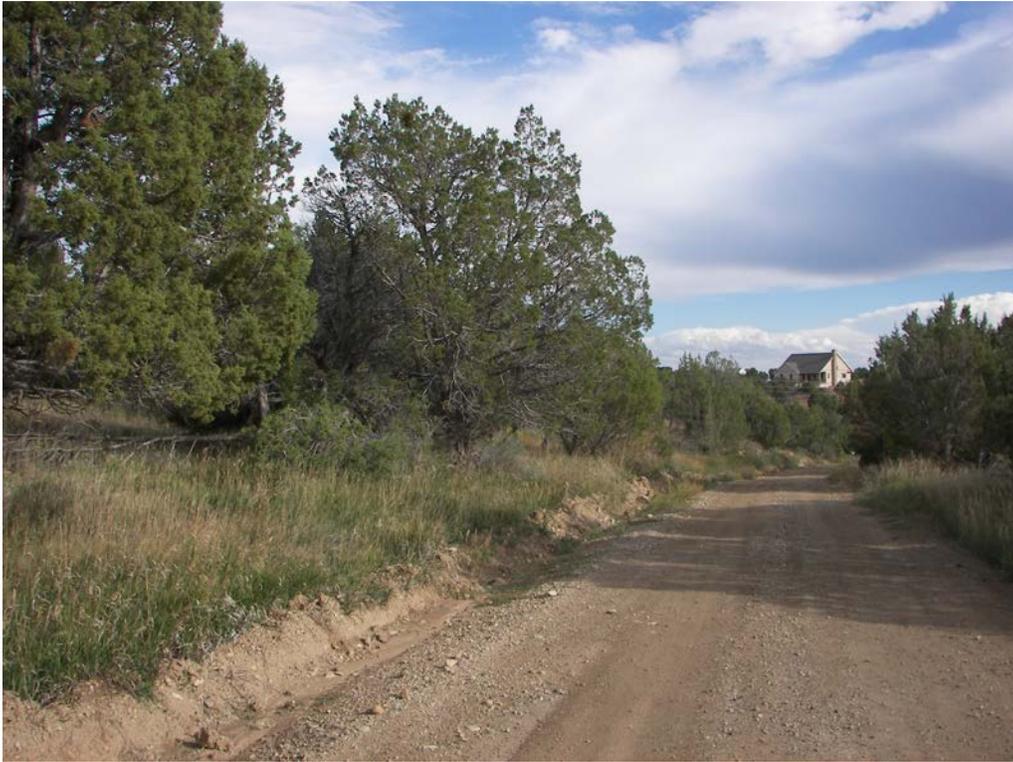
Before a habitable structure is constructed on this property, Monticello zoning ordinance requires that a special building permit, based on radiological scanning results, be obtained. There is no evidence of erosion, soil removal, or construction of habitable structures (Photo 25; Appendix A, Section VIII-C). A portion of this property was sold in 2006, and even though no supplemental standards areas exist on the new property, the property owner did not remove the zoning ordinance from it.

Photo 25. Property MS-00176.
