2013 Annual Inspection Report for the DOE Monticello, Utah, Mill Tailings Site and Monticello Vicinity Properties

December 2013

Legacy
Management

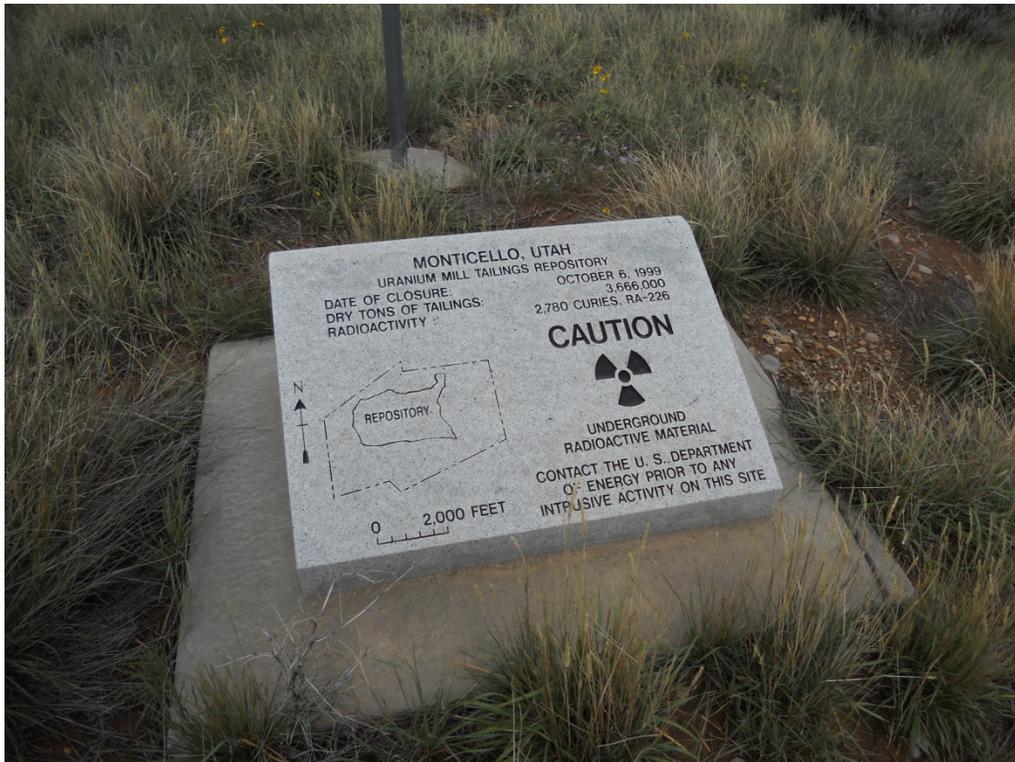
Photo 14. Site Marker 2.

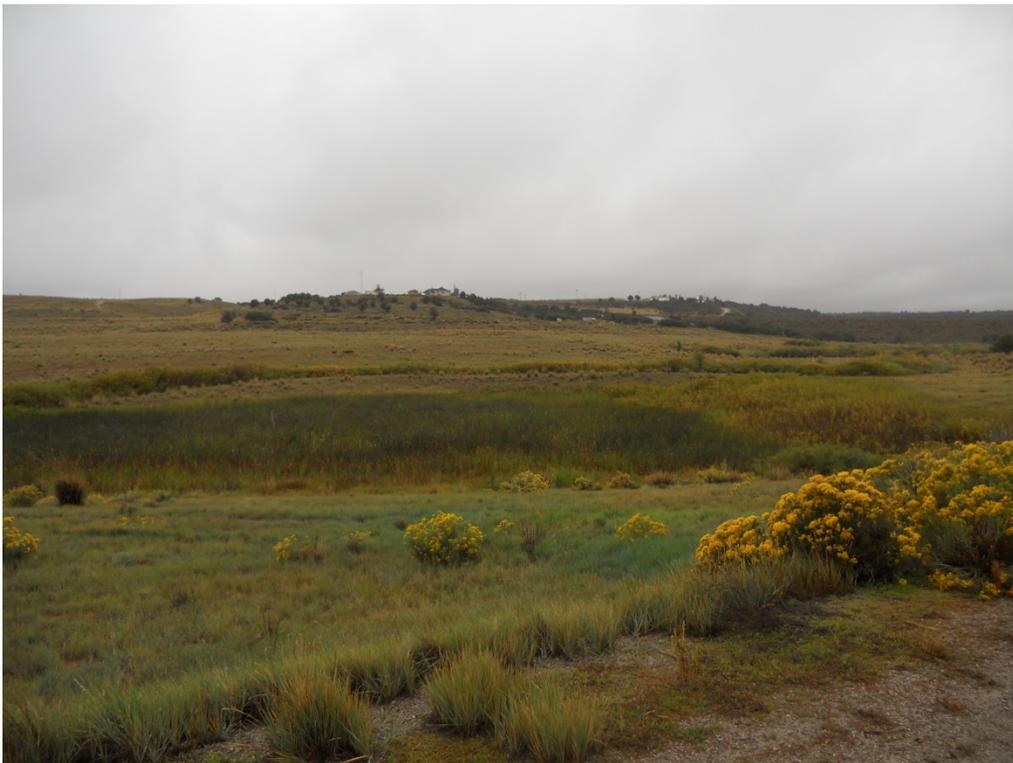
City-owned properties MP-00181, MP-00391, MS-00893, MP-01040 (north), MP-01041, MP-01042, and MP-01077 were transferred from DOE to the City of Monticello in 2000. Specific restrictions on these properties are summarized in Section 1.3, “City-Owned and Private Properties.” Photo 21 shows Wetland 2, Montezuma Creek, and vegetated slopes of the former mill site during the 2013 inspection. Property MP-00211 (Photo 22) was always City-owned and is subject only to zoning restrictions on excavation and construction.

Photo 21. View of Wetland 2 and surrounding area.

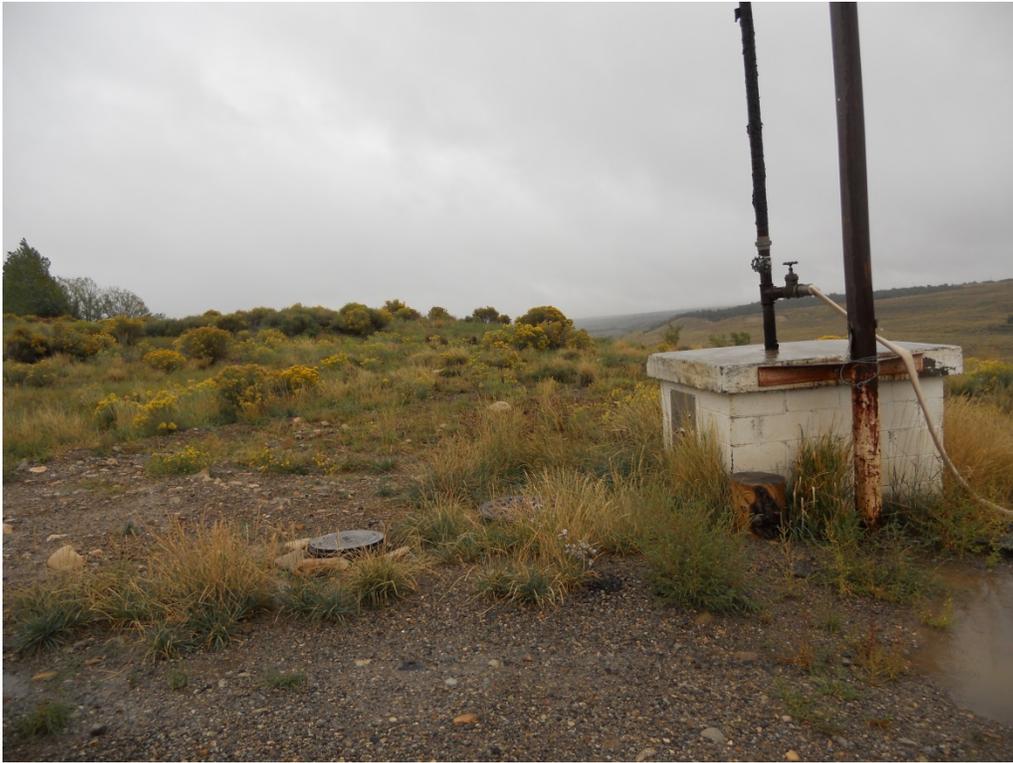
Photo 22. View from City-owned property MP-00181 toward property MP-00211.

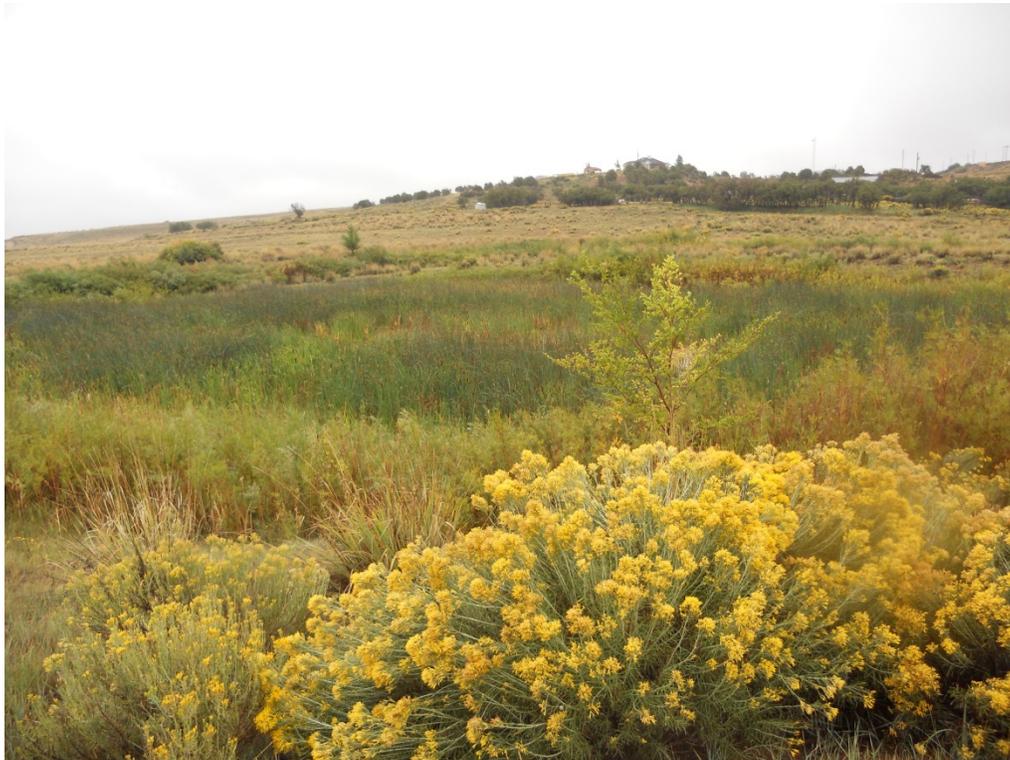
Wetlands on the former mill site were constructed according to EPA-specific criteria, and these wetlands are protected by cooperative agreement. Under this agreement, the City of Monticello will not disturb these areas without prior approval from appropriate state and federal agencies and is not responsible for repairing damage to these areas by natural causes. Montezuma Creek and three constructed marsh wetlands on the City-owned properties were ecologically healthy, and no evidence of damage by human activity or natural causes was observed during the 2013 inspection. Photo 27 shows Wetland 1 at the time of the inspection.

Photo 27. View of Wetland 1 at former mill site and surrounding area.
