2015 Annual Inspection Report for the DOE Monticello, Utah, Mill Tailings Site and Monticello Vicinity Properties

December 2015

Legacy
Management

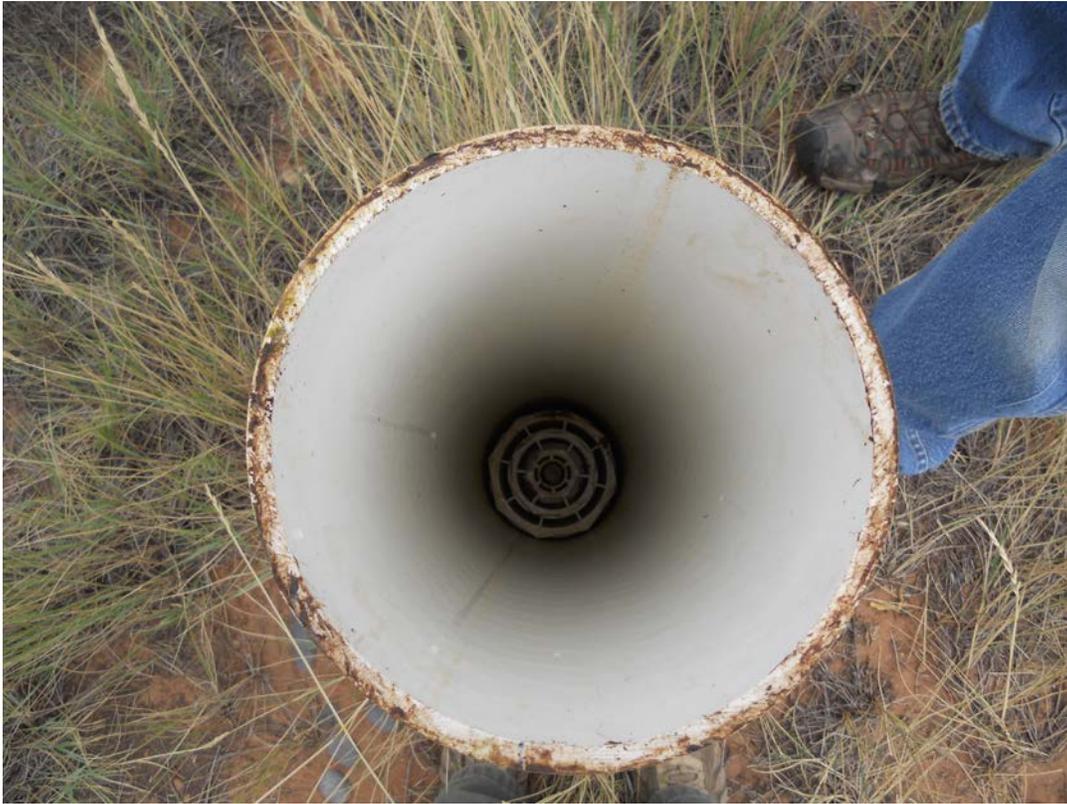
Photo 19. Interior Structures Within Settlement Plate I

(Photo 19). Elevation surveys are performed on the settlement plates every 5 years in preparation for CERCLA Five-Year Reviews. Data from the most recent elevation surveys in 2011 indicated no evidence of settlement.

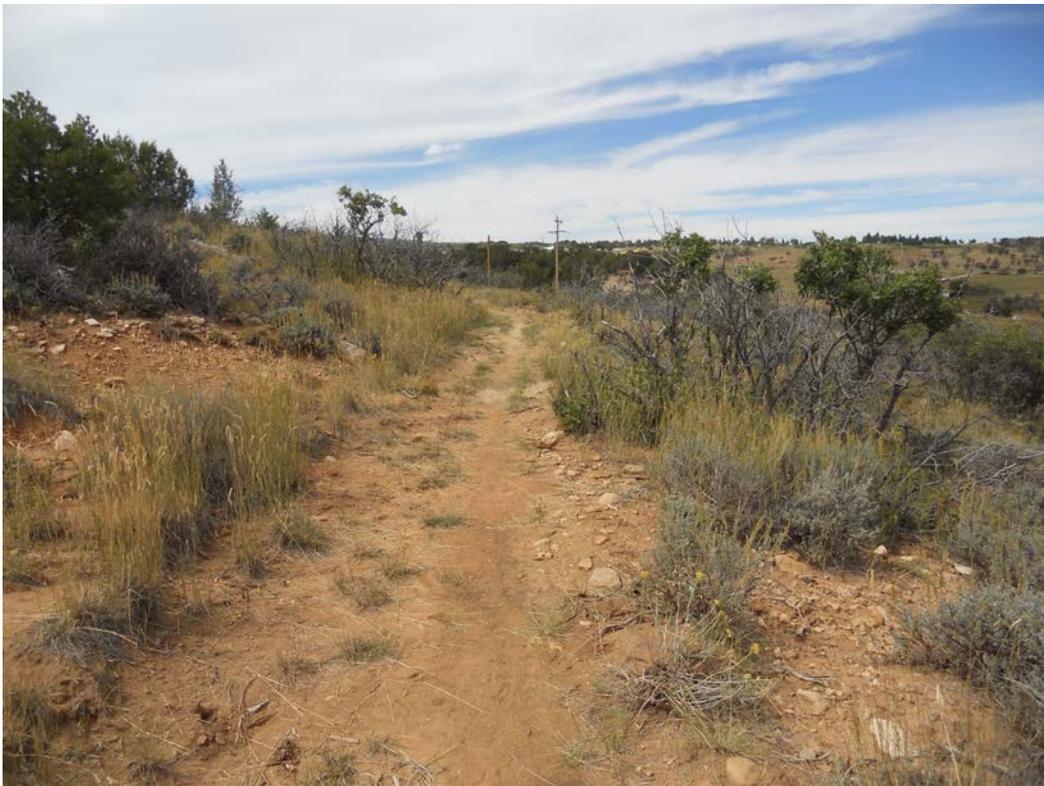
All riprap-armored structures, dams, check dams, berms, and runoff control drainages (Figure 4) were intact and functional. Photo 22 shows a section of the City's mountain bike trails, and Photo 23 shows a portion of the access road near Deer Draw Dam. Both photographs illustrate the well-vegetated and intact soils that characterize the City-owned properties.

Photo 22. Mountain Bike Trail on City-Owned Property MP-01077

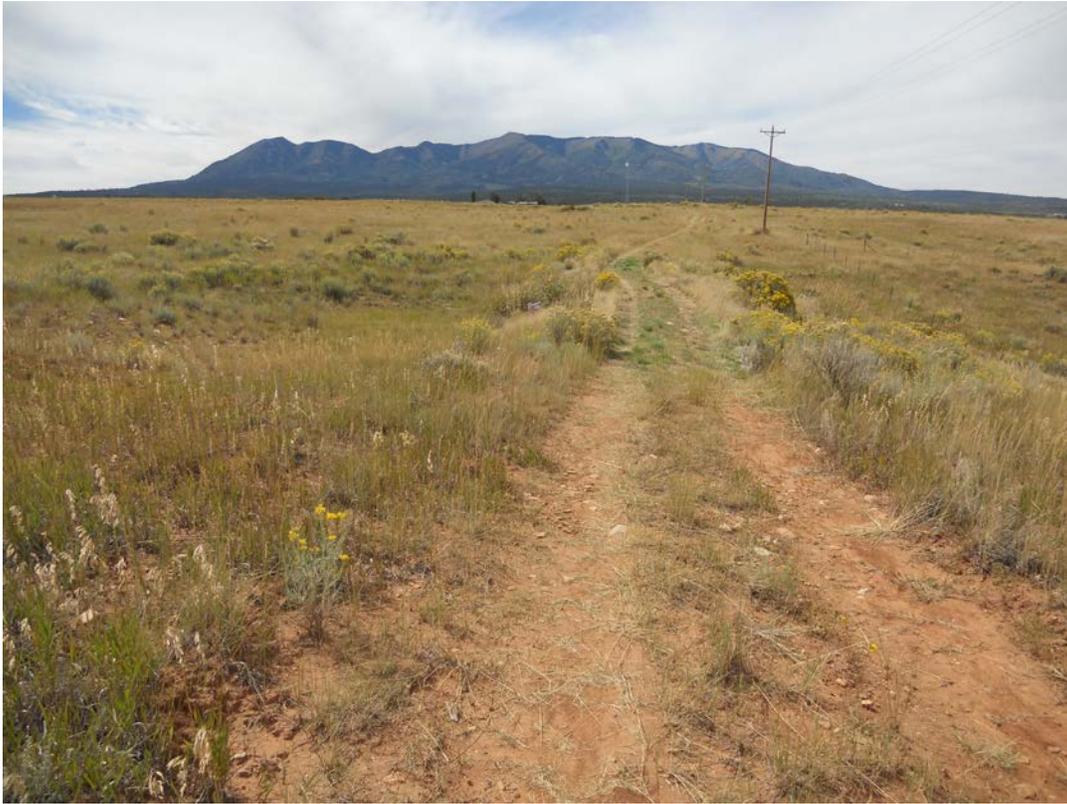
Photo 23. Deer Draw Dam Area on City-Owned Property MP-01040

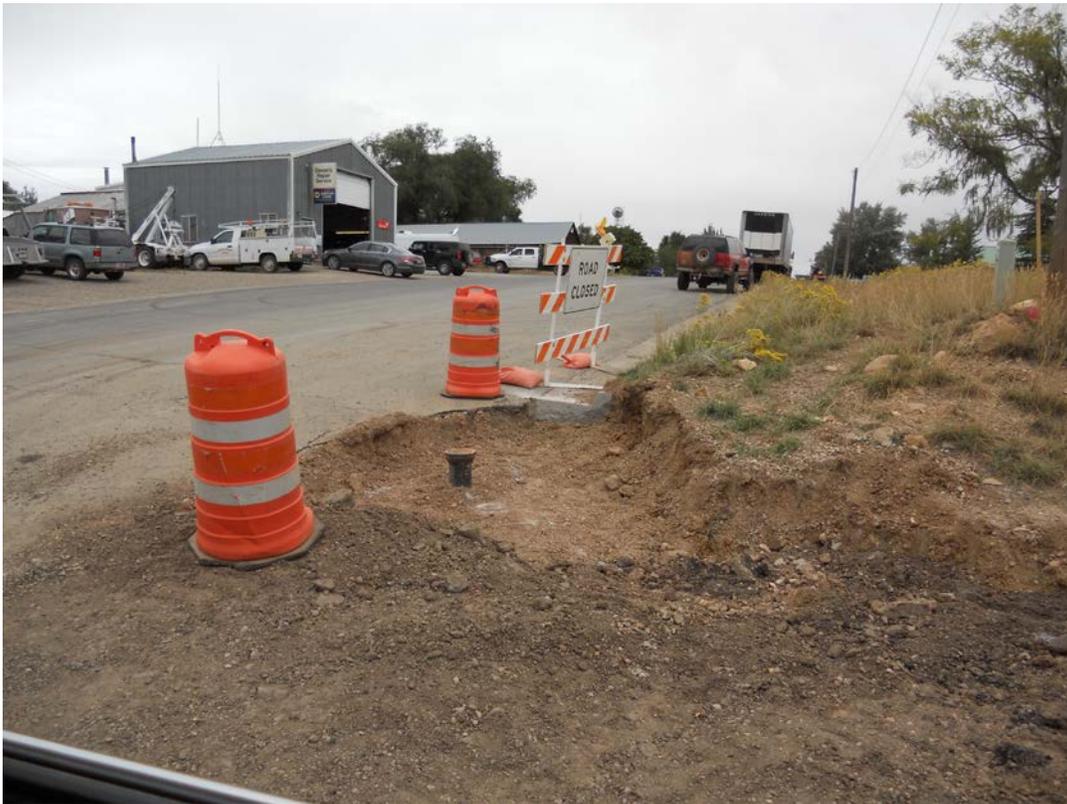
Section VIII of Appendix A presents results of the 2015 annual inspection of UDOT rights-of-way and city streets and utility corridors. No unmonitored or unplanned excavations were identified. Onsite personnel were aware of all planned excavations, and excavations were monitored in accordance with the LTS&M Plan. Photo 27 shows an area of work in city streets with deeper excavations, and Photo 28 shows the Highway 191 embankment at Montezuma Creek in 2015.

Photo 27. City Streets and Utilities Area of Deeper Excavation

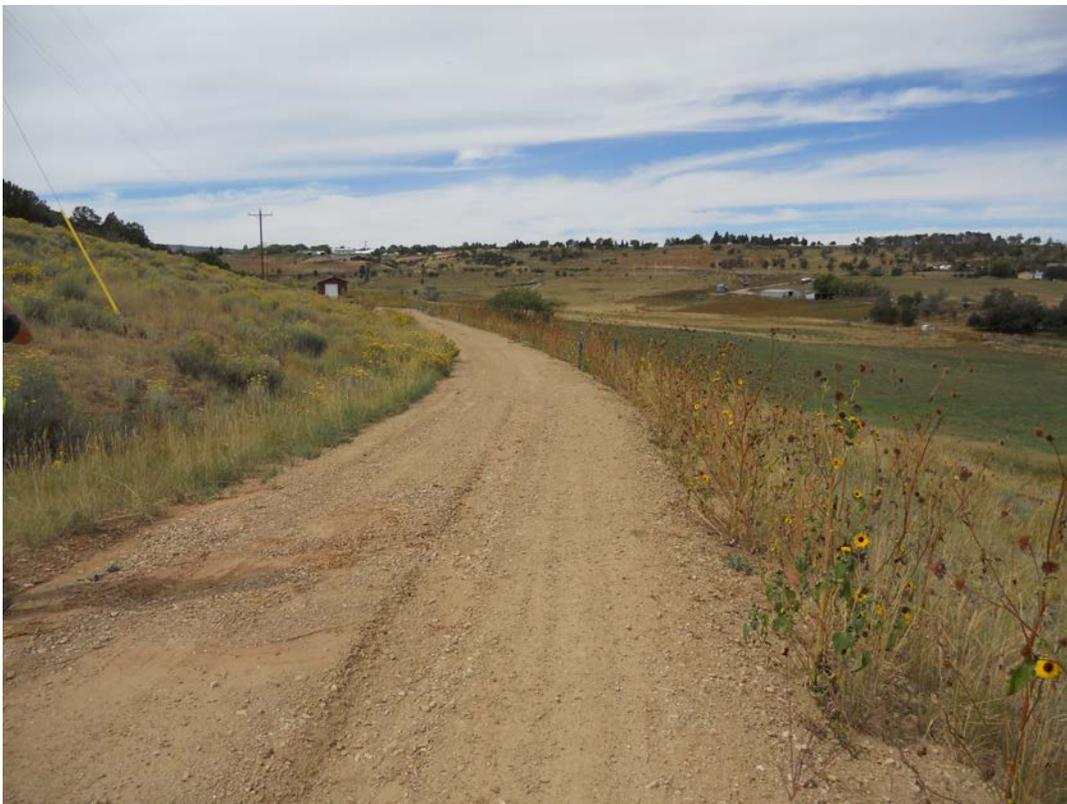
In 2014, facilities related to the groundwater remedy optimization system were installed on privately owned Property MP-00179, city-owned Properties MP-01077 and MP-01041, and the DOE-owned disposal site. Facilities include extraction wells, monitoring wells, utility vaults, a groundwater transfer building, and a water transmission pipeline. Areas disturbed by the project were successfully revegetated in 2015 (Photo 30). The facilities are regularly inspected and maintained by onsite personnel.

Photo 30. View of the OU III Water Transmission Pipeline Access Road
