# 2012 Annual Inspection Report for the Parkersburg, West Virginia, Disposal Site

## 1.0 Compliance Summary

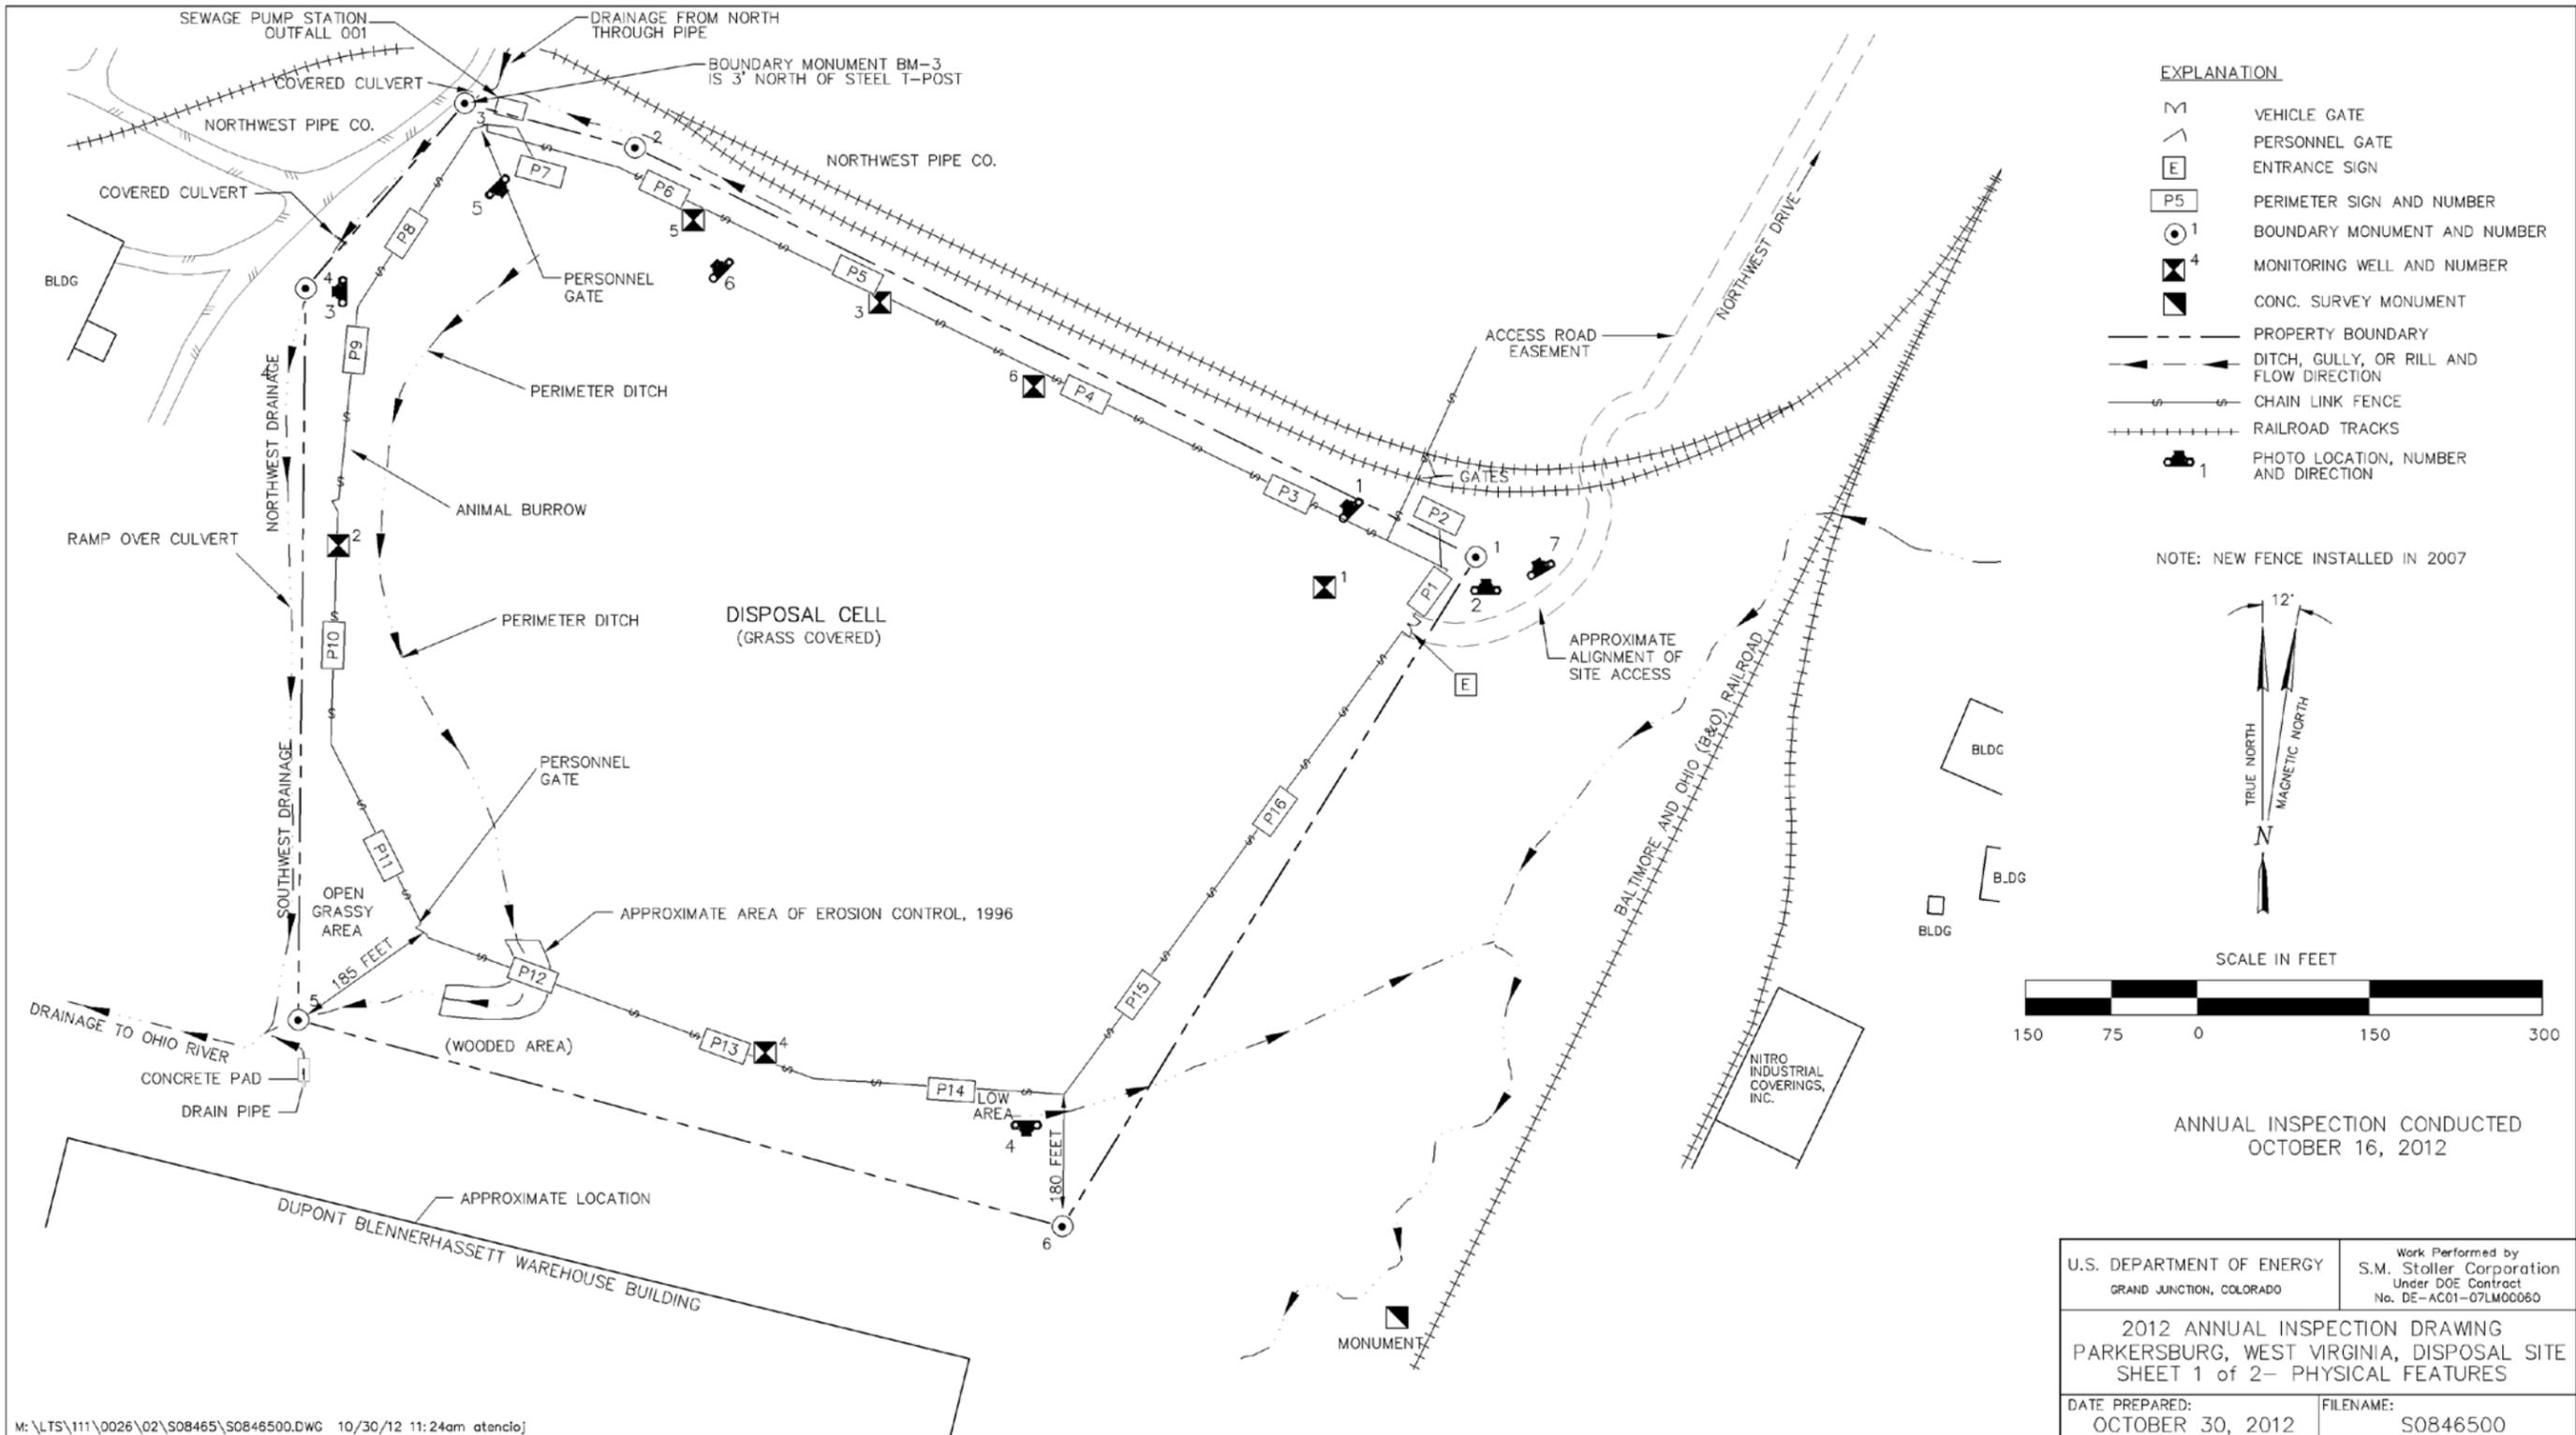
The Parkersburg site is in a developed industrial area. Inspectors observed that a pipe lay-down area next to the site has increased in size since last year’s inspection (PL-7).

PKB 10/2012. PL-7. Northwest Pipe Company lay-down area next to site.
