2016 Annual Inspection and Radiological Survey Results for the Piqua, Ohio, Decommissioned Reactor Site

July 2016

U.S. DEPARTMENT OF
ENERGY

Legacy
Management

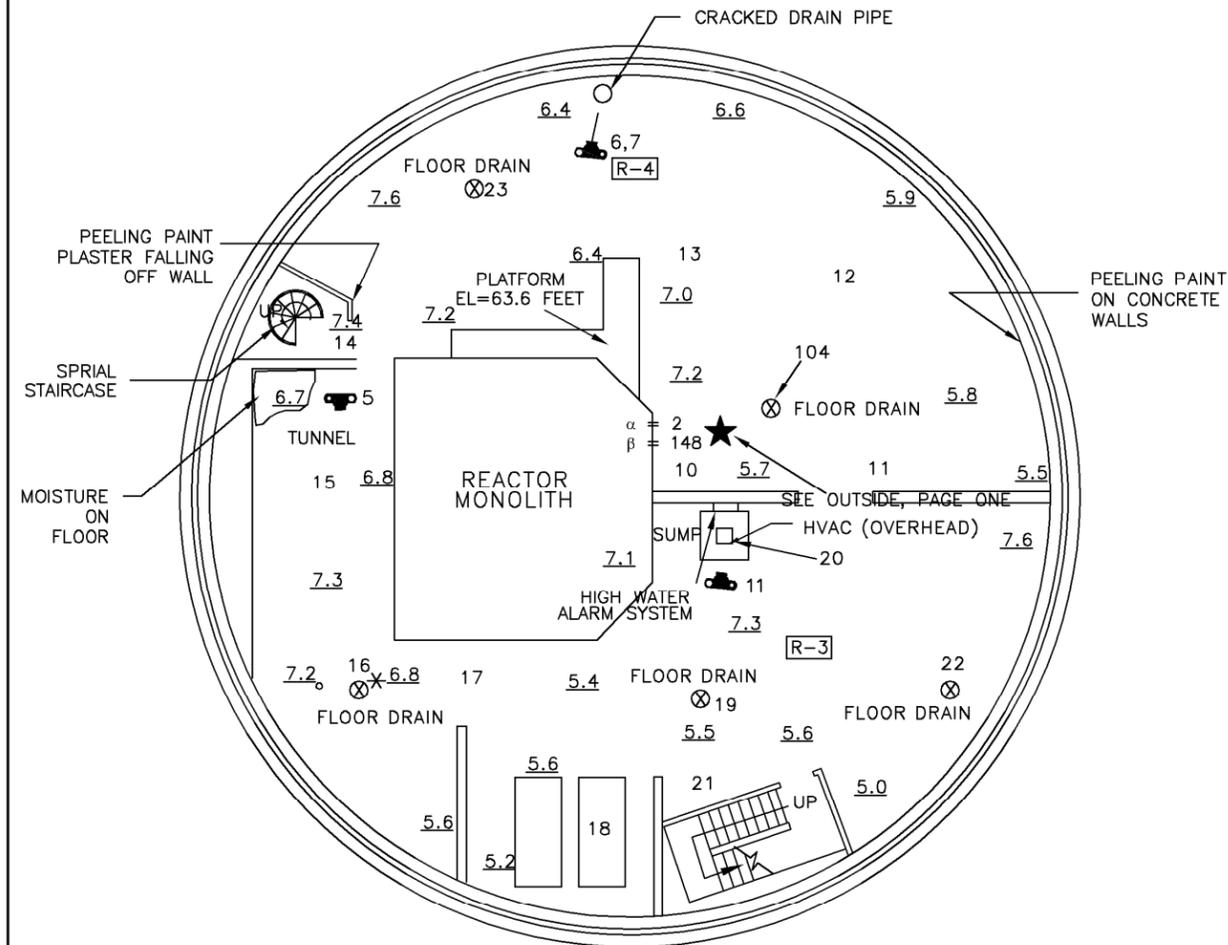
PLAN - 56 FOOT LEVEL

- 3) A vertical drain pipe on the NW wall of the Containment Building on the 56-foot level has developed a crack and split open (PL-6 and PL-7). Inspectors traced the pipe up to the 100-foot level where it is believed to be connected to a floor drain.

NOTE: ALL 2016 GAMMA READINGS WERE < BKGD ON THIS LEVEL.

Action Request: DOE requests that the City assess the cracked drain line and repair it if necessary prior to the next annual inspection to keep water from entering the 56-foot level.

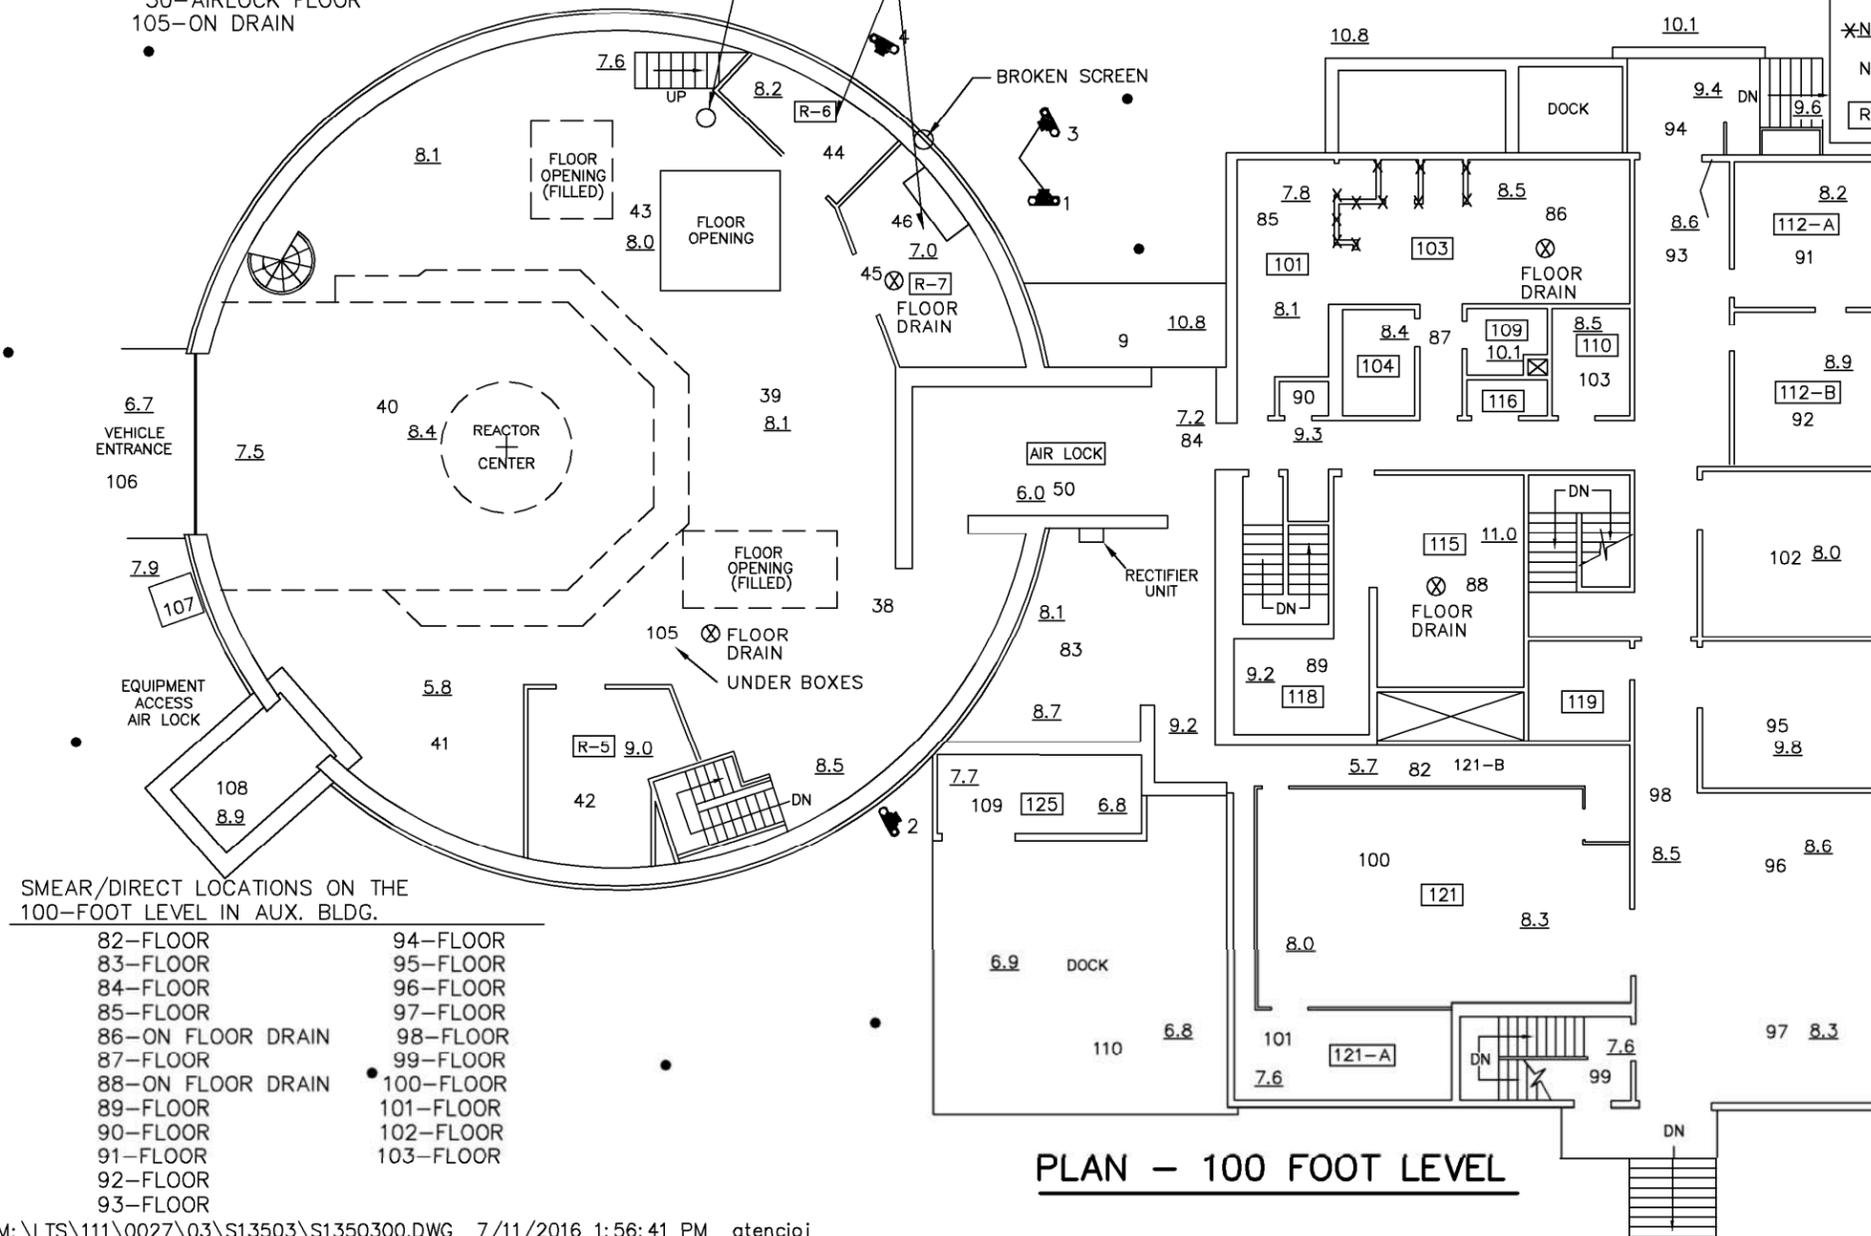
SMEAR/DIRECT LOCATIONS ON THE 100-FOOT LEVEL IN AUX. BLDG.

100-foot level: It was noted in 2015 and again this year that the concrete around the southwest airlock of the Containment Building needs to be repaired. Numerous cracks are present and some small pieces of concrete are falling off. DOE requests that the City evaluate the situation and make minor concrete repairs prior to next year's inspection.

FLOOR DRAIN BELIEVED TO BE ASSOCIATED WITH CRACKED DRAIN PIPE ON 56 FOOT LEVEL

Action Request: DOE requests that the City evaluate the situation and make minor concrete repairs prior to next year's inspection.
