14.0 Rifle, Colorado, Disposal Site

14.1 Compliance Summary

The Rifle, Colorado, Uranium Mill Tailings Radiation Control Act (UMTRCA) Title I Disposal Site was inspected on June 30, 2015. The disposal cell and all associated surface-water diversion and drainage structures were in good condition and functioning as designed. Vegetation on the site was in excellent condition. Minor fence repairs and perimeter sign maintenance will be conducted prior to the next inspection.

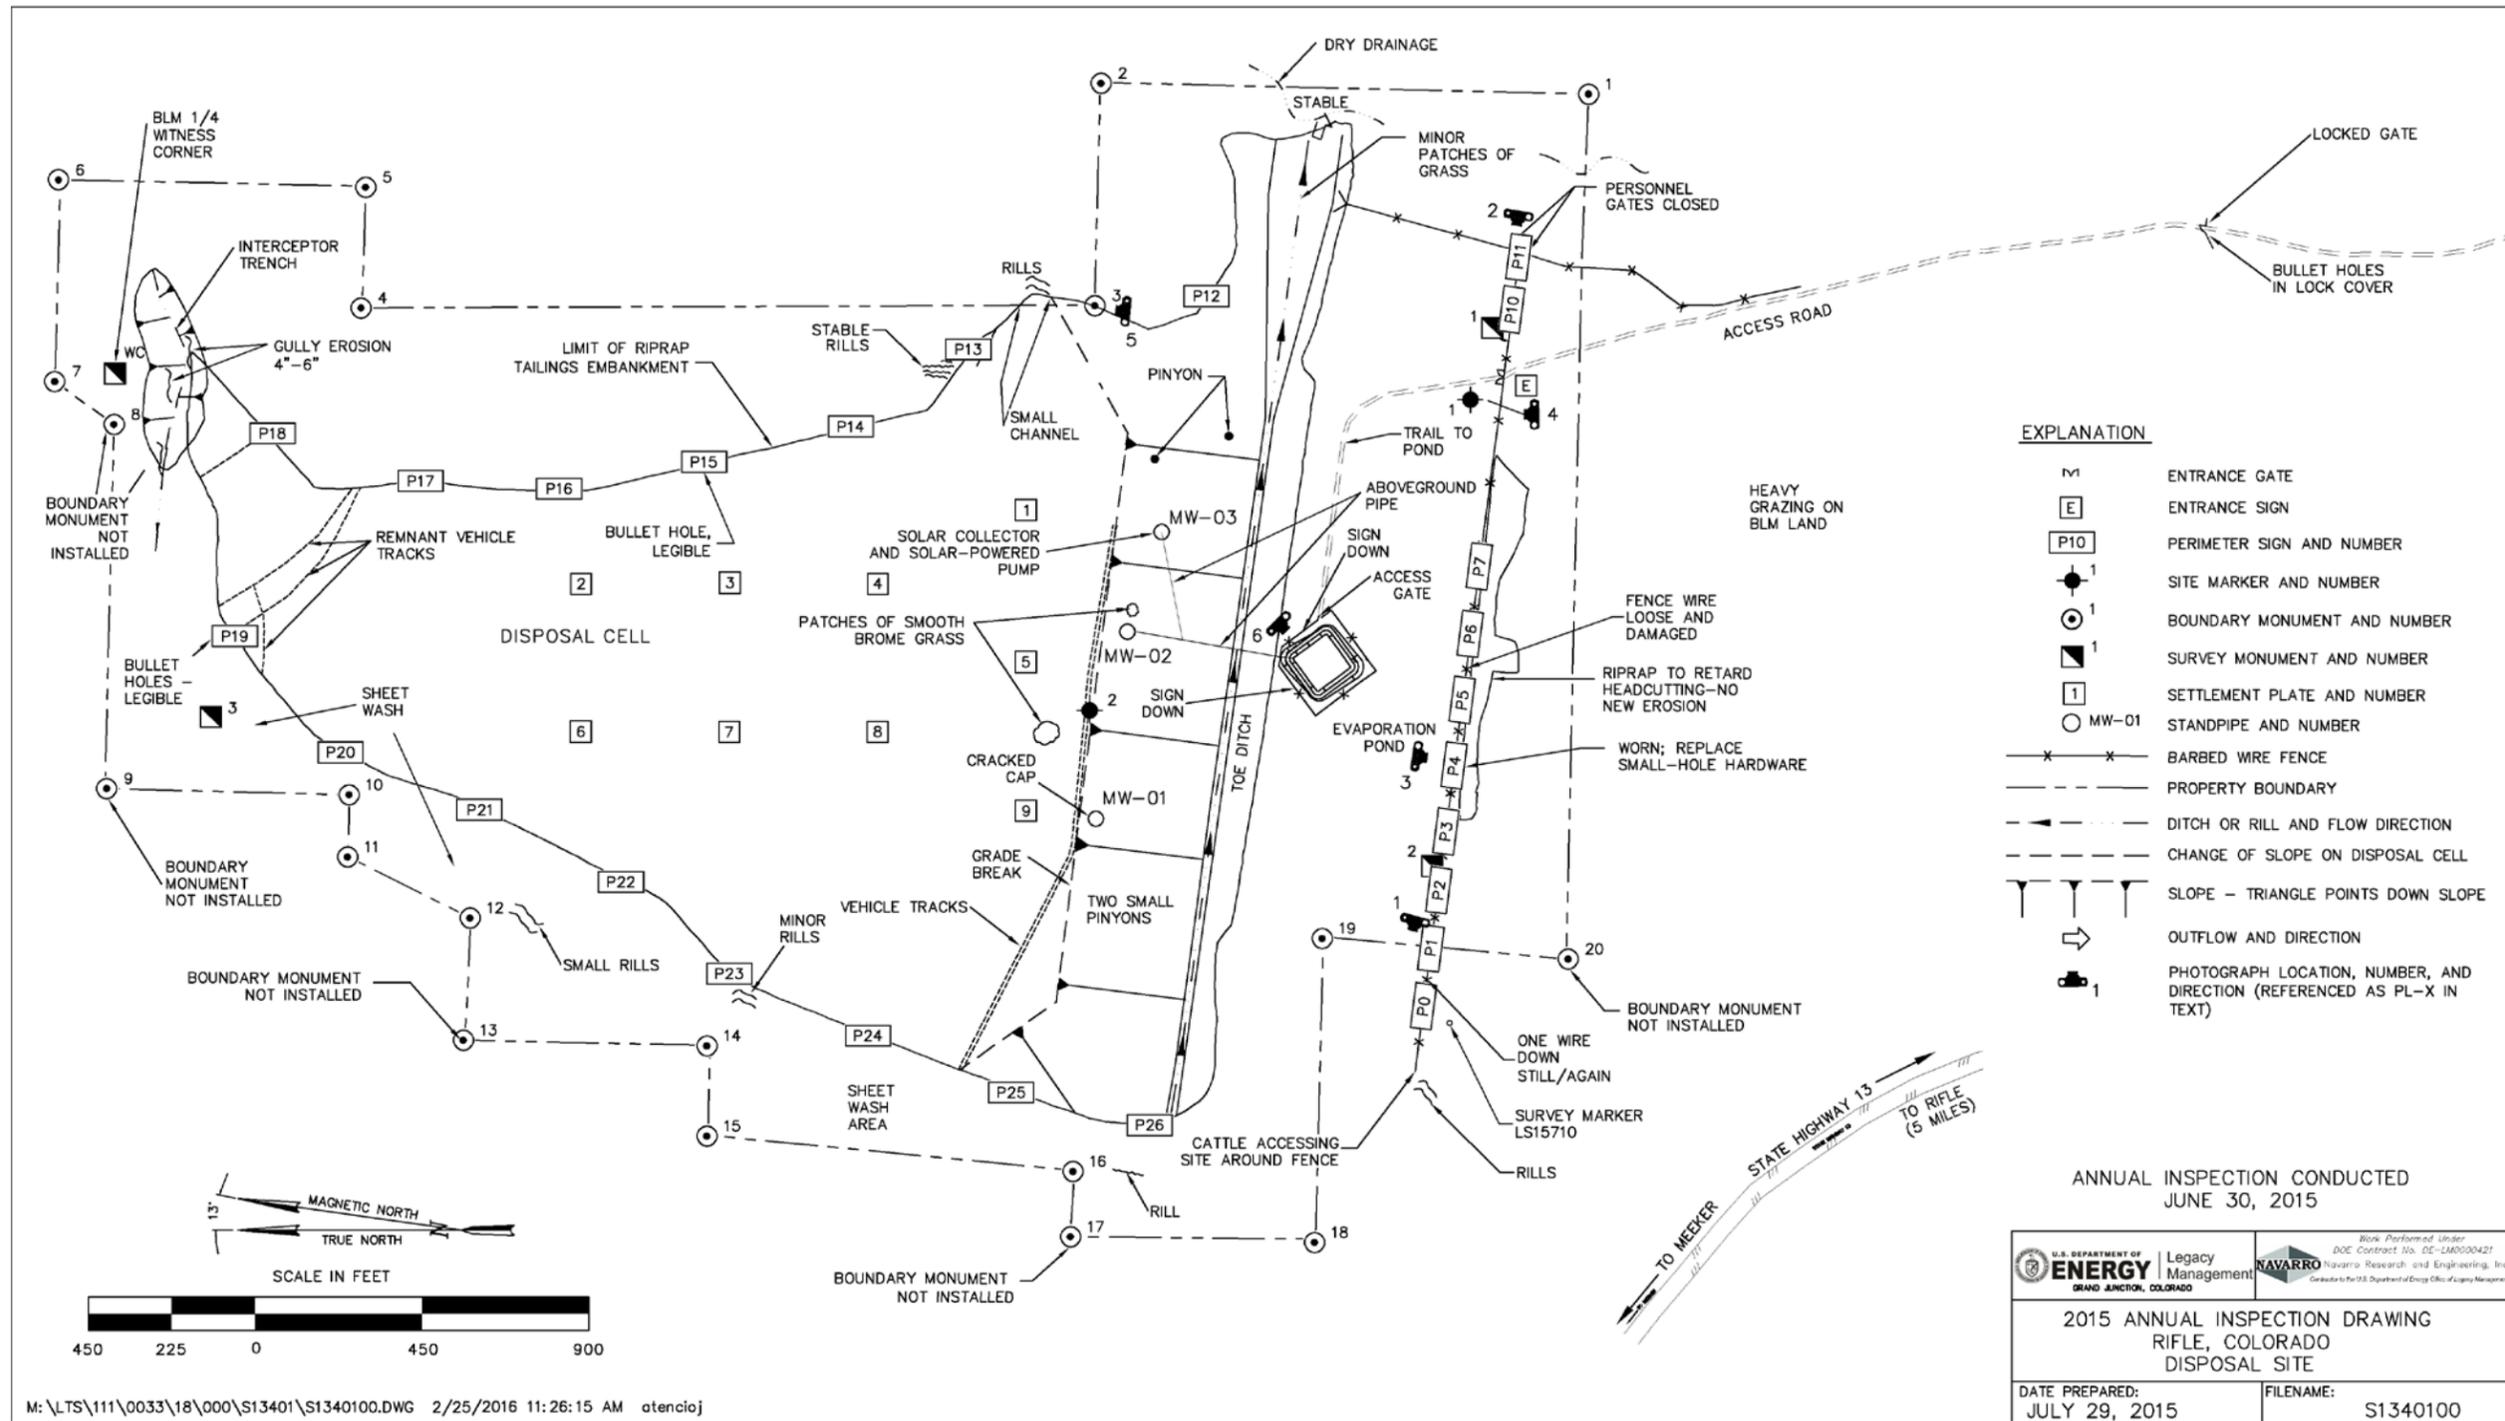
Figure 14-1. 2015 Annual Inspection Drawing for the Rifle Disposal Site

Figure 14-1 shows the locations of site surveillance features. Inspection results and recommended maintenance activities associated with site surveillance features are included in the following subsections. Photographs to support specific observations are identified in the text and on Figure 14-1 by photograph location (PL) numbers.

A barbed-wire fence, located at the south end of the site, extends to the edge of steep-sided arroyos that bound the site on the east and west and acts as a deterrent for easy access to the site. Fence damage was observed during the 2015 inspection including broken barbed wire (PL-1). Barbed-wire personnel gates at the southeast corner of the site were closed, which is a change from previous inspections where the gates have been found open (PL-2).

Perimeter signs are positioned along the fence and the edge of the disposal cell. A few signs have bullet damage but all were legible. The small-hole hardware used on perimeter sign P4 will be replaced (PL-3).

Two granite site markers, one just inside and left of the entrance gate (SMK-1; PL-4) and the other on the disposal cell (SMK-2), were in good condition.
