Overview of the Second Quarter 2009 Surveillance and Maintenance Report for the LM Rocky Flats Site

Legacy
Management

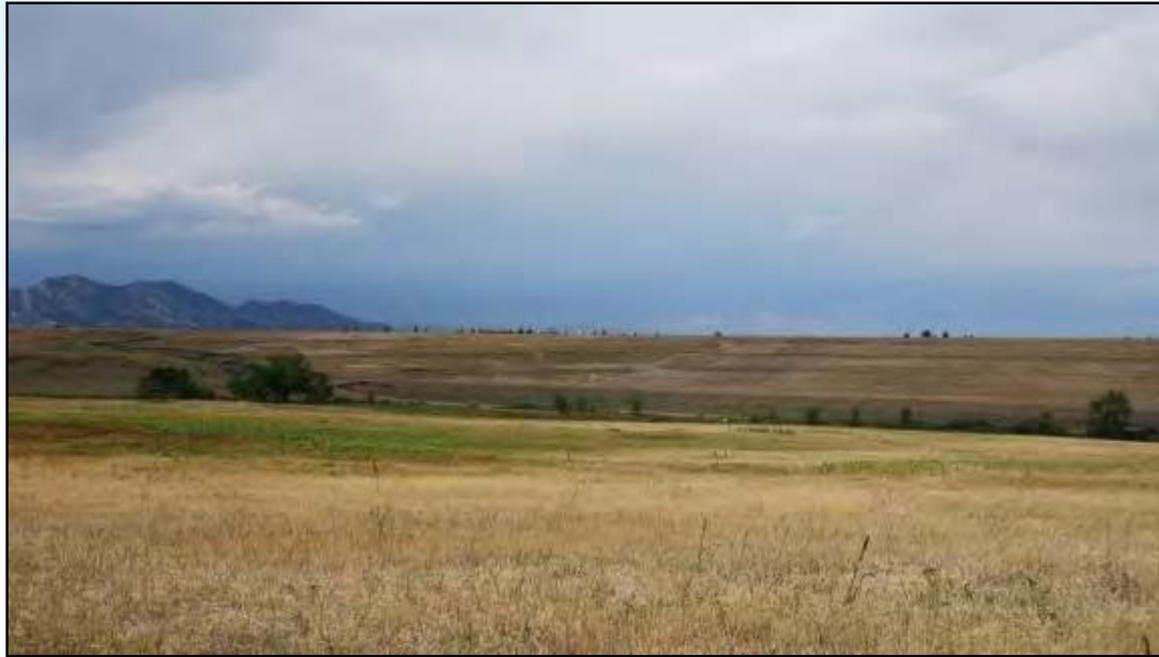
OLF Seeps

- Seep 4 had some surface expression, but did not show any surface flow. This is likely due to the rock drain that was installed during the West Perimeter Channel Regrade Project.
- Seep 8 flowed at a rate of 2 to 3 gpm throughout the second quarter
- The West Perimeter Channel flowed at a rate of 2 to 5 gpm throughout the second quarter. The higher rates were noted following precipitation events.
- Seep 7 showed surface expression along the eastern edge of the drain extension installed in September 2008 and from the south edge of the concrete pad for inclinometer 82508I

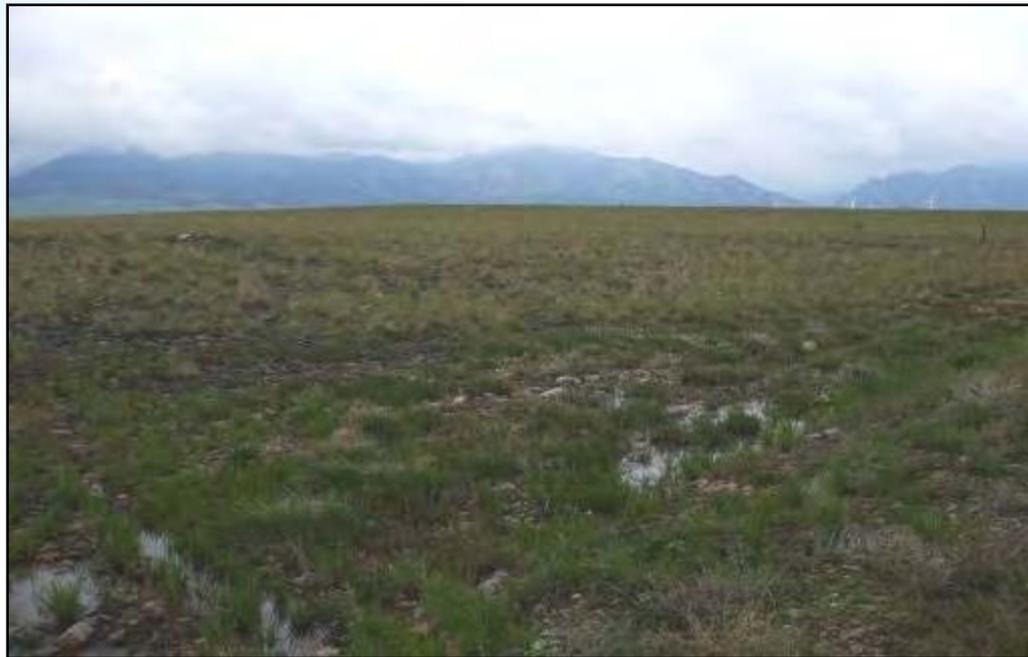
PLF Inspections and Surveys

- The quarterly inspection was completed on May 26
- No areas of concern were observed
- The vegetation inspection was completed on May 13
