# Original Landfill

February 1, 2016

Legacy  
Management

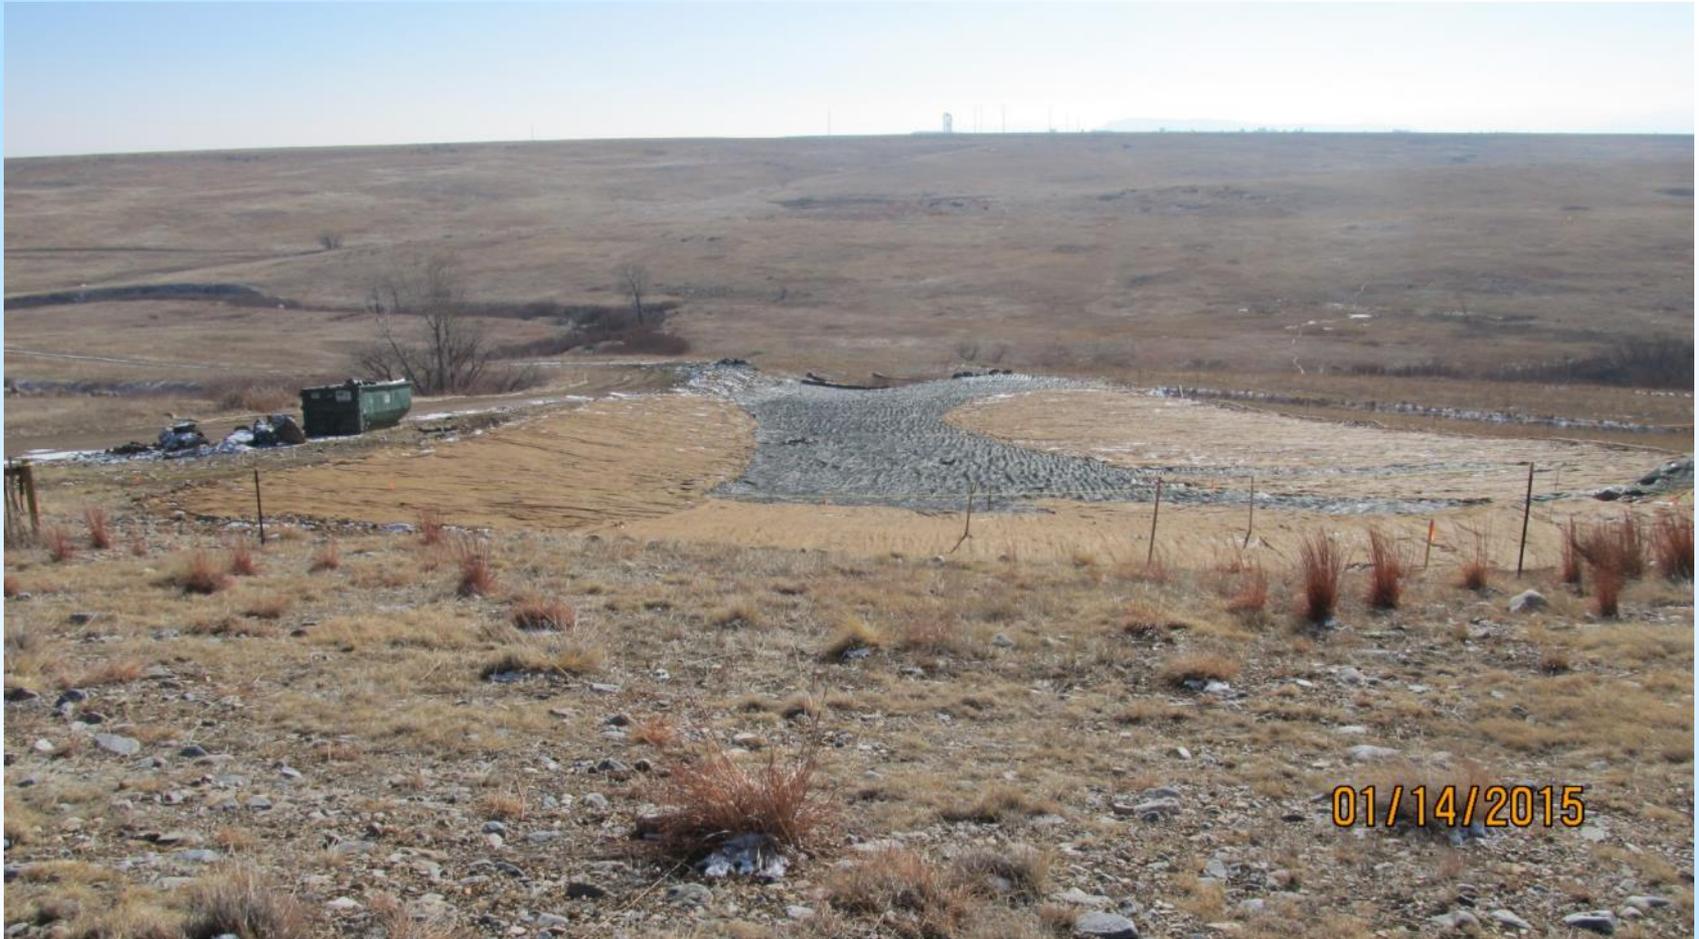
# 2015 extended heavy precipitation

- Extended heavy precipitation over several months in spring of 2015
  - Significant cracking, slumping, and movement on the east side.
  - West side experienced some movement on the west end of berms 1 and 2
  - Center section of the landfill experienced no visible movement (small cracks in a few locations)
- Immediate actions included installing overland drain pipe and developing small drainage channels to conduct water off the cover

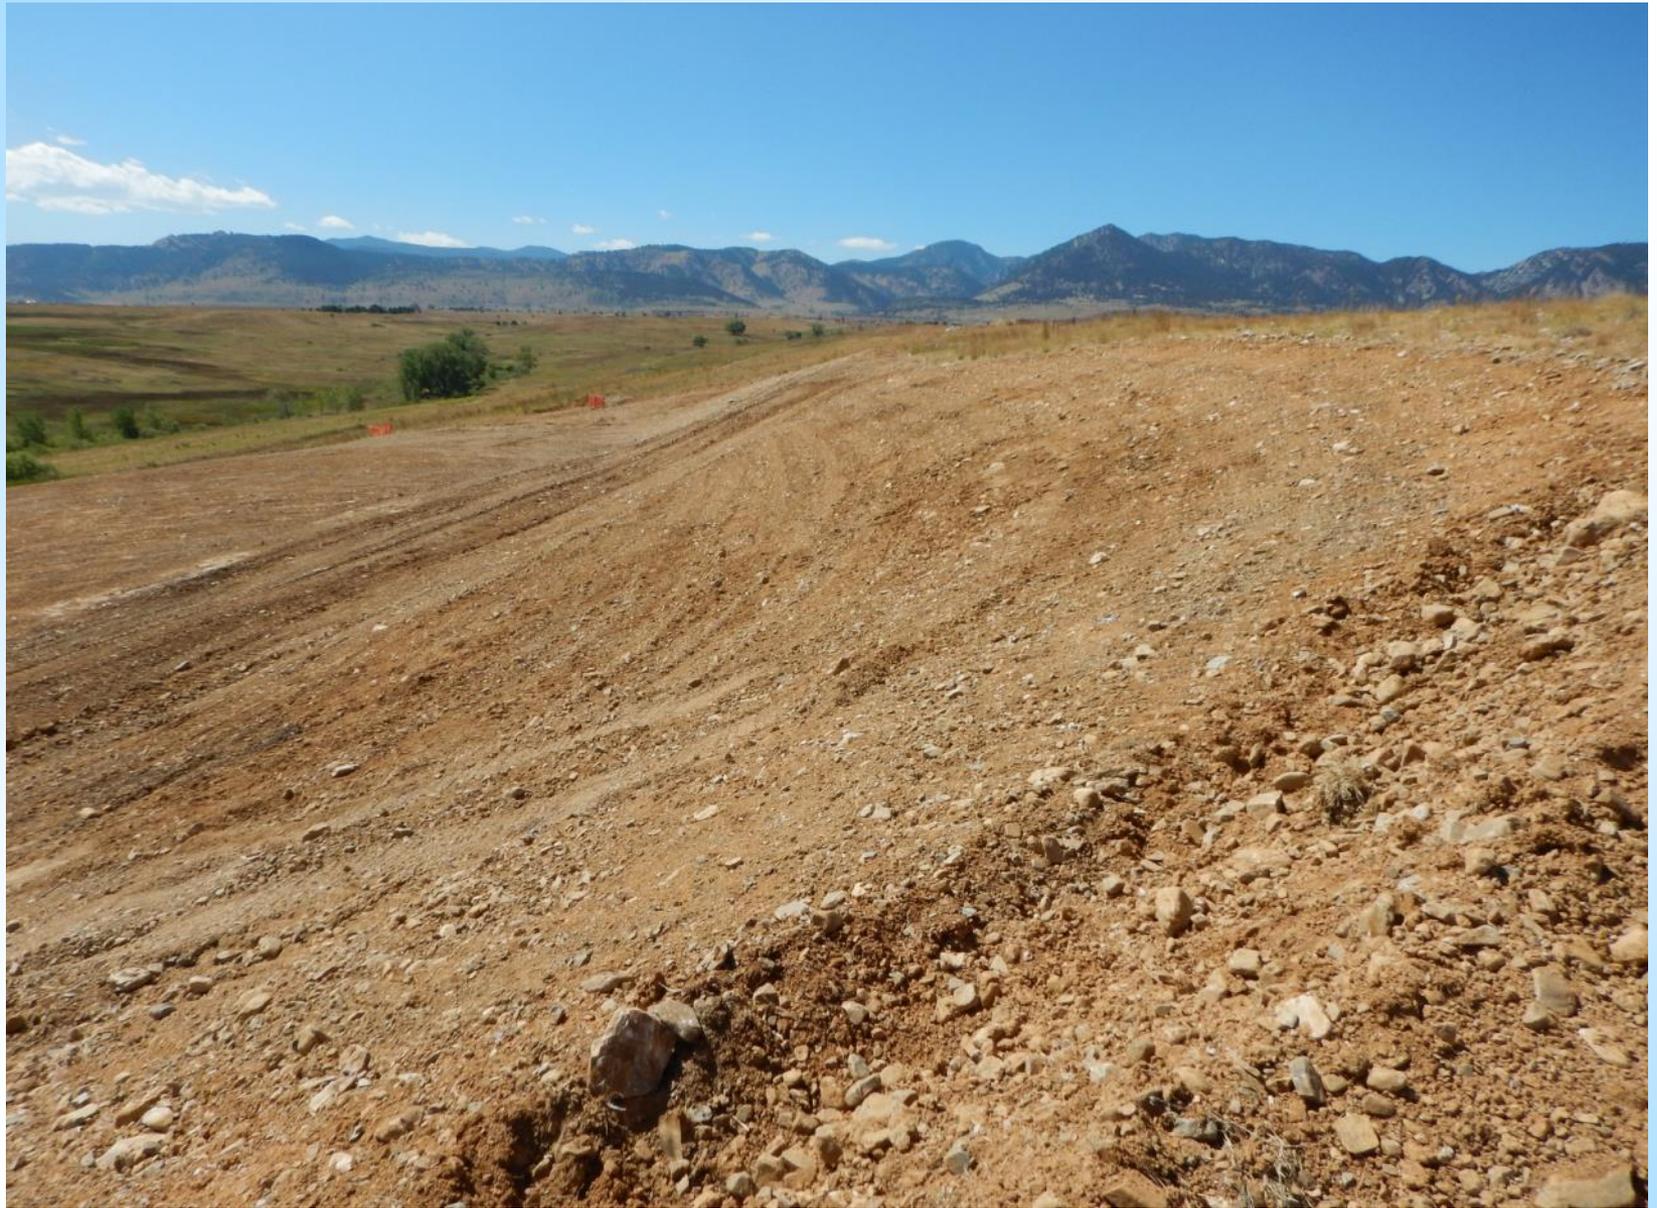
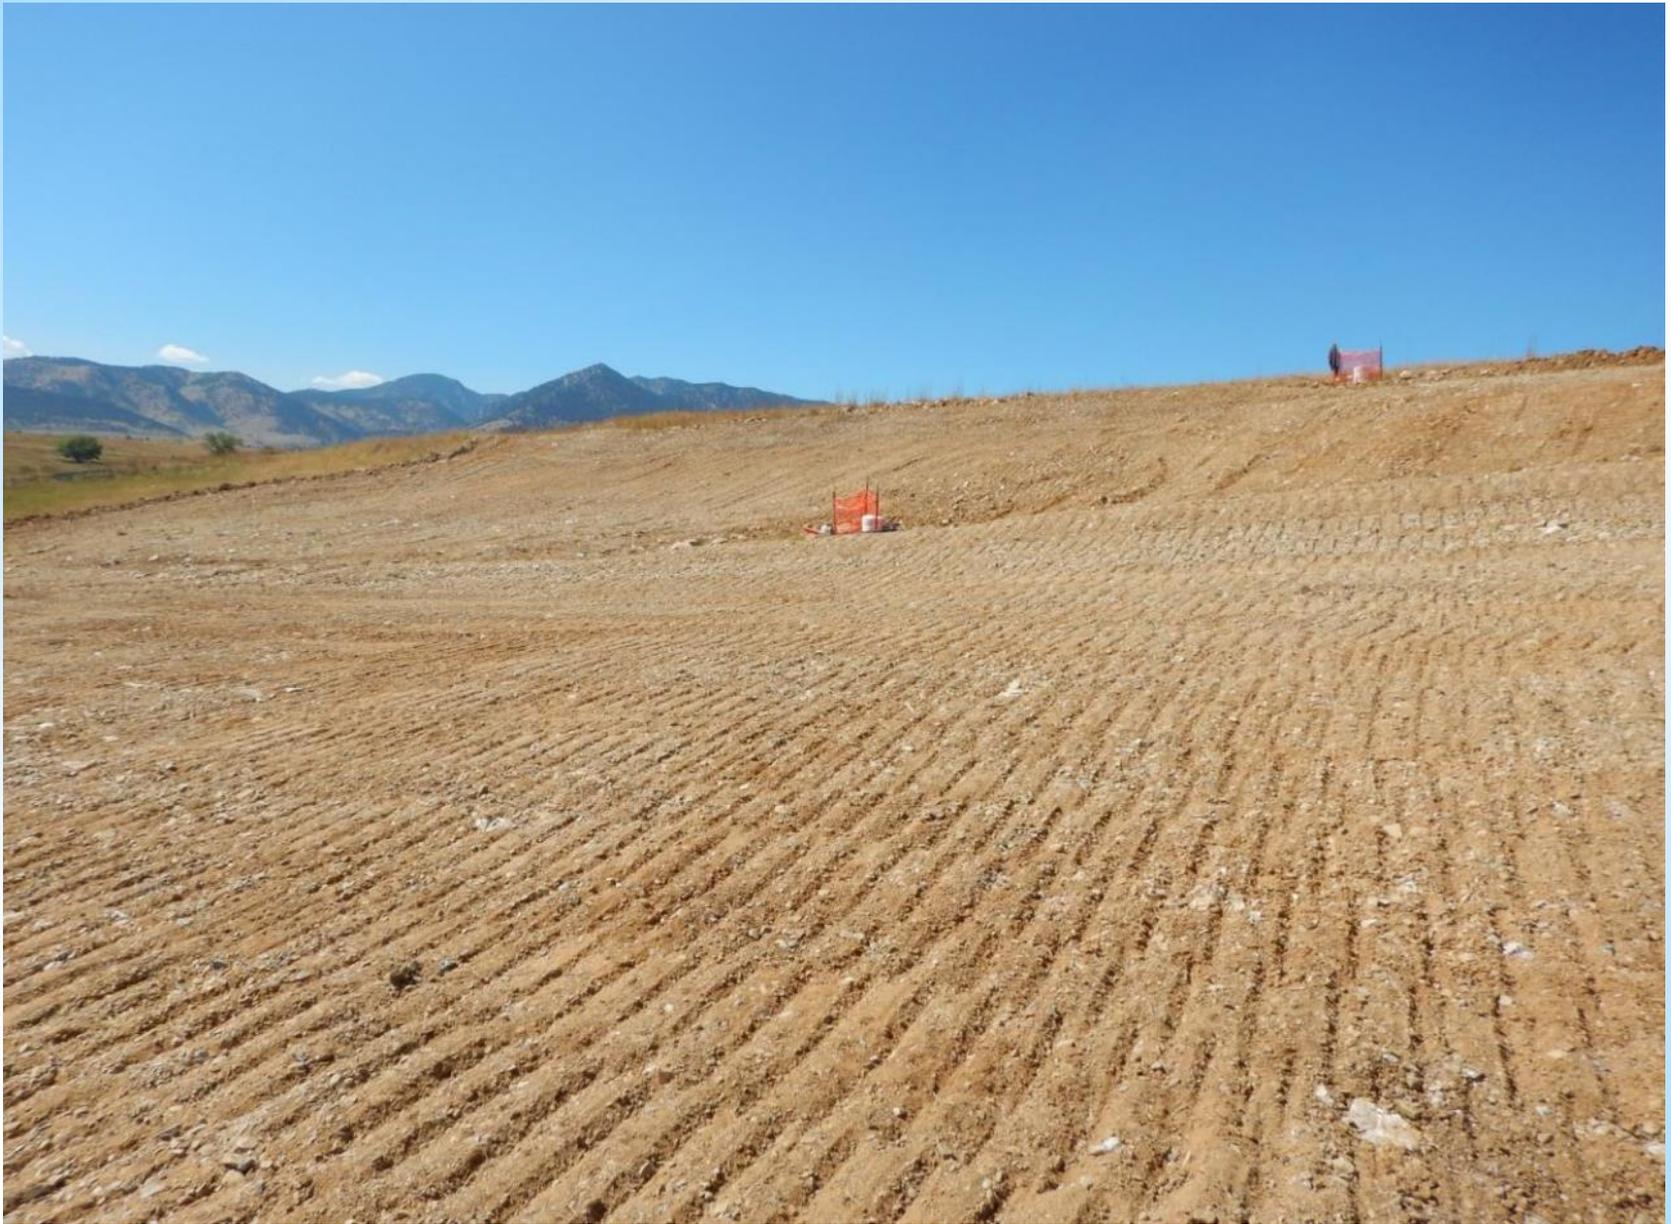
# 2015 interim action

- Re-graded affected areas to restore the water management functions of the cover and close cracks
- Two-foot cover requirement was not maintained in some areas, primarily outside the waste footprint
- A few pieces of debris were noted during regrading; none were radiologically contaminated
