Structural Response Studies for  
Project Rulison

John A. Blume & Associates Research Division  
san francisco

February 1971

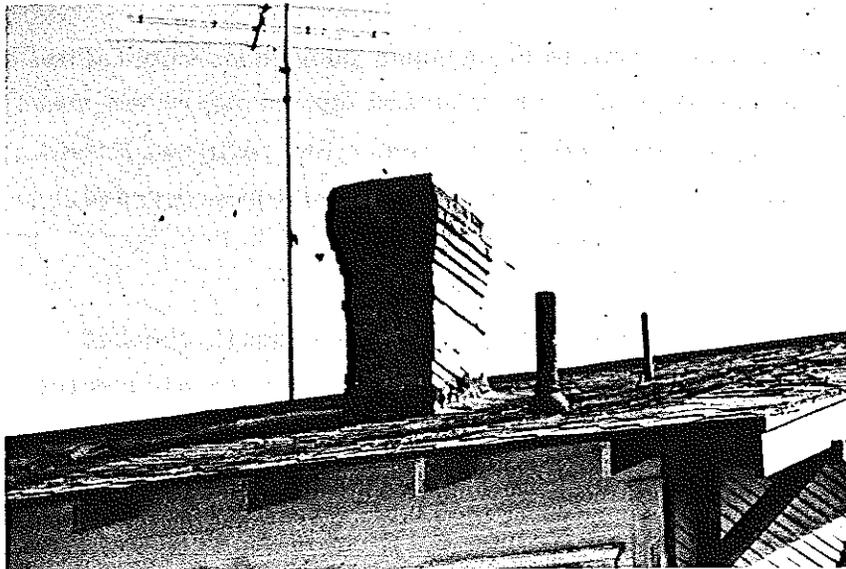
As noted, the condition-surveyed buildings were again checked shortly before the event, and detectable changes were documented. Shortly after the event the condition surveys were repeated. (Figures 10 and 11 show a RULISON area chimney before and after damage). Absence of detectable damage was documented as well as detectable damage.

FIGURE 10. PRE-SHOT CHIMNEY CONDITION.

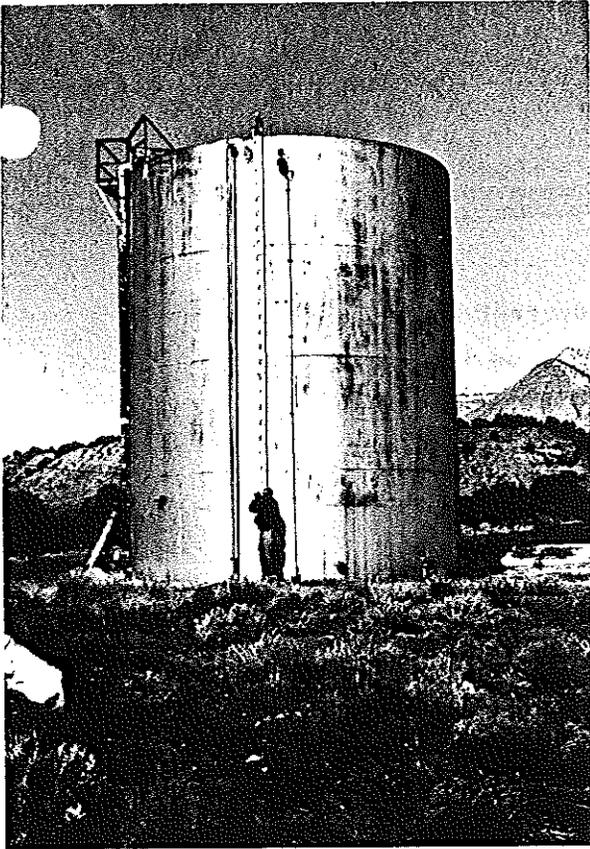
FIGURE 12. A WELDED STEEL PLATE DOMESTIC WATER TANK IN GRAND VALLEY. 24-FT DIA, 30 FT HIGH.

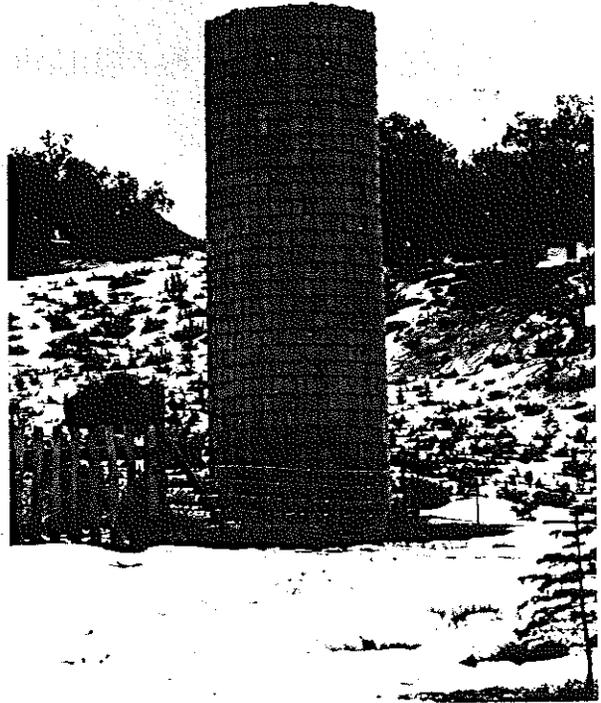
FIGURE 14. A FODDER SILO CONSTRUCTED OF CONCRETE SLABS. THE INTERIOR IS PLASTERED. 12-FT DIA, 40 FT HIGH.

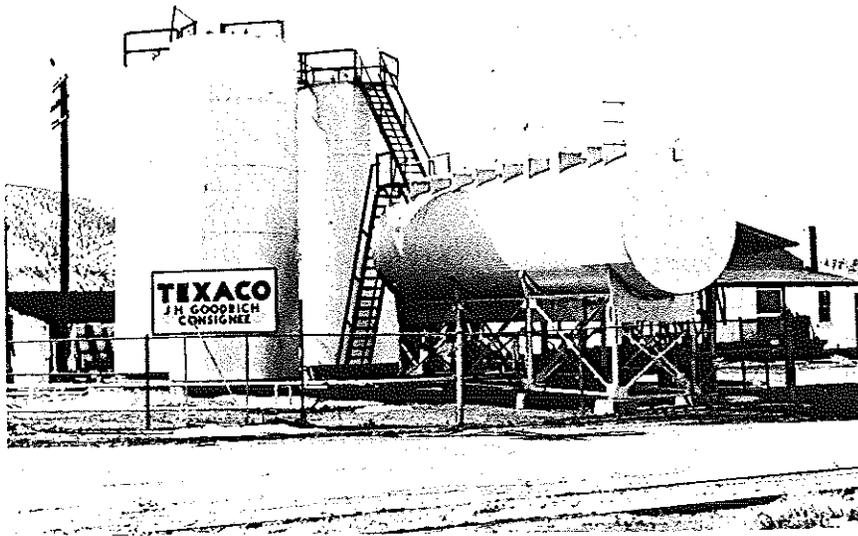
FIGURE 13. WELDED AND RIVETED ROLLED STEEL TANKS. 10-FT DIA, 36 FT LONG.

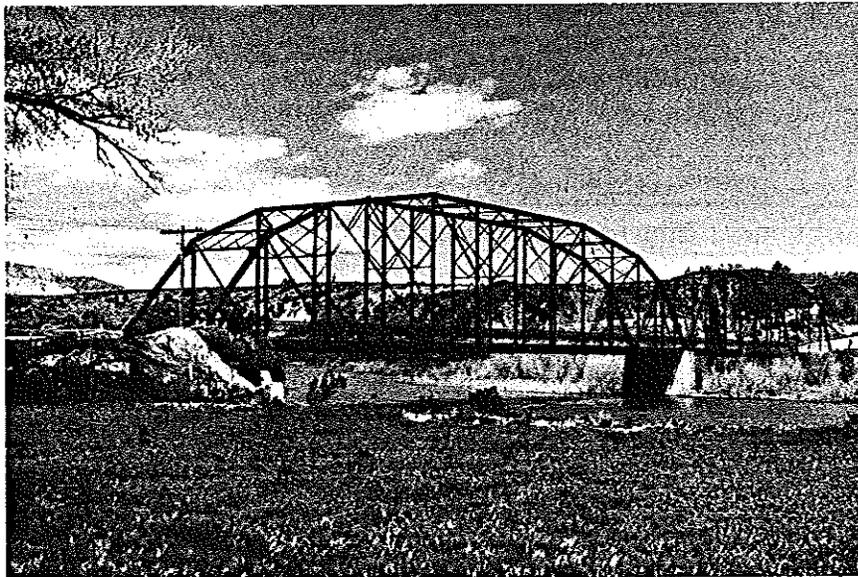
Photographs Yes Roll 28-69 Negatives #27 thru #32  
Description Bridge across the Colorado River. The south section is 180' long and the north 240'. On the east side there is an 8" flanged steel water pipe carried at road level. Also, at road level a 3" gas pipe on the west side. These pipes are tied to the bridge beams. The buttress-retaining wall on each end is concrete with a concrete pier linking the two sections. The north buttress has a large crack. On the south end there is cut stone showing which probably indicates the original buttress or retain wall. The road bed gives under a car's weight. The bridge is in fair condition.

FIGURE 17. GRAND VALLEY BRIDGE, APPROXIMATELY 10 KM NW OF GROUND ZERO. THIS TYPE OF CONSTRUCTION IS TYPICAL FOR BRIDGES IN THE STUDY AREA.

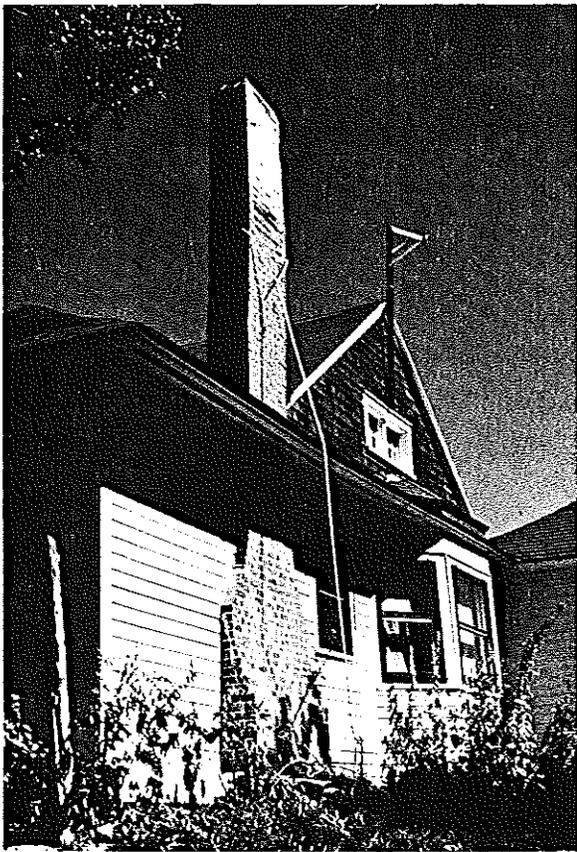
Figures 29 and 30 show selected photographs of a chimney. These photographs indicate the pre-event condition of the chimney. The post-event photographs, Figures 31, 32 and 33 can readily be compared and the extent of damage easily detected. These kinds of pre-event and post-event photographic documentation help establish the validity of damage and aided in defining ground motion damage criteria.

FIGURE 29. PRE-EVENT CHIMNEY CONDITION.

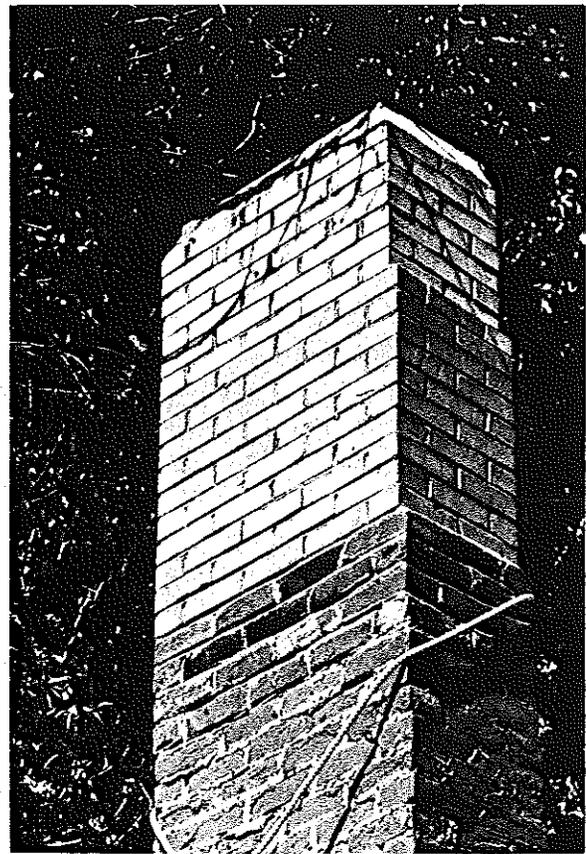
FIGURE 30. PRE-EVENT CONDITION SHOWING NEW AND OLDER BRICK AND MORTAR.

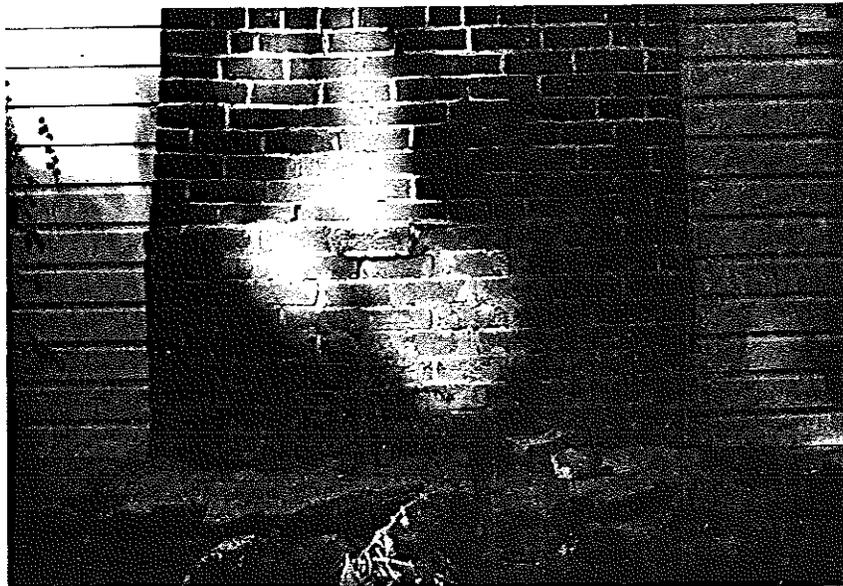
FIGURE 33. POST-EVENT CONDITION OF THE CHIMNEY BASE AND FOUNDATION. COMPARE WITH FIGURE 32.

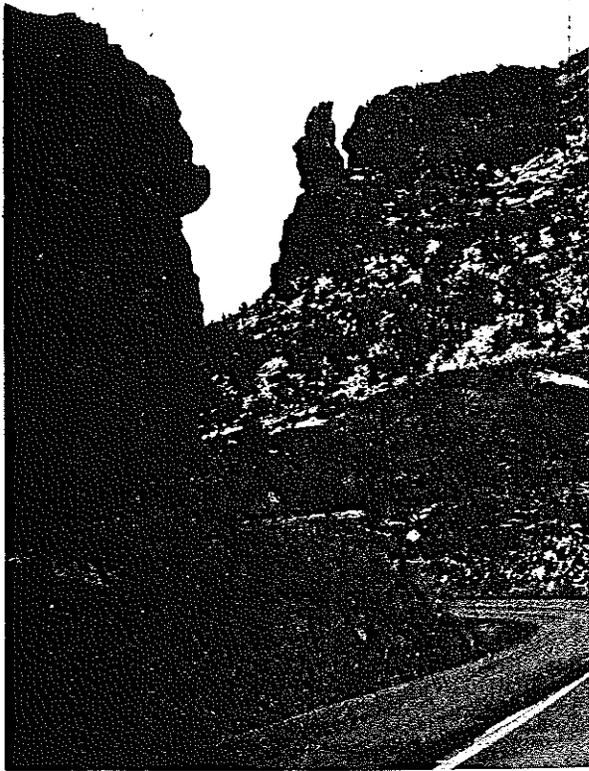
FIGURE 40. ROCKFALL AREA IN PLATEAU VALLEY, SOUTHWEST OF GROUND ZERO.

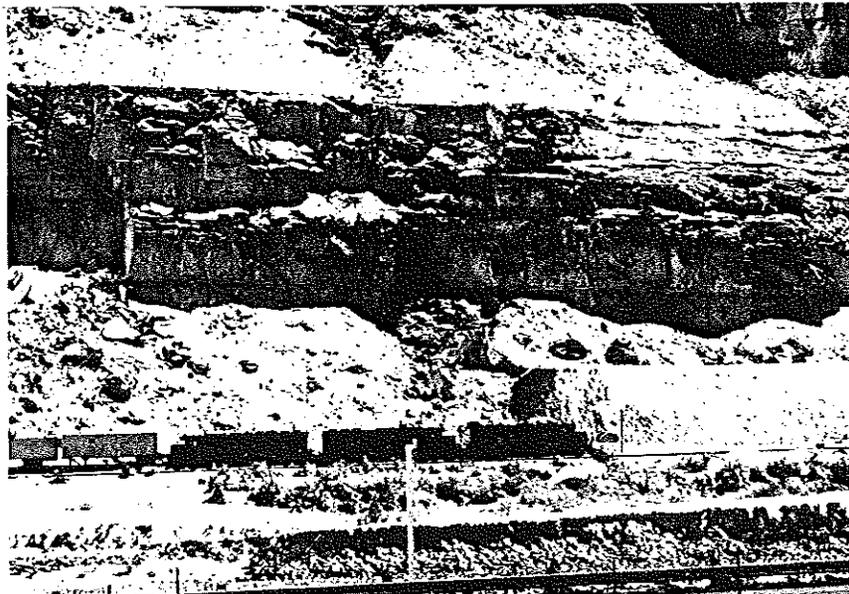
FIGURE 42. ROCKFALL AREA NEAR THE WEST END OF DEBEQUE CANYON. THE DENVER AND RIO GRANDE RAILROAD KEEPS EQUIPMENT IN THIS AREA (NEAR TUNNEL NO. 3) TO CLEAR THE TRACKS OF ROCK.

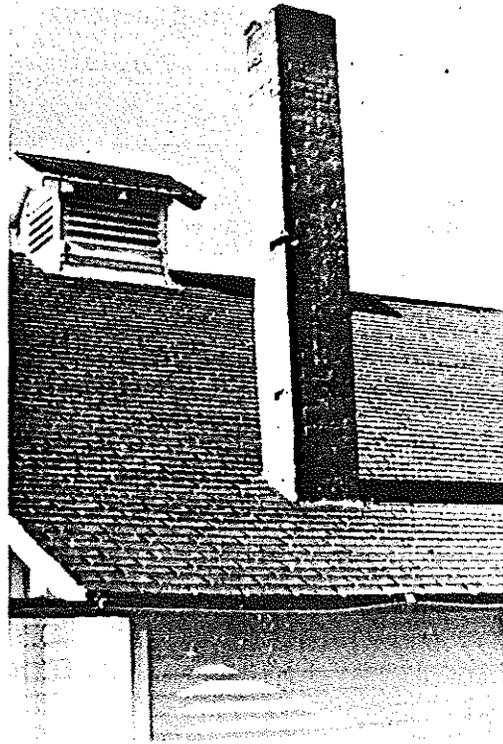
FIGURE 43. A TALL, NARROW CHIMNEY BEFORE REMOVAL. THE MORTAR IS DETERIORATED, ESPECIALLY THE TOP TWELVE COURSES. SEE FIGURE 45.

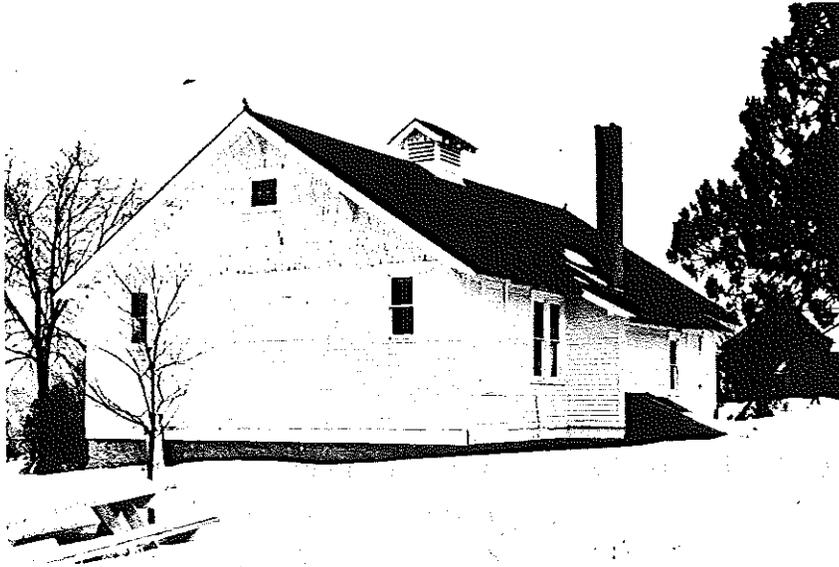
FIGURE 45. AN EXAMPLE OF WOOD-FRAME CONSTRUCTION LOCATED APPROXIMATELY 7 KILOMETERS FROM GROUND ZERO. NOTE THE CHIMNEY HEIGHT. SEE FIGURES 43 AND 44.

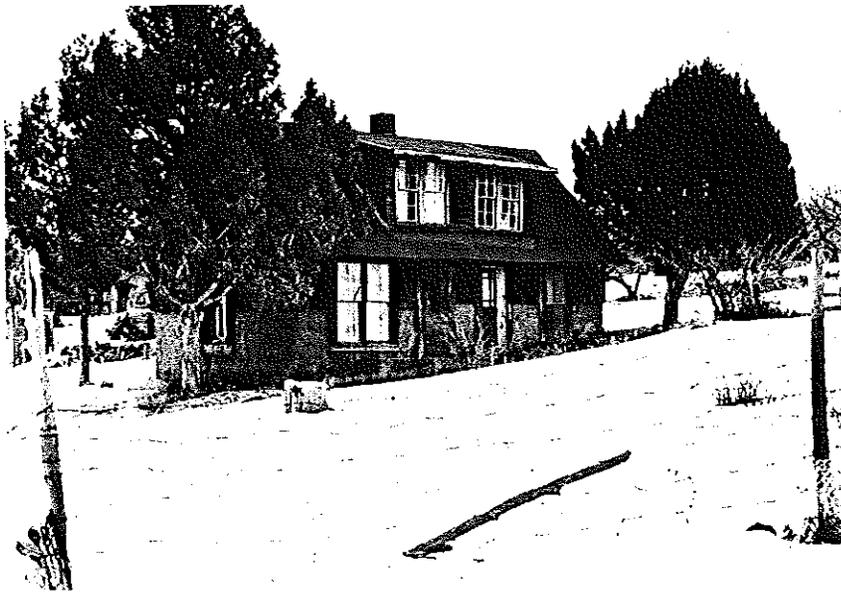
FIGURE 46. AN EXAMPLE OF ADOBE CONSTRUCTION.

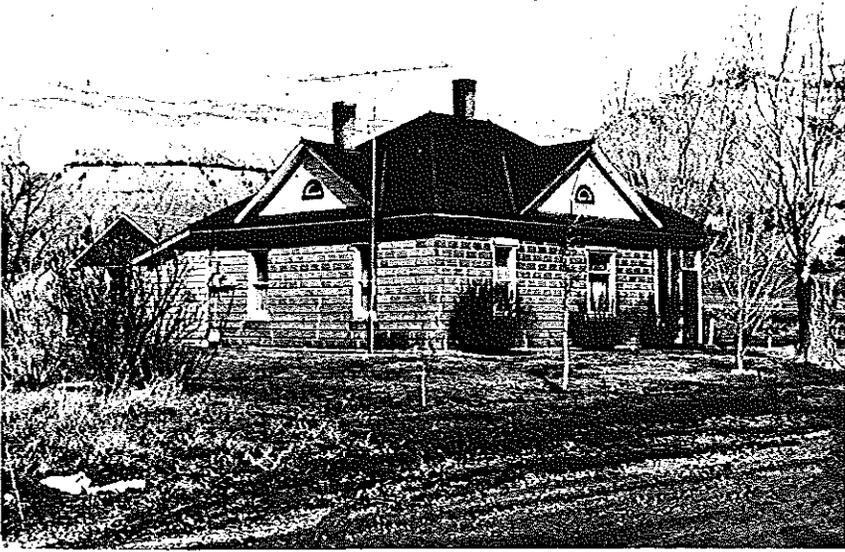
FIGURE 47. A RESIDENTIAL STRUCTURE CONSTRUCTED OF CONCRETE BLOCK. NOTE PATCHED CRACKS AND CHIMNEYS.

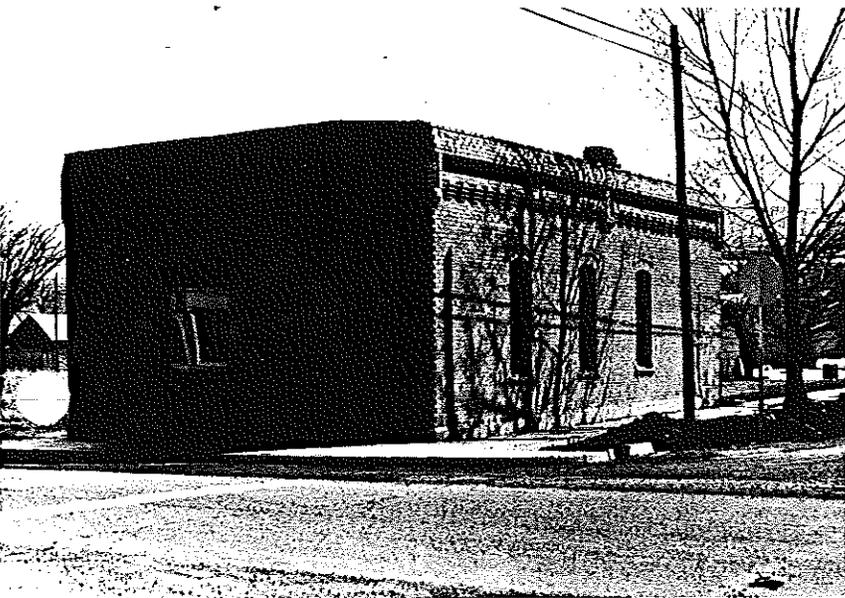
FIGURE 48. TYPICAL BRICK CONSTRUCTION. NOTE THE CHIMNEY AND PARAPET.

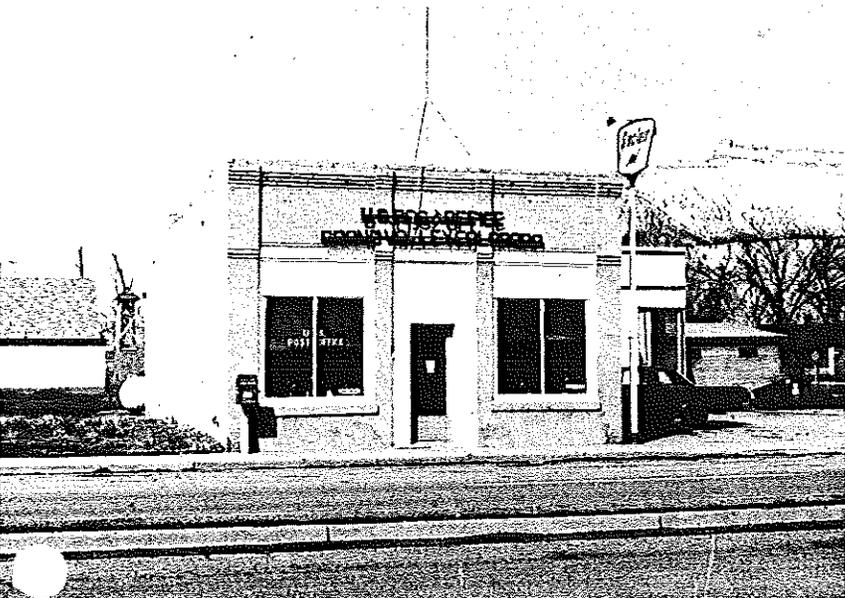
FIGURE 49. THE GRAND VALLEY POST OFFICE, PRE-EVENT. THE STRUCTURE IS BRICK WITH A STUCCO APPLICATION.

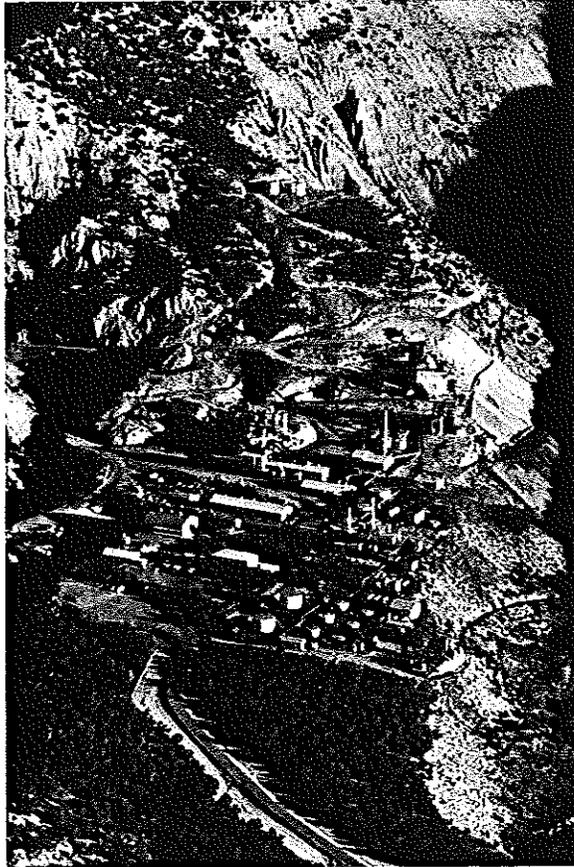
FIGURE 50. ANVIL POINTS  
RESEARCH STATION LOCATED  
AT THE BASE OF THE ROAN  
CLIFFS.

Spectral acceleration for the Anvil Points tower and retort structures at 5% damping was predicted to be approximately 0.3g; therefore, some slight overstressing might occur in bracing members, in anchor bolts, and foundations. Full storage tanks might spill over due to liquid motion. Failure of tower structures was not anticipated but it was suggested that maintenance personnel check all anchor bolts and guy wires for tightness and adequacy. Some extension of existing cracks might occur in the concrete block warehouse structures, the administration building, and the residential structures.

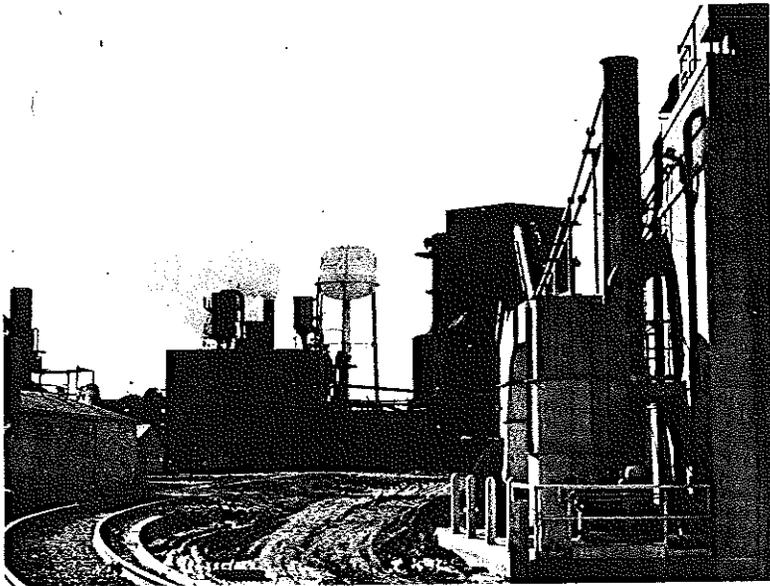
FIGURE 51. UNION CARBIDE PROCESSING PLANT WITH A 200,000-GALLON WATER TANK ELEVATED 100 FEET ABOVE THE GROUND.

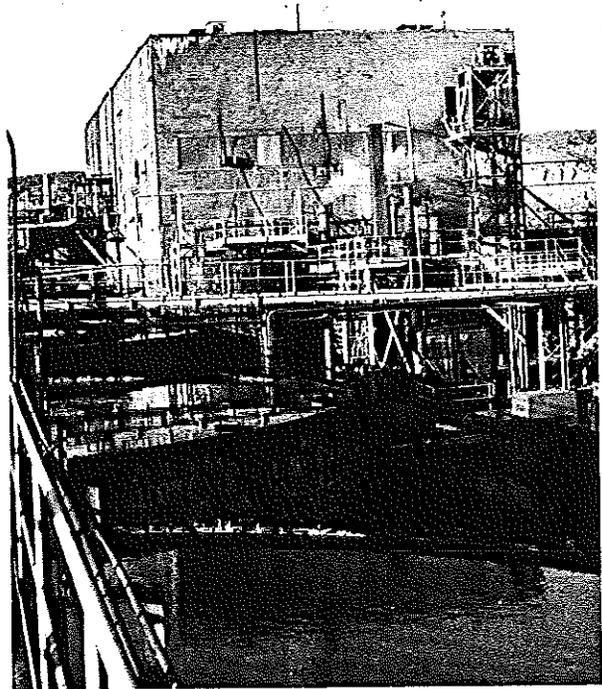
Spectral accelerations at 5% damping in the 0.2- to 0.3-second period range were predicted to be about 0.14g; horizontal ground motion was predicted at about 0.07g or less. At these levels some minor additional cracking of the concrete block filler walls of the process buildings was possible. Other features of the plant were expected to respond well. Spillage of acids and other liquids due to sloshing in tanks was also considered possible but unlikely to occur.

FIGURE 52. UNION CARBIDE CONCRETE BLOCK BUILDING AND WOOD-STAVE TANKS.

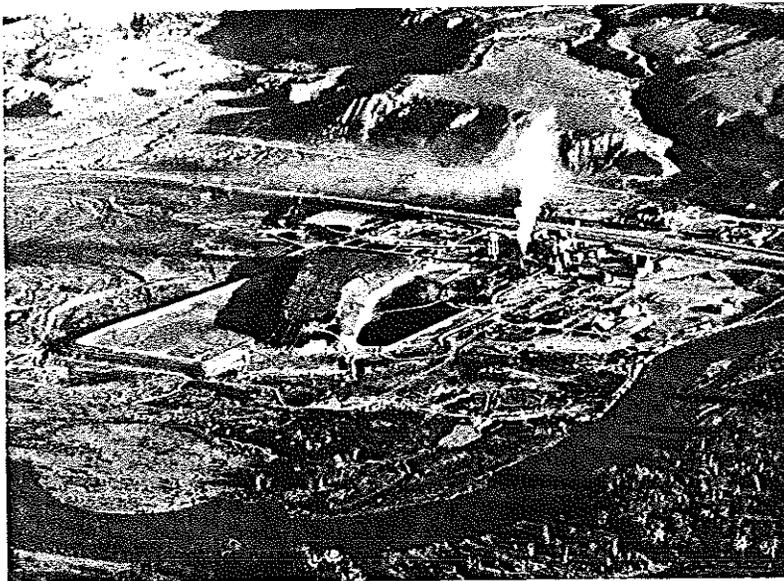
A mill tailings pile composed of silt size particles and a settlement pond which is retained in a fully saturated condition behind earth embankments are located adjacent to the plant. The saturated silty material might tend to liquefy under dynamic load, but this was believed unlikely to occur. It was recommended that persons be away from the downslope areas of the tailings pile during the RULISON event. Figure 53 is an overall view of the Union Carbide facility.

FIGURE 53. UNION CARBIDE PLANT WEST OF RIFLE. NOTE THE MILL TAILING PONDS.

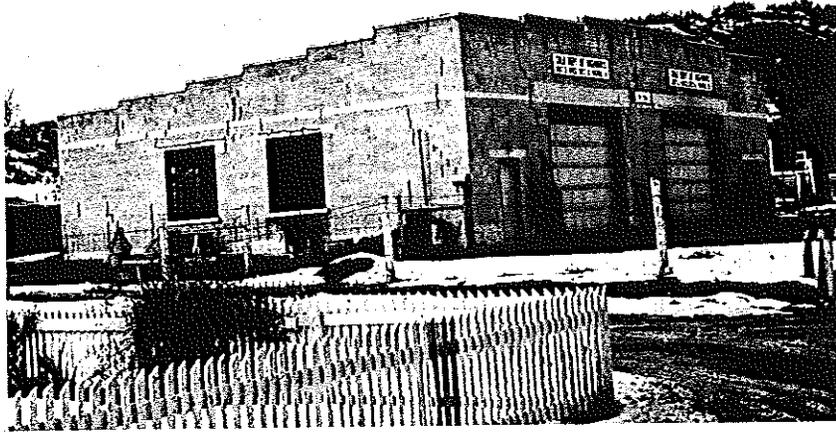
FIGURE 54. HIGHWAY MAINTENANCE BUILDING  
IN RIFLE. NOTE THE PATCHED CRACKS IN THE  
MORTAR JOINTS AND CINDER BLOCK UNITS.

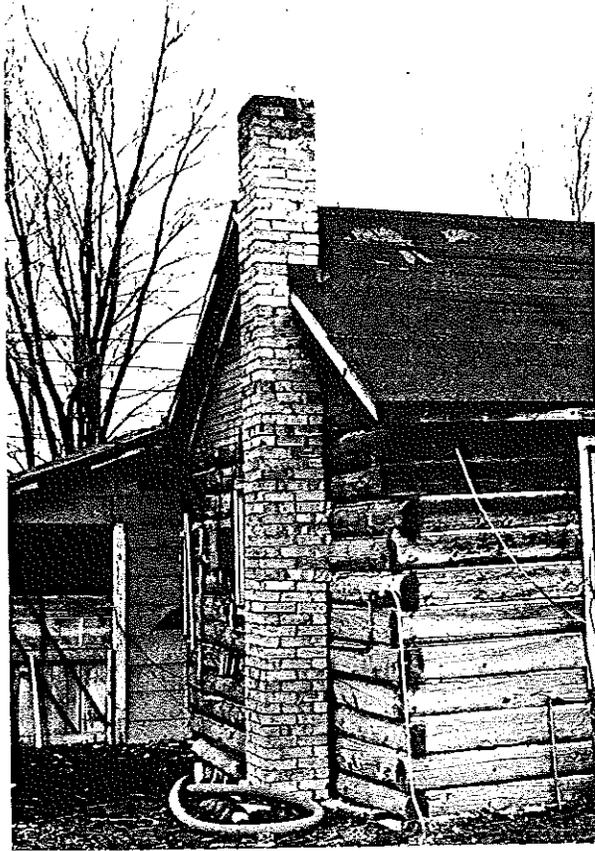
FIGURE 56. A LOG RESIDENCE IN DEBEQUE. NOTE THE MORTAR PATCHING ON THE CHIMNEY.

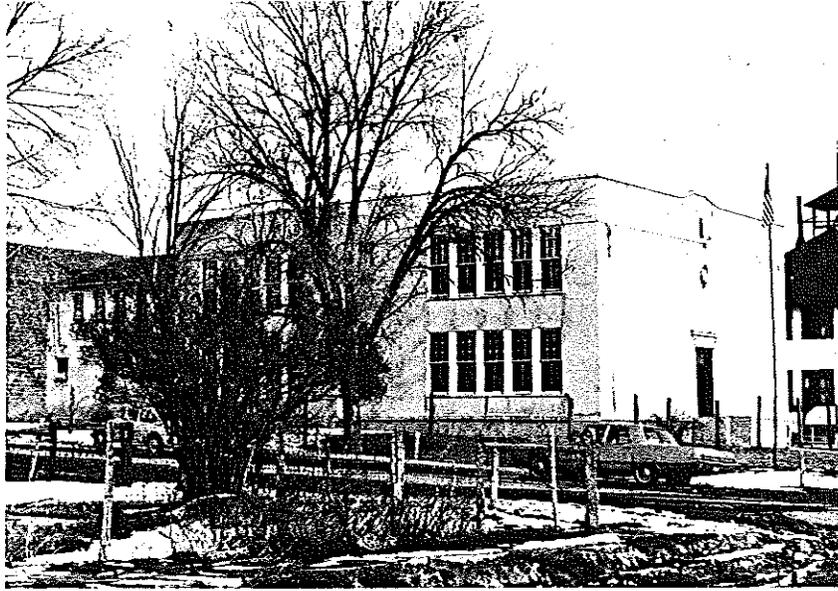
accelerations were estimated to be less than 0.04g; 5% damped spectral accelerations ranged up to about 0.07g. Minor damage to stressed plaster of stucco surfaces and some slight extension of masonry cracks were considered possible. Figure 58 shows one of the few 2-story structures in Silt.

FIGURE 58. TWO-STORY ELEMENTARY SCHOOL IN SILT. NOTE THE OLDER WOOD-FRAME SCHOOL UNIT IN THE BACKGROUND.

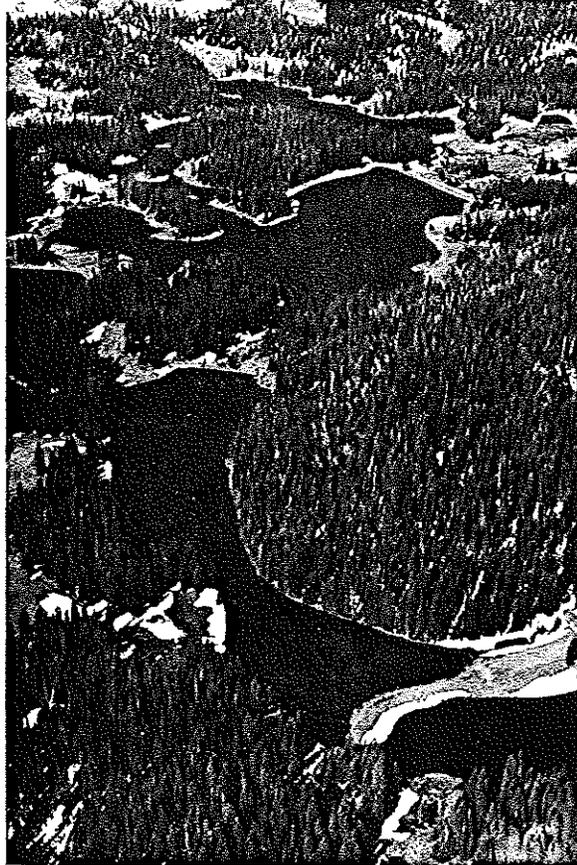
FIGURE 59. BATTLEMENT RES-  
ERVOIRS LOCATED ABOVE AND  
SOUTHEAST OF GROUND ZERO.

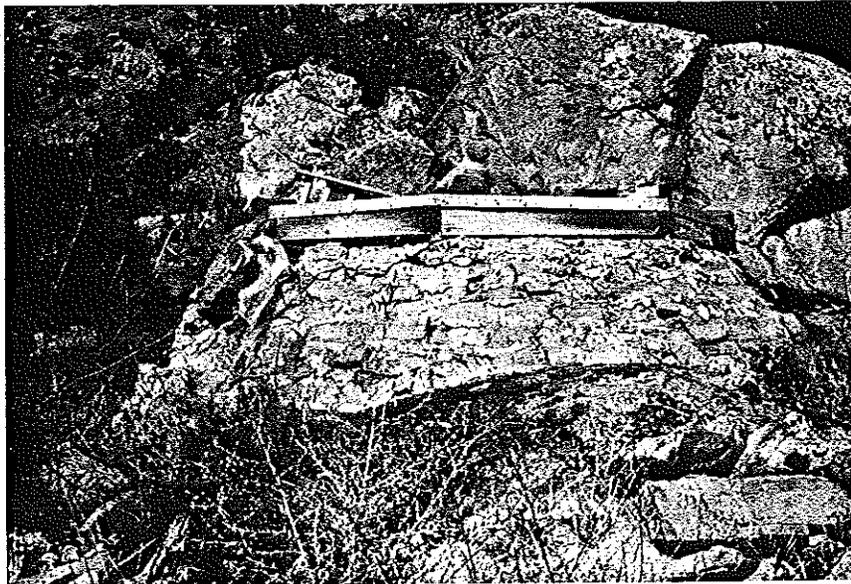
FIGURE 61. MOST CISTERNS IN THE STUDY AREA WERE TOTALLY UNDERGROUND BUT CONSTRUCTION WAS SIMILAR TO THIS. IN THIS CASE A HOLE WAS DUG, LINED WITH ROCK, THEN PLASTERED. OFTEN A HOLE WAS DUG AND THE SIDES DIRECTLY PLASTERED.

Numerous cisterns constructed both in rock and alluvium are located in the immediate vicinity (4 to 10 km) of the shot point. Figure 61 is a view of a cistern. It was considered possible that the RULISON event might cause minor damage to some of the cisterns although no extensive damage was predicted. No preventive measures were recommended since only limited minor damage was expected to occur.

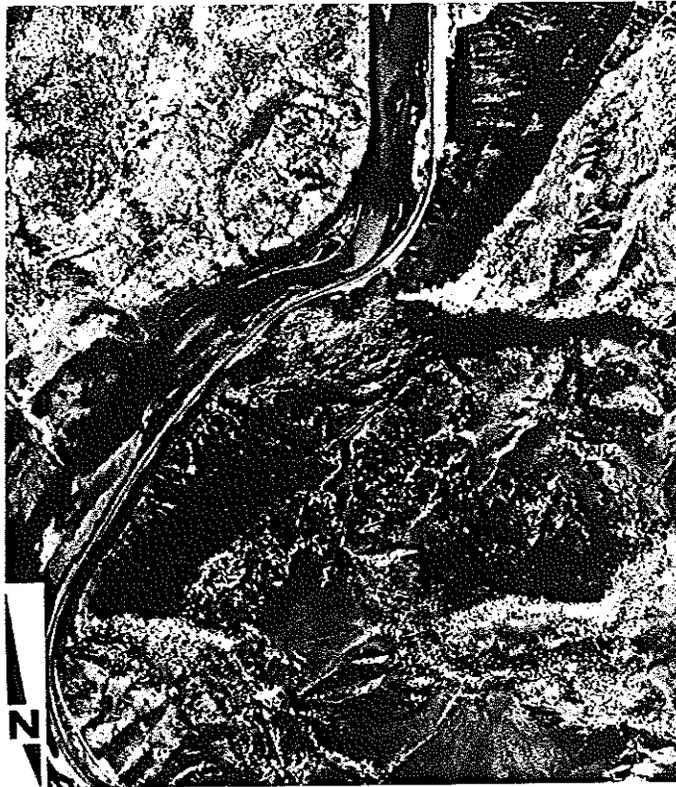
DeBeque Canyon - Rockfalls and landslides consisting of large masses of intermixed sandstone blocks and clay shale are a chronic occurrence in DeBeque Canyon. Figures 63, 64, and 65 show rockfalls. These slope failures periodically block portions of Interstate Highway I-70 and the main line of the D&RG RR for a distance of 14 miles along the Colorado River. The canyon starts just west of the town of DeBeque, and the canyon floor hazard area extends for about 22.5 kilometers almost con-

FIGURE 63. VIEW OF DEBEQUE CANYON, COLORADO LANDSLIDE, SHOWING FEATURES OF SLOPE INSTABILITY IN THE CANYON. INTERSTATE HIGHWAY 70 IS SHOWN EXTENDING FROM THE LOWER LEFT-HAND CORNER ACROSS THE TOE OF THE SLIDE. THE COLORADO RIVER IS BELOW THE HIGHWAY TO THE RIGHT OF CENTER.

THE RIM ROCK COLLAPSE IS BELIEVED TO HAVE TAKEN PLACE IN 1929. THE SLIDE CONTINUES TO BE A HAZARD, AS IT IS A SOURCE OF ROCK FALLS ONTO THE HIGHWAY AND A CHRONIC HIGHWAY MAINTENANCE PROBLEM. COMPARE THIS FIGURE WITH FIGURE 64.

FIGURE 64. DEBEQUE SLIDE TAKEN FROM AN AERIAL PHOTOGRAPH. COMPARE WITH FIGURE 63.

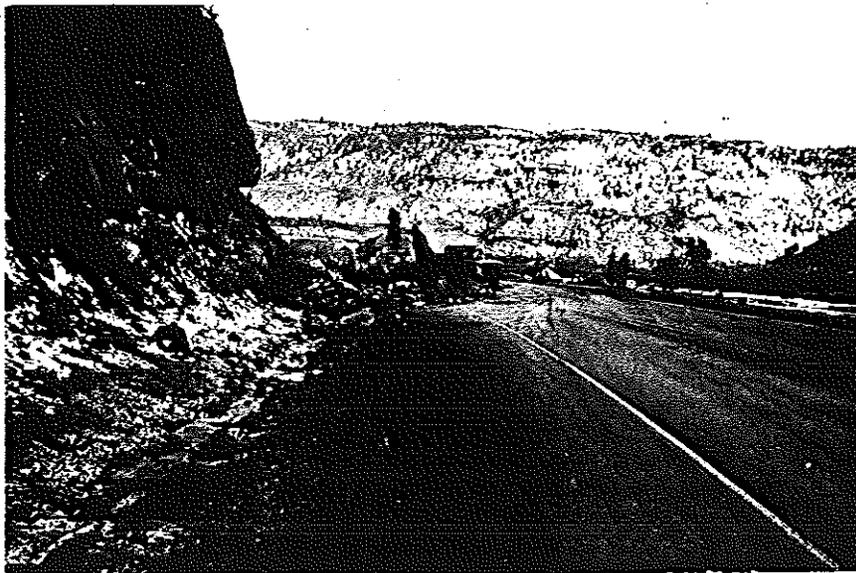
FIGURE 65. A ROCKFALL AT THE EAST END OF DEBEQUE CANYON DURING EARLY 1969.

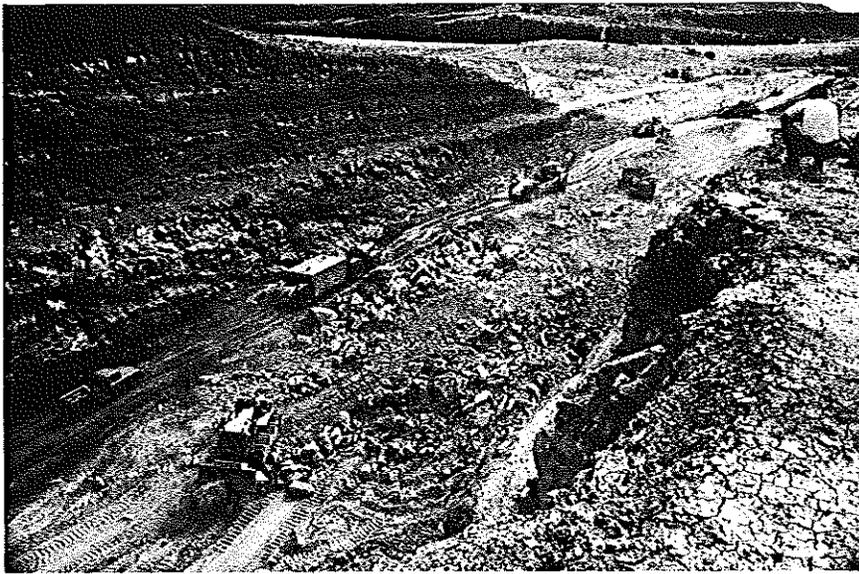
- (1) Niger Hill - 9.7 kilometers east of DeBeque
- (2) Webster Hill - 6.4 kilometers west of Rifle. This portion of the track was scheduled for relocation. Construction started in late May 1969. (Figure 66).
- (3) Track which had recently been relocated from the north to the south side of the Colorado River immediately west of Glenwood Springs parallel to I-70. In view of the expected dry condition of slopes at shot time no particular hazard from slope instability was expected as a result of the RULISON event.

FIGURE 66. WEBSTER HILL CUT-SLOPES FOR THE DENVER AND RIO GRANDE RAILROAD RELOCATION. THIS PHOTOGRAPH WAS TAKEN A FEW DAYS BEFORE DETONATION.

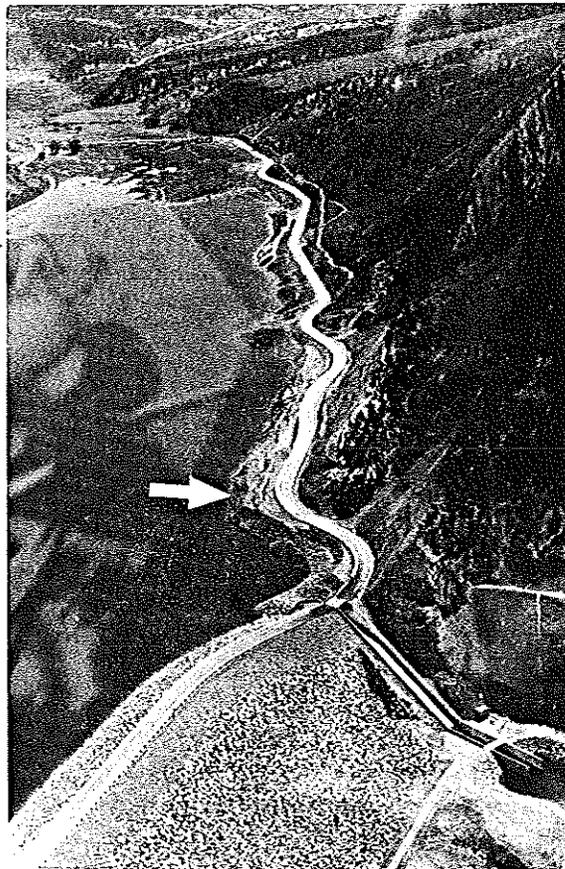
Grand Hogback at Rifle Gap and Harvey Gap Dams - Numerous old landslides were noted adjacent to the left abutment at Harvey Gap Dam as well as rockfalls and landslides downstream from the facility along the canyon walls southward to the Colorado River Valley. The dam and reservoir did not appear to be hazarded by these slides; however, the road and coal mine structures in the canyon through the Grand Hogback were vulnerable to both rockfalls and landsliding. The same observations applied to the road through Rifle Gap, which contains no other structures. However, recently relocated portions of the roads up East Rifle Creek (State Highway 325) and West Rifle Creek were slumping toward the reservoir, and recommendations were made that adjacent land and water areas be kept clear of persons at shot time. See Figures 67 and 68 of Rifle Gap Dam.

FIGURE 67. RIFLE GAP DAM AND RESERVOIR SHOWING RELOCATED STATE HIGHWAY 325. THE POINTER INDICATES THE AREA OF FIGURE 68.

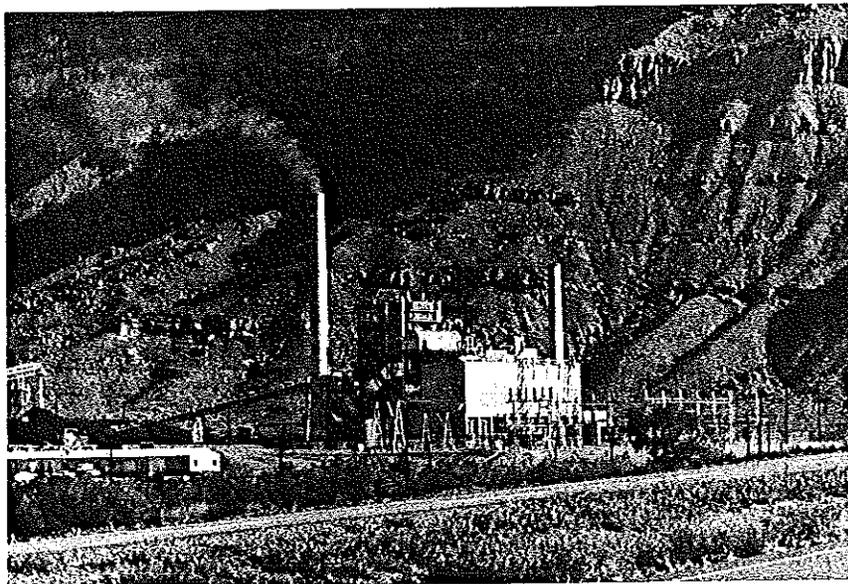
FIGURE 69. CAMEO PLANT WITH A STRUCTURAL FRAME OF REINFORCED CONCRETE AND STEEL. BOTH STACKS ARE OF REINFORCED CONCRETE. ONE STACK IS 150 FEET AND THE OTHER IS 200 FEET HIGH.

Some concern was expressed for turbines and substations associated with the Cameo Plant. (Figure 69). No effect from the RULISON ground motion was expected. It was possible that some temporary power outages might occur if the swaying motion caused uninsulated pole-mounted lines to swing together. However, it seemed unlikely that such problems would not have already arisen, and been solved, as a consequence of the same kinds of motion from high winds. Operating personnel were contacted with regard to ground motion and its possible effect on minor equipment housed in substation buildings and were advised of adequate preparation measures, to be implemented at shot time. The supervisor's panel in the Grand Valley Substation was braced by Public Service Company, prior to the event.

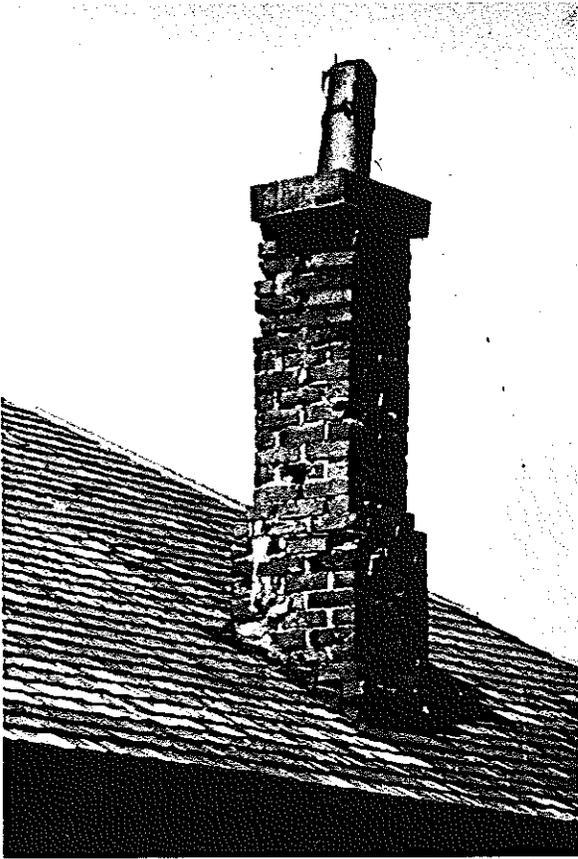
FIGURE 71.

The pre-event condition of this chimney indicates mortar deterioration and patching. Compare with Figure 72.

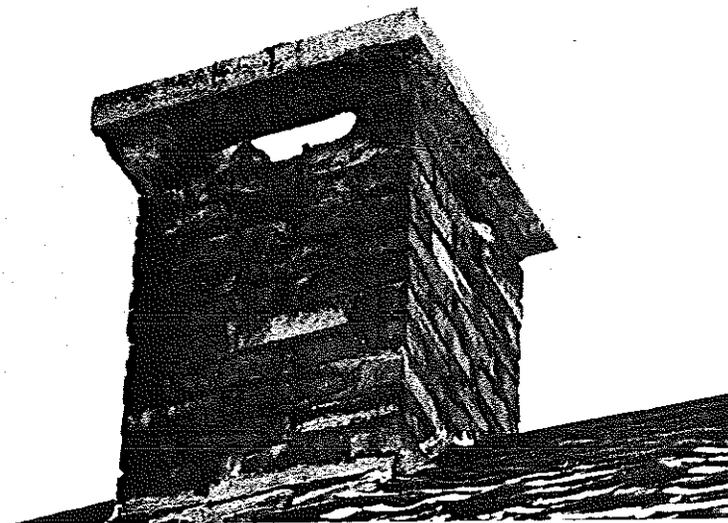
FIGURE 76. Chimney damage  
at Kansas Mesa south of  
Collbran.

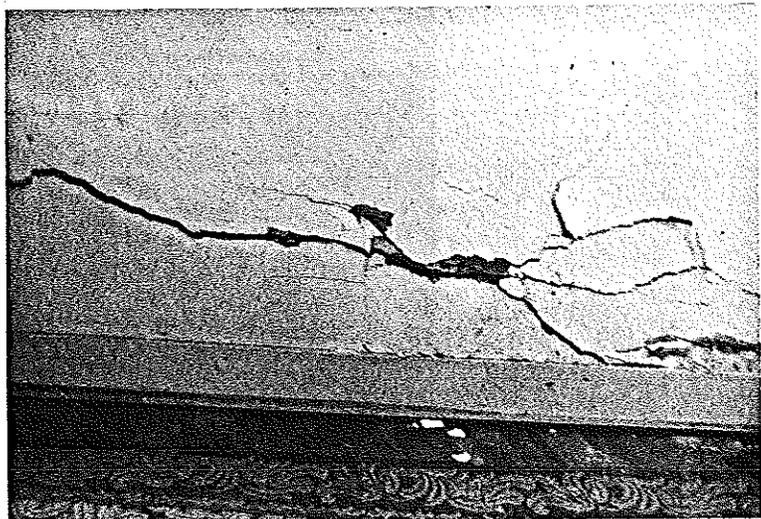
FIGURE 81. Reopened diagonal cracks on the interior wall of a stone house.
