## 5.0 Shirley Basin South, Wyoming, Disposal Site

### 5.1 Compliance Summary

Figure 5-1. 2008 Annual Compliance Drawing for the Shirley Basin South, Wyoming, Disposal Site

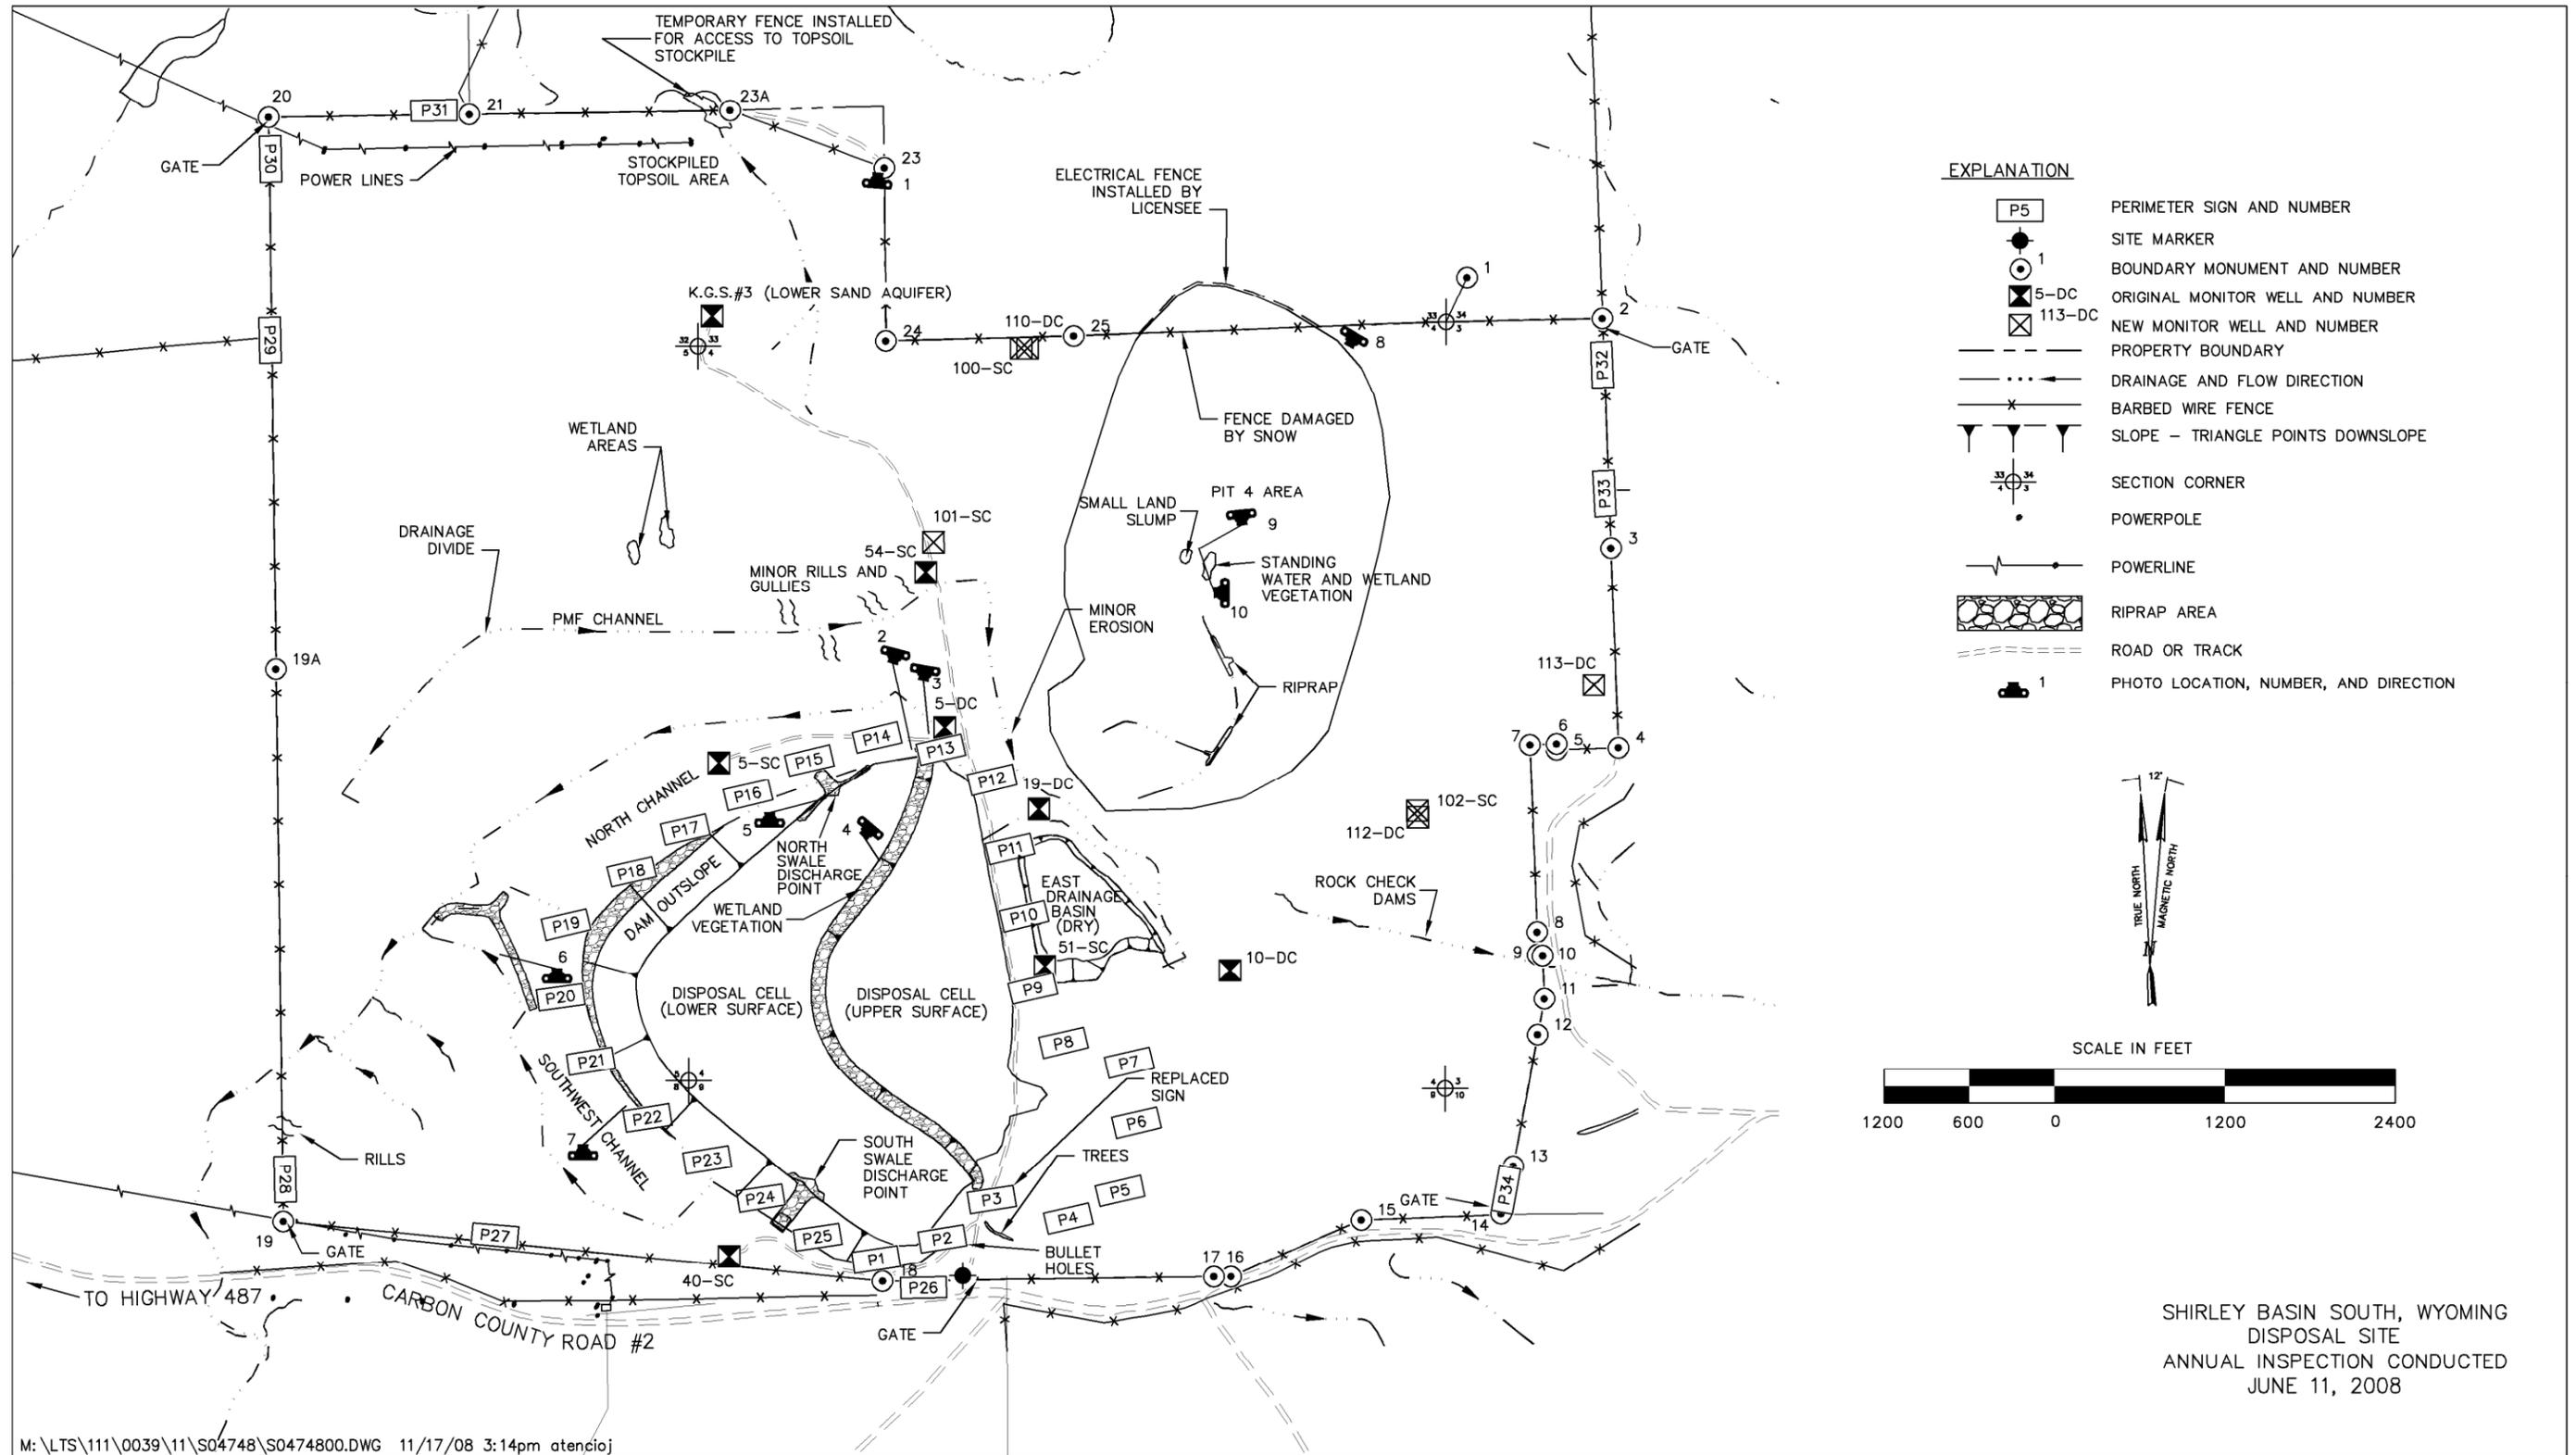
**Site Marker and Boundary Monuments**—The granite site marker, located at the site entrance, was in excellent condition. All 26 boundary monuments delineating DOE property were located and were in excellent condition (PL-1).

**Cover of the Tailings Impoundment**—The tailings impoundment, completed in 2000, occupies approximately 142 acres and has a grass cover (PL-2). The cell surface is constructed at two elevations separated by a riprap-armored slope (PL-3). The slope is in excellent condition.

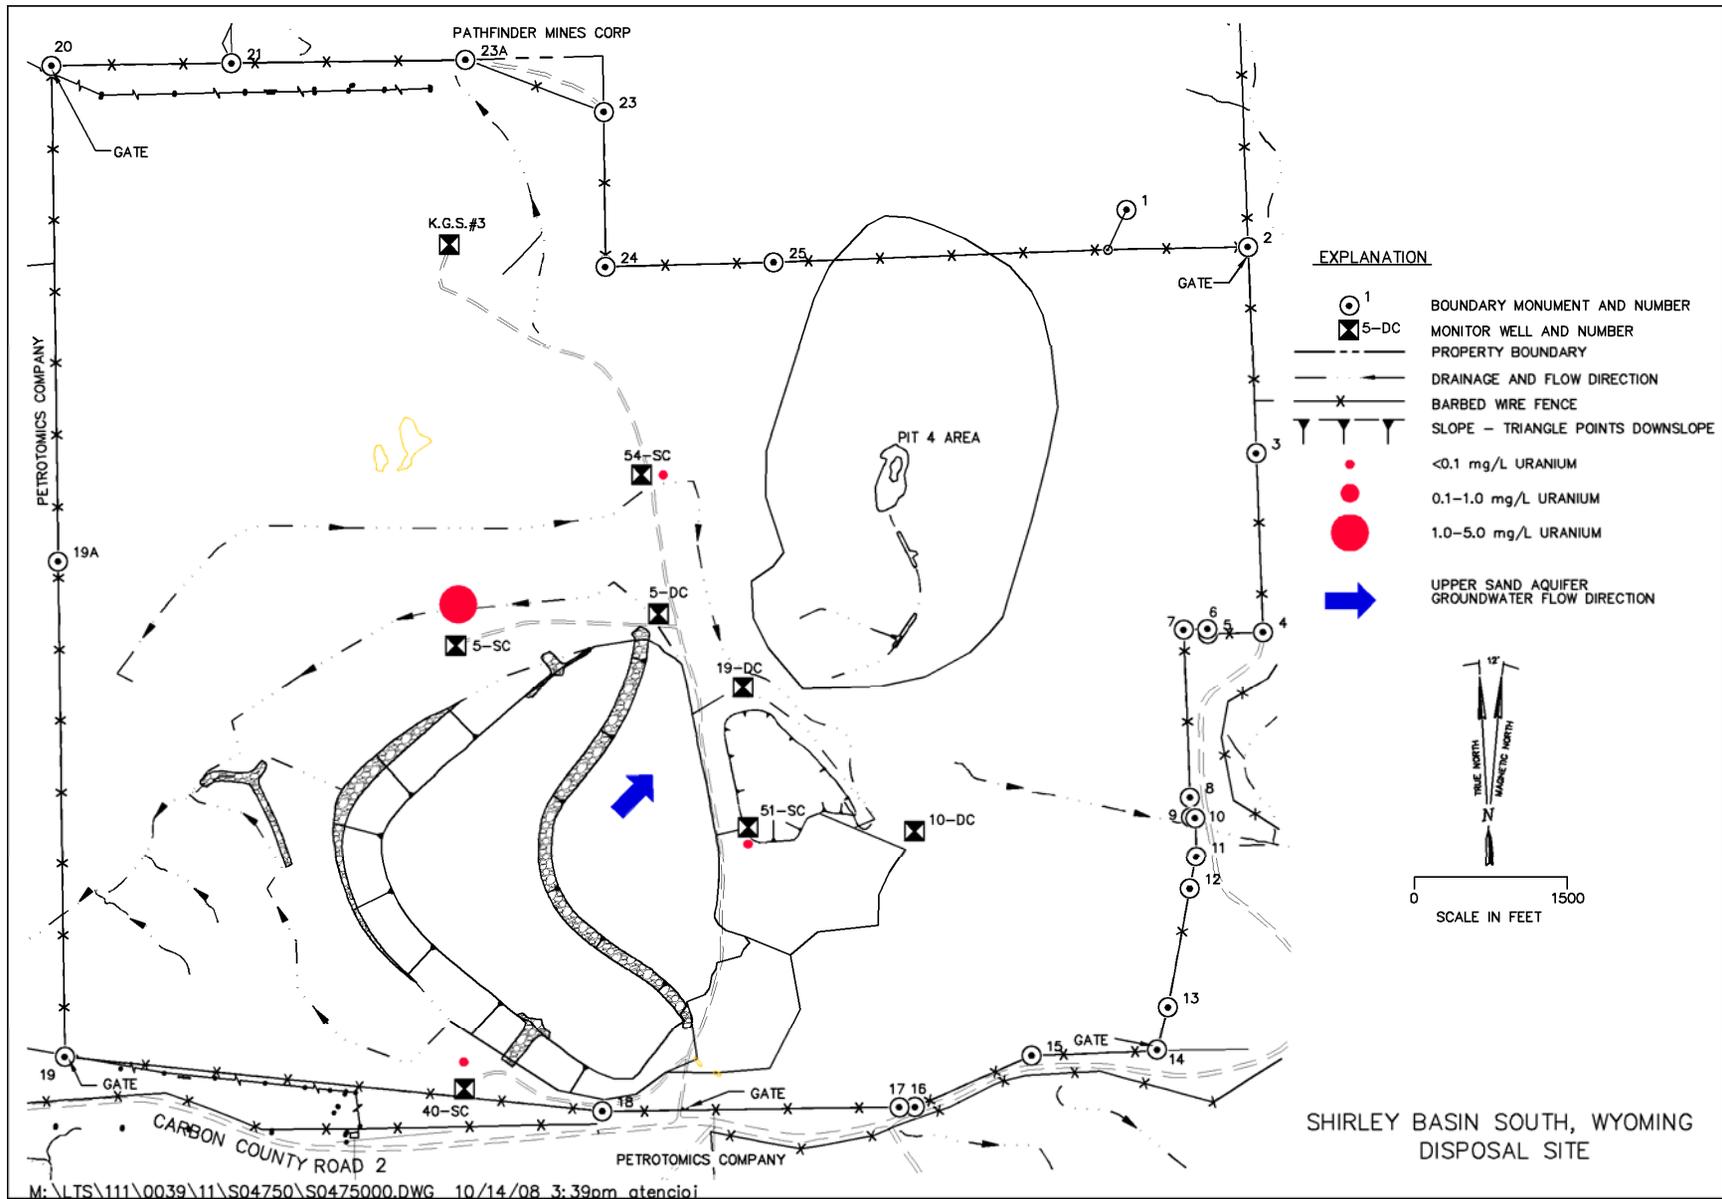
Figure 5-4. August 2008 Uranium Concentrations in the Upper Sand Aquifer at the Shirley Basin South, Wyoming, Disposal Site

The LTSP specifies that this report provide iso-concentration maps for uranium and sulfate. However, the four original wells in the upper sand aquifer and the three original wells in the main sand aquifer do not provide sufficient data points to develop contour maps of the contaminant plumes. Instead, 2008 concentrations for uranium in the two aquifers are shown on Figures 5-4 and 5-5, and concentrations for sulfate are shown on Figures 5-6 and 5-7. There were no significant changes in uranium concentrations from 2007 to 2008; concentrations in MW-5-SC indicate a slight downward trend. Sulfate concentrations were within the range of historical results with no apparent trends.

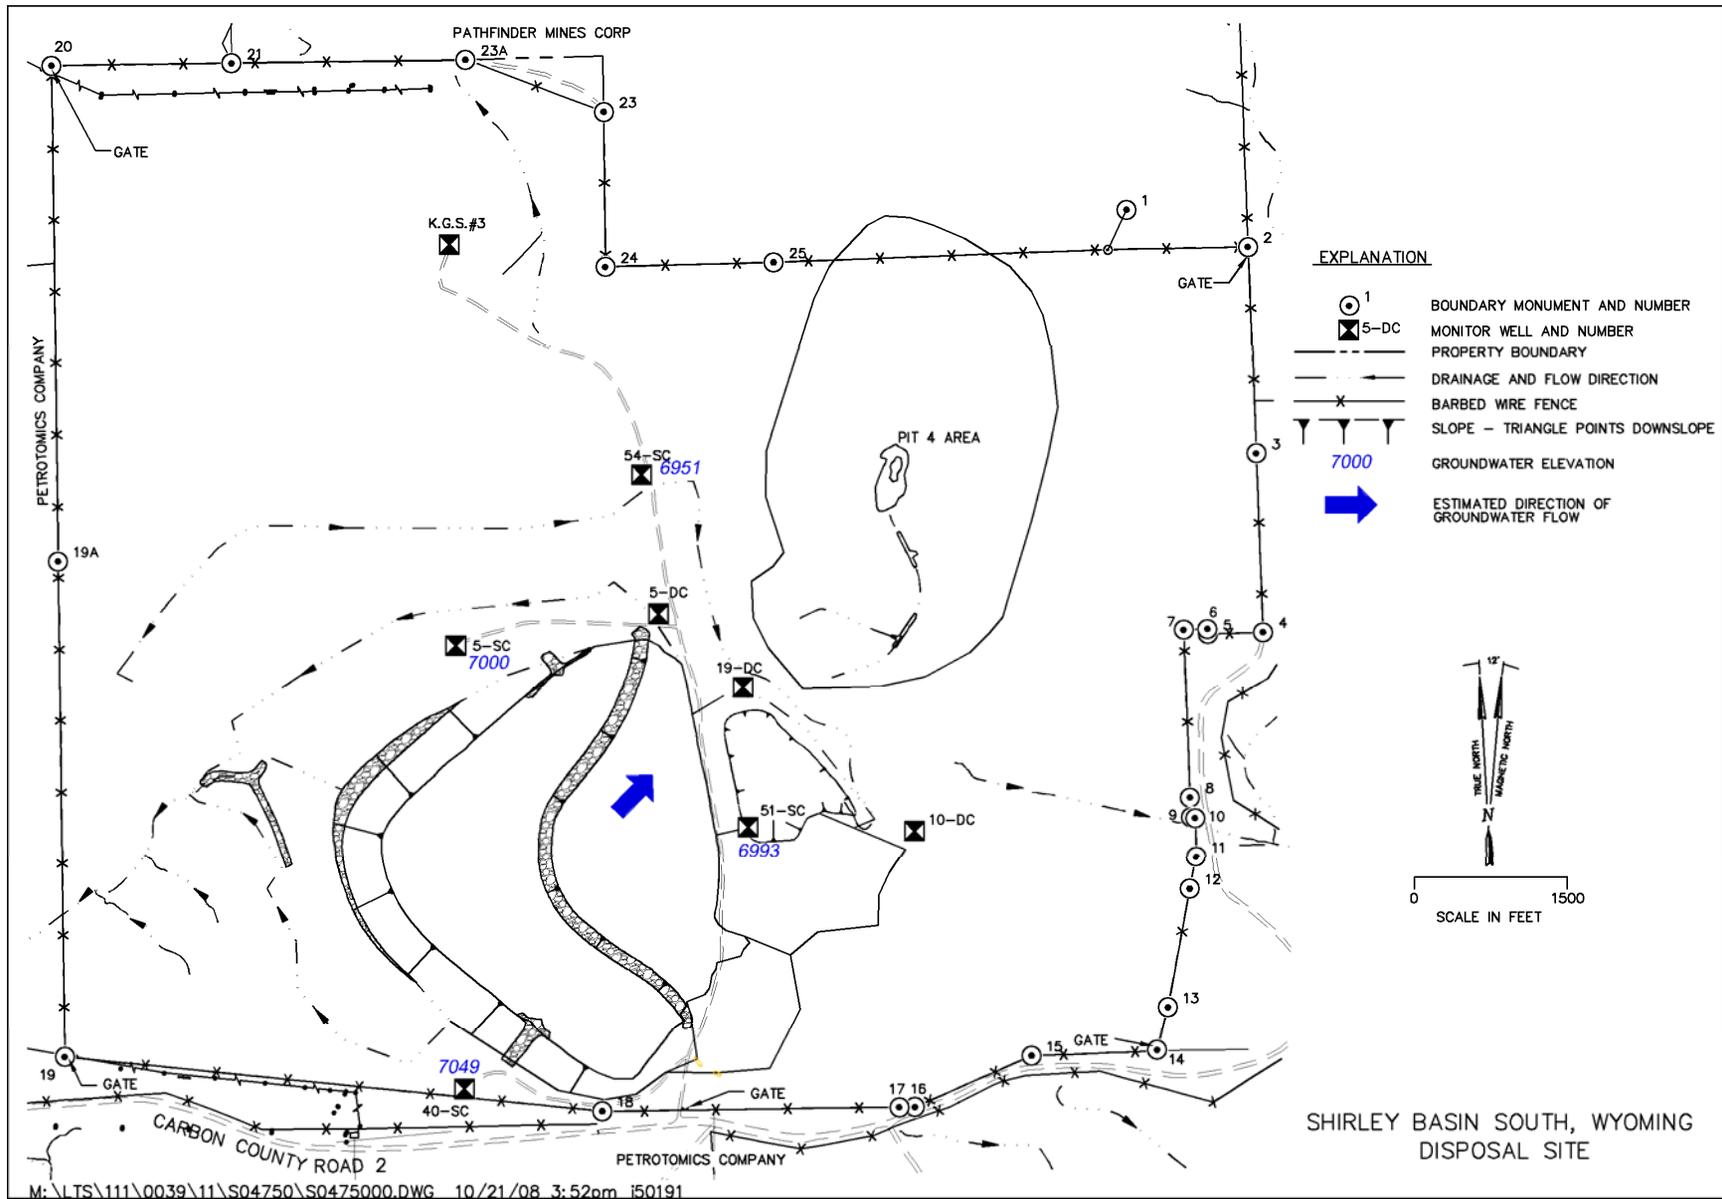
Figure 5-8. Groundwater Elevations and Estimated Flow Direction in the Upper Sand Aquifer at the Shirley Basin South, Wyoming, Disposal Site

Groundwater contour maps are also specified in the LTSP; however, insufficient data points are provided through the existing well network to develop them. Regional (pre-mining) groundwater flows are generally to the north-northeast for the upper sand aquifer and to the east for the main sand aquifer. However, local flow directions were altered by mining and dewatering activities at Pit 4 on the site and Pathfinder Pit 33 north of the site. Water elevations in the upper sand aquifer wells, based on 2008 measurements, continue to indicate a northeast groundwater flow direction (Figure 5-8). This direction is comparable to the flow direction predicted for the year 2010 in the Petrotoomics Company ACL application prepared in 1996. Water elevations in the three main sand aquifer wells, all located on the same line, are essentially equal and do not provide a means to determine flow direction. The estimated northeast flow direction shown on Figure 5-9 is the predicted 2010 flow direction included in the ACL application and likely represents current site conditions.
