17.0 Annual Inspection of the Slick Rock, Colorado, UMTRCA Title I Disposal Site

17.1 Compliance Summary

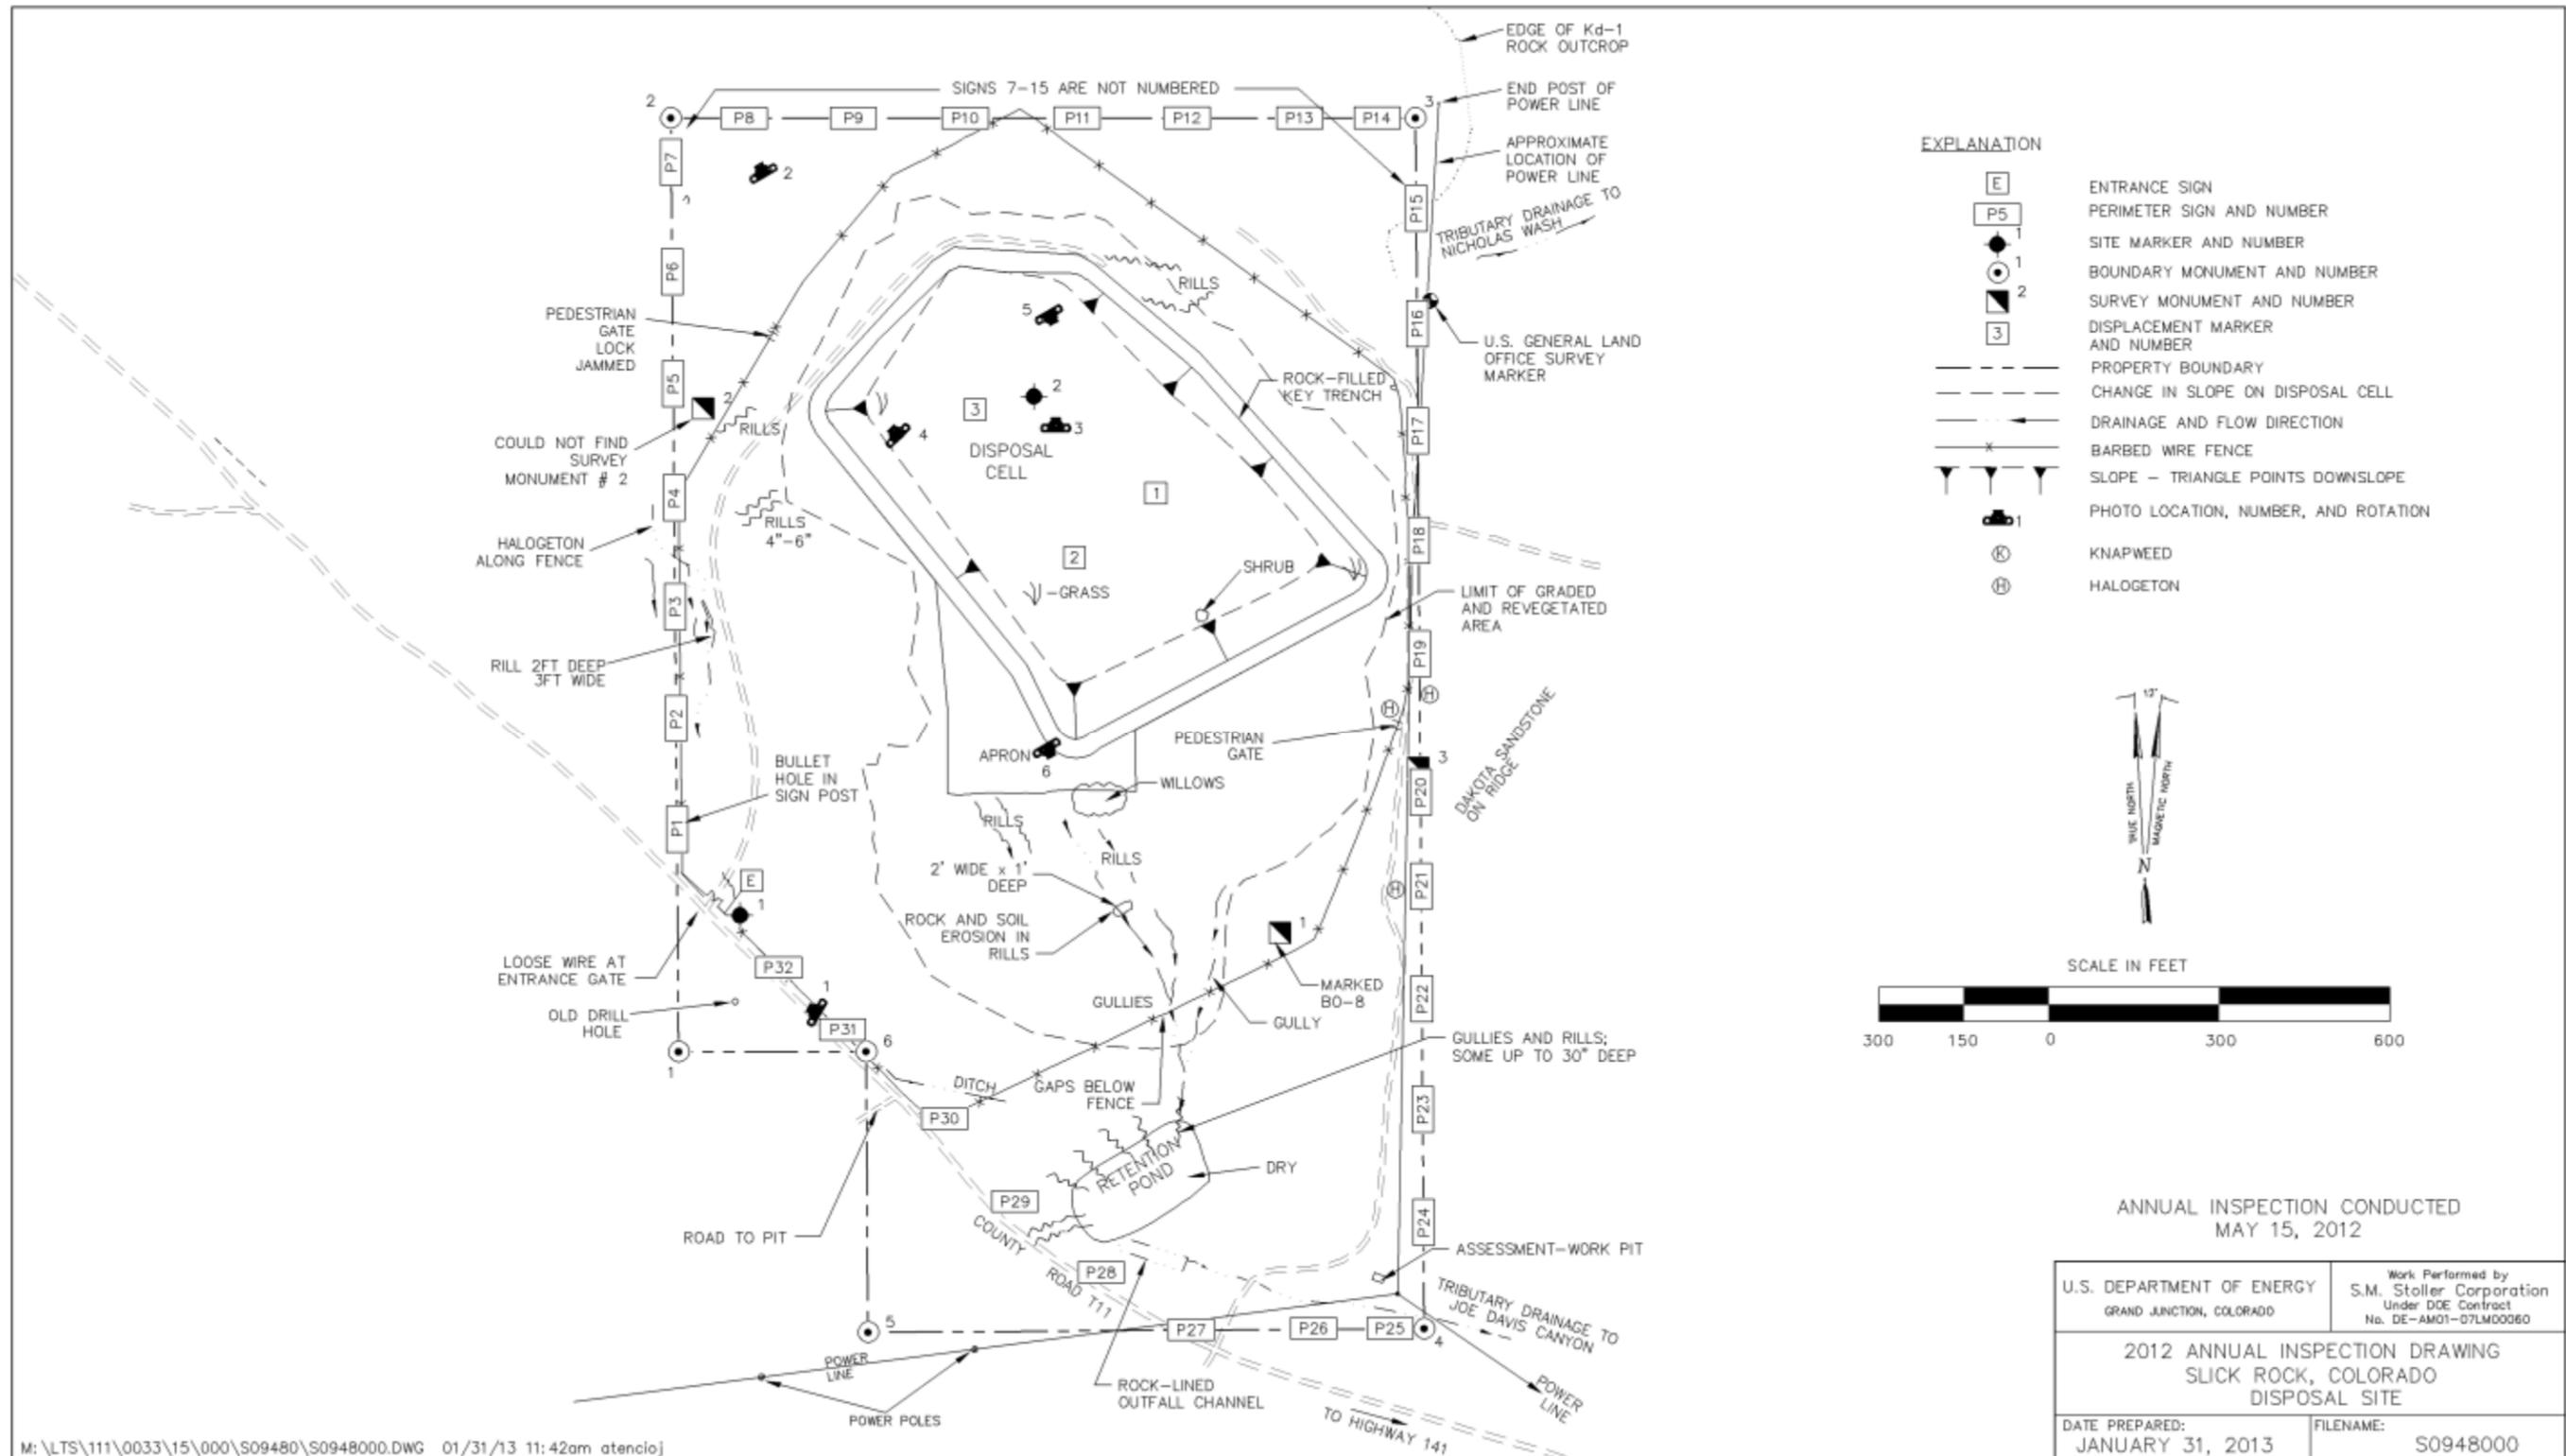
Figure 17-1. 2012 Annual Compliance Drawing for the Slick Rock Disposal Site

The locations of site surveillance features are shown on Figure 17–1. Inspection results and recommended maintenance activities associated with site surveillance features are included in the following subsections. Photographs to support specific observations are identified in the text and on the Figure 17–1 by photograph location (PL) numbers.
