**ON-SITE DISPOSAL FACILITY  
LEACHATE CONVEYANCE SYSTEM  
LEAK INVESTIGATION REPORT  
GRAVITY LINE SECTION**

**FERNALD ENVIRONMENTAL MANAGEMENT PROJECT  
FERNALD, OHIO**

**U.S. DEPARTMENT OF ENERGY**

**20110-RP-0003**

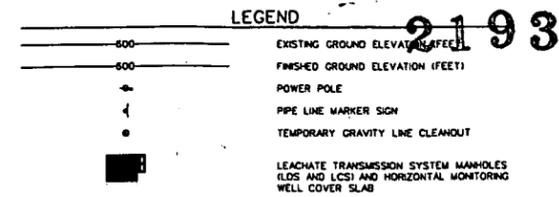
LEACHATE CONVEYANCE SYSTEM  
LEAK INVESTIGATION  
PLAN AND PROFILE DATA  
3/29/99  
FIGURE 2

The following text presents the conclusions and findings of the investigation team. The conclusions and findings were based on review of field information (DCNs, RCIs, daily logs, etc.), meetings with different parties involved in the design and construction of the leachate gravity line, discussions with manufacturers and suppliers, and inspections of pipe that had been removed from the system. For a plan view of area see Figure 1. For a location of joints see Figures 2, 3, and 4.

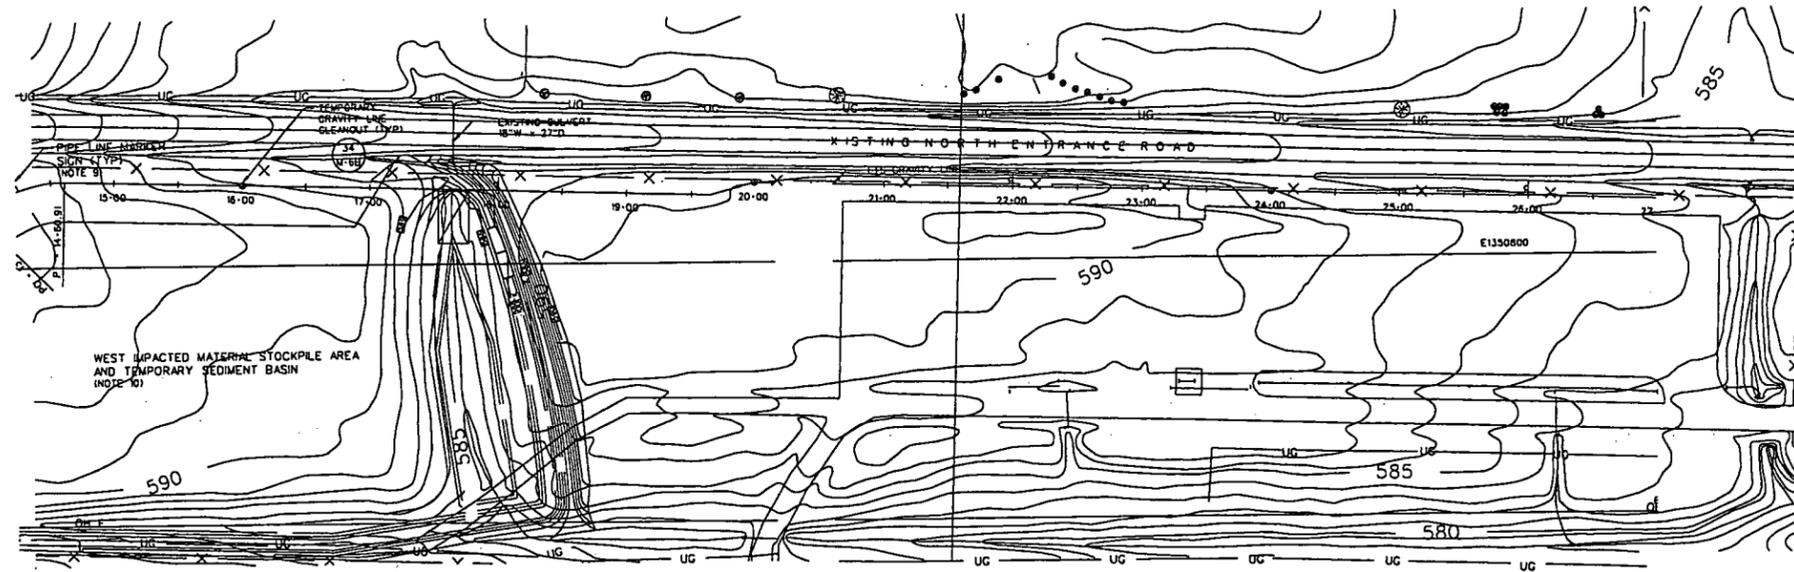
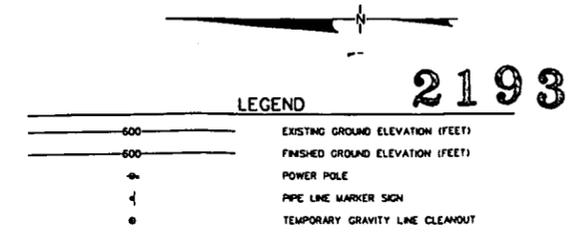
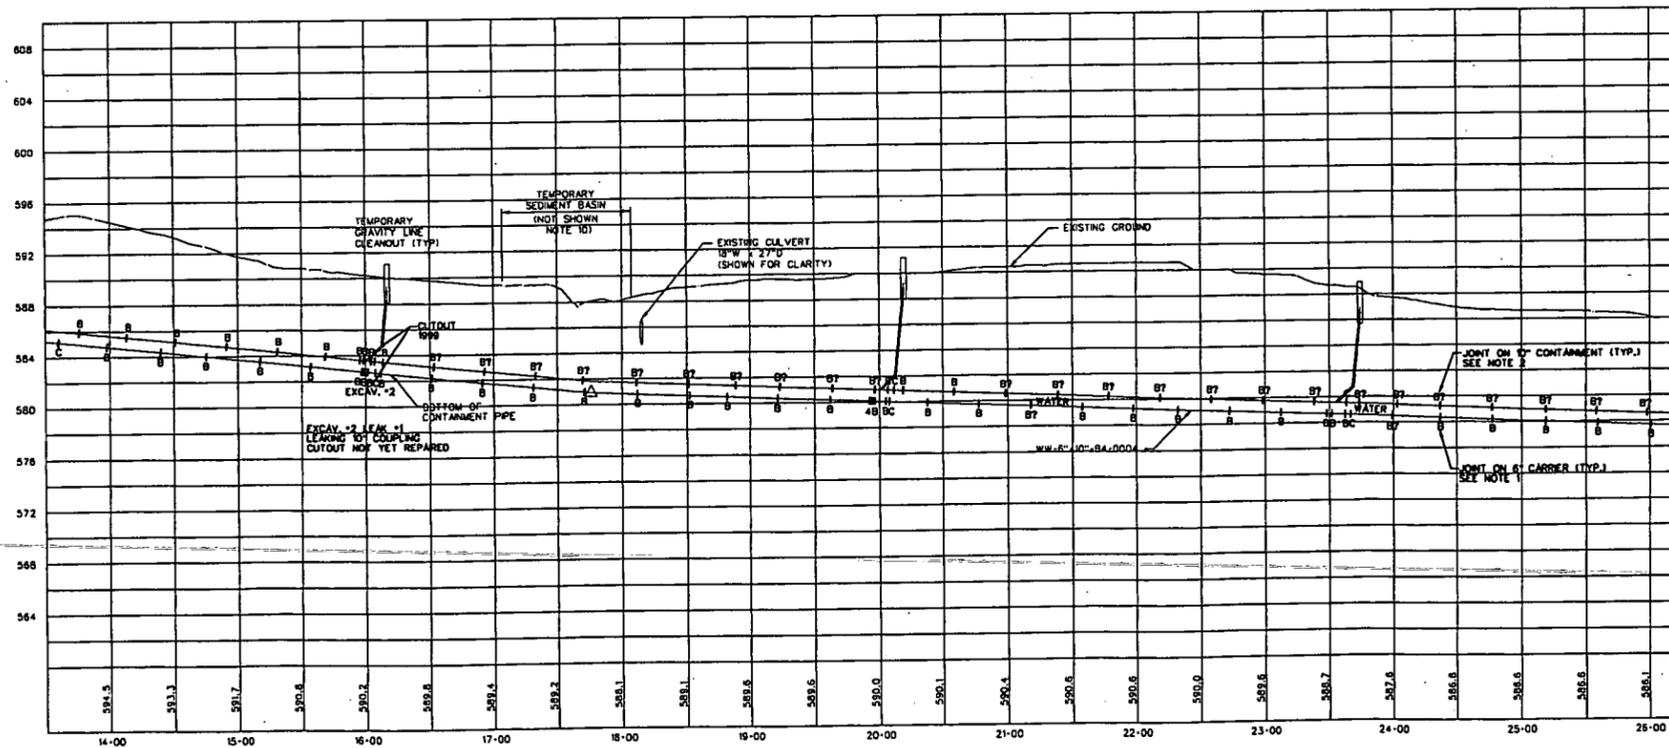
LEACHATE CONVEYANCE SYSTEM  
 LEAK INVESTIGATION  
 PLAN AND PROFILE DATA  
 3/29/99  
 FIGURE 3

Electrofusion coupling leaks due to various contributing causes were observed. A summary of all electrofusion couplings and 12-inch sleeves (See Figure 5 for use of sleeve) installed as of March 29, 1999 is presented in Table 1. Also refer to Figures 2, 3, and 4 of this report for physical locations of all joints. Contributing causes for Leaks #1, #2, and #4 are presented below.
