SUBJECT: Transmittal of the September 2104 Fernald Preserve On-Site Disposal Facility Inspection Forms

Fernald Preserve OSDF Walkdown Inspection Report

On-Site Disposal Facility Inspection Report September 2014

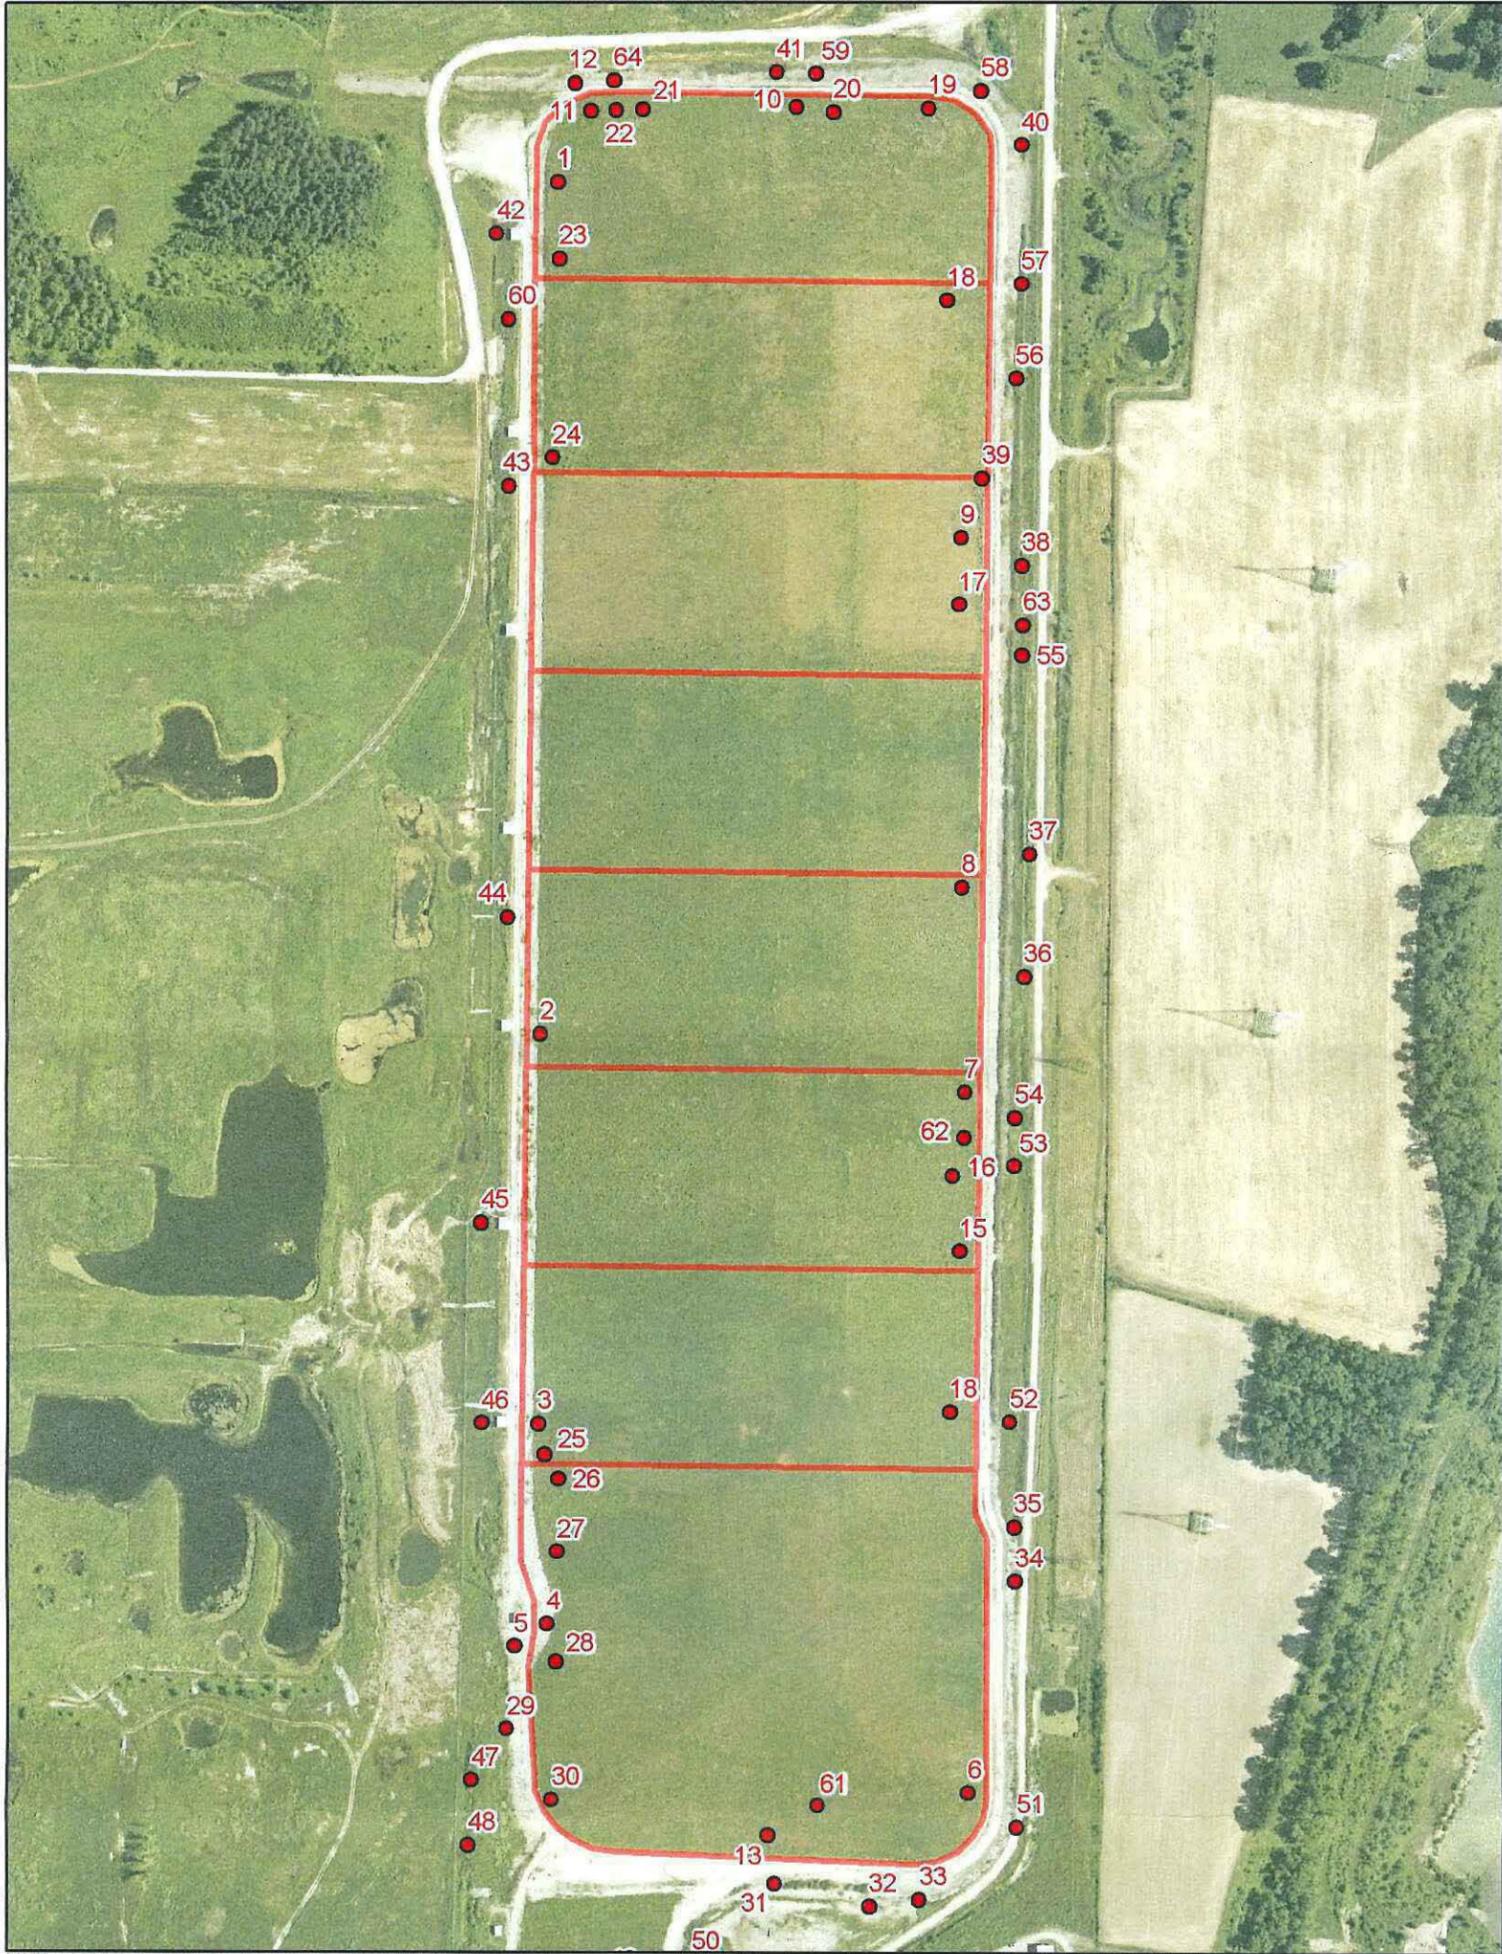
The consolidated *Fernald Preserve OSDF Walk-down Inspection Report* and a map documenting the findings from the inspection are included with this report. Most findings were related to the presence of woody and invasive vegetation. No major changes were observed in the status of erosion along the toe of the slope or the fence line. These findings have been noted during previous inspections and maintenance at these locations is ongoing.
