MOUND PLANT Potential Release Site Package PRS # 410

MOUND PLANT POTENTIAL RELEASE SITE PACKAGE

PRS 410

**MOUND PLANT
PRS 410
Soil Contamination - Fuel Oil**

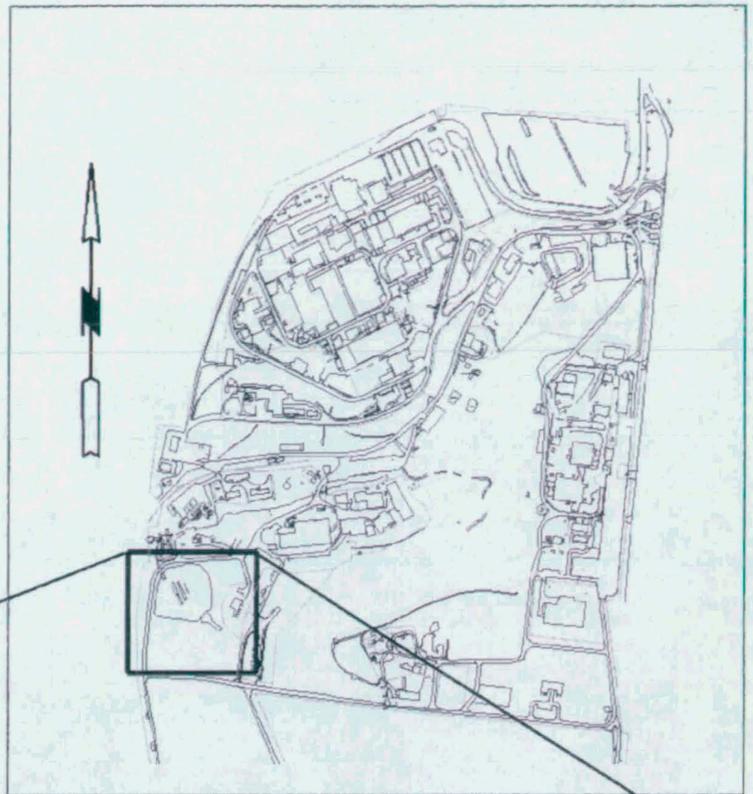
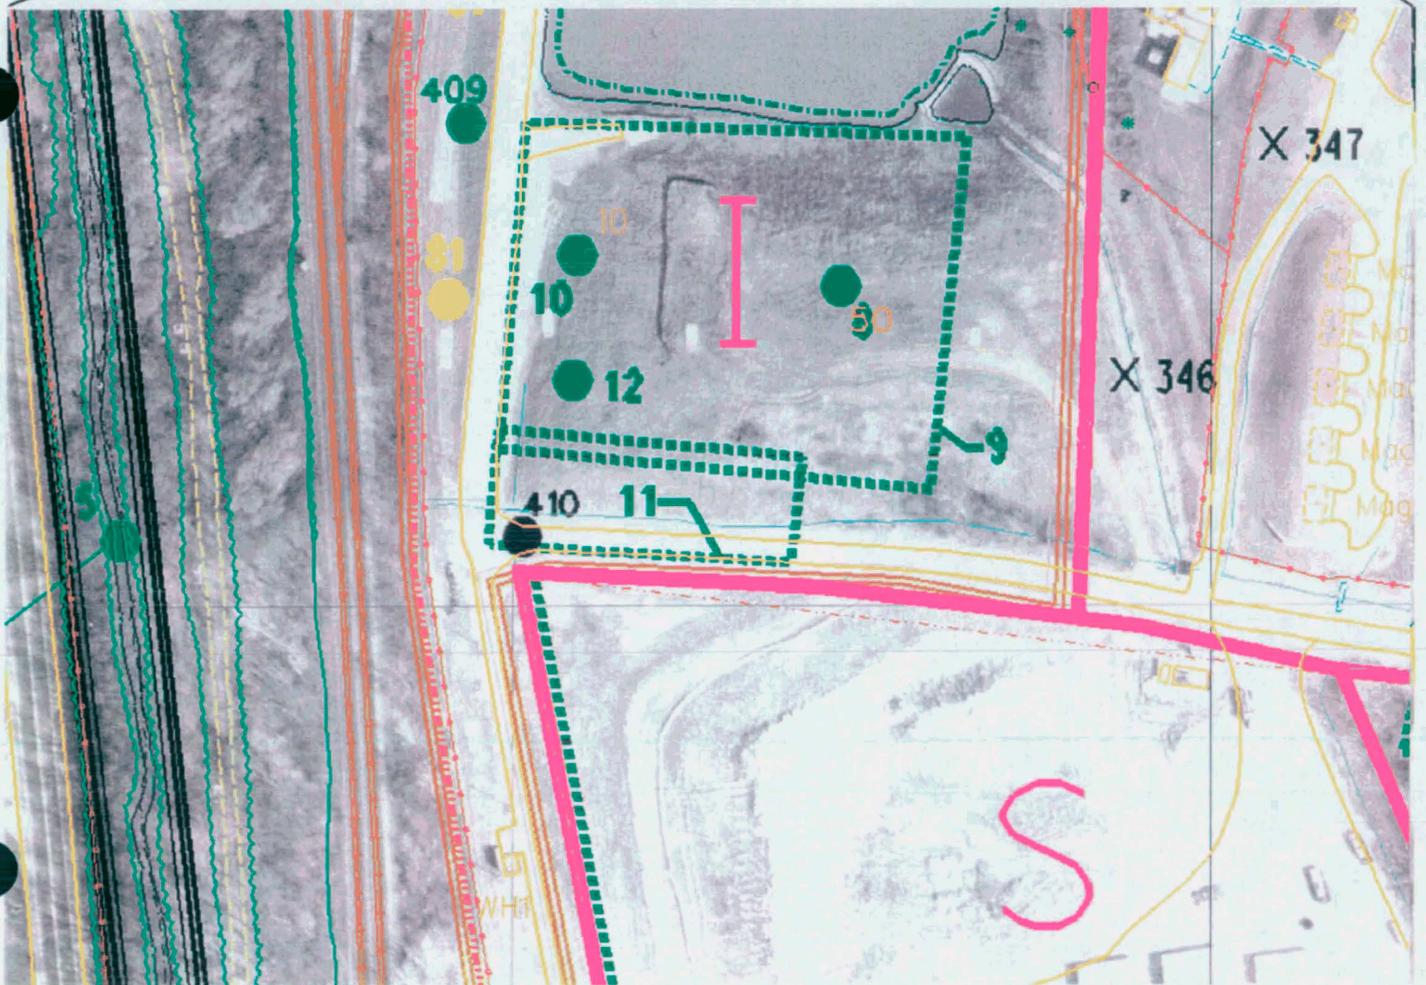
PRS 410 is a gravel/soils area located in the vicinity of the road which runs east to west between the OU1 landfill and the Spoils Area.^{1,3} The contamination was discovered when an aroma of diesel fuel was encountered during the removal and replacement of an underground drainage pipe from beneath the road.^{1,3} The road is scheduled to be asphalt paved to its original condition in the spring of 1997.² Currently (February, 1997), PRS 410 has been filled with clean gravel.²

During the work to remove and replace the drainage pipe an aroma resembling diesel fuel was encountered at approximately an eight inch depth in a graveled culvert. A FIDLER survey of the area detected no radioactive contamination.^{1,3}

The Core Team originally recommended Further Assessment for PRS 410. Subsequently, the cost of further investigation versus the cost of removing the potentially contaminated soils was evaluated. Cost estimates indicate that the cost of removal is not significantly greater than the cost of further assessment at PRS 310. Additionally Further Assessment findings may indicate the need for a Response (removal) Action, resulting in costs associated with both Further Assessment and Response Action. Therefore, the Core Team recommends a RESPONSE ACTION as a more cost-effective course of action for PRS 410.
