MOUND PLANT

Potential Release Site Package

PRS # 405

**MOUND PLANT
PRS 405
Soil Contamination – Building 23**

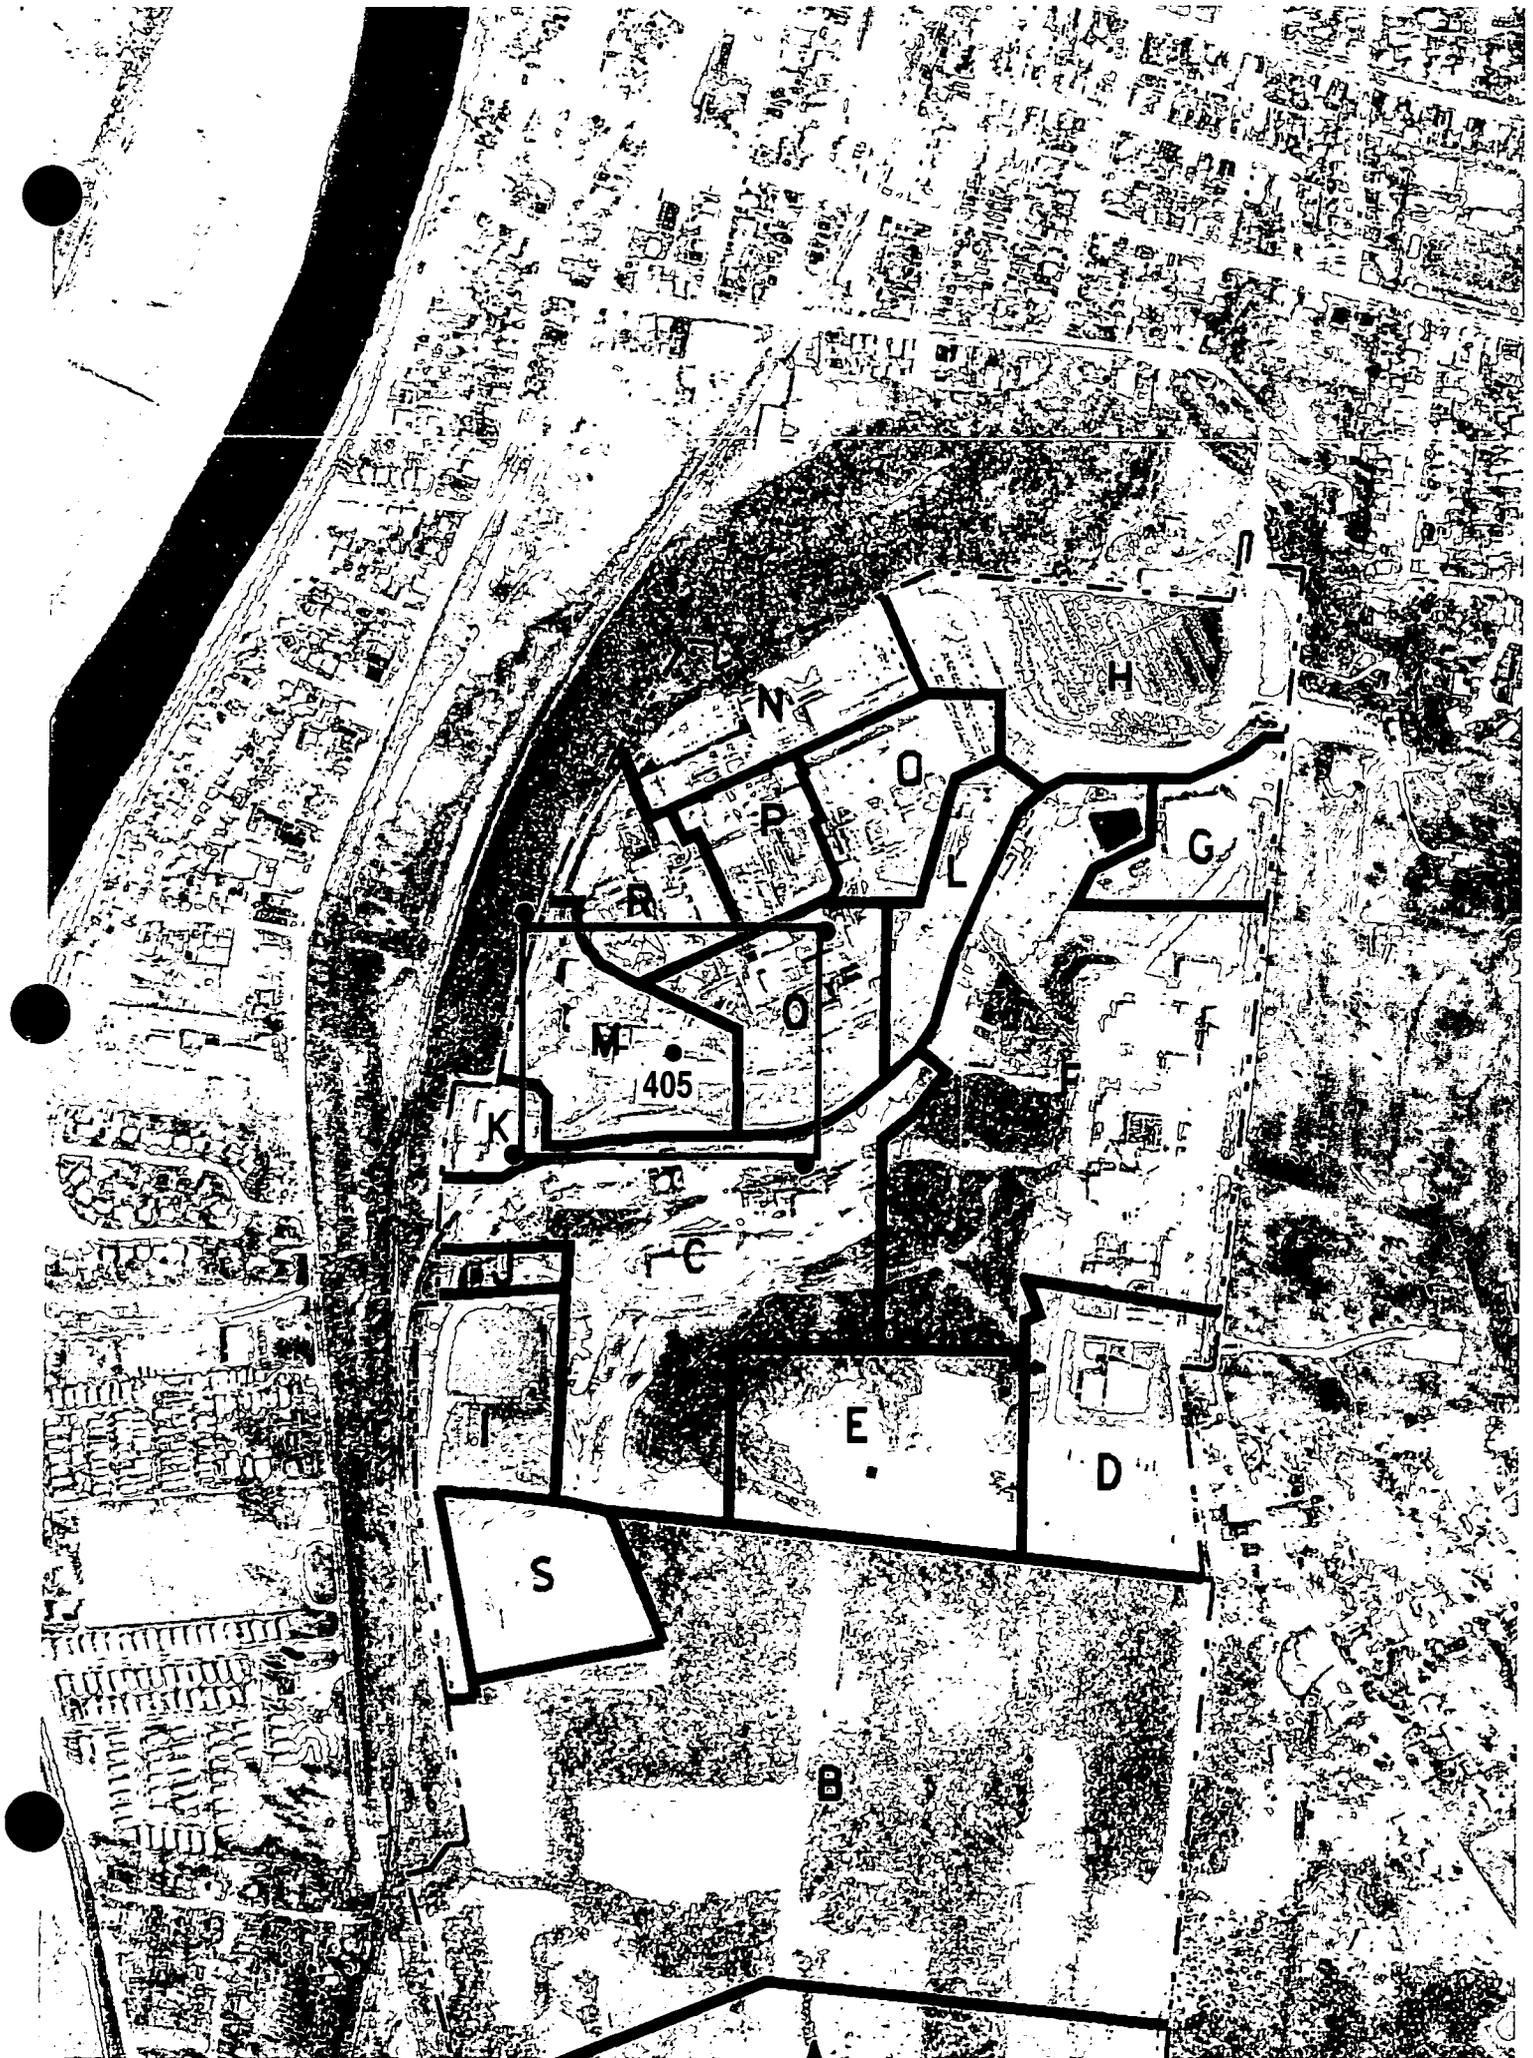
Potential Release Site (PRS) 405 is a soil area located approximately 5 feet north of Building 23 (Waste Management Facility) at the east end of that building. PRS 405 was identified during construction activities in June 1994.² The contaminant of concern during construction was an oily substance.

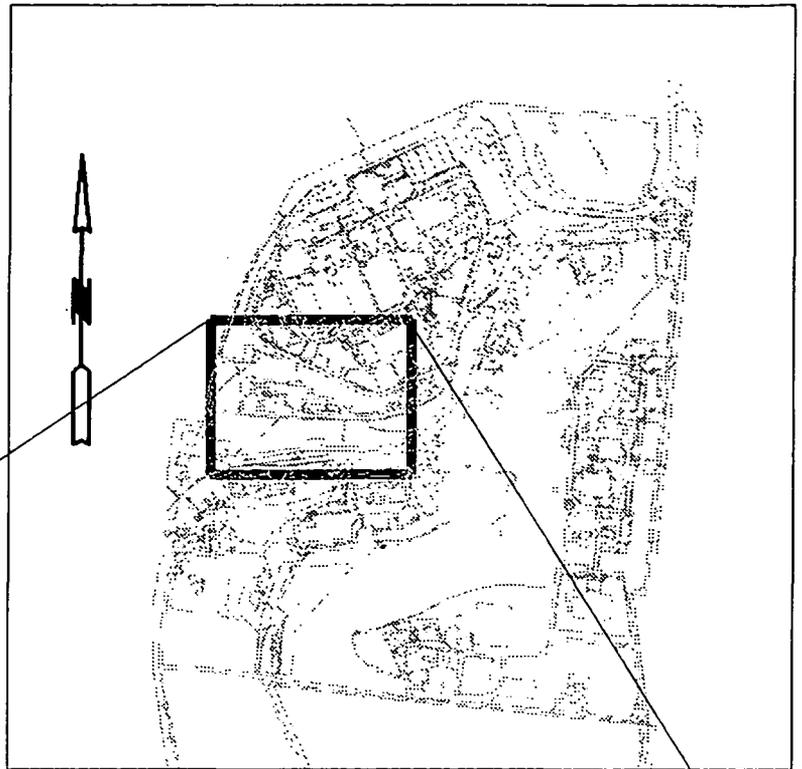
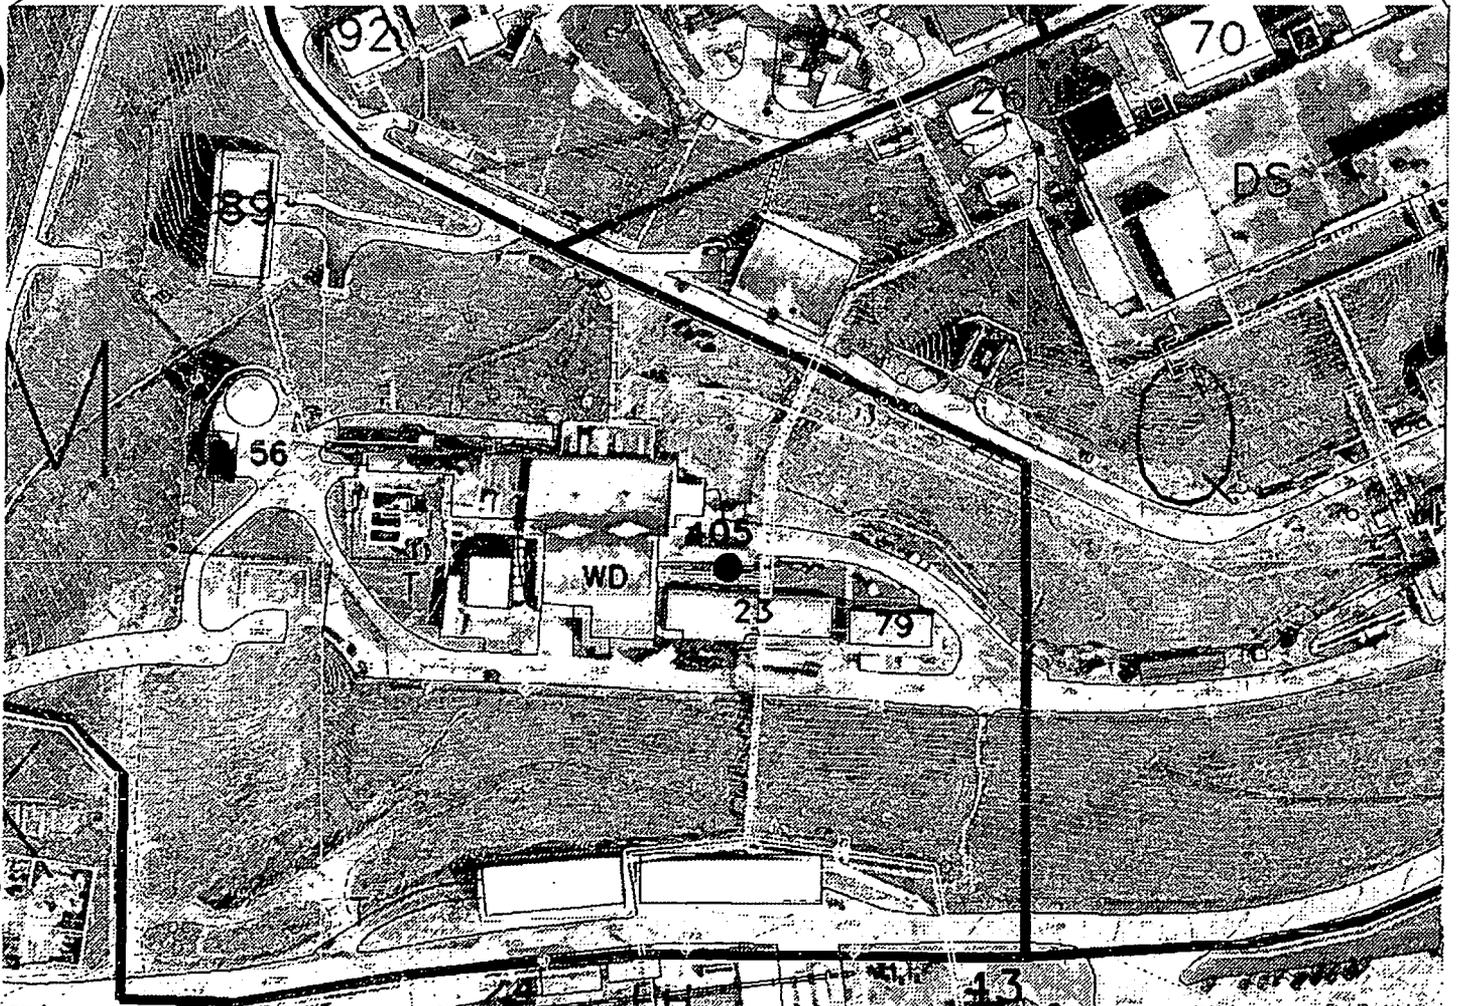
PRS 405

In June 1994, during excavation for a potable water line, dark stained soils with an oily residue were discovered.² Preliminary field screening results indicated that the soil contained diesel fuel and polychlorinated biphenyls (PCBs). Two soil samples were taken and analyzed for PCBs and several soil samples were analyzed for radionuclides. The analysis indicated:

- No PCB contamination was detected.⁴
- The maximum radionuclide concentrations detected were Plutonium-238 at 110 pCi/g and Thorium-232 at 6.8 pCi/g.⁵ Pu-238 exceeded the Mound Plant ALARA of 25 pCi/g and Th-232 exceeds the regulatory limit of 5 pCi/g.

The Core Team originally recommended Further Assessment for PRS 405. Subsequently, the cost of further investigation versus the cost of removing the potentially contaminated soils was evaluated. Cost estimates indicate that the cost of removal is not significantly greater than the cost of further assessment at PRS 405. Additionally Further Assessment findings may indicate the need for a Response (removal) Action, resulting in costs associated with both Further Assessment and Response Action. Therefore, the Core Team recommends a RESPONSE ACTION as a more cost-effective course of action for PRS 405.

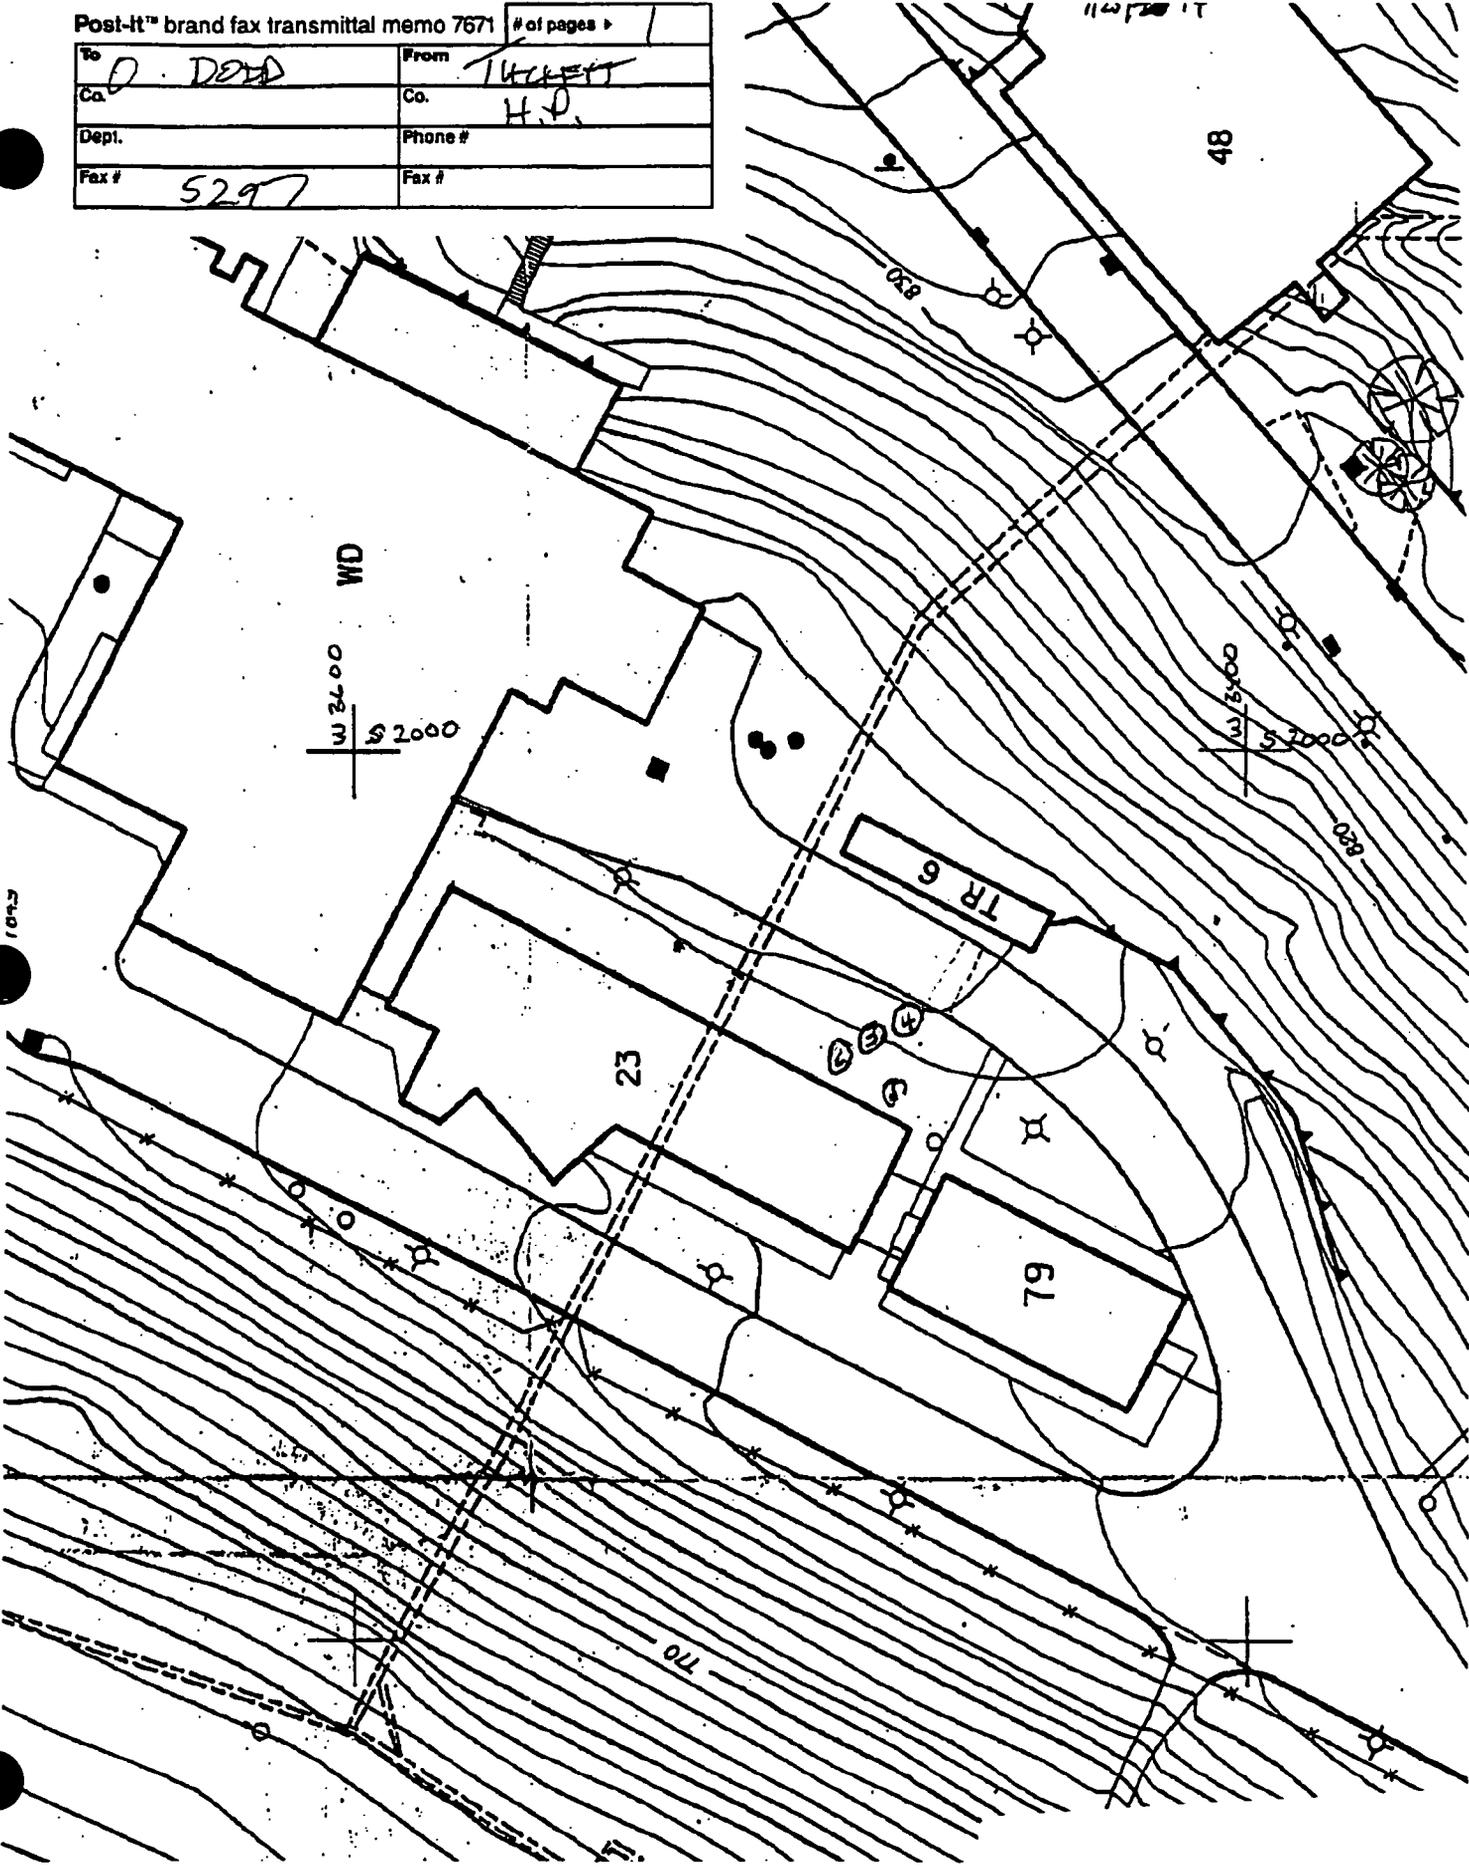
SODIUM IODIDE SOIL SCREEN, 400 SECOND COUNT
PREPARED BY _____

SAMPLE NO.	DATE COLLECTED	DATE SCREENED	SAMPLER	SAMP TYPE	REGION 1(a)	REGION 2(a)	MORE ISO-TOPEs	GRID LOCATION	WELL
					<i>Pu-238</i>	<i>Th-232</i>			
94063034	07/21/94	07/21/94	[REDACTED] 2768	CONT	17	1.0	N	DYNO BLDG-23 TRENCH #1	A
94063035	07/21/94	07/21/94	[REDACTED] 2768	CONT	12	1.1	N	DYNO BLDG-23 TRENCH #2	B
94063036	07/21/94	07/21/94	[REDACTED] 2768	CONT	16	1.2	N	DYNO BLDG-23 TRENCH #3 TOP LAYER	C
94063037	07/21/94	07/21/94	[REDACTED] 2768	CONT	24	1.7	N	DYNO BLDG-23 TRENCH #4 TOP LAYER	A
94063067	07/21/94	07/22/94	[REDACTED] 2768	CONT	19	1.5	N	DYNO BLDG-23 TRENCH #5	B
94063068	07/21/94	07/22/94	[REDACTED] 2768	CONT	16	0.7	N	DYNO BLDG-23 TRENCH #6	C
94063069	07/21/94	07/22/94	[REDACTED] 2768	CONT	21	1.4	N	DYNO BLDG-23 TRENCH #7	A
94063070	07/21/94	07/22/94	[REDACTED] 2768	CONT	20	1.1	N	DYNO BLDG-23 TRENCH #8	B
94063074	07/21/94	07/22/94	[REDACTED] 2768	CONT	15	2.3	N	DYNO BLDG-23 TRENCH #9	B
94063099	07/25/94	07/25/94	[REDACTED] 5983	CONT	110	6.8	N	DYNO BLDG-23 SURFACE SAMPLE	C
