Department of Energy  
Office of Legacy Management

SUBJECT: Status Report of Steps Taken Regarding Monitoring Results at Surface Water Point of Evaluation (POE) SW027

# **Report of Steps Taken Regarding Monitoring Results at Surface Water Point of Evaluation (POE) SW027**

## **August 31, 2010**

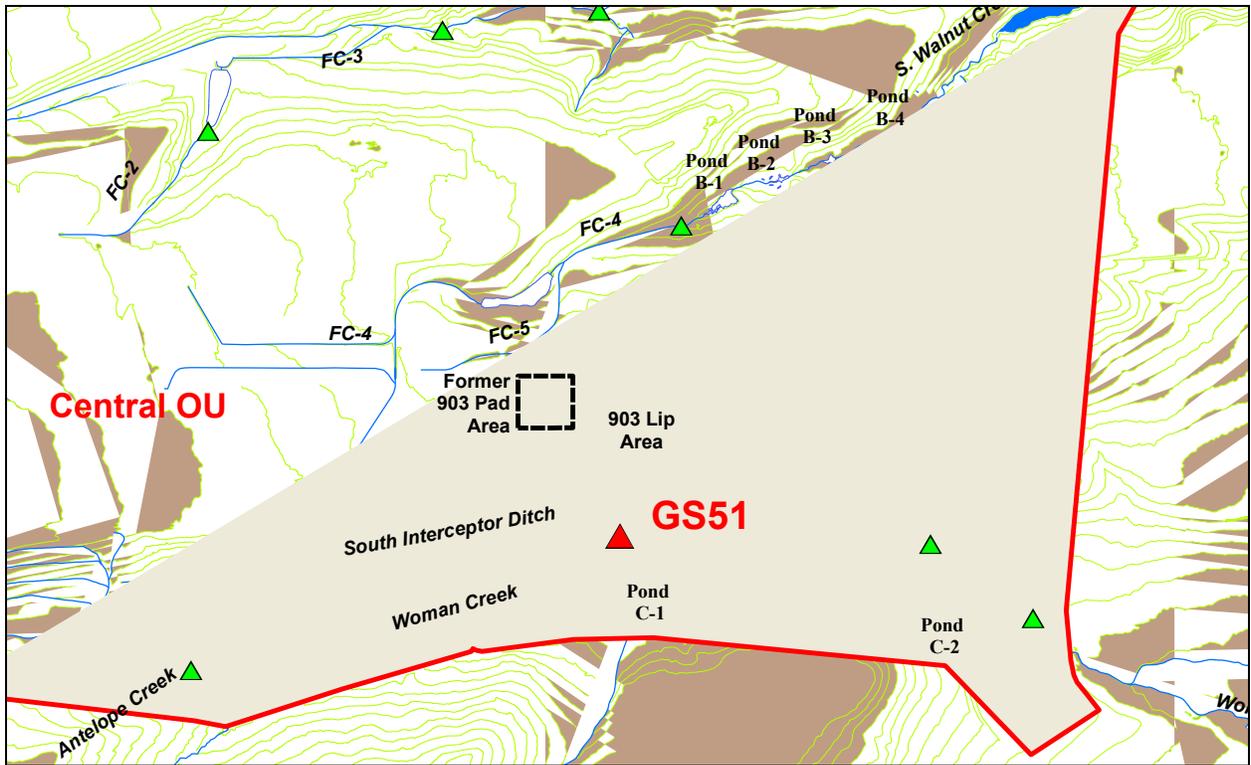
Figure 1. GS51 Drainage Area

Figures 1 and 2 show the drainage area for SW027 and the subdrainage within this area for GS51. This drainage area includes the former 903 Pad Lip Area, designated Individual Hazardous Substance Site (HSS) 900-155, which lies directly north of the SID. Large volumes of surface soil with residual Pu were removed from the surface of the 903 Lip Area in 2004, and the resulting surface was contoured and revegetated. Cleanup goals were met, but measurable concentrations of Pu in surface soil remained.
