# environmental inventory

A HISTORICAL SUMMATION OF ENVIRONMENTAL  
INCIDENTS AFFECTING SOILS AT OR NEAR THE  
U.S.AEC ROCKY FLATS PLANT.

J. B. OWEN

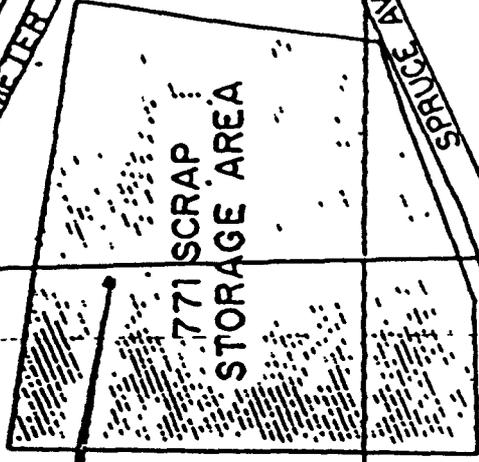
771 SCRAP  
 STORAGE AREA

SCRAP STORAGE CONTAINER AREA..  
 ALTHOUGH NOTED LEAKS OR SPILLS  
 HAVE BEEN CLEANED AND INVOLVED  
 SOILS REMOVED, RESIDUAL LOW LEVEL  
 RADIOACTIVE AND CHEMICAL INFILTRATION  
 PROBABLE.

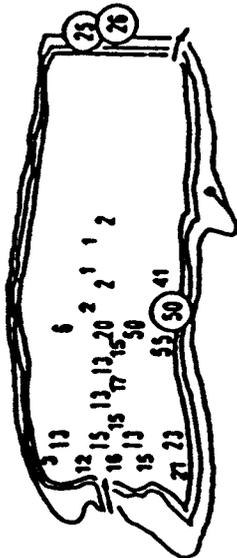
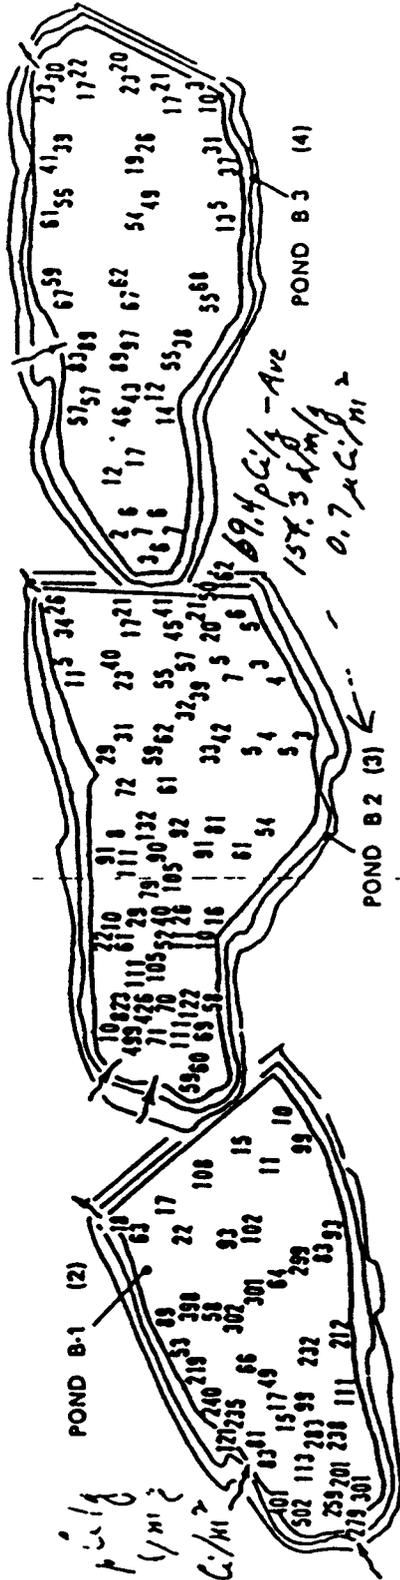
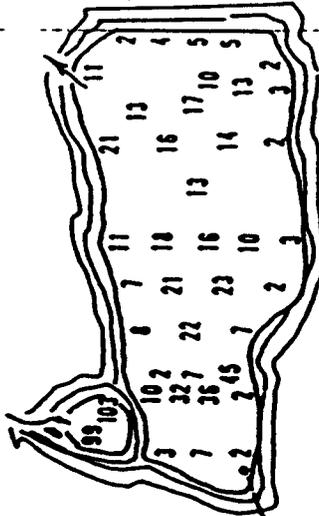
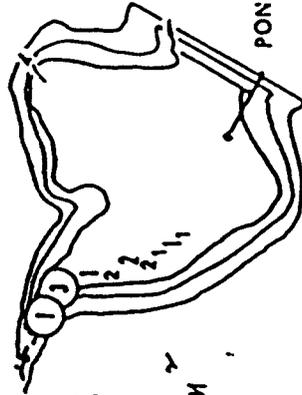
POND A-1

*Av. - 151 pCi/g  
336 d/mi<sup>2</sup>  
1.5 μCi/mi<sup>2</sup>*

POND B-1 (12)

*35.5 pCi/g  
78.4 d/mi<sup>2</sup>  
0.4 μCi/mi<sup>2</sup>*

*89.4 pCi/g - Ave  
157.3 d/mi<sup>2</sup>  
0.7 μCi/mi<sup>2</sup>*

POND B-2 (3)

POND B-4 (5)

*Ave = 16.2 pCi/g  
36 d/mi<sup>2</sup>  
0.2 μCi/mi<sup>2</sup>*

POND C (9)

PLUTONIUM CONCENTRATIONS IN HOLDING POND SEDIMENTS (PICOCURIES/GRAM-DRY) CONSECUTIVE SAMPLES TAKEN IN APRIL AND MAY, 1971, BY RADIOBIOLOGY DEPT., COLORADO STATE UNIVERSITY. PONDS ARE NOT DRAWN TO SCALE.

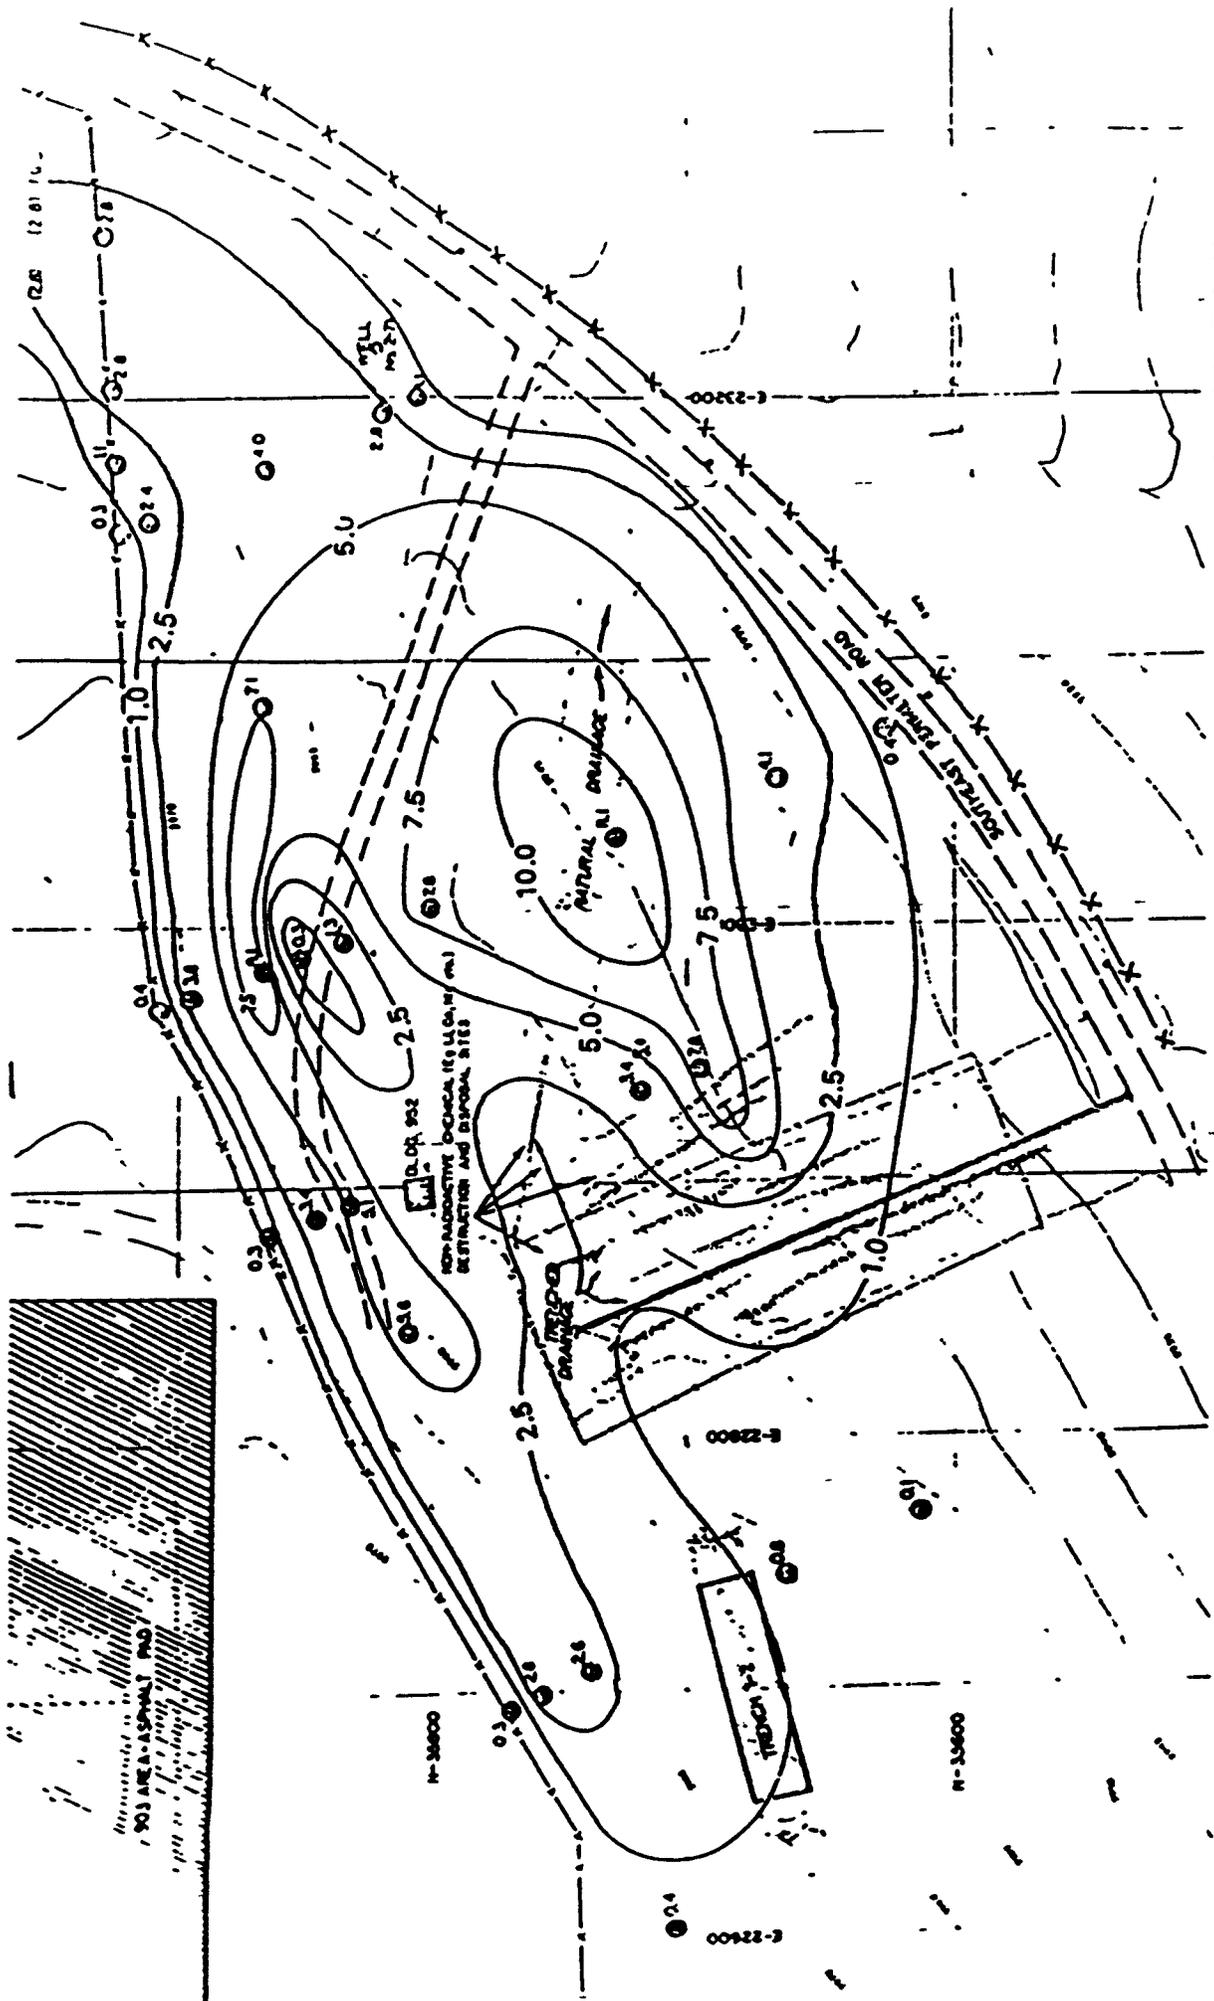
MAP 12A.

AMERICIUM CONCENTRATIONS ( $\mu\text{Ci}/\text{m}^3$ ) DETECTED BY FIDLER SURVEY. MULTIPLY NOTED CONCENTRATIONS BY  $10^4$  TO OBTAIN APPROXIMATE PLUTONIUM CONCENTRATIONS IN  $\text{mCi}/\text{km}^2$  OR BY  $10^1$  TO OBTAIN  $\sim\mu\text{Ci}/\text{m}^2$ .

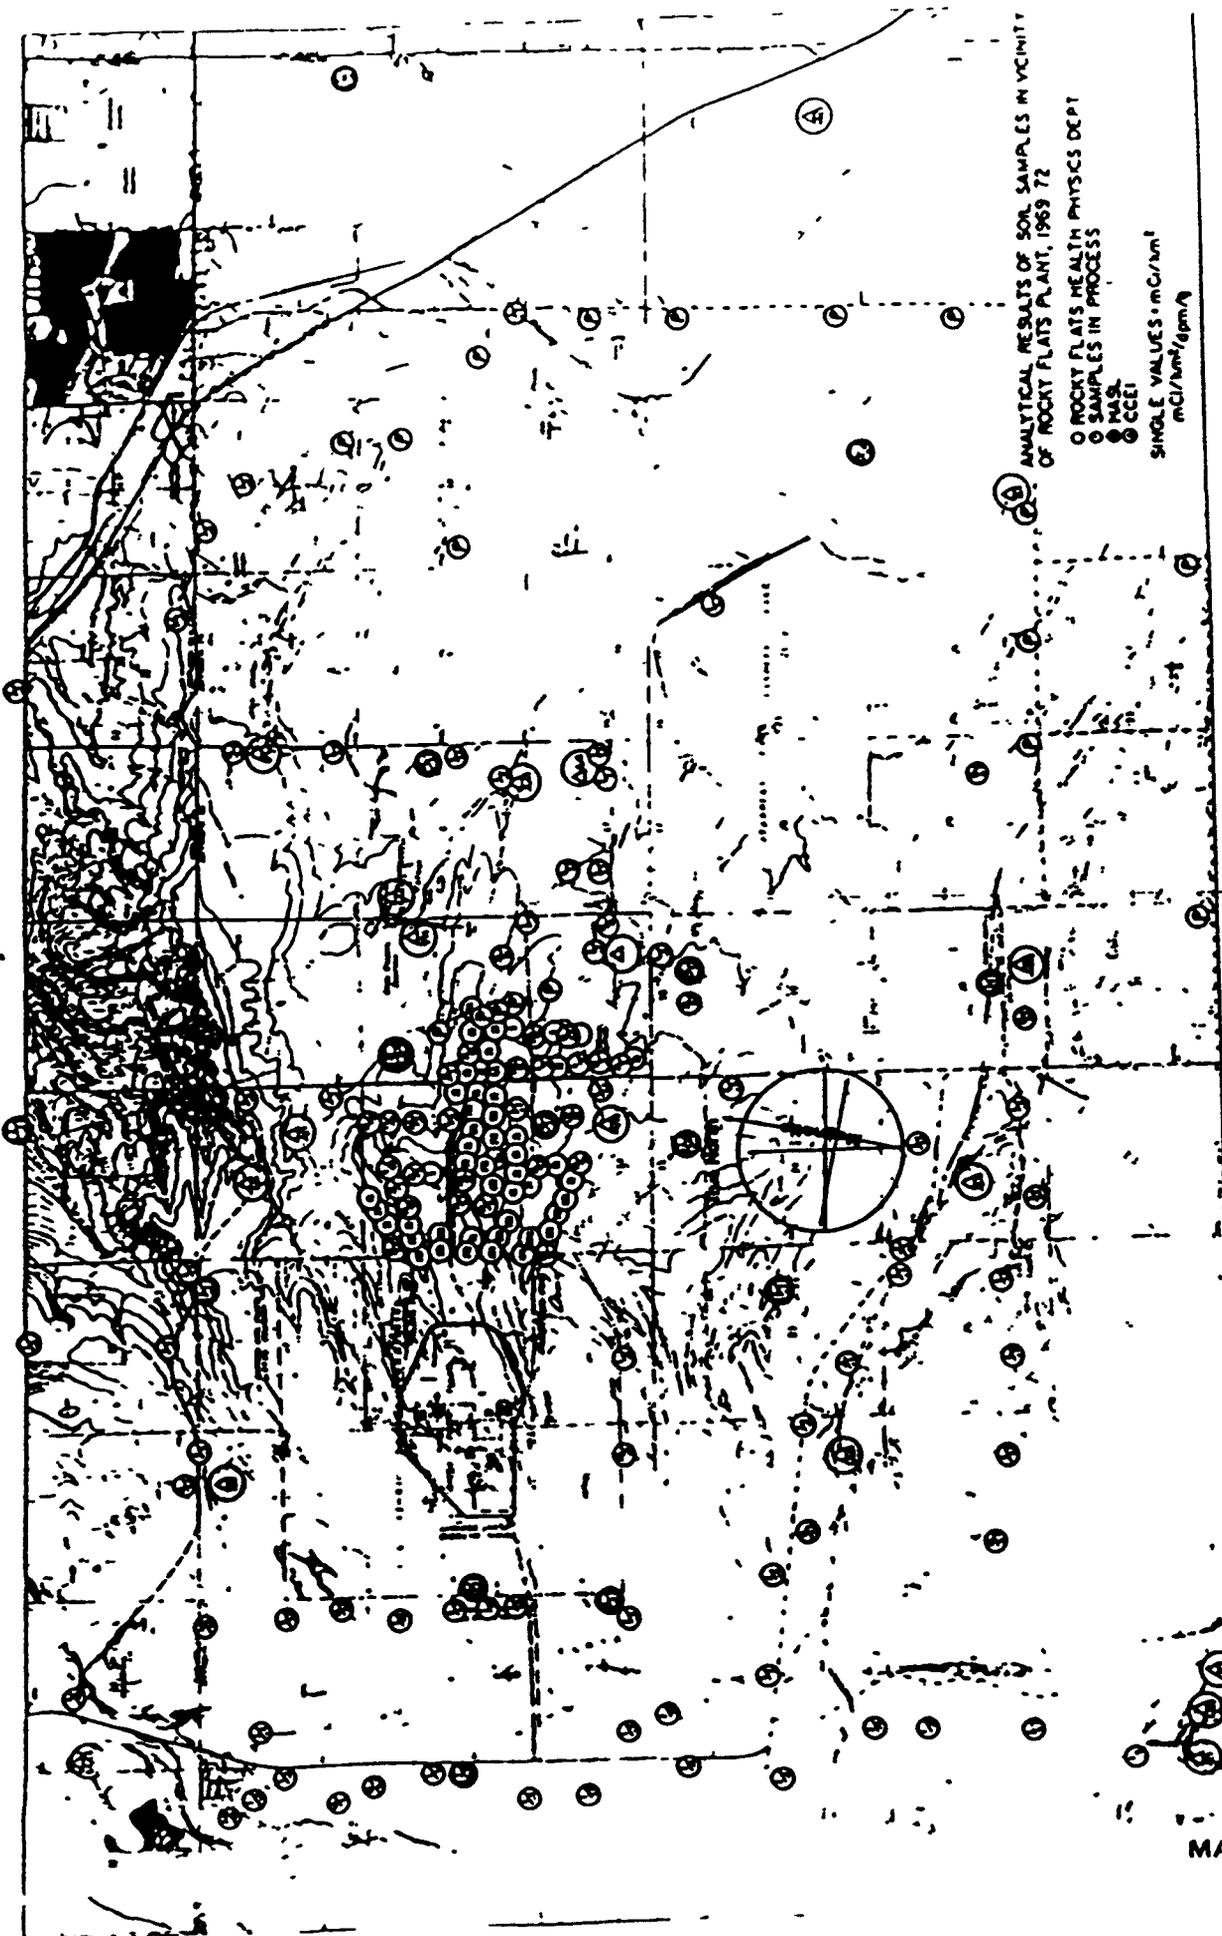
MAP 16A.

ANALYTICAL RESULTS OF SOIL SAMPLES IN VICINITY  
 OF ROCKY FLATS PLANT, 1969-72

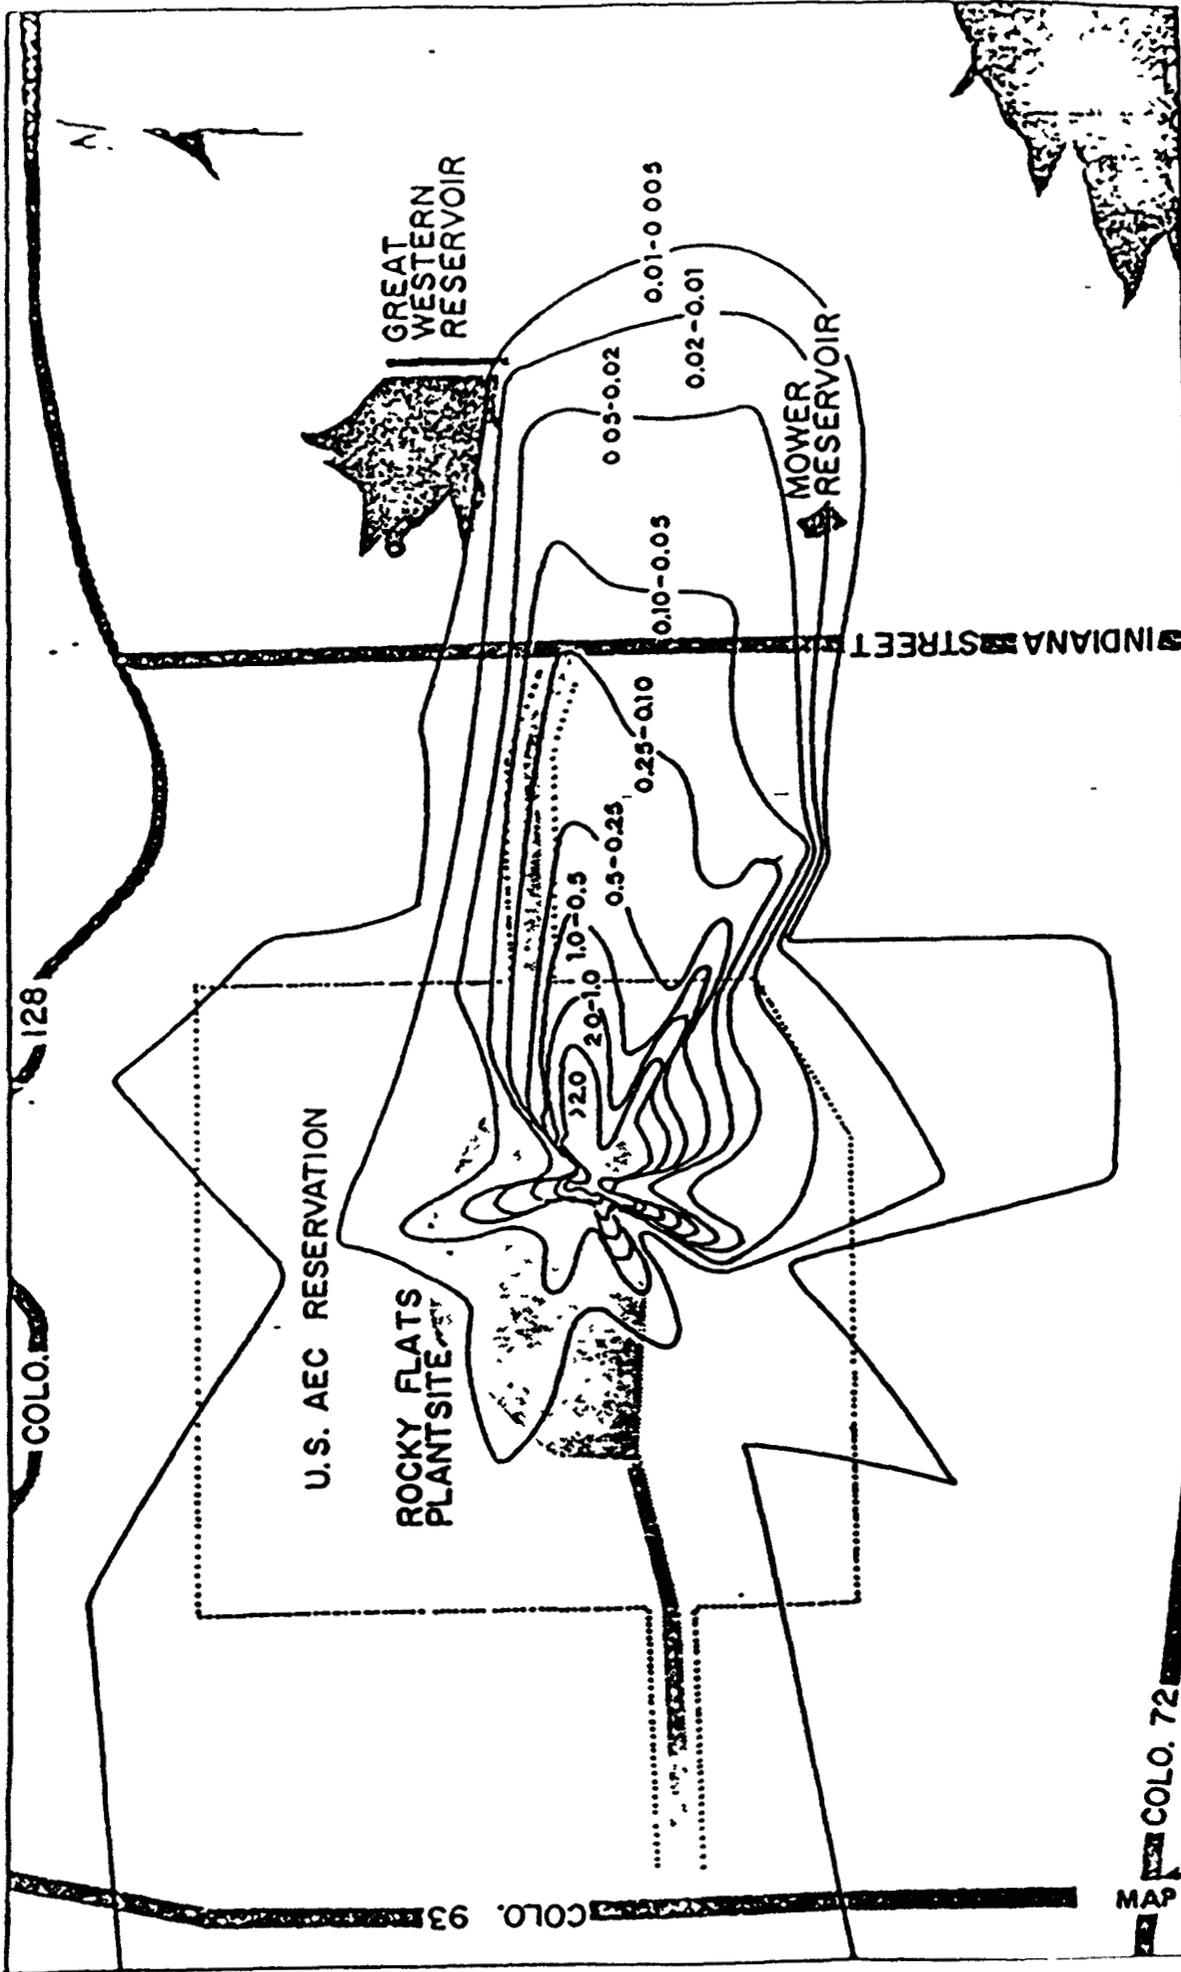
MAP 16  
 COLO. 72  
 U.S. AEC RESERVATION  
 ROCKY FLATS PLANT SITE  
 GREAT WESTERN RESERVOIR  
 MOWER RESERVOIR  
 INDIANA STREET  
 COLO. 128  
 COMPUTER DERIVED PLUTONIUM ISOPLETHS (MICROCURI/SQUARE METER) BASED ON EVALUATION OF OVER 300 SOIL SAMPLES, ASSUMING A SOIL DENSITY OF 1 GRAM /CC AND COMPATIBILITY OF SAMPLES FROM VARIOUS AGENCIES.
