**ANNUAL REPORT
FOR THE
ROCKY FLATS ENVIRONMENTAL TECHNOLOGY
SITE
GROUNDWATER PLUME TREATMENT SYSTEMS
January through December 2002**

May 2, 2003

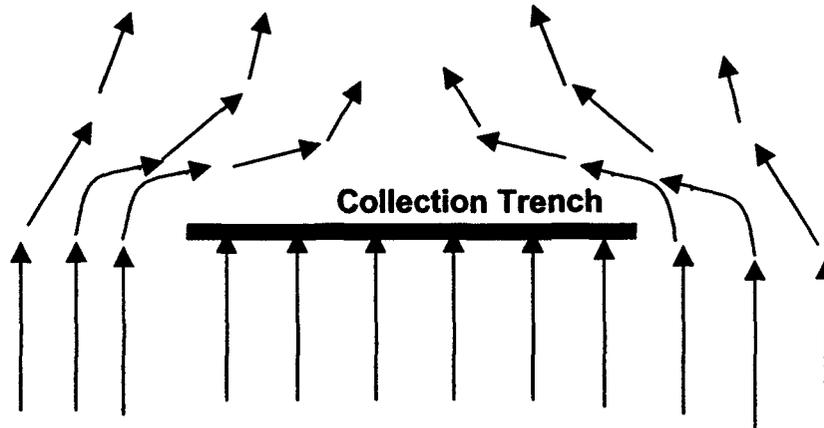
Figure 3. Conceptual Model of Flow Downgradient from Mound Collection Trench

Figure 3 is a schematic model of downgradient flow. Water elevations are shown graphically in Figure 4. The hydraulic gradient induced by the trench can be seen in the difference in water elevations driving the water from the edges of the capture area, toward the center of the downgradient portion of the plume.

The groundwater elevation in Well 15199, at the eastern edge of the collection trench, is about seven to 10 feet higher than downgradient Wells 15799 and 15599. At the center of the downgradient area, Well 15699 has a lower groundwater elevation, indicating that a gradient exists from the outside edge of the capture area toward the center of the downgradient area. Although there is a steep hydraulic gradient, groundwater flow is minimal because there is little groundwater in the area. Based on groundwater elevation differences, the collection system appears to be working as designed.

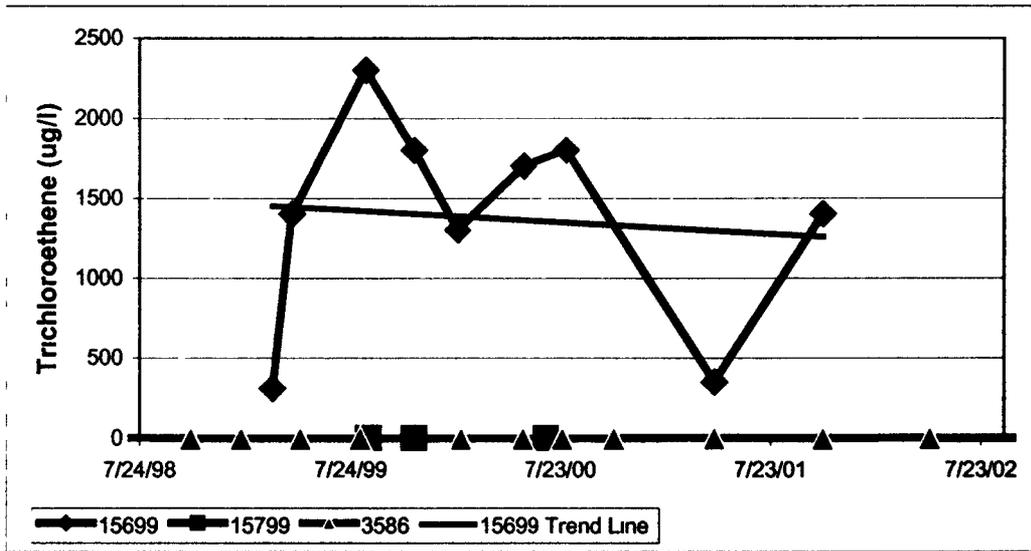
Figure 5. Trichloroethene Concentrations in Mound Site Plume Downgradient Wells

Previous elevated contaminant concentrations downgradient of the Mound Site Plume Treatment System appear to be the result of residual contamination rather than contamination that has bypassed the system. Downgradient Well 15699 is located within the preferential flow path for the Mound Site Plume and along the trend of the highest plume concentrations defined in the pre-remedial investigation (DOE 1997a). The analytical results from the pre-remedial groundwater investigation from nearby Geoprobe™ Hole 10797 were 844 micrograms per liter (ug/l) trichloroethene, and 261 ug/l tetrachloroethene. As shown in Figures 5 and 6, these analytical results are roughly the same order of magnitude as those seen in Well 15699. By comparison, the historical concentration of trichloroethene within the collection trench ranges from 67 to 160 ug/l. The trench concentrations are lower because groundwater is collected from across the plume area, including lower concentration areas.

Based on the similarity between downgradient water quality and the pre-remedial downgradient concentrations, and the disparity between downgradient and collection trench water quality, the contaminant concentrations observed in Well 15699 are most likely due to residual contamination as opposed to contaminants bypassing the collection system. There is no clear trend shown in Figures 5 and 6 due to the variations in contaminant levels. Continued monitoring should provide enough information to determine whether some of these values are anomalous or other factors are causing these erratic results.

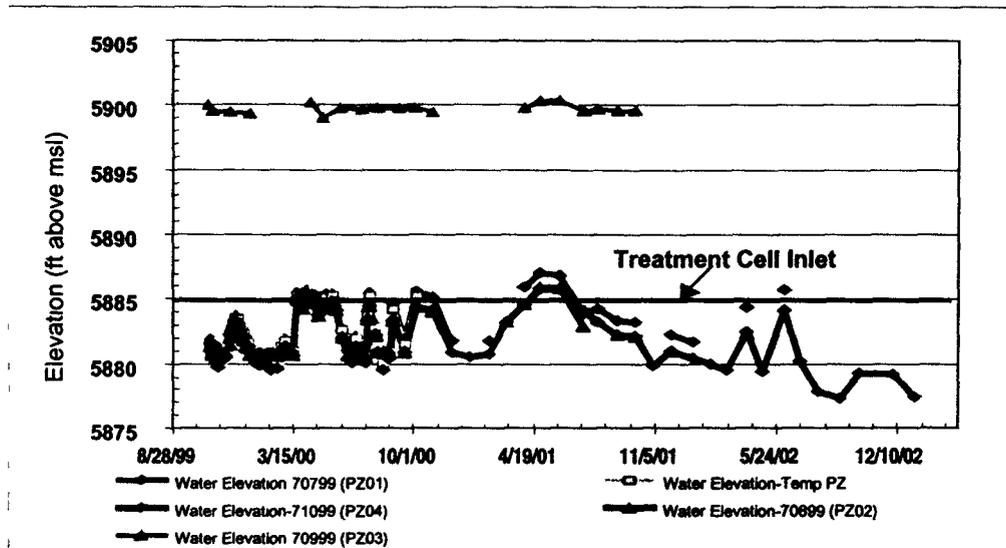
Figure 15. Solar Ponds Plume Collection Trench Piezometer Water Levels

Water levels within the collection trench are monitored at five piezometers. The inlet to the treatment cell is 5,885 feet above msl and the bottom of the collection trench is approximately 5,875 feet above msl. As shown in Figure 15, water levels in four of the piezometers fluctuate between 5,880 and 5,885 feet above msl. The fifth piezometer, located at the east end of the trench, has a water elevation of 5,900 feet. By design, water collected in this part of the trench drains to the west. This piezometer is generally dry when the water level of the other piezometers drops to 5,880 feet. As shown below, water in the trench was lower than in past years, and it was below the inlet most of the year.

Prior to pump installation, it was evident that groundwater was bypassing the treatment system. Water levels in the collection trench fluctuated rather than hold a constant level of 11 feet, the height of the treatment cell inlet. Elevated nitrate and uranium levels in North Walnut Creek indicate that untreated groundwater was reaching surface water. Water quality in North Walnut Creek continues to be well below applicable standards for nitrate and uranium despite the apparent bypass of the treatment system. Water levels in the downgradient wells of the system were monitored monthly. These data are provided in Table 8. Quarterly monitoring was initiated in October 2002.

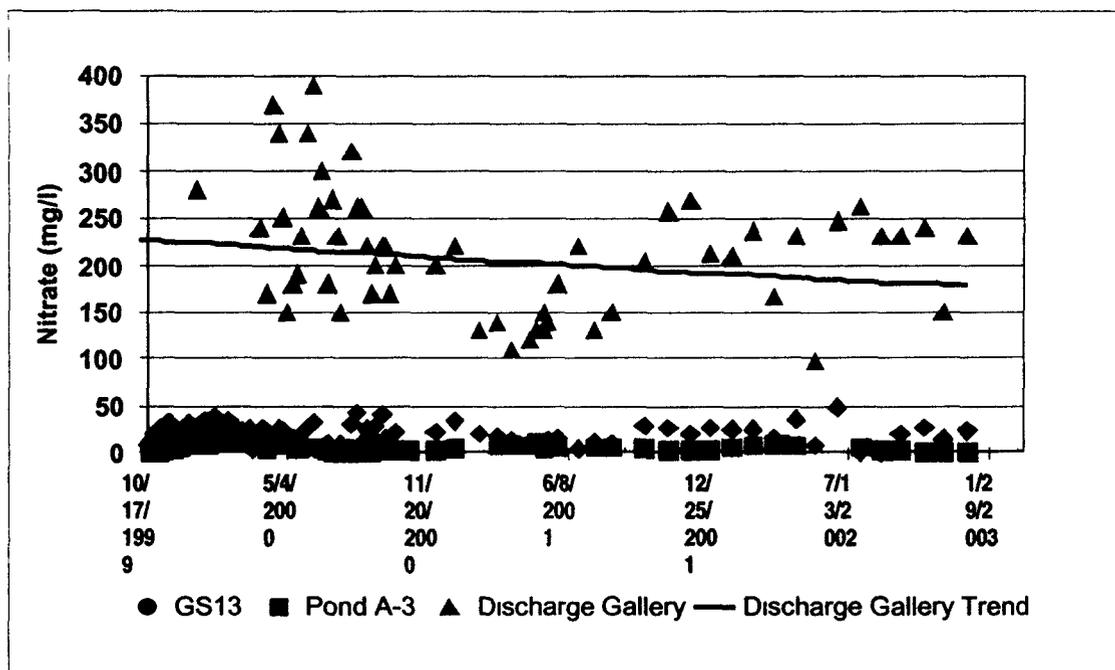
Figure 19. Nitrate Concentrations in Solar Ponds Surface Water Locations

As discussed above, the concentrations of nitrate at the discharge gallery are higher than the treatment system influent because the pre-existing, higher concentration portion of the plume is adjacent to the discharge gallery. As shown in Figure 19, there is a downward trend in nitrate concentrations at the discharge gallery, partly attributable to the lower concentration groundwater flowing into this area from the treatment cell.

The nitrate concentrations still remain well below the applicable surface water standard of 100 mg/l (DOE 1999) At Pond A-3, located downstream of GS13, nitrate concentrations have been declining steadily since March 2000, and they were below 10 mg/l throughout CY2002, even with less dilution from surface water than in past years, due to a lack of stream flow The concentrations are lower in Pond A-3 than GS13, probably due to dilution from downstream water sources and phytoremediation within the pond

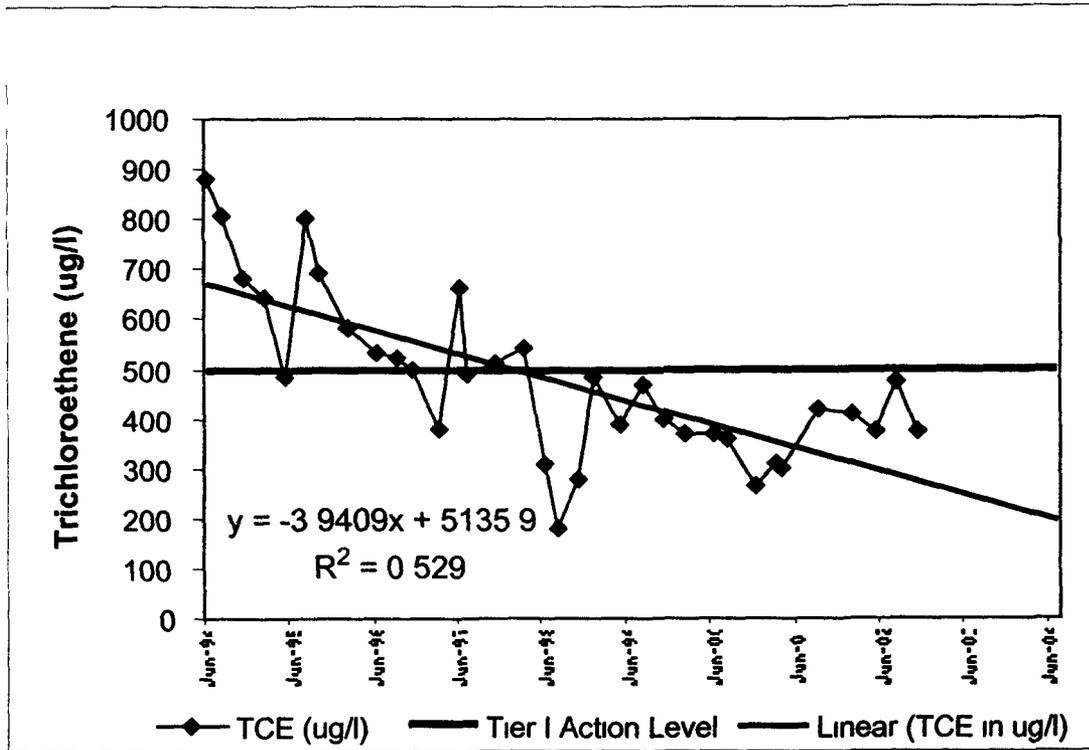
Figure 21. Trichloroethene Concentrations in the OU1 Collection Well

The Collection Well continues to be sampled quarterly. The CY2002 VOC analytes that are above detection limits are provided in Table 13. Figure 21 shows the trichloroethene concentrations relative to time. Figure 21 also illustrates the general trend of higher concentrations during dryer periods and the overall downward trend. Even with the continued drought, trichloroethene and other contaminants remained below the RFCA Tier I Groundwater ALs throughout the year.

Consistent with the modified CAD/ROD, the Collection Well was operated for one year after the signing of the Final Modification (DOE 2001). As of April 2002, collection of groundwater from the Collection Well ceased. Per the modified CAD/ROD, monitoring of the Collection Well will continue in order to verify that levels are below RFCA Tier I Groundwater ALs.

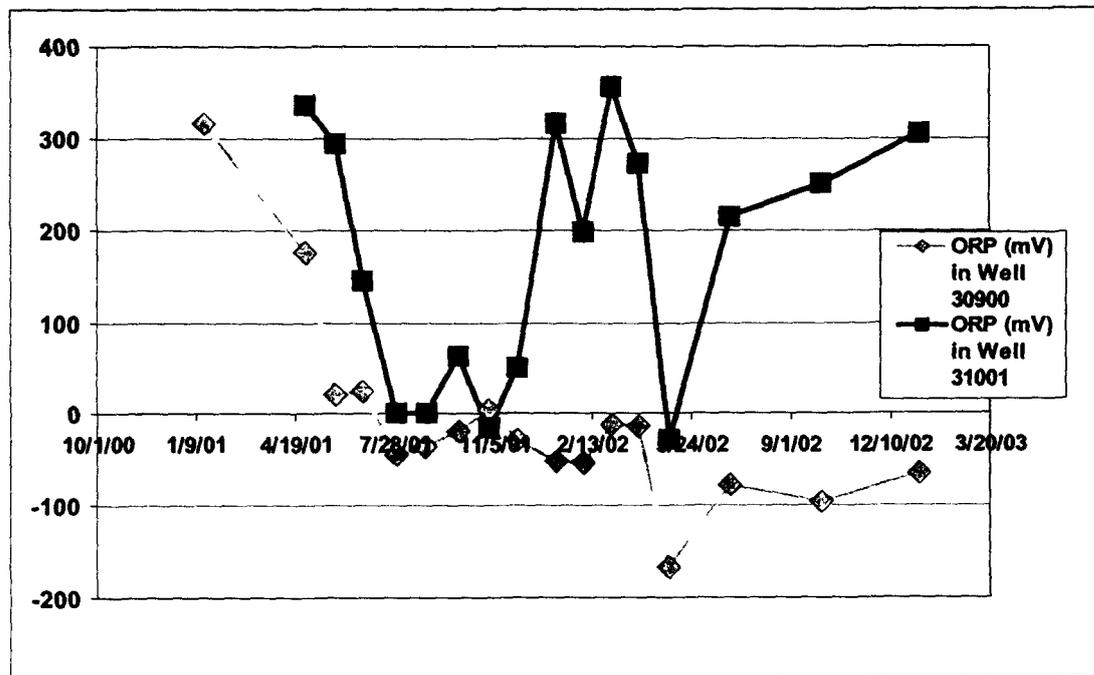
Figure 29. Oxidation Reduction Potential in PU&D Yard Wells versus Time

The area of anaerobic degradation appears to expand and contract with water table fluctuations. The area expands as the HRC[®] is released and contracts as it is consumed. Figure 29 shows how oxidation potential changes with time in both the source area well (Well 30900) and in the downgradient well (Well 31001). Reduced conditions in the source area well increased as the anaerobic bacterial community developed. Since it is at the center of the community, it has remained in a reduced state.

Downgradient, the area of reduced conditions increased but then contracted when the HRC[®] was consumed and the area of anaerobic degradation shrank. When the water table rose, and more HRC[®] became available, the area of reduced conditions again expanded. Figure 29 also shows seasonal variations in the downgradient well. When more HRC[®] was released in the Spring of 2002, the area of anaerobic bacteria expanded to include this well and the oxidation-reduction potential again dropped.
