Appendix A

Site Inspection Photographs

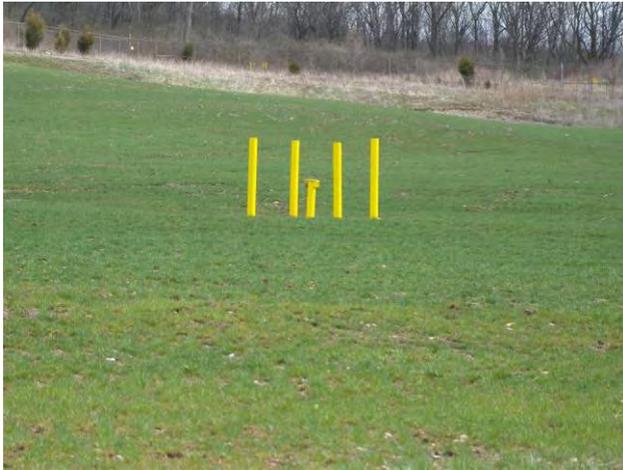
Well P015

Table A-3 and Figure A-2 list and show the locations of the OU-1 monitoring wells. Table A-4 contains photos of all wells. All wells were locked and in good condition.

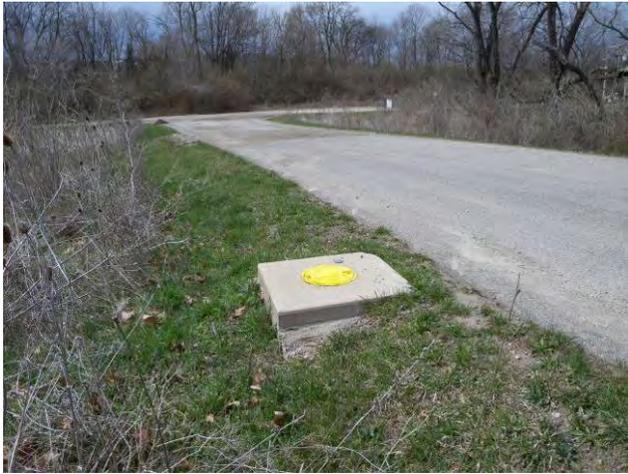
Well P033

All wells were locked, had permanent markers, and were in good condition.
