Appendix C

Site Inspection Photographs

1.0 Parcels 6, 7, and 8 Remedy Wells and Seeps

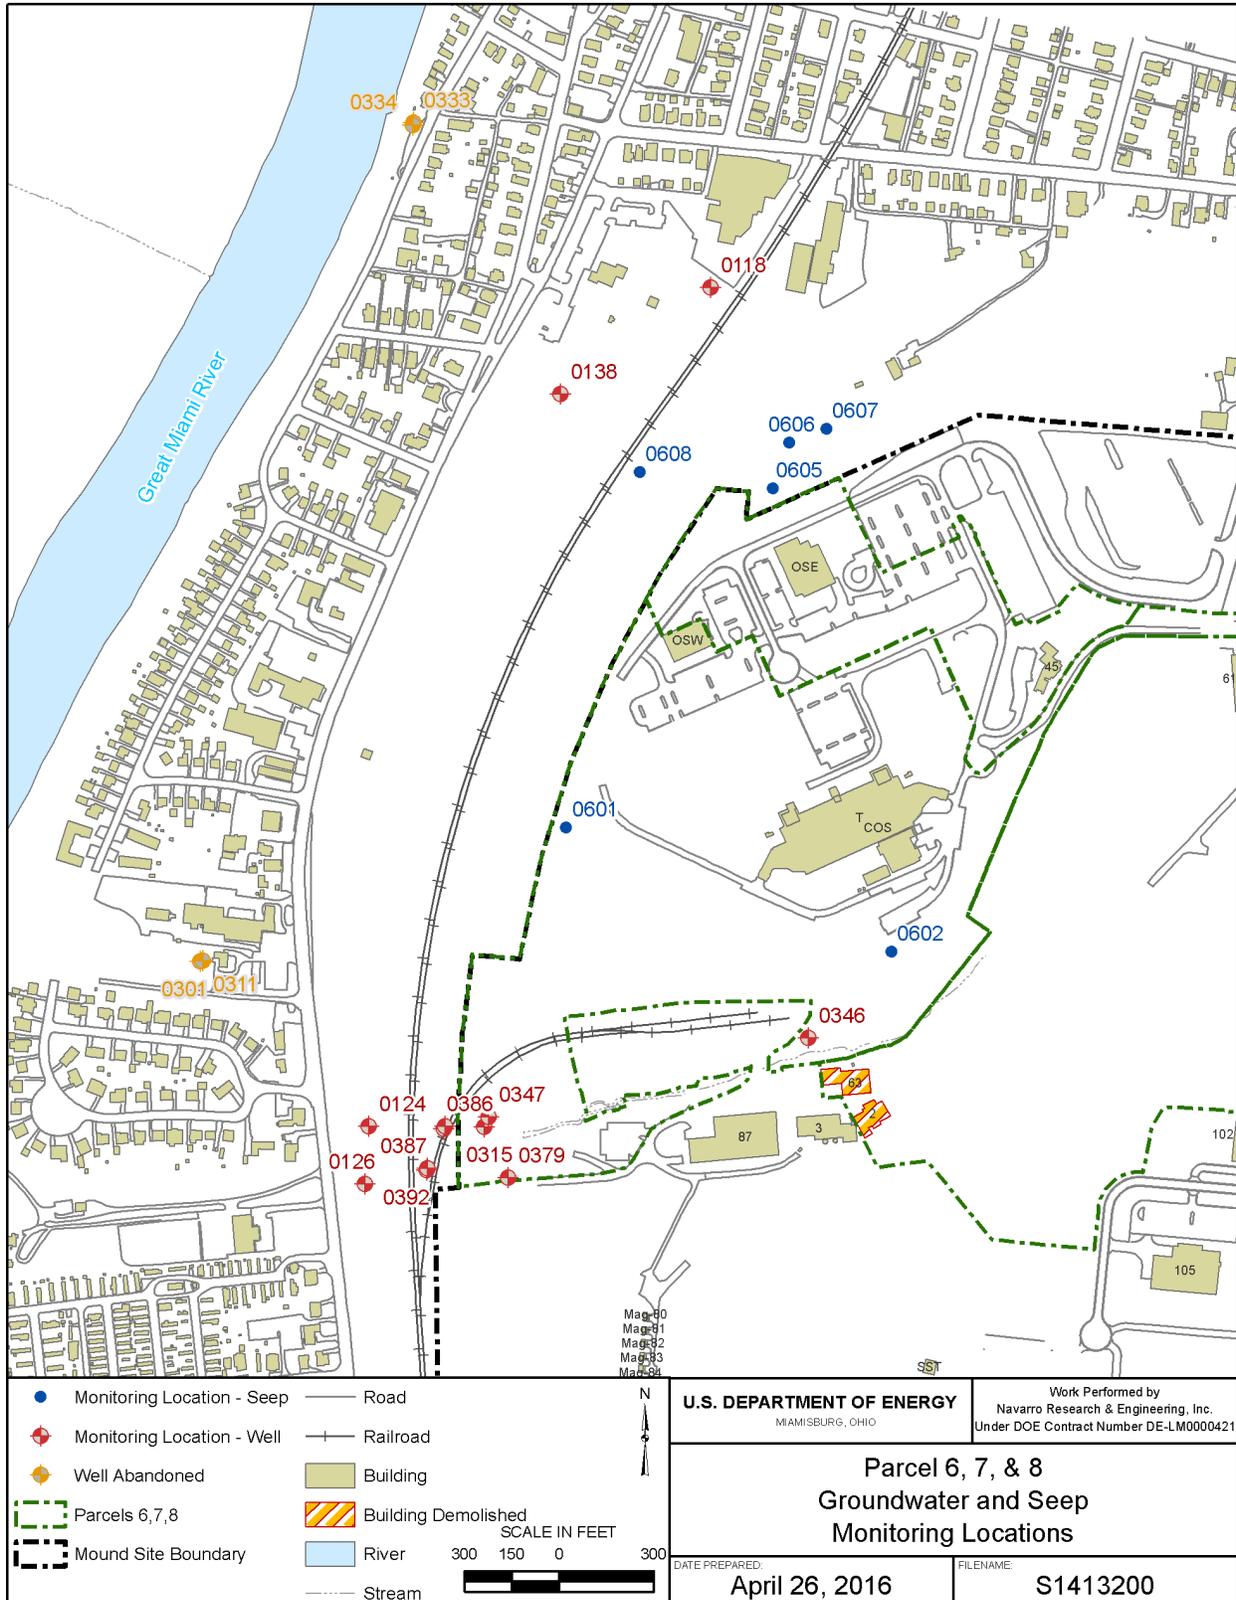
Figure C-1. Parcels 6, 7, and 8 Groundwater and Seep Monitoring Locations

Table C-1 and Figure C-1 list and identify the locations of the Parcels 6, 7, and 8 monitoring wells. Table C-2 contains photos of all wells and seeps. All of the Parcels 6, 7, and 8 wells were locked and in good condition and the seeps were accessible.

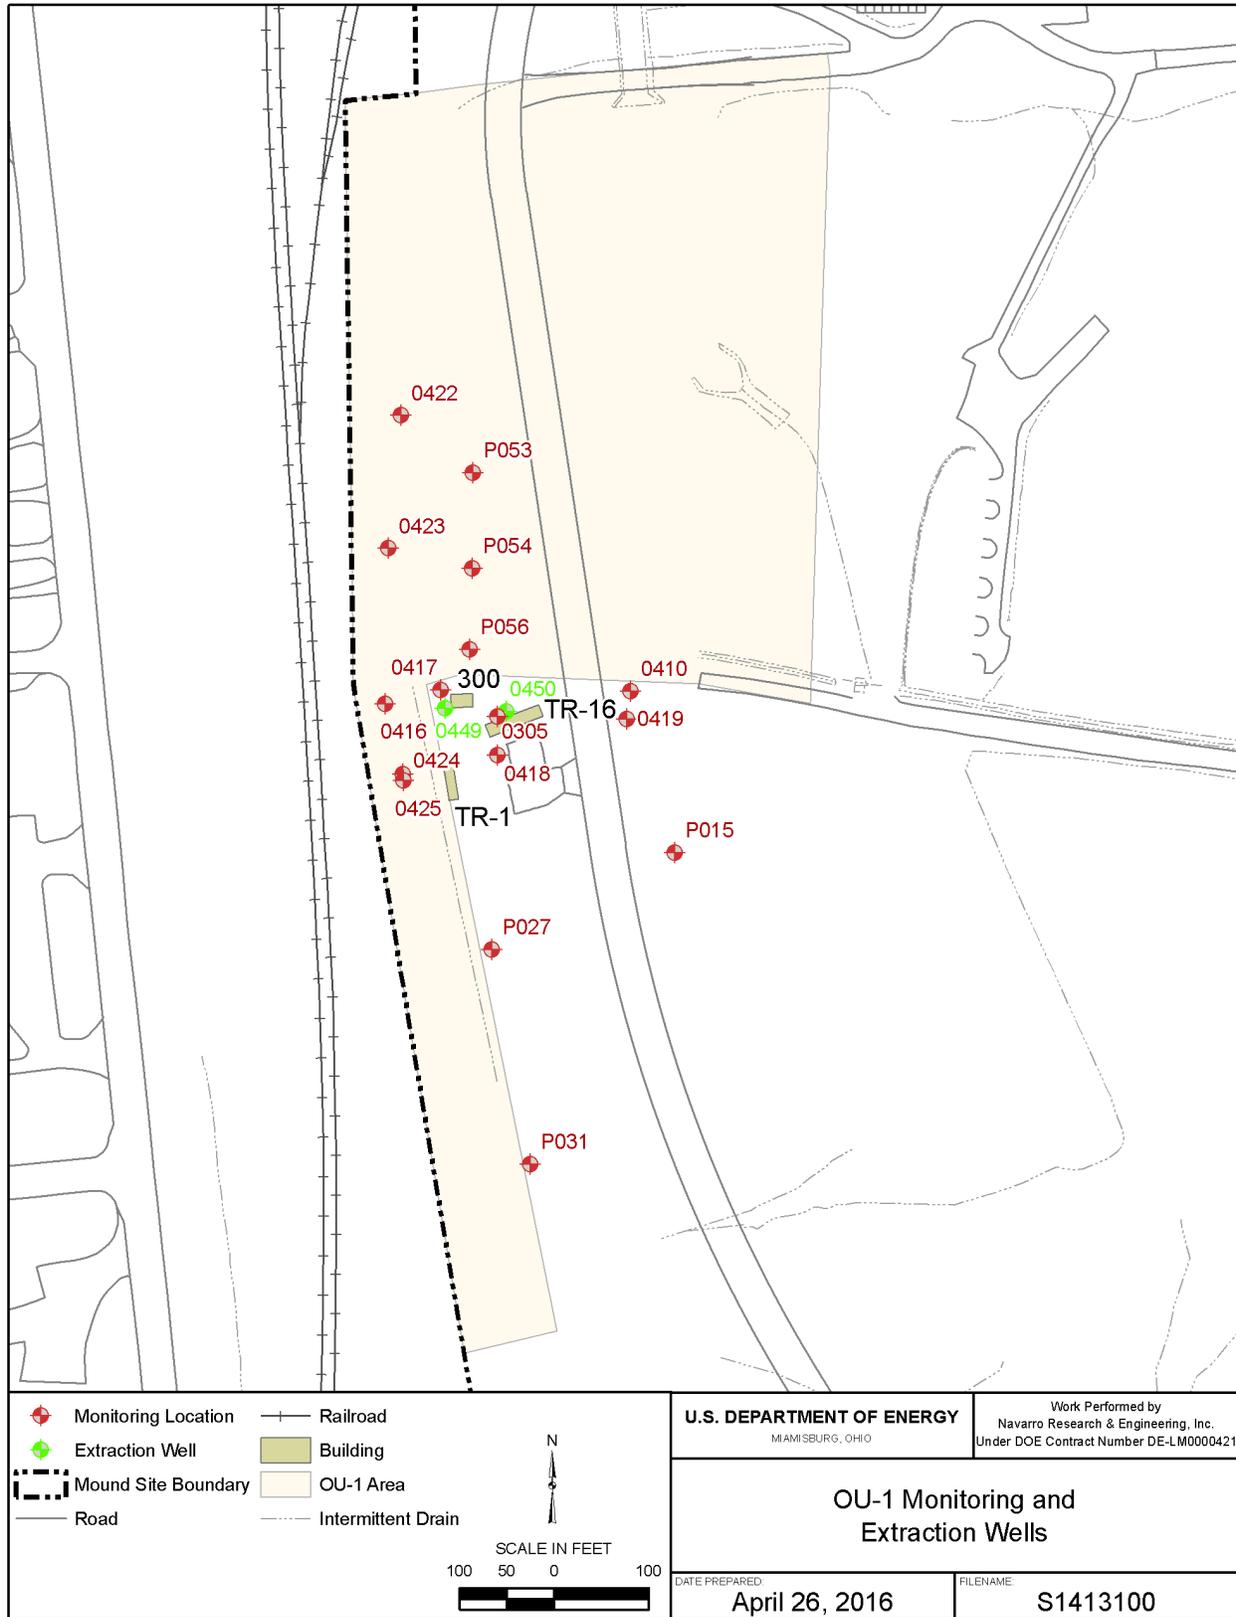
Figure C-2. OU-1 Monitoring and Extraction Wells

Table C-3 and Figure C-2 list and identify the locations of the OU-1 monitoring wells, including those monitoring wells added as part of the OU-1 Field Demonstration project that was initiated in 2014. Table C-4 contains photos of all wells. All wells were locked and in good condition.

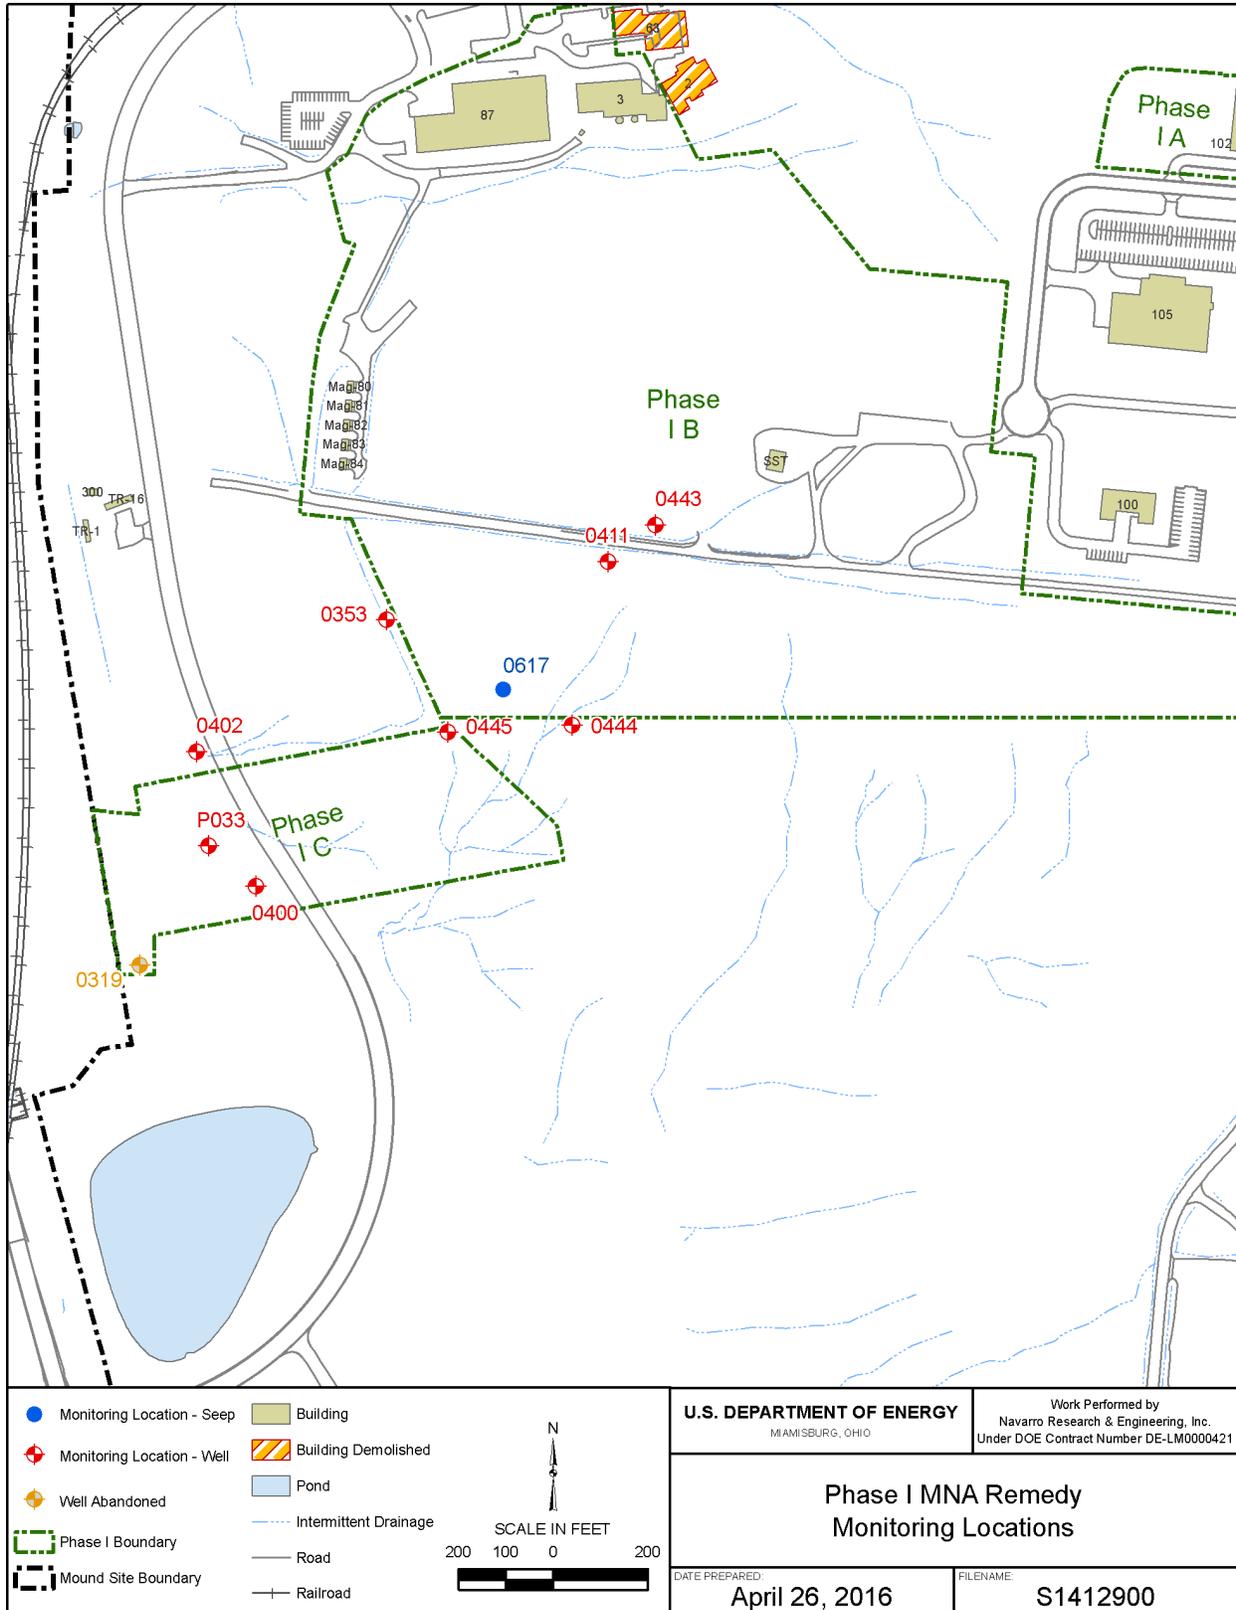
Figure C-3. Phase I MNA Remedy Monitoring Well Locations

Table C-5 and Figure C-3 list and identify the Phase I groundwater monitoring wells and one seep. Table C-6 contains photos of all wells and the seep. All wells were locked and in good condition.

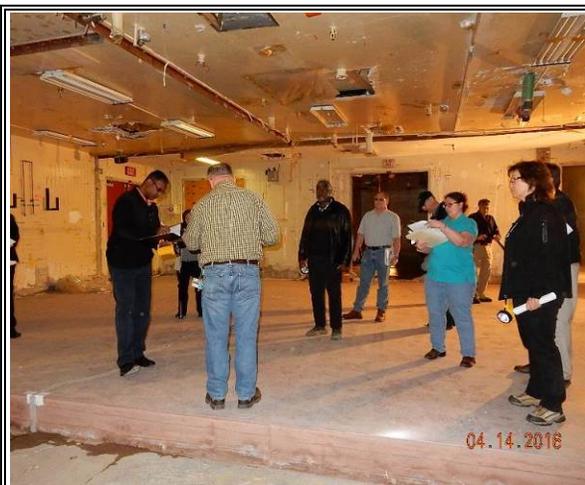
Anthony Campbell (Ohio EPA), Gary Weidenbach (Navarro), Larry Kelly (EMCBC), David Seely (EPA), Chuck Friedman (Navarro), Shannon Dettmer (ODH), Ken Armstrong (EMCBC) and Gwen Hooten (LM) examining red concrete cap in T Building during the site walkdown on April 14, 2016
