Technical Memorandum Regarding Instrumentation and Monitoring at the Rocky Flats OLF

Technical Memorandum

To:	Mr. Rick DiSalvo	From:	Heather Trantham, Ph.D. PE, Thomas A. Chapel, PE
Company:	S. M. Stoller Corporation	Date:	April 15, 2010
Re:	Instrumentation and Monitoring, Rocky Flats OLF	Tt Project #:	114-181750

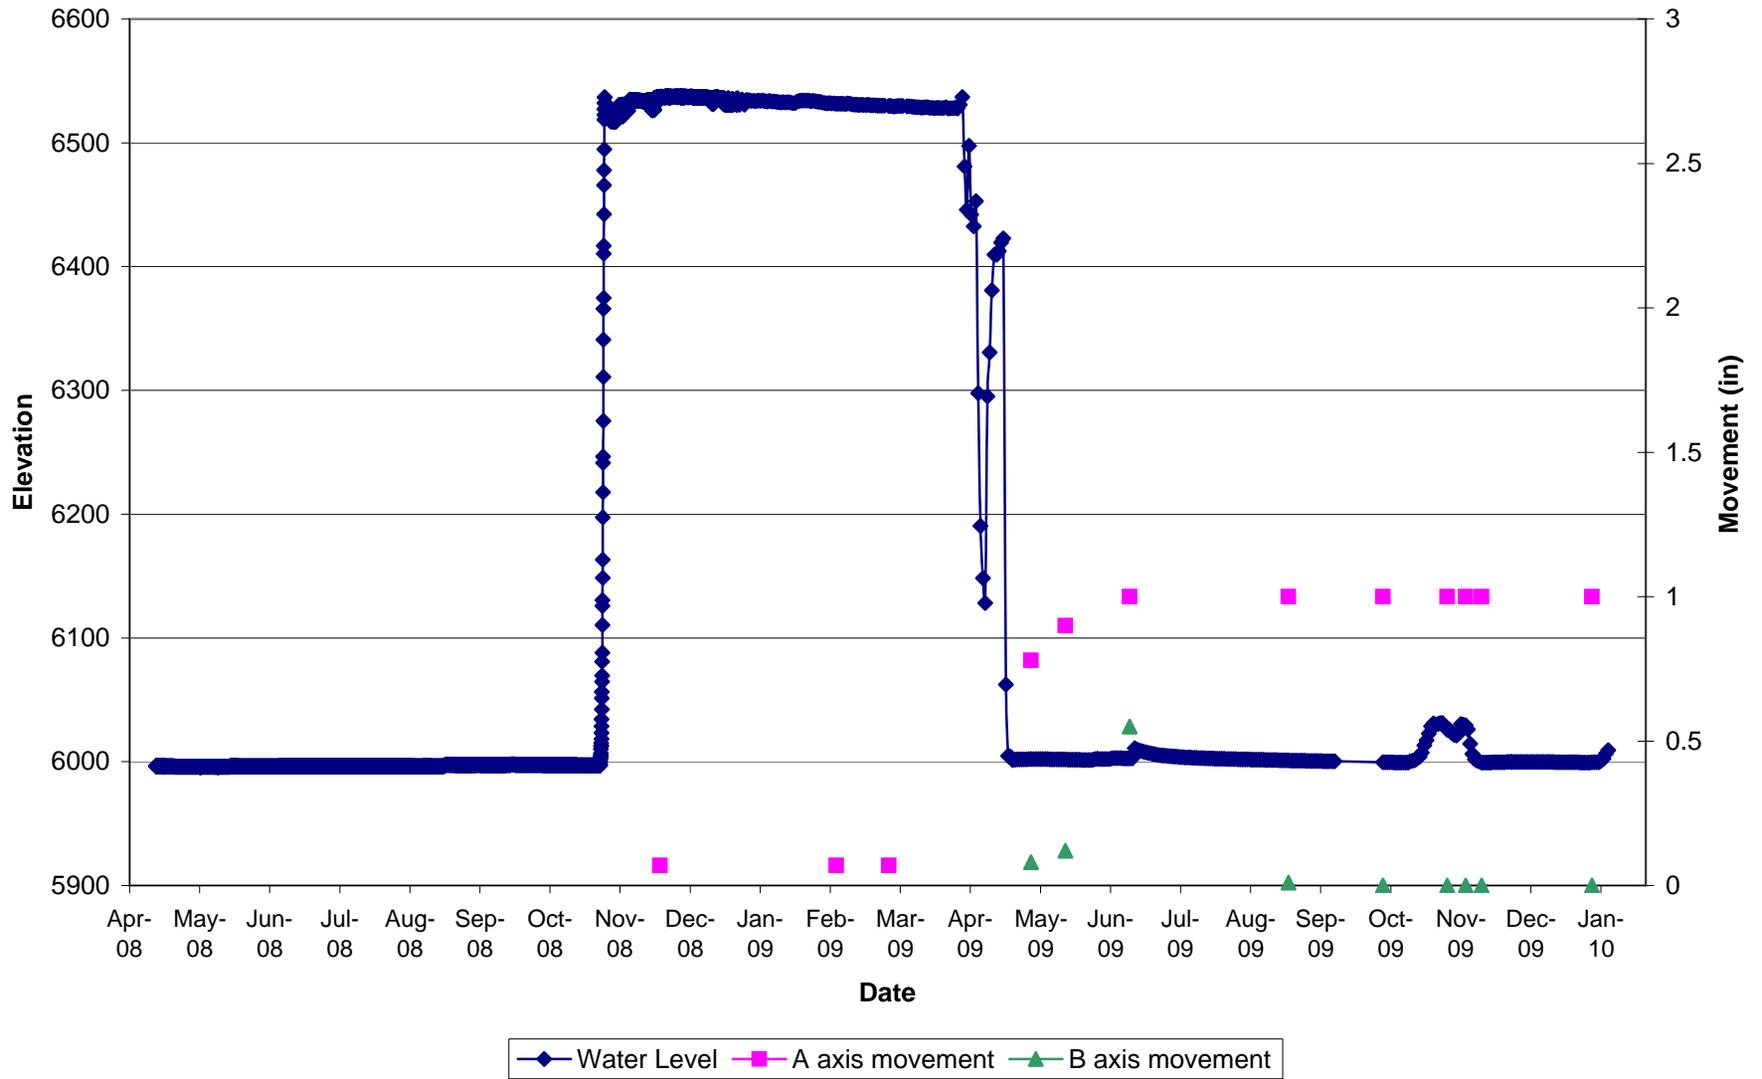
Unfiltered Inclinomometer and Piezometer Data: Tt-3

Tt-3. Movement in the direction of the A-axis started in November 2008, and movement in the B-axis direction started in April 2009. The maximum movement in both the A- and B- axes seems to coincide with a spike in water level that occurred on June 13, 2009. It is likely that the precipitation that caused the maximum movement occurred prior to the water level spike seen at this time. We are unable to verify this due to the erratic piezometer behavior prior to the end of April 2009. After the peak movement occurred, the movement seems to decrease in the A-axis direction even though there is a large fluctuation in the water level as measured by the piezometer in October and November, 2009. Movement in the B-axis direction did not correlate with the large fluctuation in the water table seen in October and November, 2009.
